FINAL PHASE I ENVIRONMENTAL PROPERTY ASSESSMENT REVISION 1 MILLINGTON
SUPPACT TN
1/23/1992
ENSAFE/ALLEN & HOSHALL

**PHASE I
ENVIRONMENTAL PROPERTY
ASSESSMENT**

**DAVID TAYLOR RESEARCH CENTER
MEMPHIS, TENNESSEE**

**CONTRACT N62467-89-D-0318
CTO - 021**

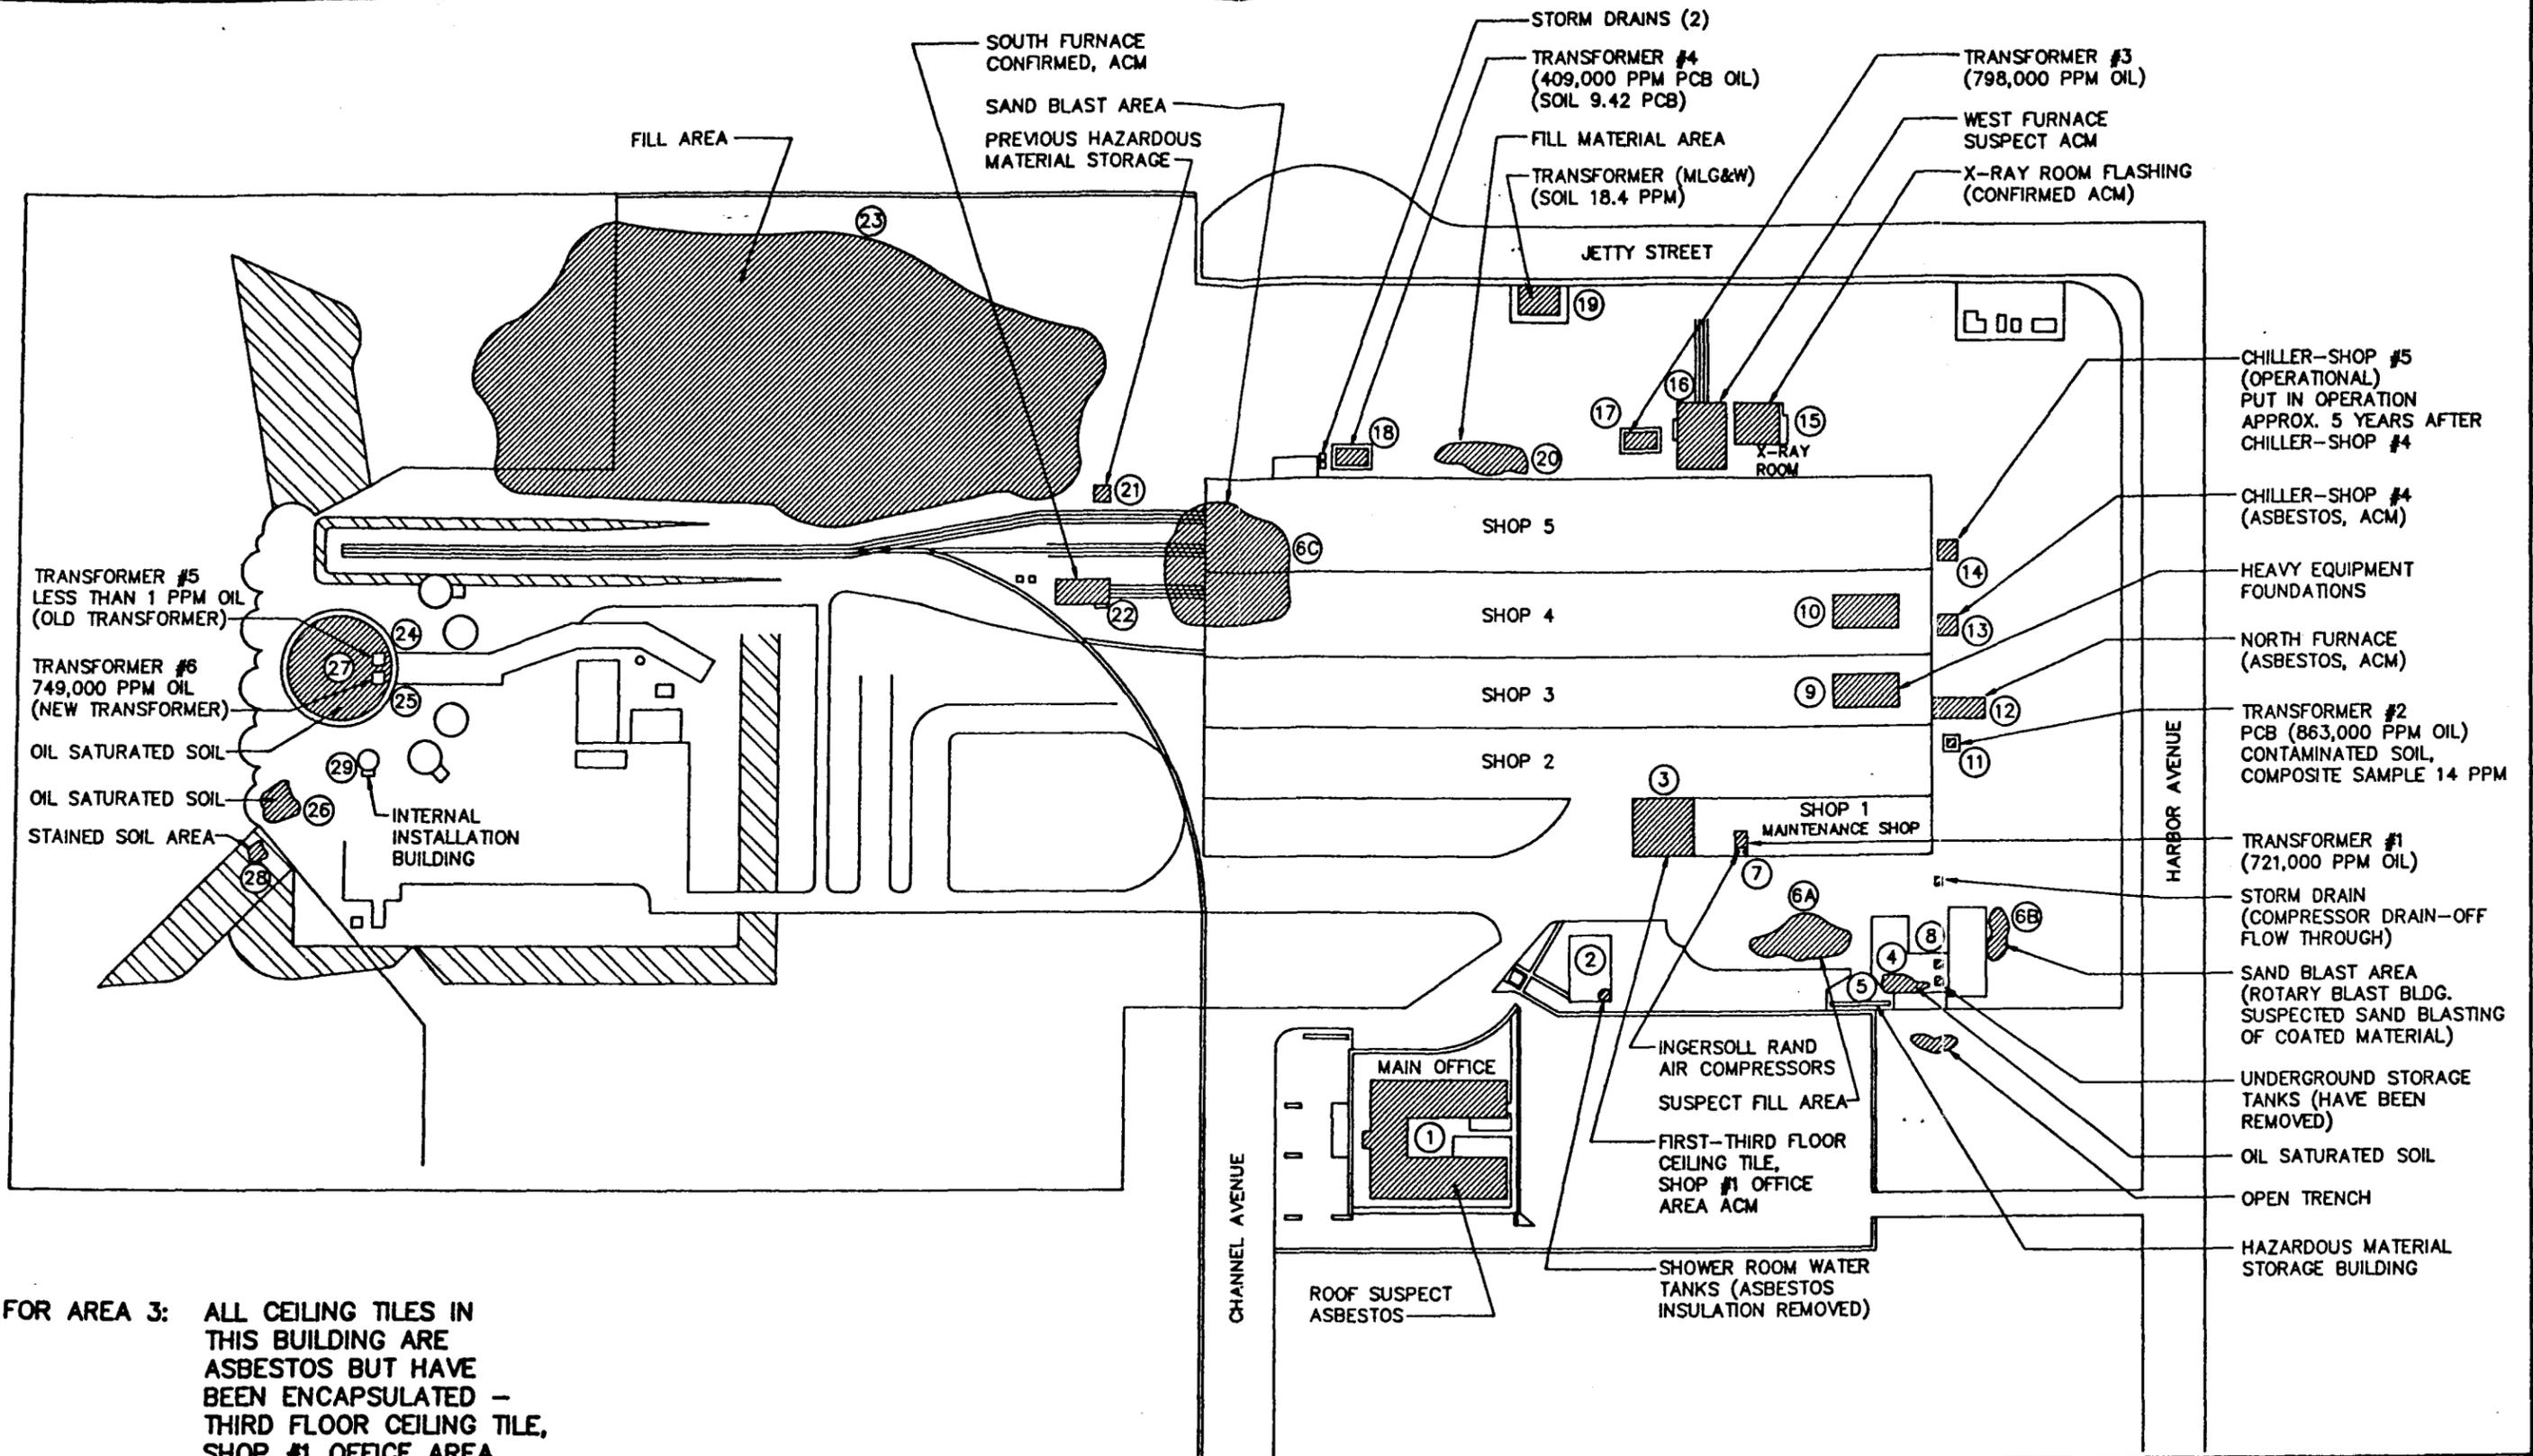
FIGURE - 1
FACILITY LAYOUT MAP
 DATE: 12/13/91 DWG. NAME: CLNCBI

This section outlines areas at the CBI Na-Con site that are of environmental concern and require further investigation or testing. Those areas can be located on Figure 1.

Area 4 and 8, the concrete pad and formerly located USTs storing diesel and gasoline have been reported by CBI to contain elevated levels of contaminants. CBI is currently conducting further investigation in this area through an outside consulting firm. E/A&H recommends conducting both soil and groundwater sampling in this general area to determine nature and extent of contamination. Previous tank removal documentation is provided as Appendix B.

NOTE FOR AREA 3: ALL CEILING TILES IN THIS BUILDING ARE ASBESTOS BUT HAVE BEEN ENCAPSULATED - THIRD FLOOR CEILING TILE, SHOP #1 OFFICE AREA HAS BEEN REMOVED. FLOOR TILE ON ALL 3 FLOORS IN THIS AREA IS SUSPECT ACM FLOOR TILE.

Area 5, the drum storage areas which were used for storage of solvents, petroleum products and hazardous waste, are areas at significant risk of contamination from spills and warrant further study. EnSafe/Allen & Hoshall (E/A&H) recommends that both soil and groundwater sampling be conducted to determine the full nature and extent of contamination in this area; analytical parameters should include total petroleum hydrocarbons (TPH), volatiles, and semi-volatiles.

Areas 9 and 10 are areas of large metal processing equipment foundations, with subsurface access to allow for maintenance of the machinery. E/A&H observed substantial leaking that had occurred from the Area 9 machine. E/A&H recommends that wipe samples be obtained from the walls and floors of these subsurface areas and analyzed for TPH and semi-volatiles.

Area 27, which is on the interior track area of the crane located at the south end of the property, has visible signs of soil staining. Site maintenance personnel reported to E/A&H during the site investigation that the crane uses hydraulic fluid that leaks from the equipment and drains to this interior track area. E/A&H recommends soil sampling be conducted in this area, and in other areas where oil staining or contamination is suspected to determine nature and extent of contamination; samples should be analyzed for TPH and semi-volatiles.

Area 26 and 28, also contain visible surface stains. The stains were again reported by facility maintenance personnel to have appeared after painting subcontractors had positioned a mobile air compressor in the immediate vicinity. Because the stains are suspected to be from oil leaking from

Areas 7, 11, 17, 18, 24 and 25, are transformers owned by CBI Na-Con located at the site. Four of these transformers have been documented as having contained polychlorinated biphenyls (PCBs); transformer #5 has been tested by CBI Na-Con and documented as not containing PCBs. Three of the on-site transformers (Areas 11, 18, 24) are either suspected or known to have leaked PCBs onto the soil and/or the concrete pads supporting the transformers. Limited remedial action has occurred at these areas and supporting documentation from CBI Na-Con is supplied in Appendix C. E/A&H recommends obtaining soil samples from areas surrounding the pads of transformers #2 (Area 11), #4 (Area 18) which are known to have had previous leaks. Although transformer #5 (Area 24) has been tested and documented as not containing PCBs it has been recorded as having previously leaked. Therefore, E/A&H recommends sampling of the area surrounding this transformer to confirm that the transformer did not at one time contain PCBs which may have leaked causing contamination. E/A&H further recommends that soil samples be obtained from the areas surrounding transformers #2, #4, and #5; these samples should be analyzed for PCBs and TPH.

Areas 1-3,12-13,15-16,22, 29, 31, are areas throughout the facility which are either confirmed or suspected areas of having asbestos containing materials (ACM). Portions of the areas with confirmed ACM have had abatement of the ACM performed, while other areas or certain materials in previously surveyed areas have not been adequately surveyed. All available documentation from CBI Na-Con is provided in Appendix D. E/A&H recommends conducting a detailed asbestos visual survey of the complete facility and bulk sampling of homogeneous areas suspected of containing ACM. E/A&H further recommends having the asbestos contractor provide recommendations on corrective action in ACM areas.

Areas 6A-C, where sandblasting operations occurred or where the spent sandblast material was disposed, are at a significant risk of being contaminated with metals. Therefore, E/A&H recommends obtaining

Areas 32, identifies all storm drains located around the exterior grounds of the CBI Na-Con property.. Due to the previous manufacturing activities at the site and known wastewater discharges at the facility during operation, E/A&H recommends conducting limited sampling at these locations by obtaining sediment samples from all storm drains located on the CBI Na-Con property. E/A&H further recommends analyzing these samples for TPH and metals.

Area 19 A and B, are areas where suspected creosote coated railroad ties have been stored. These railroad ties were removed from the railroad on the site property and have not been disposed. Although leaching of constituents from the ties is possible, this possibility is regarded as remote. Sampling conducted in this area would need to be accomplished in close proximity to the ties, due to the lack of horizontal migration associated with creosote constituents. E/A&H recommends performing only limited sampling in these areas, analyzing samples obtained for semi-volatiles.

Area 30 A-E, are silos used for testing the pressure vessels once fabricated at the site. During the fabrication of these vessels, processing included the use of lubricants and processing oils, cleaners, sandblasting and paints. Therefore, E/A&H recommends sampling the sediment remaining in the silos to ascertain the level of any contamination. These samples should be analyzed for metals, TPH and semi-volatiles. The age of these silos would also suggest that they had been painted at some point with lead based paint. E/A&h recommends obtaining a bulk sample of paint from the silos to analyze for leachable lead.

Area 31, is the building in which demineralization of water used during testing was performed. This process consisted of two demineralizing tanks and a boiler. The process used heat exchange and filtering to remove minerals from the water, the pH of this water was then adjusted by adding caustic solution. Thus returning the water to an approximate pH level of 7 (neutral). This operation ceased in 1980 at
