## Naval Facilities Engineering Command Northwest

# Safety Lessons Learned Accident Abstract

**Accident Type:** Natural Gas Boiler Catastrophic Failure - explosion

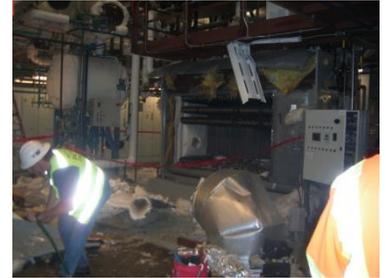
On 11 September 2012, boiler installation subcontractor was nearing overall completion of the installation of two Bryan Model EB -200-boilers, outfitted with Riello RLS-250 burners, at the Naval Hospital Bremerton. The subcontractor was initiating boiler performance testing on boiler #2 and was providing training to BOSC personnel and demonstrating boiler performance to the boiler burner manufacturer –Riello. Boiler technicians were unable to attain the required combustion rate and the subcontractor noted the boiler's inability to fire off at high fire specification requirements. At 1520 Boiler #2 explodes during the high fire evolution, which forced the combustion chamber doors to blow off into the mechanical room. The exhaust flue was destroyed by the shock and anchor bolts separated from boiler's foundation. Adjacent equipment in the mechanical room suffered collateral damage and luck yielded no serious injuries - seven contractor personnel present at time of the explosion.

- ◆ Burner manufacturer/vendor stated the addition of a Gas Pilot Ignition Assembly (GPIA) for the North American market to a burner proven in the European market caused the flame to separate from the burner combustion head during high fire operations, enabling the accumulation of unburned fuel.

Having identified that the boiler system was not performing properly the installation technicians manipulated the control system well beyond what would be considered normal adjustments when tuning a new boiler.

- ◆ Manufacturer's publication of faulty performance specifications for RLS-250 model burner after integration of a GPIA for the North American market.

- ◆ The prime contractor did not effectively control personnel presence, failing to recognize performance testing as a high risk activity.
- ◆ The troubleshooting steps identified and employed should have raised a red flag and/or triggered questions for a higher level decision maker or a more qualified boiler technical specialist / mechanical engineer.
- ◆ Detailed planning is required prior to initial boiler run-up testing and demonstration to ensure proper operational risk management is conducted – determine indicators requiring testing securement and ensuring only essential personnel are present during testing.
