Initial Near-Miss Notification Report

1-Name of activity, installation, and exact location where incident occurred:
ROICC Miramar, MCAS Miramar, B-6310 Parking lot area

2-Name of contractor, title of contract, and number of contract:
Romero General Construction, Demolition of asphalt, N62473-09-C-3412

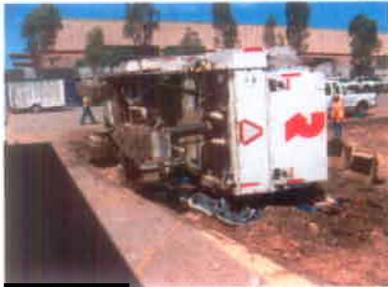
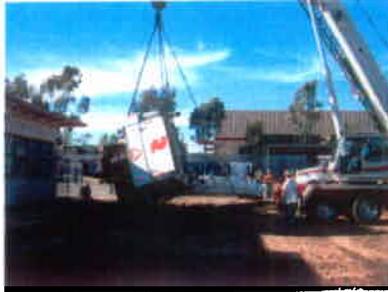
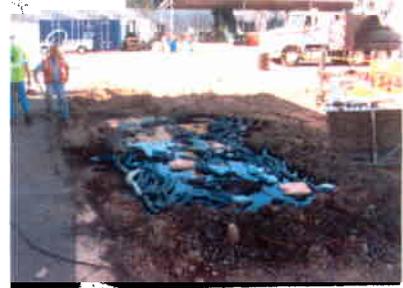
5-Brief description of the incident (Include Photographs if available):
Equipment Operator was backing the grinding machine into position between the building and the last pass of removed asphalt to complete final pass of asphalt removal.

The Equipment Operator (sub-contractor) positioned the machine too close to the already removed asphalt which was approximately 12" deep from the existing asphalt the machine was traveling on. There was no spotter provided.

The weight of the machine (60,000 lbs) caused the edge of the asphalt to collapse causing the machine to slip into the 12" opening and the momentum of the tip of the machine caused it to roll over on its right side.

6-Extent of property damage: Cosmetic damages to the operator station ladder, track fender and various areas of damage throughout the under carriage that was created by the tip over and the removal and up righting by a crane. Grinder is currently onsite pending further investigation of damages and site specific plans on how to safely remove equipment from the site and load onto low-boy trailer for transport.

10- Follow up Actions to be taken: Contractor held a Safety Stand-Down on 21 April to discuss best working practices. The stand-down was conducted by Primary Contractor Site Safety Officer (Dustin Danbury).

12- Initial Lessons learned - (FINAL LESSONS LEARNED FORMAT - WITHIN 30 DAYS - SEE SAMPLE ON PAGE 9): Good communication is essential when heavy equipment is in use. The equipment operator must always recognize the limitations of the equipment he operates. The awareness of the operating area, environment and potential hazards by both the equipment operator and spotter are essential prior to commencing work.
