Naval Facilities Engineering Command, Mid-Atlantic **Safety Lessons Learned Accident Abstract**

Accident Type: FIRE
Injury: NONE
Damage: NONE (BLDG
BEING
DEMOLISHED)
Type of Work: DEMOLISHING
WWII ERA
HANGAR
Equipment: EXCAVATORS

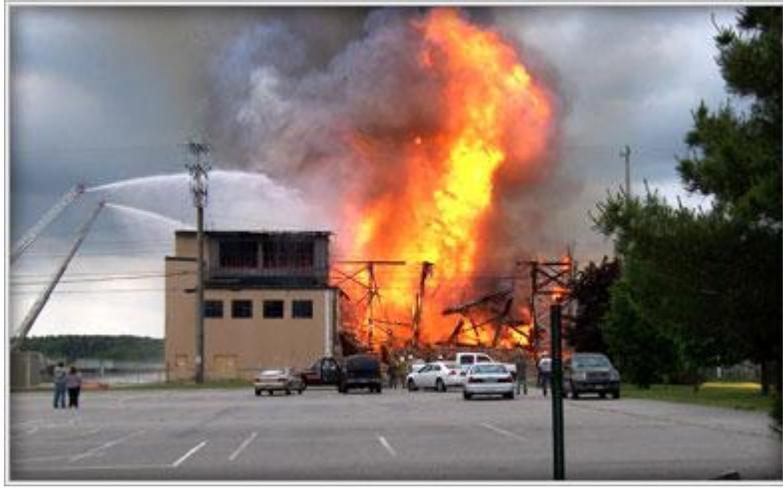
- ◆ A 3 story wooden WWII era Aircraft Maintenance Hangar was in the process of being demolished, with the east side and 2 quadrants of the roof previously removed. The demolition subcontractor was actively separating structural steel from the dropped roof section when the excavator operator discovered smoke rising from the debris. Unsure if it was smoke or dust, the excavator operator lifted some of the debris with his excavator to investigate and the fire flared up. One of his co-workers to spray with the charged fire hose that he was using for dust suppression. The excavator operator then noticed that the fire had also flared up in the original debris location. Contractor attempts to extinguish the fire with the fire hose and with a 4A:80B:C fire extinguisher was futile. There was no damage to Government property since the facility had already been turned over to the contractor for demolition and disposal.

- ◆ The fire department performed an investigation of the suspected fire origin area. However, it was impossible to conduct any type of forensic investigation to determine the exact point of origin or any type of potential evidence. Therefore, based on witness statements, interviews, and site investigations, the fire department has listed the official cause of the fire to be “UNDETERMINED – NOT SUSPICIOUS”.

- ◆ The building’s wooden timbers and rubber membrane roof proved to be very flammable.

- ◆ Since it was somewhat windy that day, it's likely that the weather conditions contributed to making the fire burn as quickly as it did.

- ◆ **Unknown.** There is speculation that metal on metal contact or heat generated from bending metal during the demolition operation may have inadvertently created a spark that smoldered in the debris until the excavator exposed the spot to the air and it flared up. However, this is only speculation.

- ◆ The Accident Prevention Plan and the Activity Hazard Analysis should have been more specific to anticipate the flammability of the hangar building, particularly the wooden timbers that had not been exposed to water for over 65 years.

- ◆ Although the demolition contractor was spraying the debris with water for dust suppression and fire prevention, the water was primarily wetting only the surface of the debris. The rubber membrane roof in the debris limited the water from reaching the debris below it.

- ◆ In hindsight, the wooden building timbers could have been sprayed with water from the inside of the building prior demolition. However, this likely would not have changed the outcome since it would only have dampened the outside of the wood and the inside of the timbers would have remained bone dry.

- ◆ The charged fire hose used by the contractor for dust suppression and fire prevention was difficult to move with just one individual. The site superintendent helped the hose operator move the hose, but it was too late to have any meaningful effect on the fire.
