Atlantic Division, Naval Facilities Engineering Command

FLASH WARNING - This could happen to you -

ACCIDENT ABSTRACT

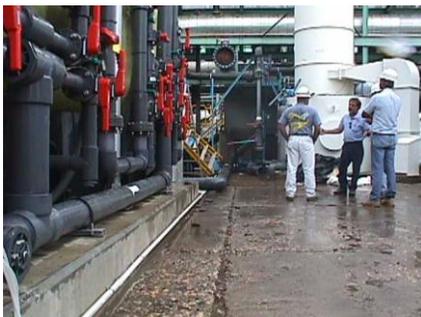
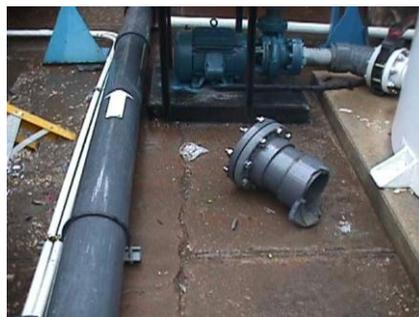
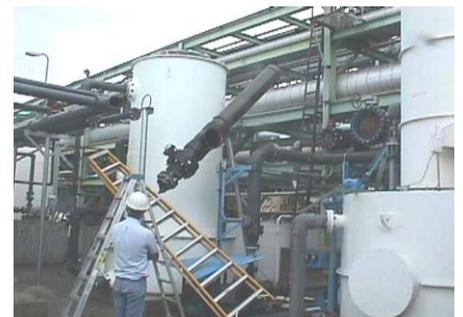
A service contractor was awarded a design build contract to upgrade a reverse osmosis (RO) water purification system. The contractor provided drawings detailing steel piping for the intake of seawater. During construction, the contractor changed the piping configuration allowing for PVC and Fiberglass piping to be used instead of the originally designed steel piping. During a required hydrostatic test procedure in which the pipe was to be pressurized to 100 PSI, a violent pipe failure occurred, causing the pipe to explode, sending rigid plastic fragments in every direction for hundreds of feet. One fragment contacted a passer by, not associated with the construction effort, resulting in a severe laceration to the head.

The test procedure did not allow for the release of entrapped air as required by the pipe manufacturer printed instructions. Instructions called for the placement of vents in piping high points where entrapped air is likely to occur. Entrapped air was created during the filling of the pipe with water for the pressure test. It is crucial that PVC pipe test procedures include provisions for the venting of entrapped air at the system high points to ensure the potential violent release of energy, due to the rapid displacement of the air from the water being pressurized, is prevented. Please refer to USACE EM 385-1-1 - 20.A.04 and printed manufacturer instructions.

The designer of record hired by the contractor did not submit revised drawings for review prior to changing the piping configuration.

Air or gas in PVC piping from any source is to be avoided. PVC pipe fittings do not have an established ASME rating. Letters to OSHA from similar mishaps describe the violent release of energy like an explosion, where in one example, the shrapnel of plastic flew 27 feet in the air and across a plant 60 feet embedding itself in an industrial roll of paper. This violent force, though published as common by manufacturer organizations has not been appropriately distributed throughout the construction industry.
