**PWD Pensacola
Safety Investigation Board**

**BRAC-CSO Bachelor Housing
Project**

Prepared for RDML Slates

28 October 2011

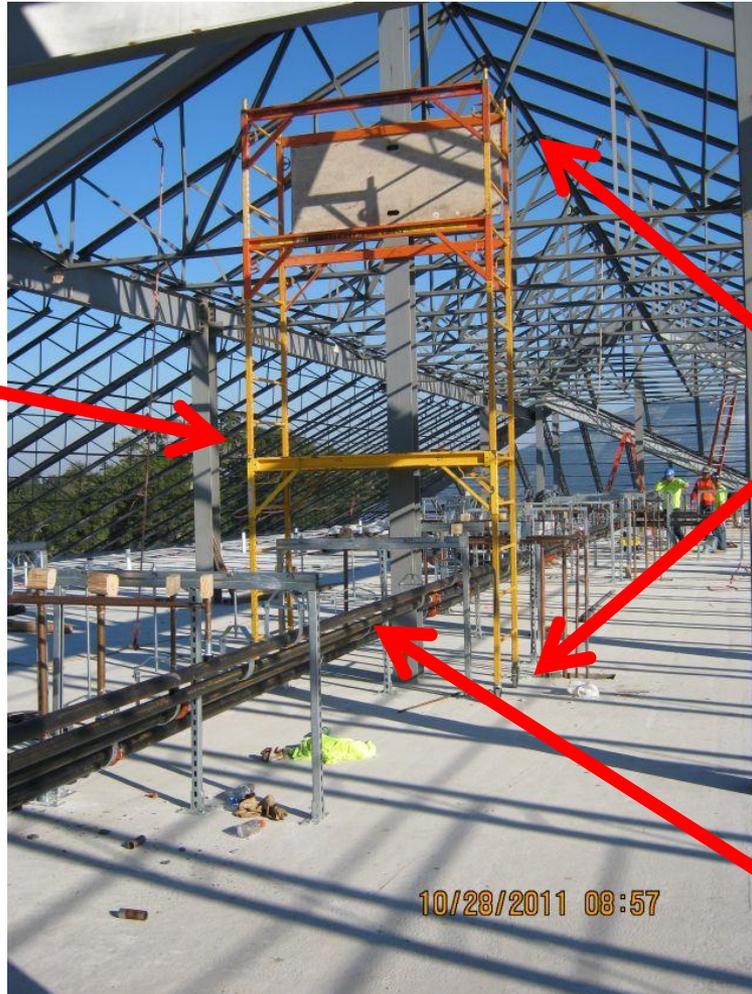
Mishap Site Drawing (Ground View)

Scaffold platform

Height = 14' 6"

Piping where
employee landed

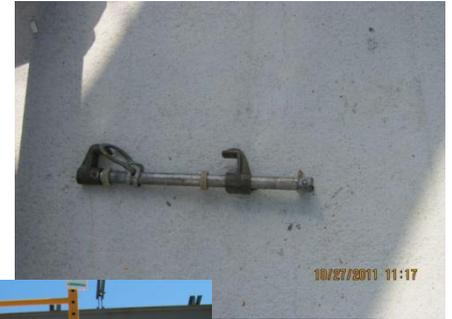
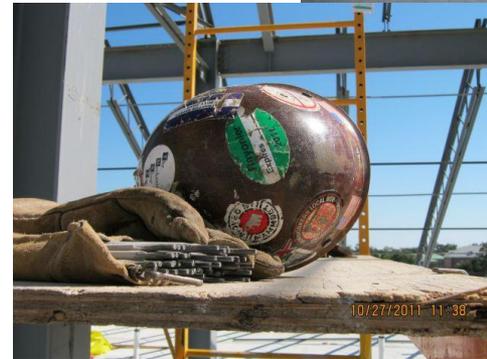
- Steel workers had erected scaffold under supervision of Competent Person
- Scaffolding components from at least two manufacturer's
- **AHA for specific task did not cover use of scaffold**
- Injured worker was one of two erectors on the job
- **Platform dislodged upon IW standing up on platform.**
 - Panel dropped away like a “Trap Door”.
 - No retaining clamps holding platform
- Scaffold exceeded 3:1 height limitations (22.C.06.e)
 - No outriggers

- Worker on the scaffold was equipped with the following PPE:
 - Personal Fall Arrest harness lanyard and beamer
 - Hard hat, safety shoes, glasses, gloves, safety vest, and hearing protection
- **No fall protection used while erecting scaffolding**
- Scaffolding competent person is CN Construction Supervisor
- **CP failed to inspect/sign off on scaffold prior to employee climbing on platform**

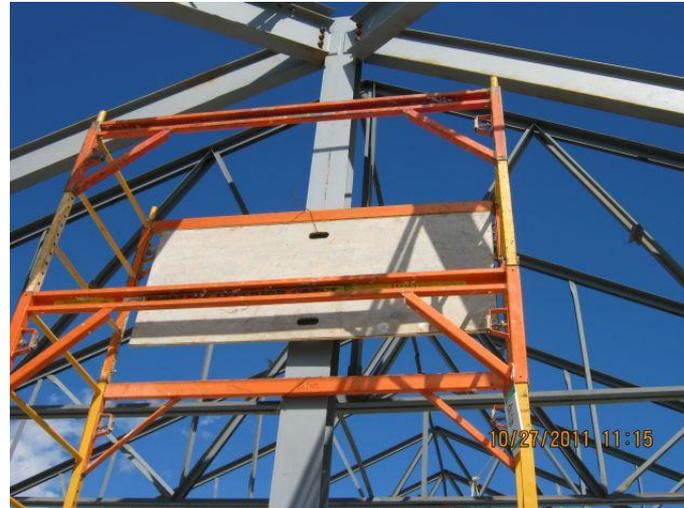
Direct Cause of Incident

- Scaffold platform became dislodged and collapsed
 - Scaffold platform designed to set into channels on each side brace
 - Platform clips should be rotated to prevent platform from becoming dislodged
- **WARNING:** *Recheck platform to be sure it is properly seated within side brace channel and the platform clips are fully engaged before accessing.*
(Ref: Safety Rules and Instructions for UST Multipurpose Scaffold)

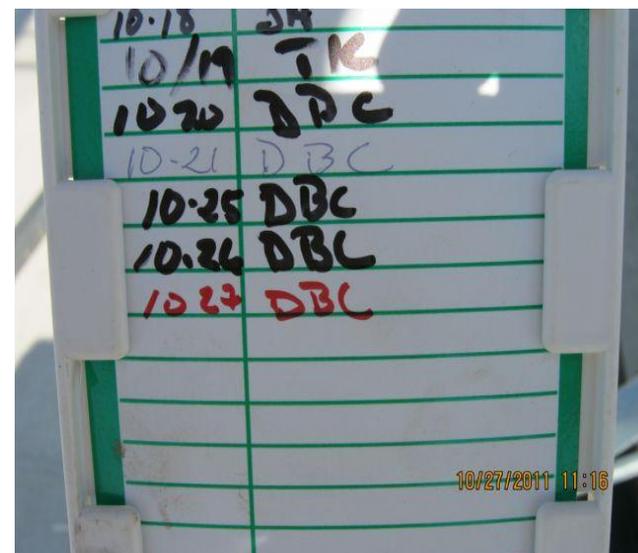
Root Cause of Incident

Scaffold was not inspected prior to employee getting on platform to set fall protection

- Tags applied to scaffold were invalidated when the scaffold was dismantled and relocated
- Competent person did not inspect scaffold after it was erected at new location
- Scaffold tags indicated scaffold was ready for use
- When scaffolding is used by another contractor tags should be removed

- **Fall protection devices should have been erected prior to erecting scaffold.**
 - Use of extension ladder would have allowed employee to connect a retractable device to overhead structure.
- **No one should access a scaffold until CP had inspected and signed off on tag system.**
 - CP must be from the company using the scaffold or designated to provide service.
- **Properly evaluate site-specific hazards to determine engineering controls and correct equipment for the task**
- **Properly plan all phases of work (include updating AHAs), especially when conditions change**
- **Ensure On-the-job training or weekly training provided by competent/qualified persons incorporated into scheduled training**

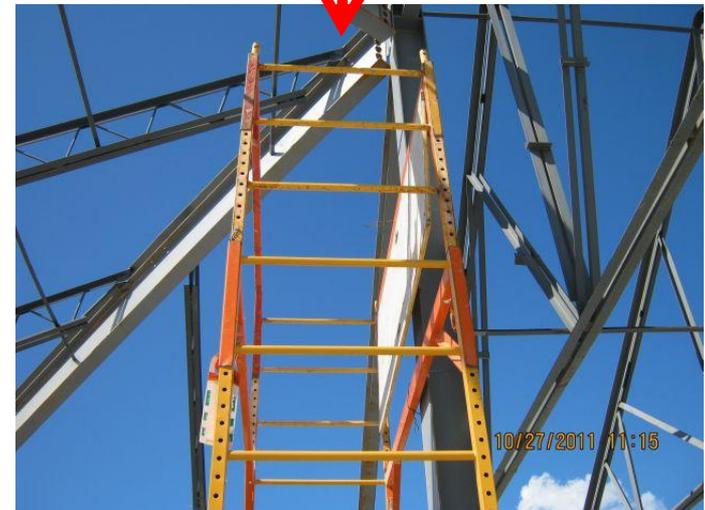
- No task specific AHA
- Exceeded 3:1 Height/Base requirement. Workers on scaffold at 14' 6" not tied off
- Decision to use scaffold to install fall protection
- Rework activity (Steel erection progressed to Building A)
- Had not previously used this scaffold
- Components from multiple manufacturers
- Scaffold inspection tag left on from previous location

Employee attempting to put beam clamp on horizontal member.
