## NAVFAC NW MISHAP HEADS UP INITIAL NOTIFICATION

NAVMAG Indian Island, at magazine 58.

Mowing brush

12/12/2007 @ 1345

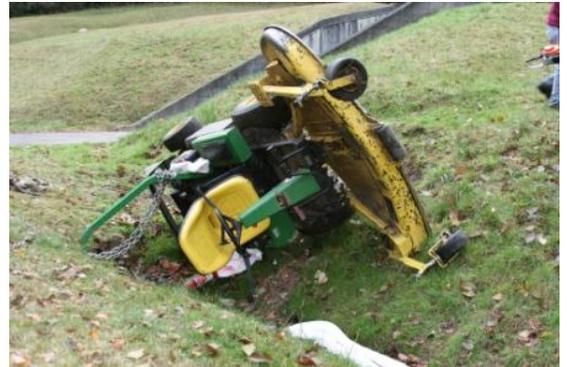
KTR EE was operating a 72-inch riding lawn mower for contract cutting. He was mowing brush on magazine #58 on East Road. While attempting to drive up the incline on the magazine the mower slid on the wet grass and mud. The mower rolled over near the ditch and came to rest in the ditch. The driver jumped off of the lawn mower prior to the rollover. The supervisor was on site and checked the individual driver for injuries, there were none.

Complete a magazine site evaluation for equipment use and dangerous locations prior to start of next season. Consider using high angle mowing machinery.

Ensure all equipment operators are familiar with the operating parameters of their equipment...this could be determined via manufacturer's equipment manuals, regulatory requirements, hazard analyses, past mishaps/near misses.

Review equipment application for this project...another piece of equipment may be more suitable

Assess operating environment...wet grass, steep slopes, moving wheeled equipment equals higher slide potential.
