Naval Facilities Engineering Command, Mid-Atlantic

Safety Lessons Learned Accident Abstract

Accident Type: Employee finger mashed between log and wood chipper infeed chute edge

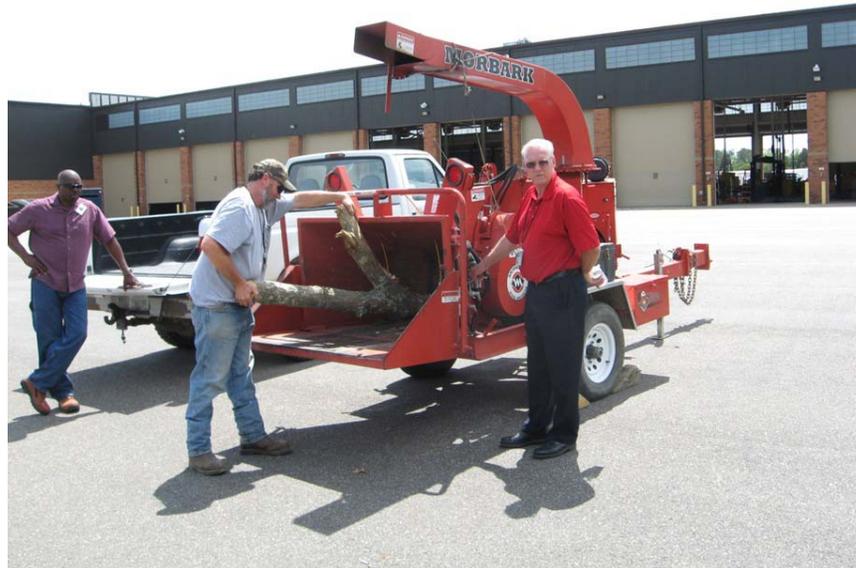
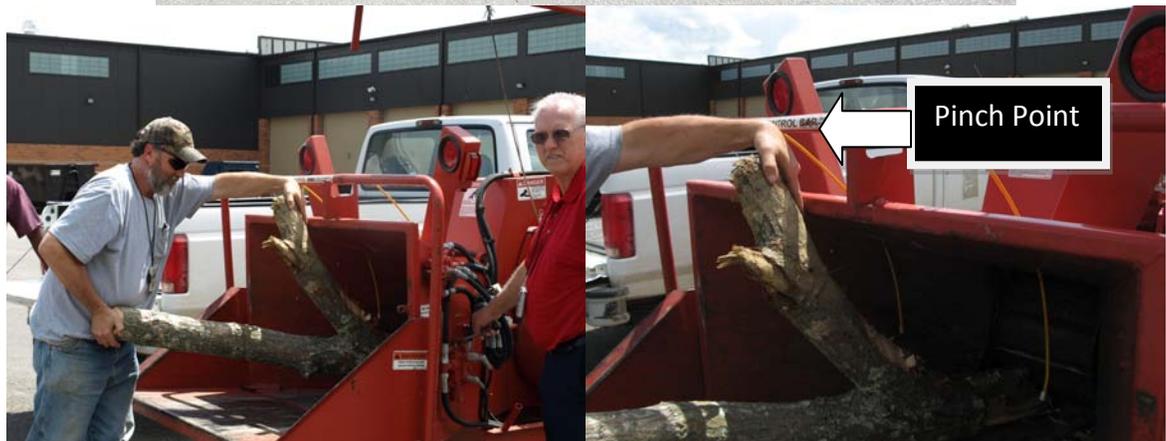
A PWD operations employee was putting tree limbs into a wood chipper from tornado damaged trees. While conducting chipping operations, a "Y" shaped limb shifted and would not go through the feed chute. Upon repositioning the limb, the feed wheel grabbed the limb causing it to shift instantly upward, while the employee's hand was still on the limb, and mashed the employee's right index finger between the limb and the outer edge of the top edge of the chipper infeed chute.

- Employees hand mashed between tree limb and chipper in-feed chute while the chipper was running.

- Lack of Situational Awareness and Proper Application of Task Risk Management
- Lack of Job Specific Training

- Never stand in front of the feed table when the chipper is running
- Cut all “Y” shaped branches and trees into a “straight” log before putting them in the chipper chute

- Decertify all chipper operators until all supervisors and employees are re-trained by a factory representative.
- Reinforce the importance of situational awareness when operating a wood chipper.
- Incorporated the mandated use of NAVFAC MIDLANT Wood Chipper SOP #700E0.00
- Create and incorporate a fully comprehensive checklist for wood chipper operations to supplement SOP
- Implement and mandate annual refresher training for all authorized wood chipper operators
