# THE CRANE CORNER

**Weight Handling Equipment Technical Bulletin**  
<http://ncc.navfac.navy.mil>

**36th EDITION Web Version**  
**December 2002**

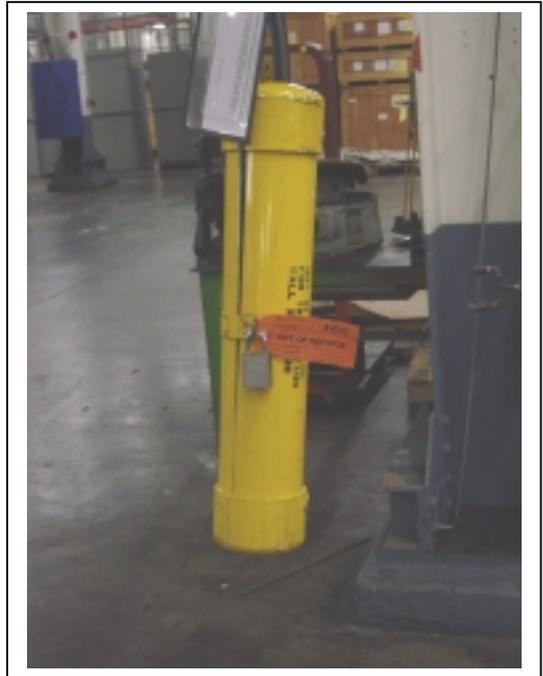
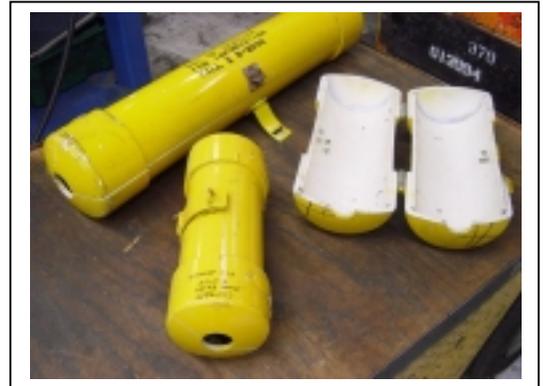
They devised a pendant control-securing device that is easily constructed using inexpensive, readily available materials. The device consists of a piece of PVC pipe of sufficient diameter to fit loosely around the pendant control and long enough to close around the pendant and its fittings. PVC pipe caps are glued onto both ends of the pipe. One of the pipe caps must be drilled in the center with a hole sufficient to allow the pendant wire and strain relief to pass through (about 1 1/2 inch). Once the pipe caps have been glued on and allowed to set, the pipe must be cut in half lengthwise. The two pieces are then hinged together by pop riveting hinges over the split on one side and a hasp over the split on the other side. The finished product can be painted a bright color for easy visibility. Point-of-contact information can be stenciled on the sides of the pipe. These devices can be built in a variety of sizes to fit various electrical pendants as well as pneumatic controllers.

This pendant control-securing device is a method of preventing the use of a crane that is out-of-service. This is not an energy control lockout/tagout device. Any work performed on the crane would still require an energy control lockout/tagout of the power source in accordance with the activity's energy control program (lockout/tagout). ■
