# THE CRANE CORNER

## *Navy Crane Center Technical Bulletin*

39th Edition Web Version - September 2003

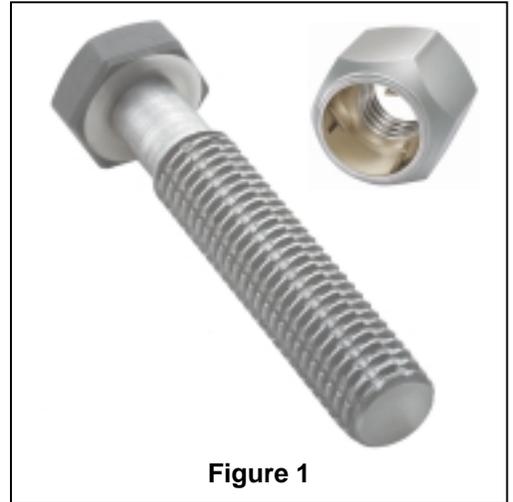
Figure 1

A recently introduced nut and bolt fastener system reportedly incorporates a positive self-locking, vibration-proof feature that is neither torque nor clamp-load dependent. The bolt has longitudinal grooves across the threads and the nut has one-way tines that seat in the grooves and prevent it from backing off. Each of the tines engages one of several grooves around the circumference of the thread. (See figure 1.) The bolt, nut, and tine ring are made of stainless steel. The tine ring is swaged in the nut bore and its scalloped edges secure it against rotation. This fastener system is intended for use on non-structural connections that are susceptible to loosening because of vibration or with limited access for inspection and tightening.

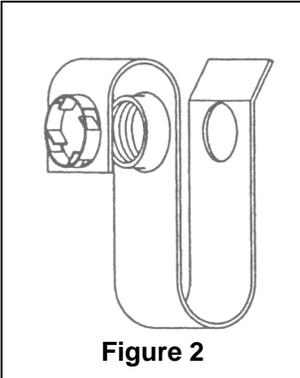
Figure 2

The fasteners are available in all sizes - both standard and made to order. Hangers in the forms of U-, J-, and S-shapes are also available for supporting electrical conductors and hoses. (See figure 2.)
