**EX-USS KILLEN SITE INVESTIGATION
AND BIOLOGICAL CHARACTERIZATION,
VIEQUES ISLAND, NAVAL STATION ROOSEVELT ROADS,
PUERTO RICO**

FINAL REPORT

JUNE 2002

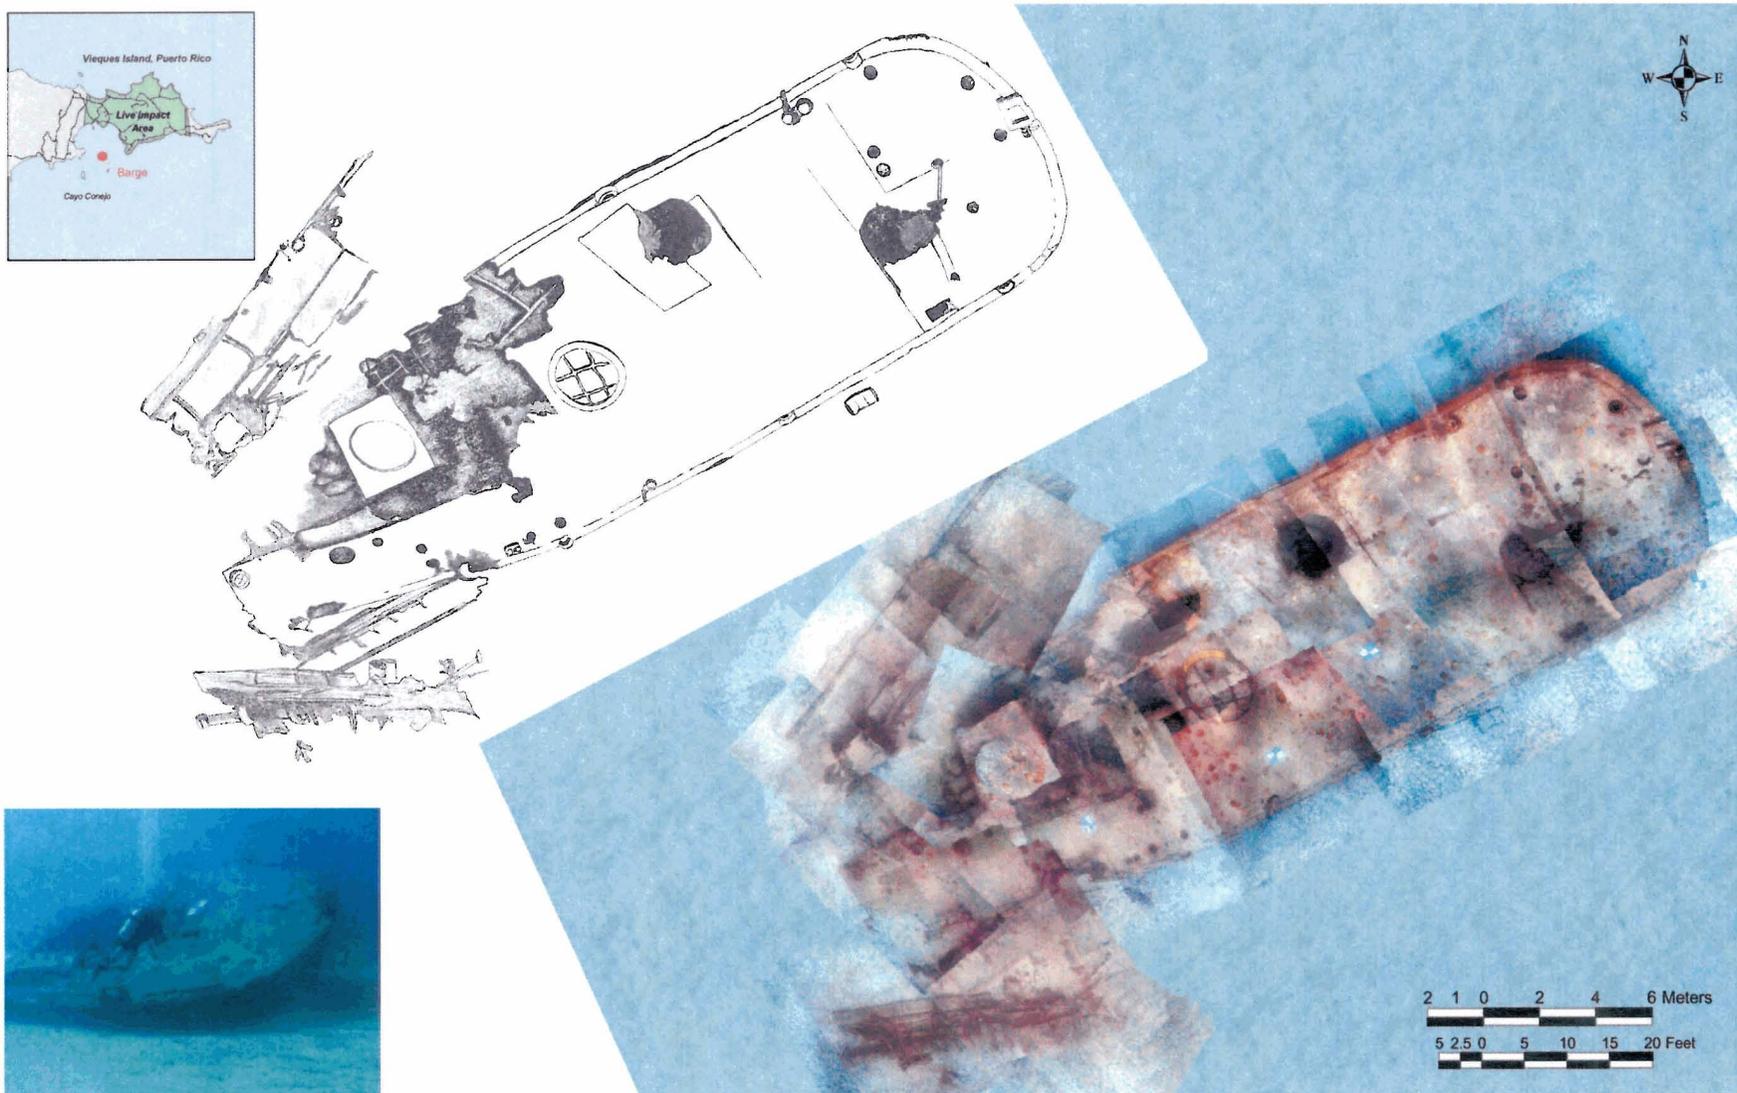
Figure 4. Sketch and photomosaic of a barge sunk as a target in Bahía Salina del Sur, Vieques Island, Puerto Rico

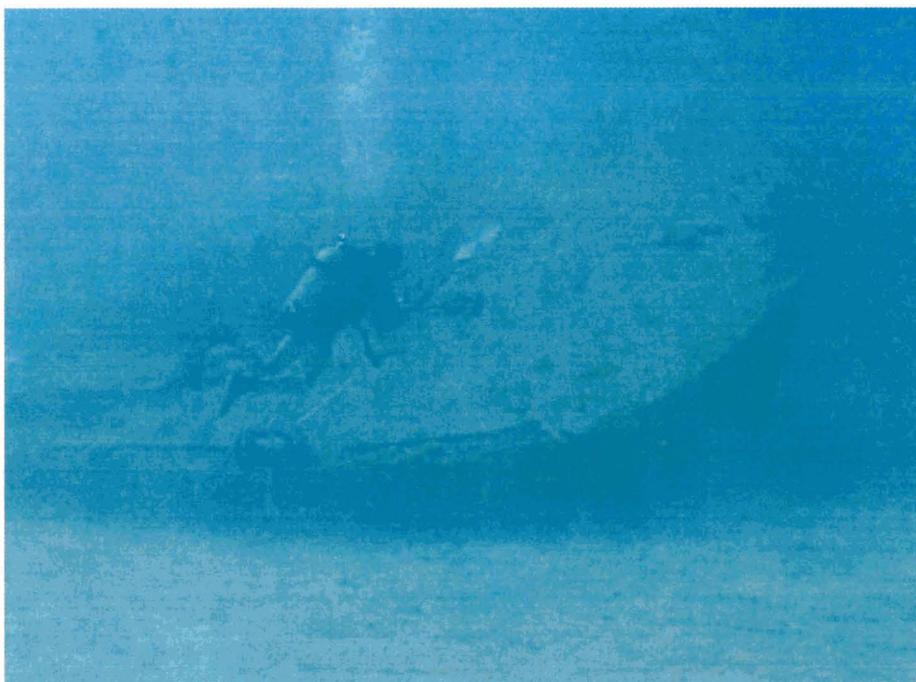
Figure 6. Underwater view of the barge bow (Bahía Salina del Sur, Vieques Island, Puerto Rico)

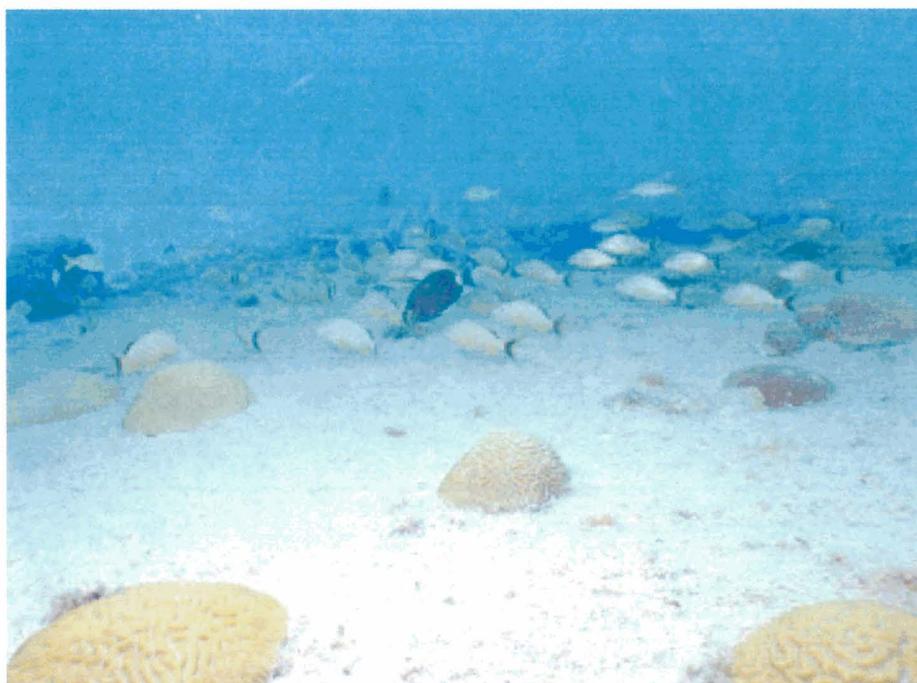
Figure 7. Corals growing on the barge deck (Bahía Salina del Sur, Vieques Island, Puerto Rico)

Despite the fact that the vessels were sunk in the middle of a large seagrass area, they were able to function as productive artificial reefs for coral. Hard coral density (col/m^2) and diversity on the wrecks were not statistically different from what was found at the reef control site. Nevertheless, we observed reef building coral colonies to be significantly larger at the wreck sites. The barge deck supported in excess of 300 massive coral colonies, mostly symmetrical brain corals (*D. strigosa*), grooved brain corals (*D. labyrinthiformis*), and massive starlet corals (*S. siderea*). The photomosaic of the barge clearly shows the abundance of these coral heads (Figure 4). What was not visible in the photomosaic were the ever present lesser starlet coral (*S. radians*) colonies. In addition to the mature coral colonies, there were literally thousands of juvenile corals (mostly *S. radians*) disseminated across the barge deck. The Killen wreck also contained numerous juvenile corals and hemispherical coral heads. These growth and colonization characteristics were definitely absent from the reef control site. The higher abundance of corals on the wrecks suggested that the artificial reef was a more suitable environment for successful coral recruitment and growth. Between the two wrecks, we found 18 of the 29 coral species known to occur at the eastern end of Vieques Island (NSRR 2002). We did not witness obvious signs of massive bleaching, abundant coral diseases, or physical destruction at either study site. Further, there was no evidence of any recent impacts on the wrecks and their coral biota that would have been caused by inner range activities (e.g., physical impacts or ordnance).

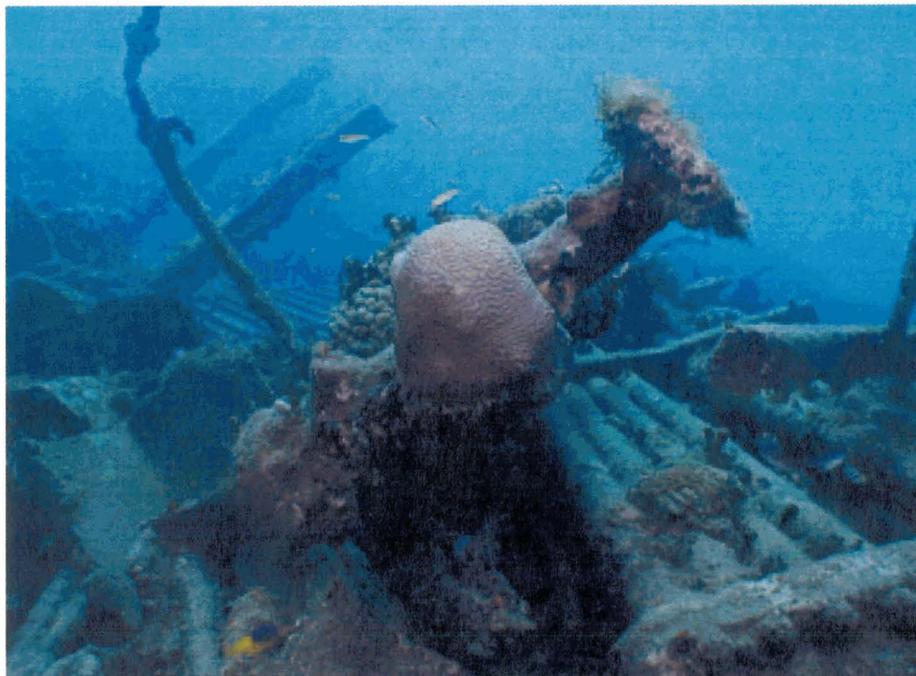
Figure 10. Coral growing on the Killen (Bahía Salina del Sur, Vieques Island, Puerto Rico)

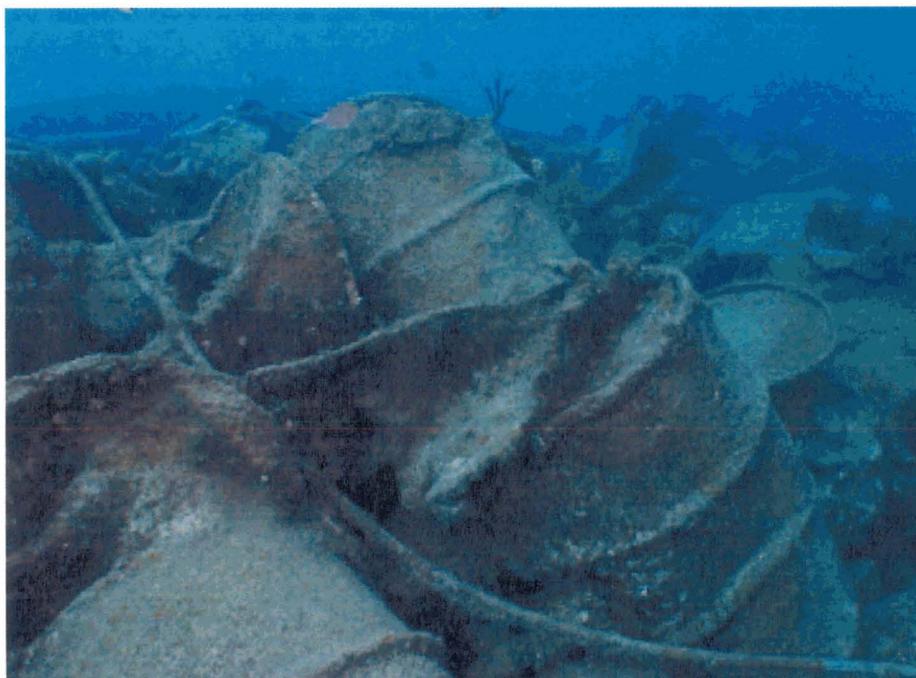
Figure 11. Drums on the Killen (Bahía Salina del Sur, Vieques Island, Puerto Rico)

A recent broad survey of metals and explosive compounds in fish and shellfish collected at the Killen and barge sites revealed that the 55-gallon drums on the Killen and the barge were and continue to be unlikely sources of contaminants on the surrounding marine biota (ATSDR 2002). No shellfish nor fish collected at the Killen site contained concentrations of metals or explosive compounds that would be a health hazard to humans consuming fish or shellfish captured either at the Killen or the barge site. As discussed below, rather than being used to store hazardous substances, the drums found on the wrecks were most likely used for target stabilization and for reserve buoyancy.

Considering the alterations made to the Killen prior to sinking, the presence of the 55-gallon drums could very likely have been used as ballast to redistribute the weight of the modified target ship. With the amount of superstructure, armament, and heavy engineering components that were missing from the Killen when it was sunk, the added ballast weight may have been necessary to stabilize the target vessel during towing to it's the site and during the time it was a target. The ship's fuel and water storage holds may also have been filled with seawater to provide the ballast needed for stabilization, yet additional weight may have been necessary due to the highly reduced tonnage of the modified configuration of the Killen. Removal of various engineering components may have unbalanced the ship causing it to list to one side or the other. If drums were used for ballast, they were most likely filled with sand or seawater.

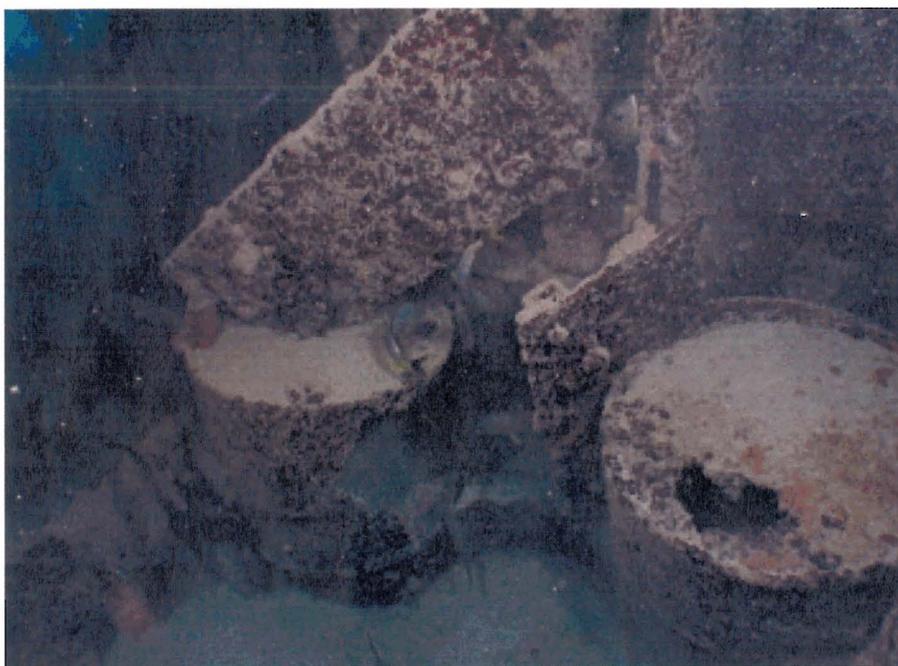
Figure 8. Drums in the barge (Bahía Salina del Sur, Vieques Island, Puerto Rico)

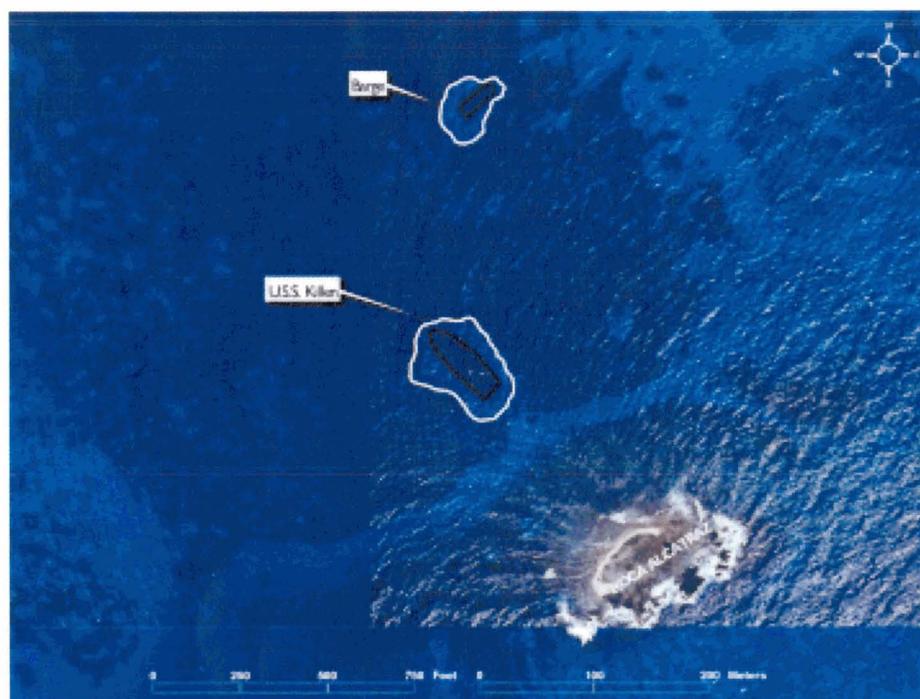
Figure 9. Sediment aprons surrounding the barge and the Killen (Bahía Salina del Sur, Vieques Island, Puerto Rico)

Sand aprons (halos) surrounded both the Killen and the barge. Halos of non-vegetated areas are typical around significant reef structures, be they natural or anthropogenic. Halos are natural rather than symptomatic of environmental distress. Herbivorous reef fishes typically graze on SAV located closest to the reef (shelter from predation) causing a barren area (halo in the case of this study) along a reef margin (Randall 1965). This was clearly illustrated by two patch reefs and associated halos located approximately 120 m north of the barge site.
