FINAL REPORT

ADDENDUM TO: EX-USS KILLEN SITE INVESTIGATION

THE SPLIT-UP WRECKAGE OF THE EX-USS KILLEN, VIEQUES ISLAND, NAVAL STATION ROOSEVELT ROADS, PUERTO RICO

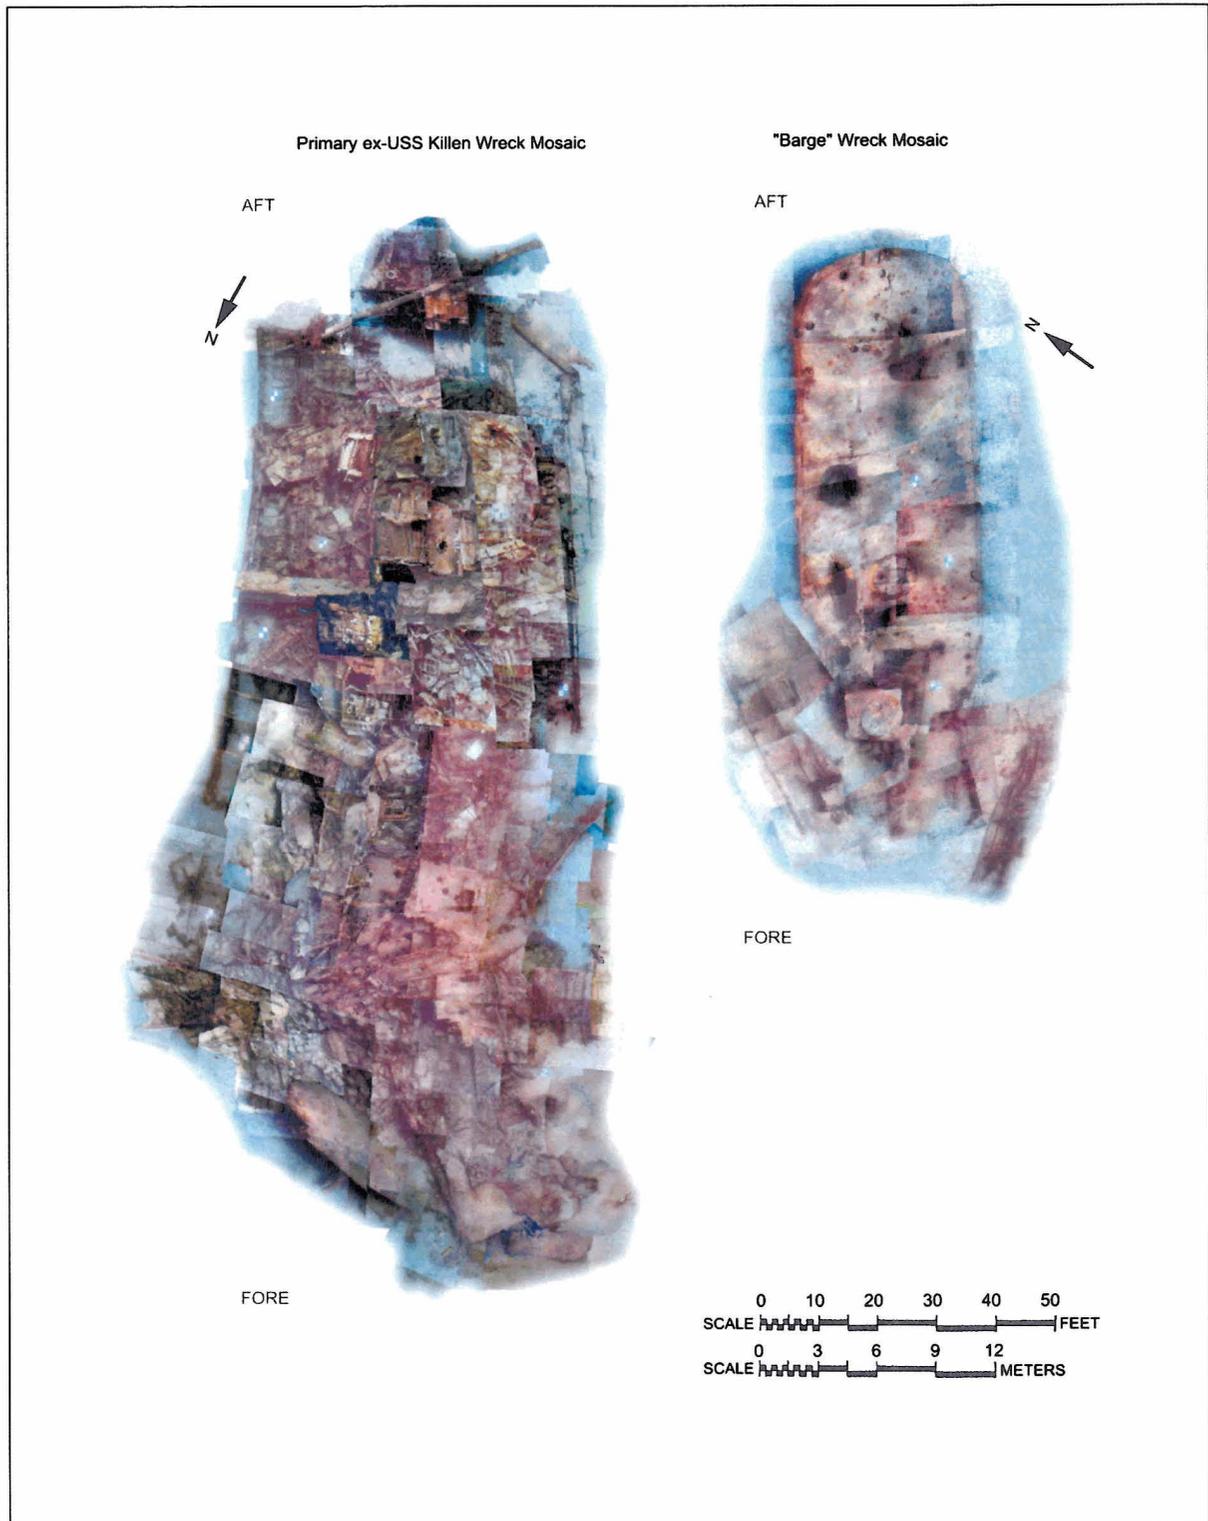
Figure 3. Photo-mosaics of the ex-USS Killen and "barge" wrecks as surveyed in November 2001 (DoN 2002).

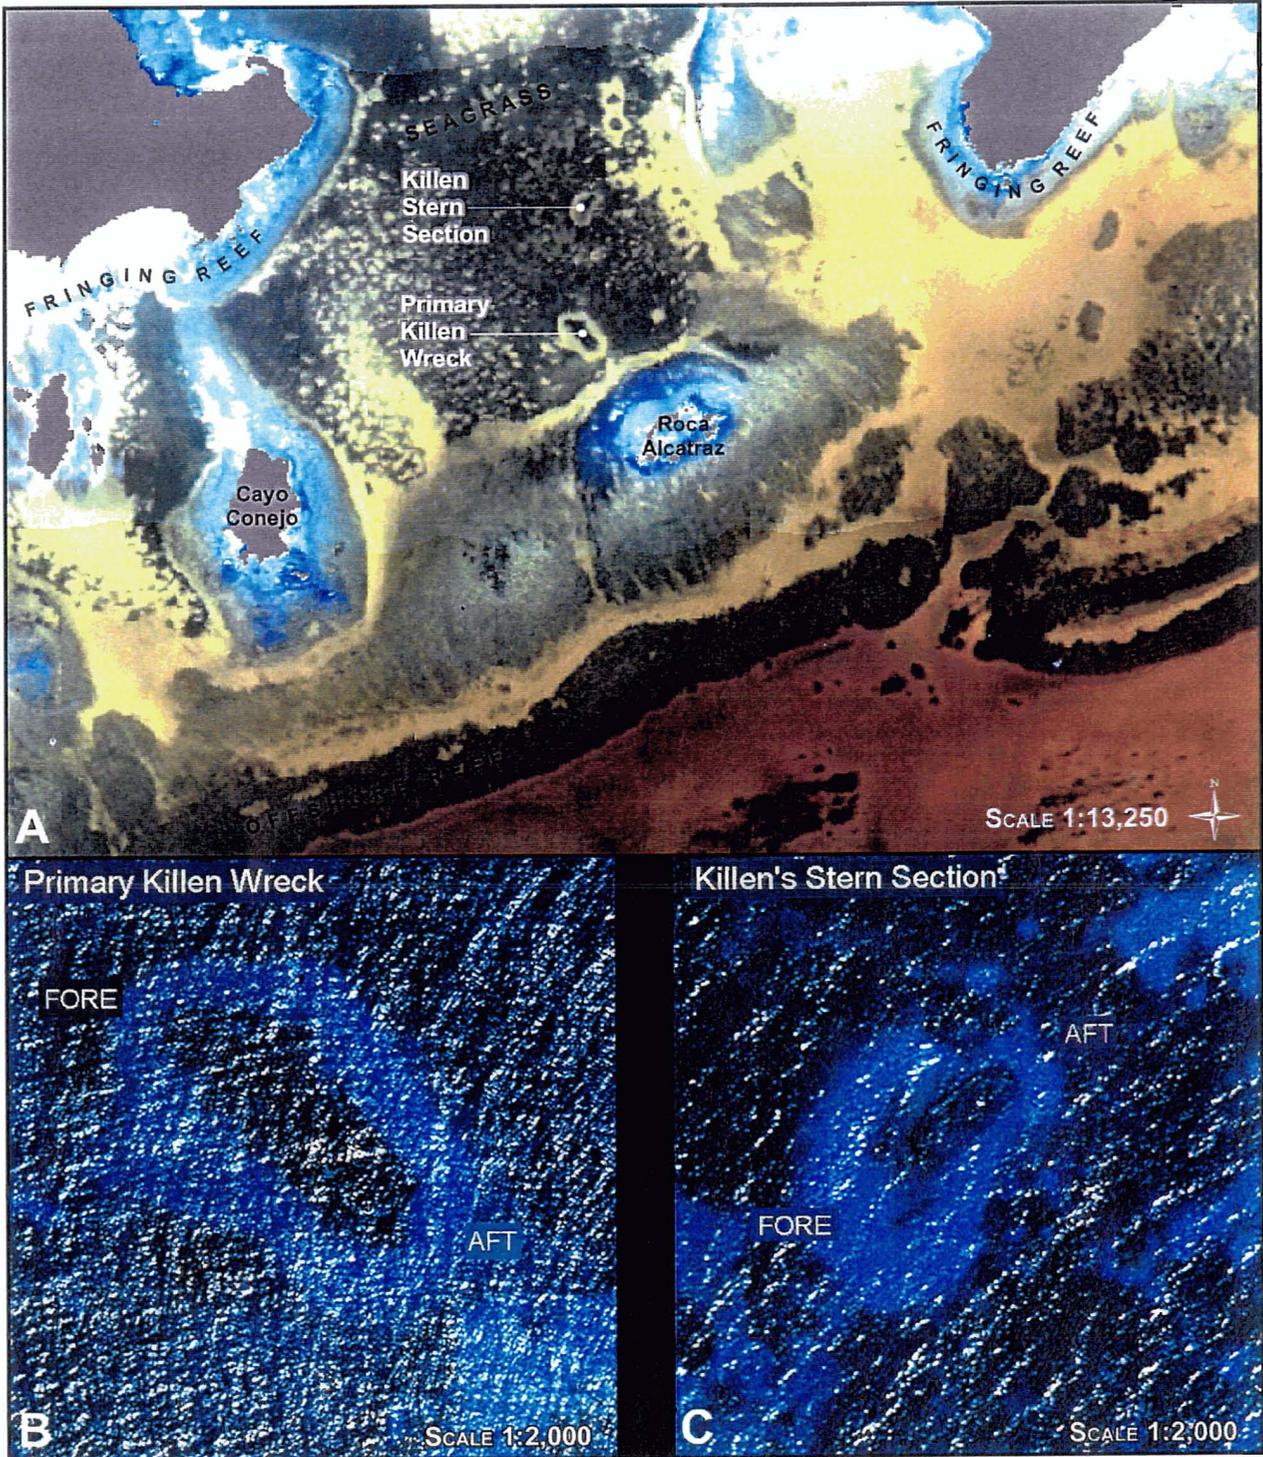
Figure 5. (A) Hyperspectral imagery of Bahia Salina del Sur; (B) Aerial view of the Killen primary wreck site; (C) Aerial view of the Killen secondary wreck site.

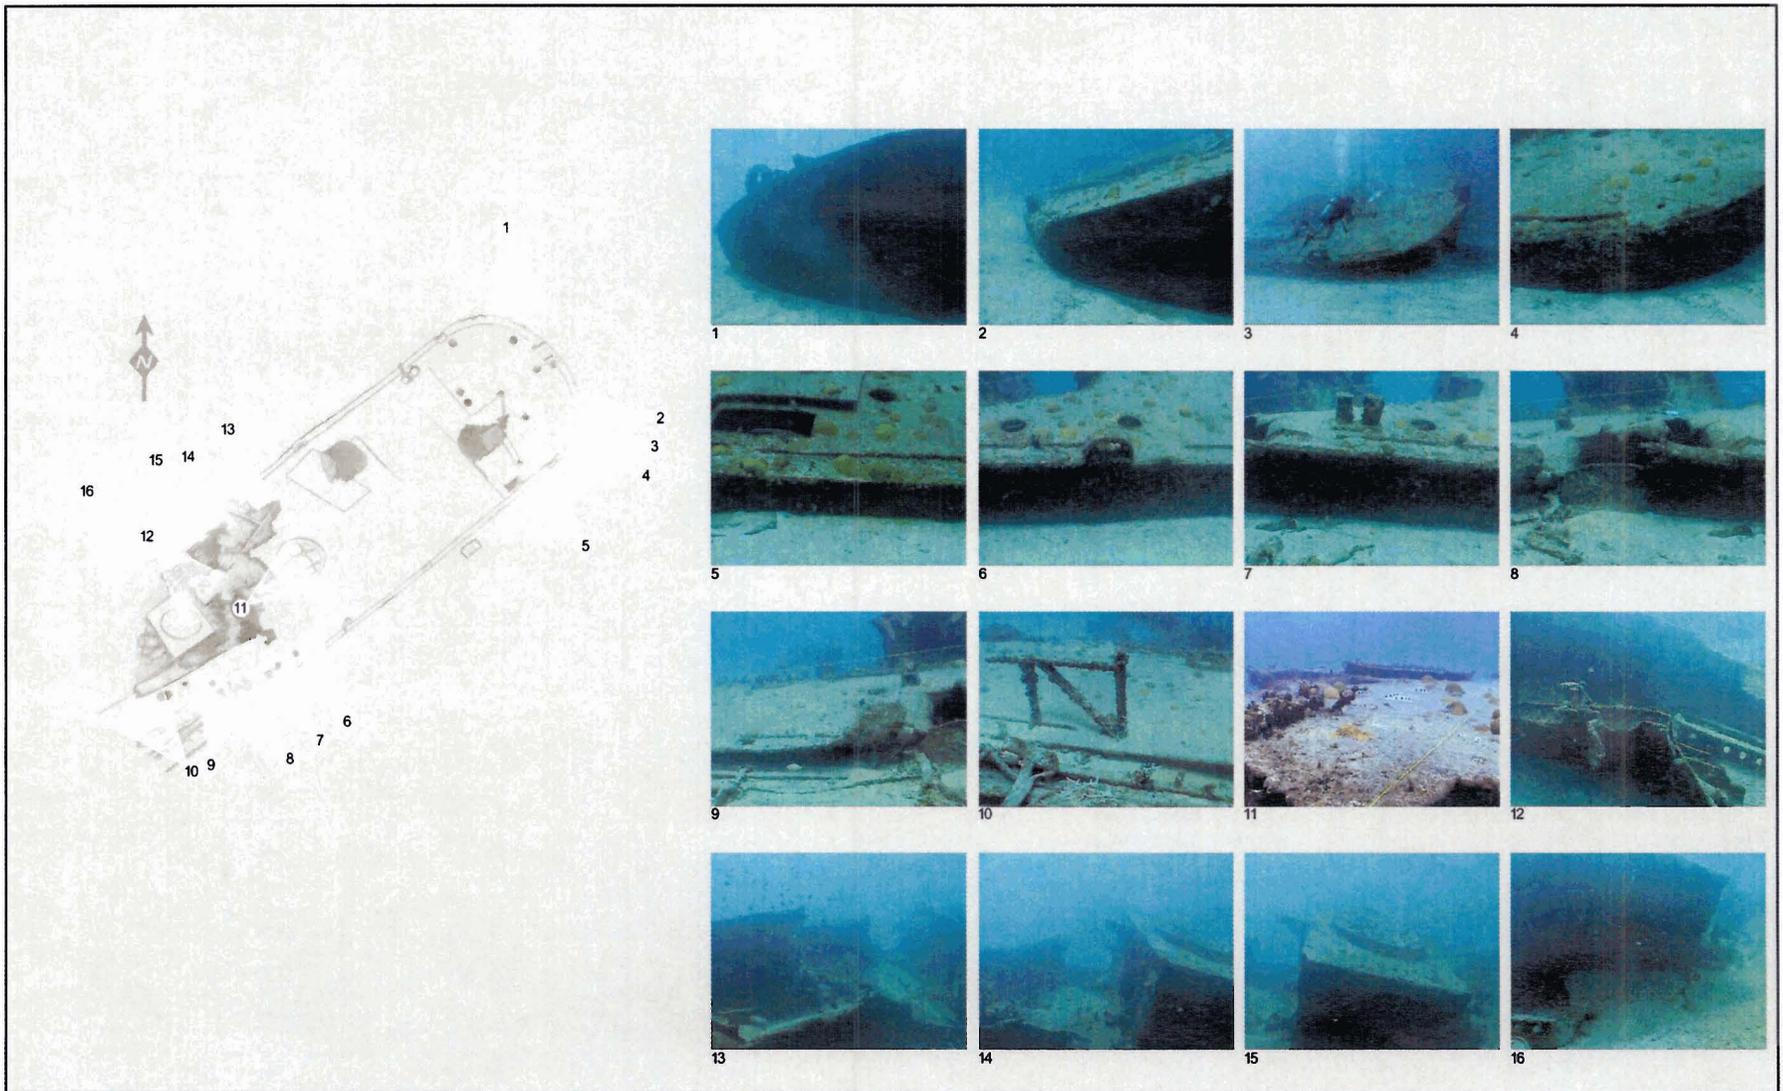
Figure 6. Artist's rendering and views of the wreckage at the secondary wreck site.

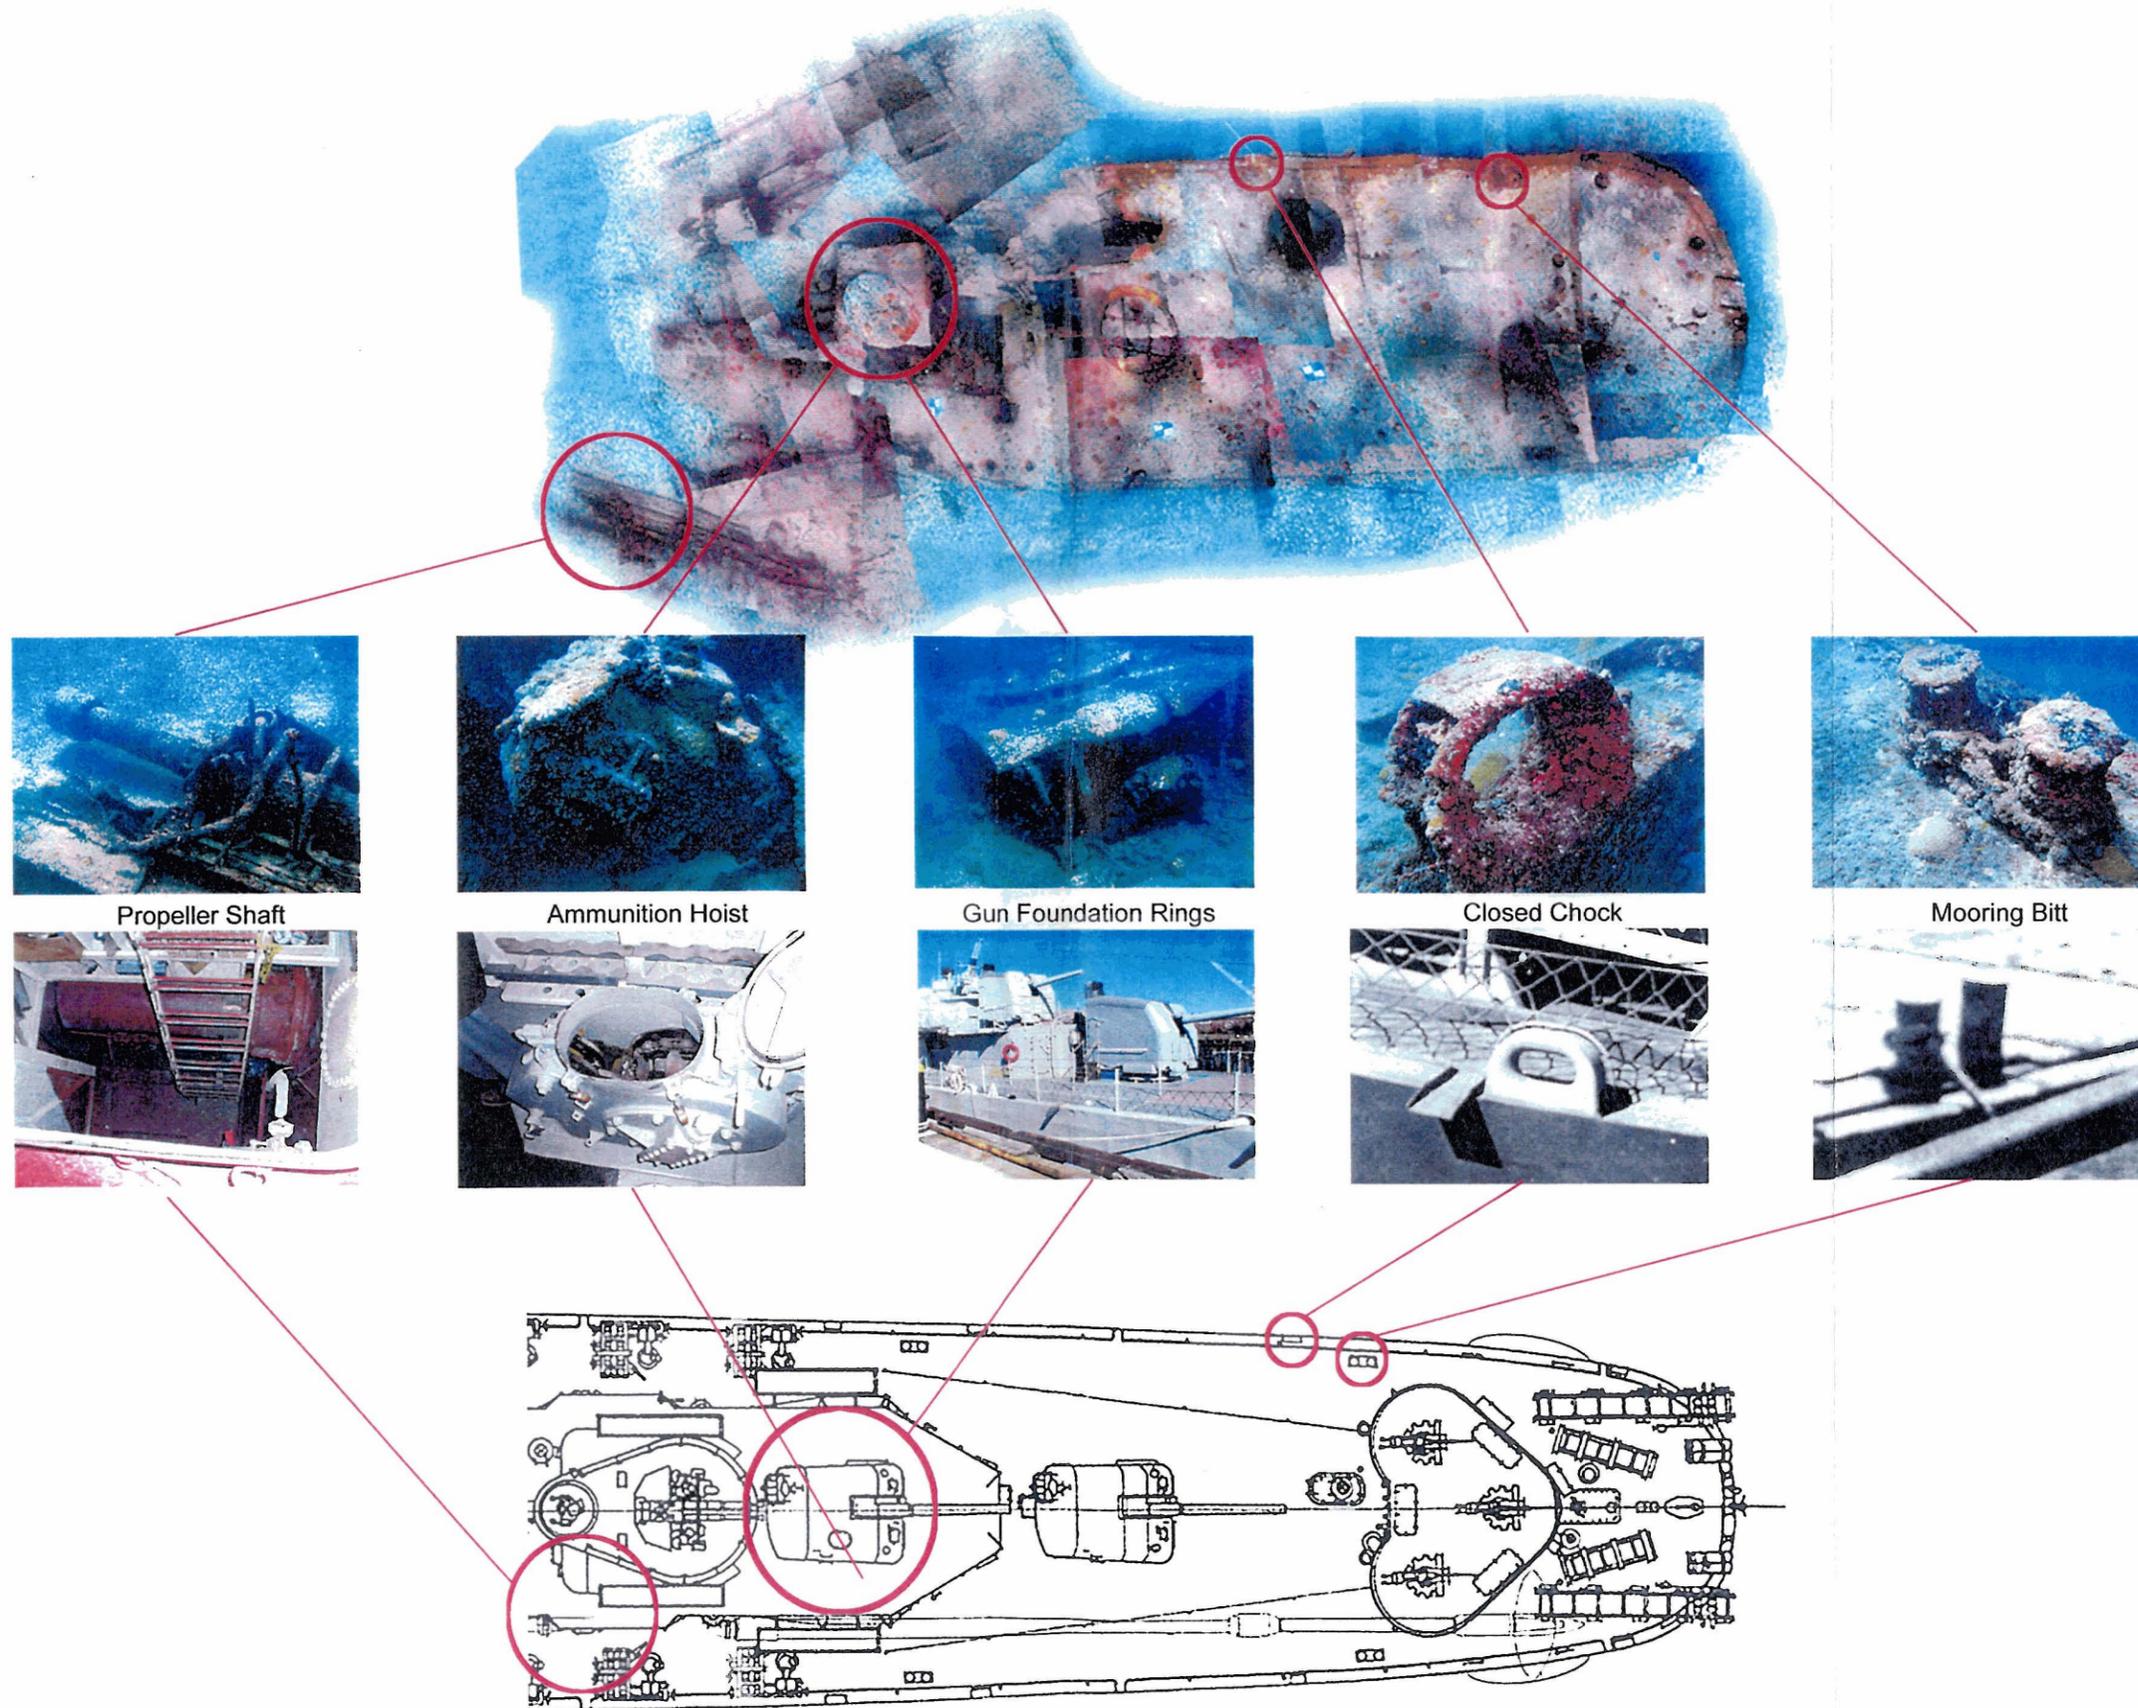
Figure 17. Summary of photographic and line drawing evidence identifying the barge as the stern section of the Killen.
