REVIEW OF EXISTING CONDITIONS AT THE WAYSIDE AREA

NAVAL WEAPONS STATION EARLE Colts Neck, New Jersey

**Prepared by
Northern Division
Naval Facilities Engineering Command**

FEBRUARY 1999

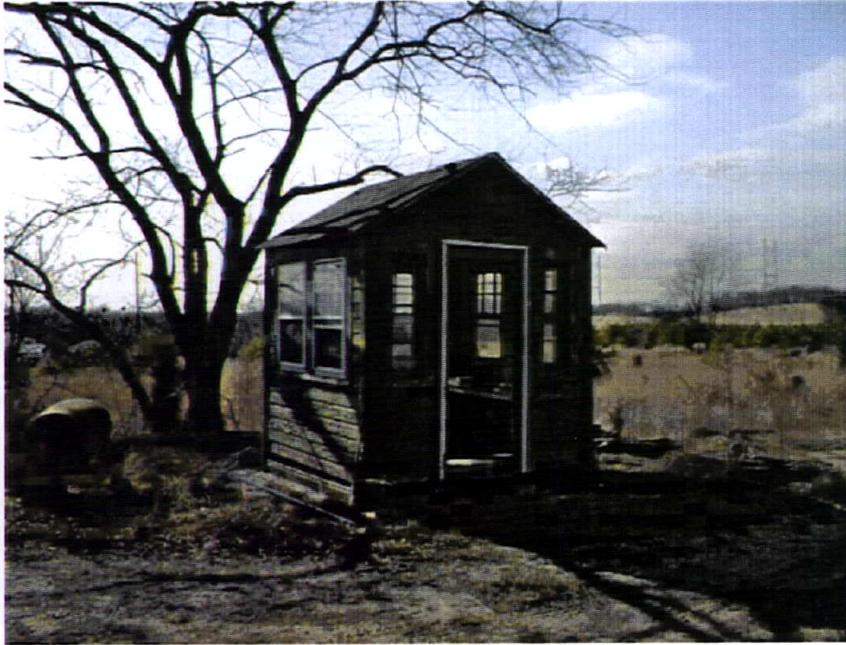
No maintenance has been performed on the structures in this area since the Army ceased operations in 1991. As stated in the 1992 Design Analysis, the buildings and structures were in a deteriorating condition at that time. Conditions have only gotten progressively worse. Peeling paint is evident throughout the site and the geodesic dome structure has collapsed completely. Other structures appear to be unstable. The abandoned septic systems and wells have still not been closed in accordance with state regulations.

Gate House – Peeling lead paint and suspected asbestos floor tiles

The Design Analysis performed by Henkels & McCoy, Inc. for the Army in 1992 is an excellent representation of the actions needed to restore the Wayside Area. The only change is that additional deterioration of the structures has occurred since no maintenance has been performed since 1991. This project should be implemented as soon as possible.

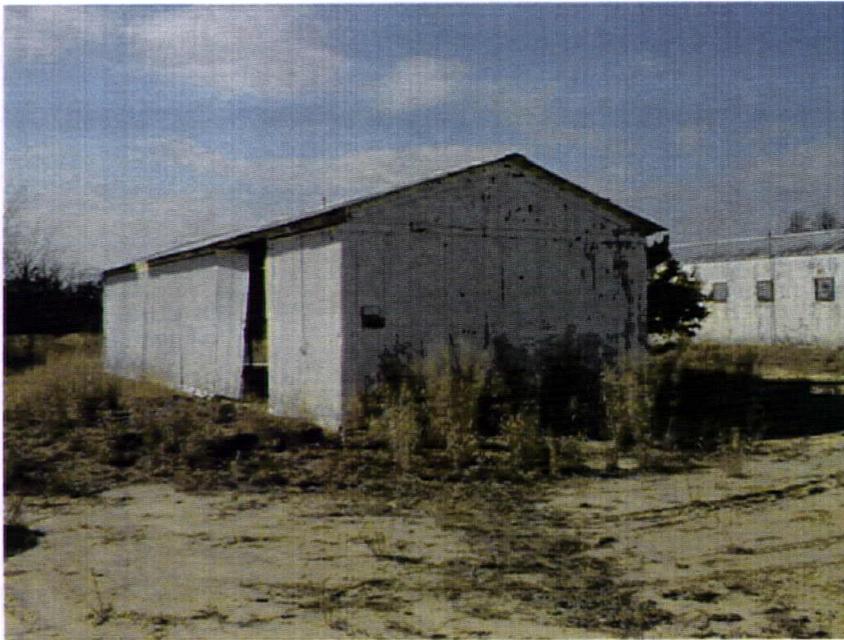
Deteriorating building with peeling paint

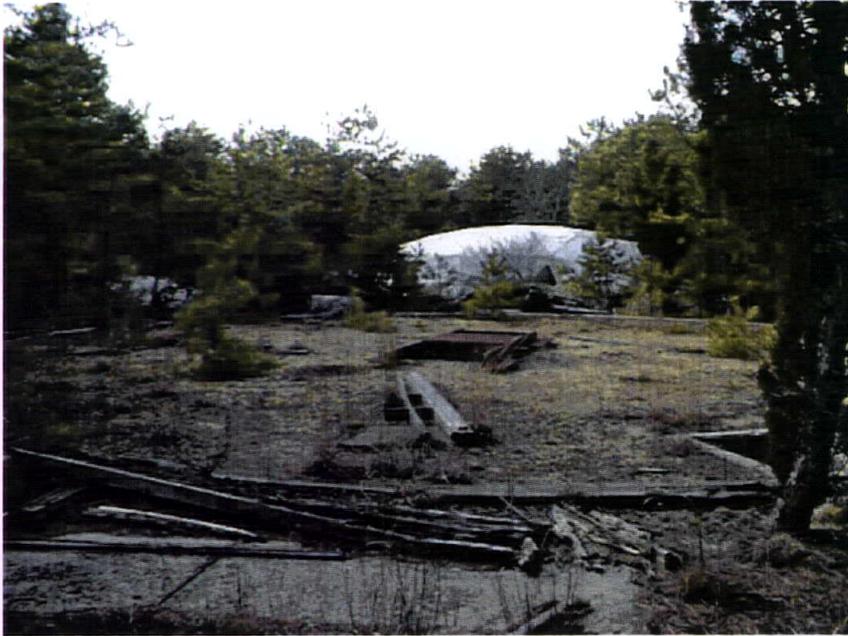
Collapsed Geodesic Dome

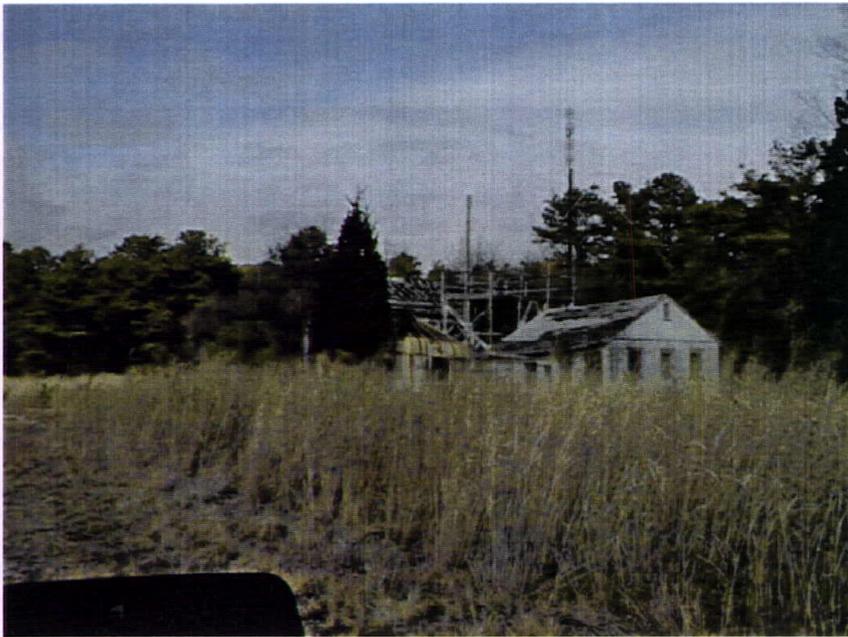
Deteriorating structures

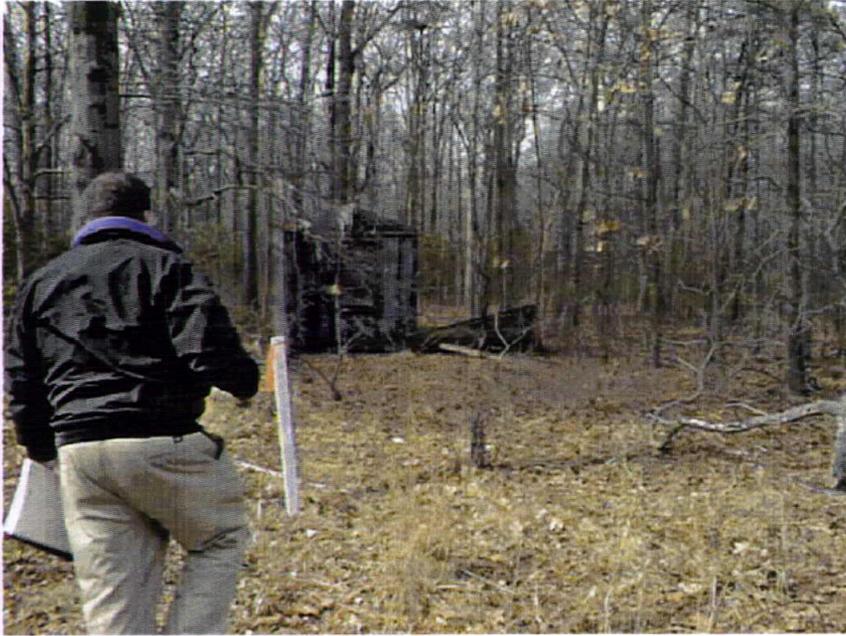
Shed at Area 8L of Design Analysis Report

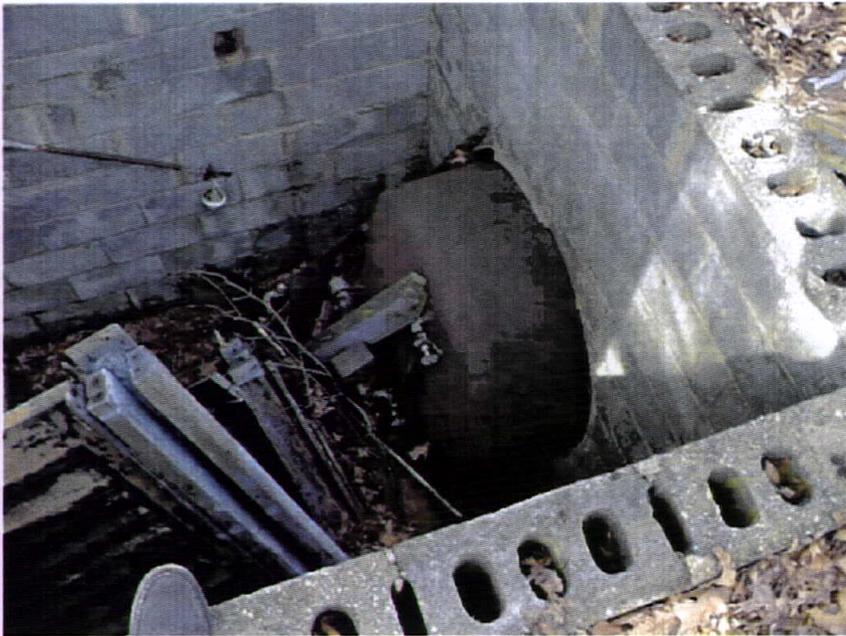
Structure description 8L in the Project Notes from the Design Analysis Report identifies a below grade water tank. If any possibility exists that this tank held any substance other than water, subsurface soil sampling would be appropriate upon excavation. If these samples indicate any leakage from the tank, a groundwater investigation would be warranted.

Below grade tank at 8L (reportedly held water)

The use of the below-grade tank in structure description 8L for water storage should be confirmed or soil sampling should be conducted upon excavation.

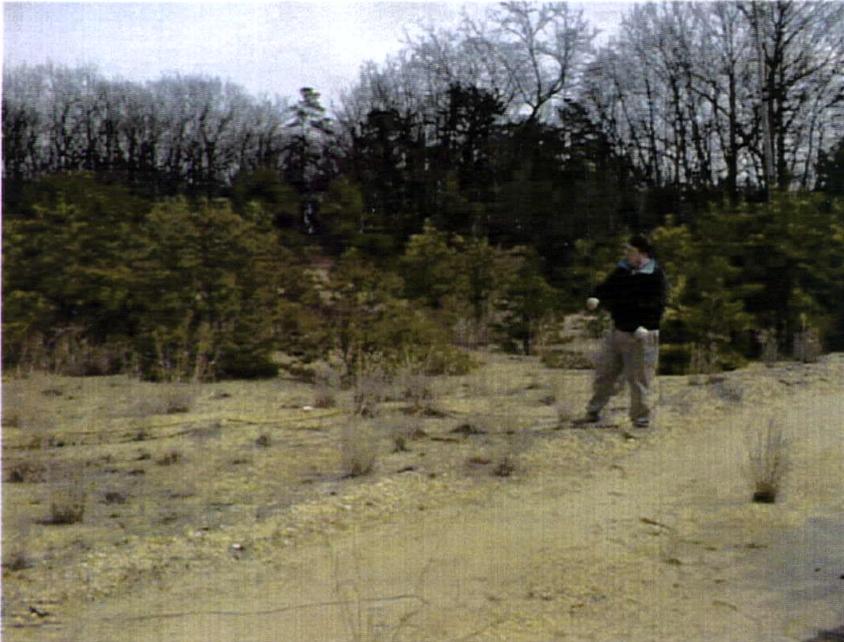
Recent analyses of three types of electrical cable found in the Wayside Area revealed the presence of elevated levels of lead and cadmium. All underground cable is apparently in conduit, but removal of this cable would eliminate the possibility of any environmental exposure to these compounds in the future. Additionally, the presence of this cable could be a hazard during any future construction on the site. The cable is already exposed above grade in several locations.

Cable above ground surface which had elevated cadmium levels

All underground cable should be removed wherever feasible. Since all structures will be removed, the cable is in conduit, and soil conditions are quite sandy, a complete removal should be possible.

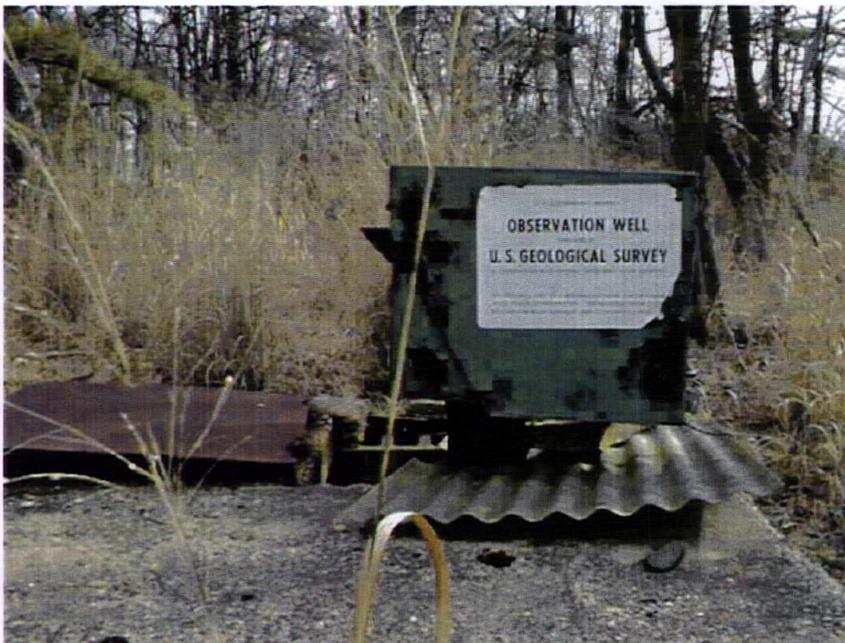
U.S. Geological Service observation well

Navy Monitoring Well MW-BG-01, a U.S. Geological Service Observation Well, and the pistol range should not be disturbed during any restoration activities.
