COMPREHENSIVE ENVIRONMENTAL SURVEY BUILDING 27 NS GREAT LAKES IL
12/16/2004
RAYMOND PROFESSIONAL GROUP, INC.

**COMPREHENSIVE ENVIRONMENTAL SURVEY
NAVAL STATION GREAT LAKES, ILLINOIS
BUILDING 27**

Raymond Project No. 876885

December 16, 2004

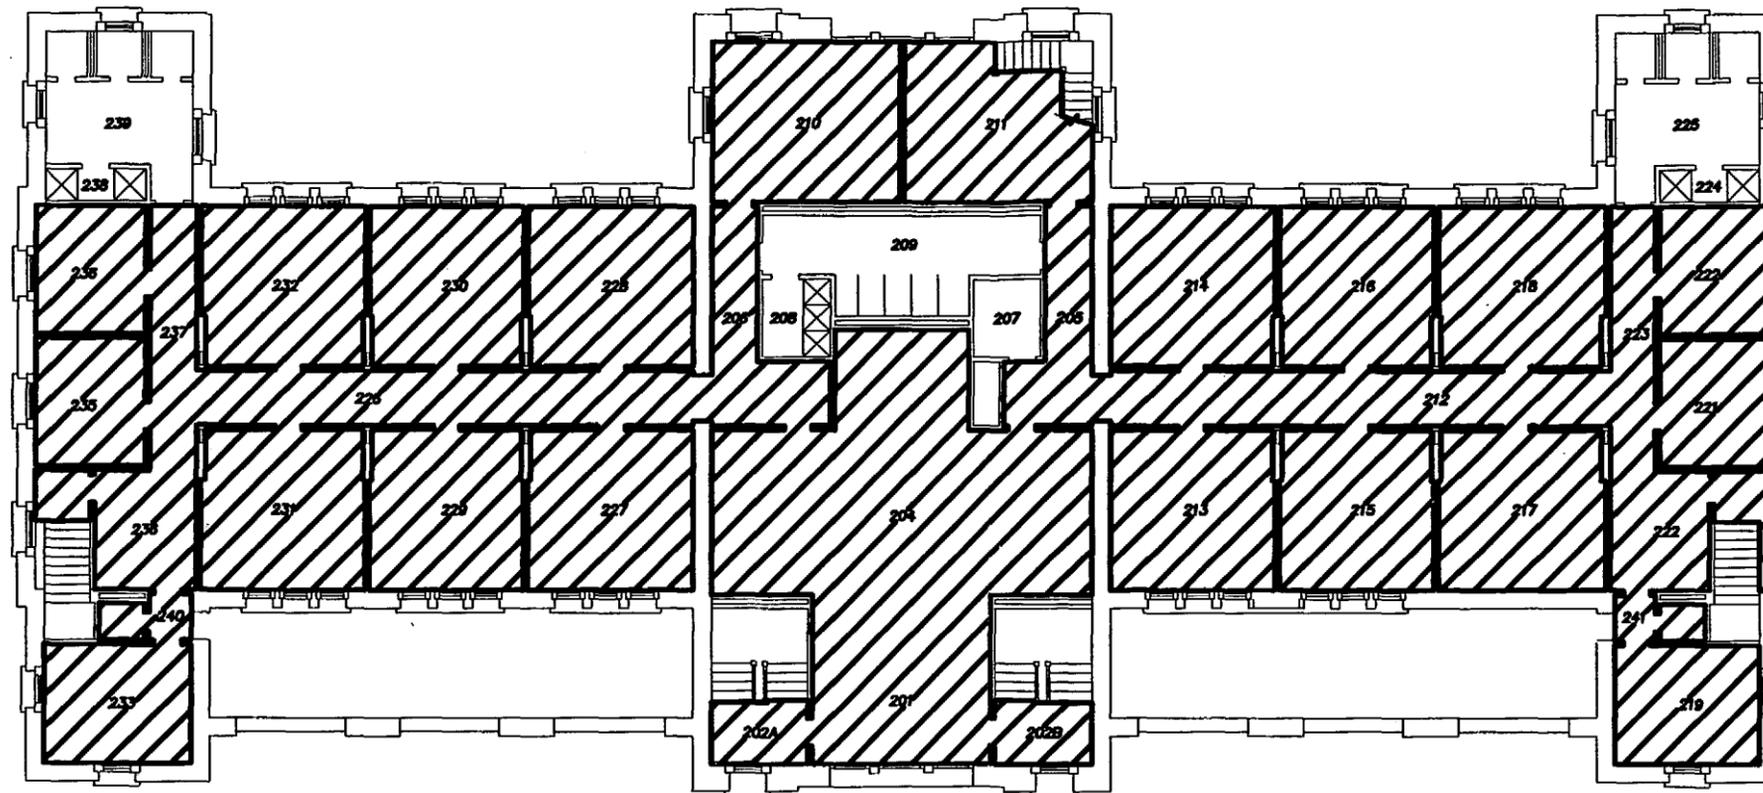
PROJECT NUMBER
87-6885
 DATE: 12/20/04
 DRAWING NO.
15
 SHEET 15 of 17

**POSITIVE HOMOGENOUS AREA**
 HOMOGENOUS AREA MFH-
 MFI FLOOR TILE & MASTIC
TOTAL POSITIVE AREA IS 8653 SQ. FT.

The floor tiles, floor tile mastic and roof flashing are considered Category 1 Non-Friable materials. The conditions of these homogenous areas are all good. Subpart M of 40 CFR 61 of the National Emissions Standard for Hazardous Pollutants (NESHAP) states that all Category 1 Non-Friable materials that are in good shape can be disposed of as general construction debris when a demolition of the building occurs. Therefore asbestos abatement is not necessary for these positive homogenous areas if you were to demolish the building. If you were to renovate the building where asbestos is present, the asbestos must be abated by a licensed asbestos abatement contractor under NESHAP regulations at a minimum.

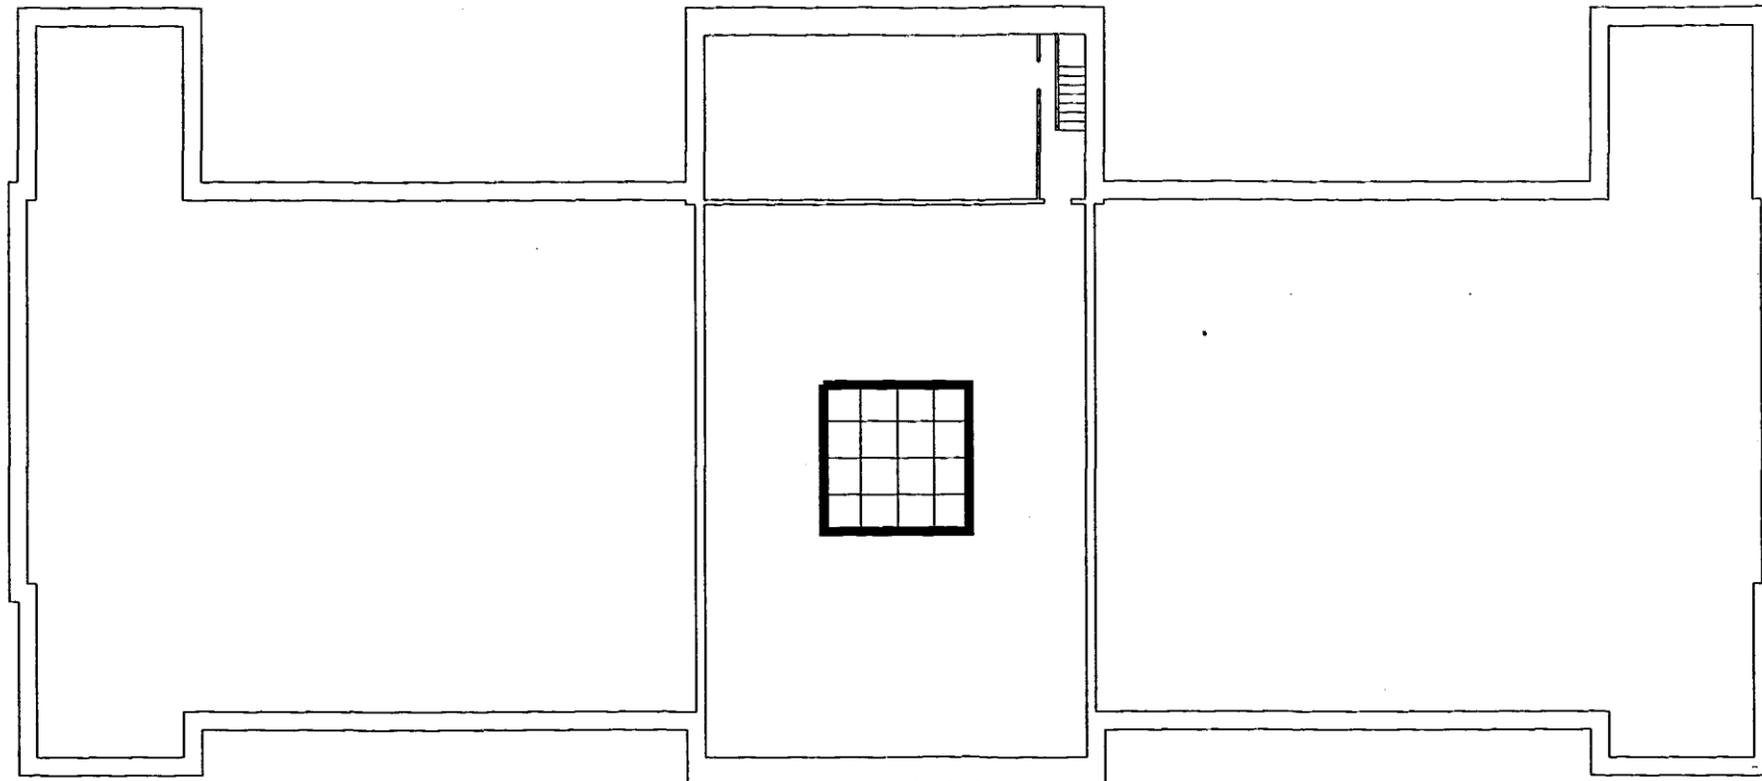
PROJECT NUMBER	87-6885
DATE	12/20/04
DRAWING NO.	17
SHEET	17 OF 17

—— POSITIVE HOMOGENEOUS AREA
HOMOGENEOUS AREA MRC
SKYLIGHT FLASHING
TOTAL POSITIVE AREA IS 150 LVL. FT.

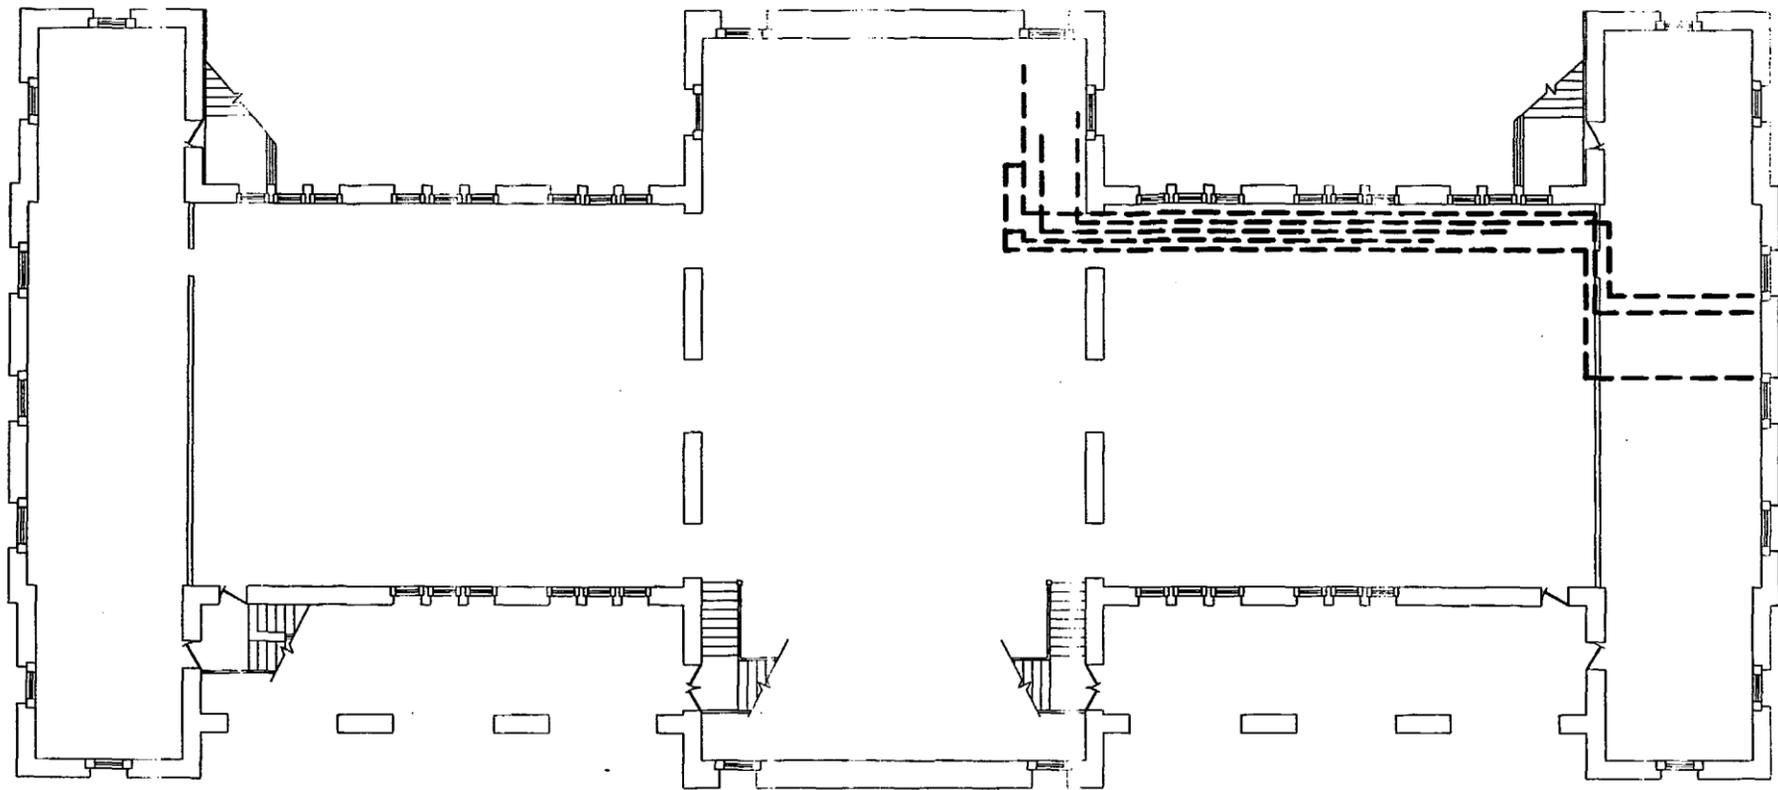
----- POSITIVE HOMOGENOUS AREA
 HOMOGENOUS AREA TPA-
 TPC PIPING INSULATION AND FITTINGS
 TOTAL POSITIVE AREA IS 450 LN. FT.

NOTE:
 BASEMENT CONTAINS APPROXIMATELY 10 ACM PIPE FITTINGS ON ACM
 PIPES. (SHOWN IN DRAWING)
 BASEMENT CONTAINS APPROXIMATELY 85 ACM PIPE FITTINGS ON NON-ACM
 (FIBERGLASS) PIPES. (NOT SHOWN IN DRAWING)
