RESTORATION AND MAINTENANCE PLAN FOR PETTIBONE CREEK RAVINE NS GREAT  
LAKES IL  
7/1/2000  
ENVIRONMENTAL QUALITY MANAGEMENT, INC.

**RESTORATION AND MAINTENANCE PLAN  
FOR PETTIBONE CREEK RAVINE  
NAVAL TRAINING CENTER,  
GREAT LAKES, ILLINOIS**

July 2000

**ATTACHMENT 1  
ANALYSIS AND RECOMMENDATIONS  
FOR SUBSTRATE INSTABILITY**

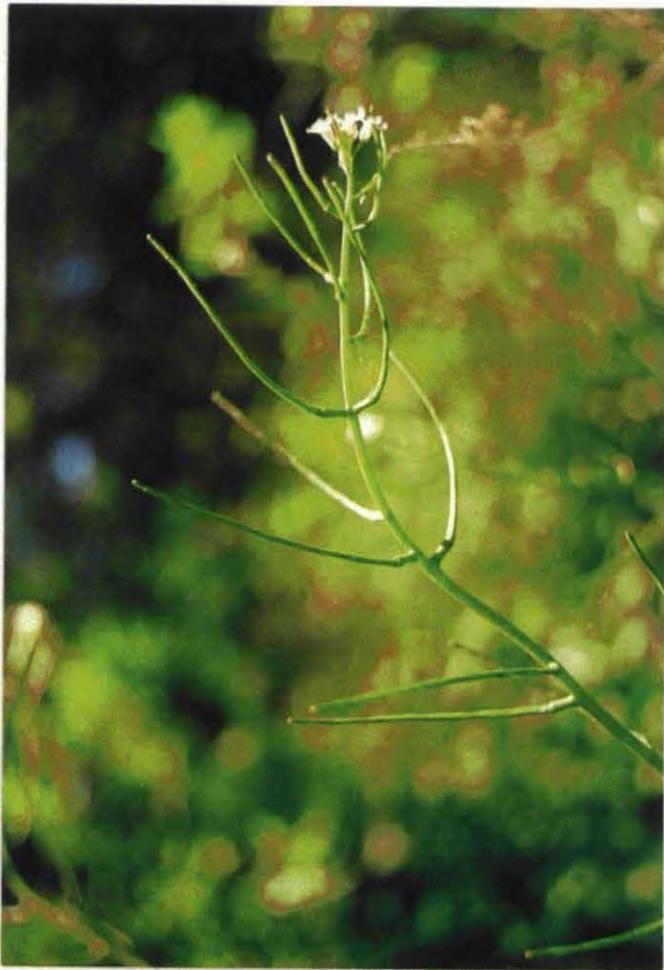
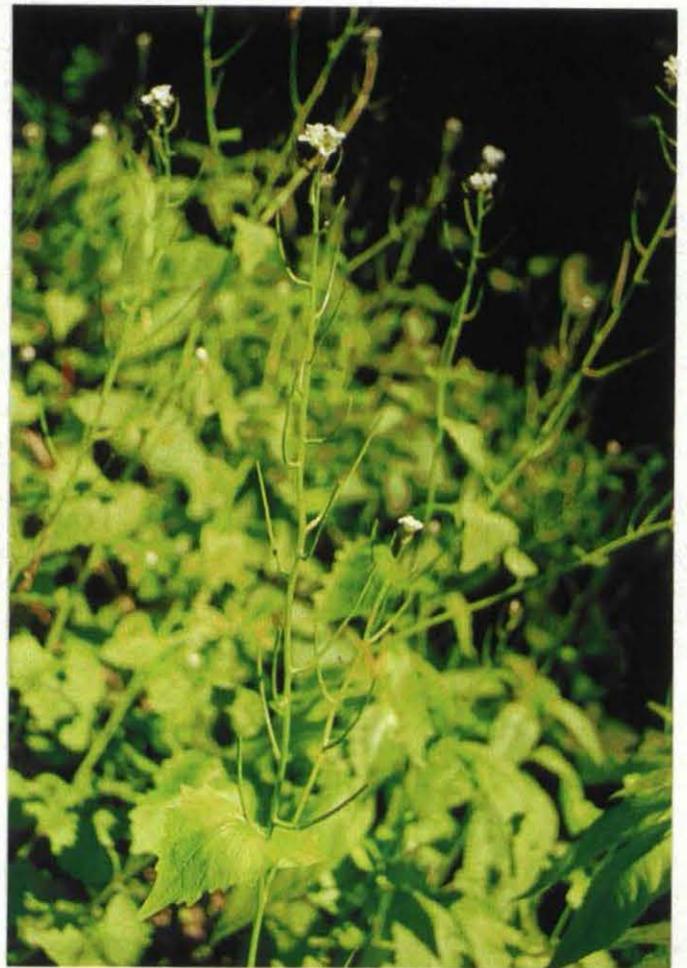
1. Garlic Mustard (2<sup>nd</sup> year plants)

2. Garlic Mustard (2<sup>nd</sup> year plants)

The recommended and preferred action for removing garlic mustard is by a low-intensity prescribed burn during the early spring for several successive years until garlic mustard's seed bank is exhausted. Fire effectively kills young seedlings, but has little or no effect on the second-year plants. Prescribed burning especially along the mid to upper slopes will minimize further damage to the substrate by excessive pedestrian movement across these slopes. Cutting and removing the stems of second-year plants is an acceptable option in those areas immediately adjacent to the access road that winds through the ravine. As is the case with prescribed burning, flowering stems must be cut over several years because of the longevity of a viable seed bank. Chemical control is not recommended because most of the garlic mustard does not occur in pure stands and chemical control could adversely impact other more-desirable species.

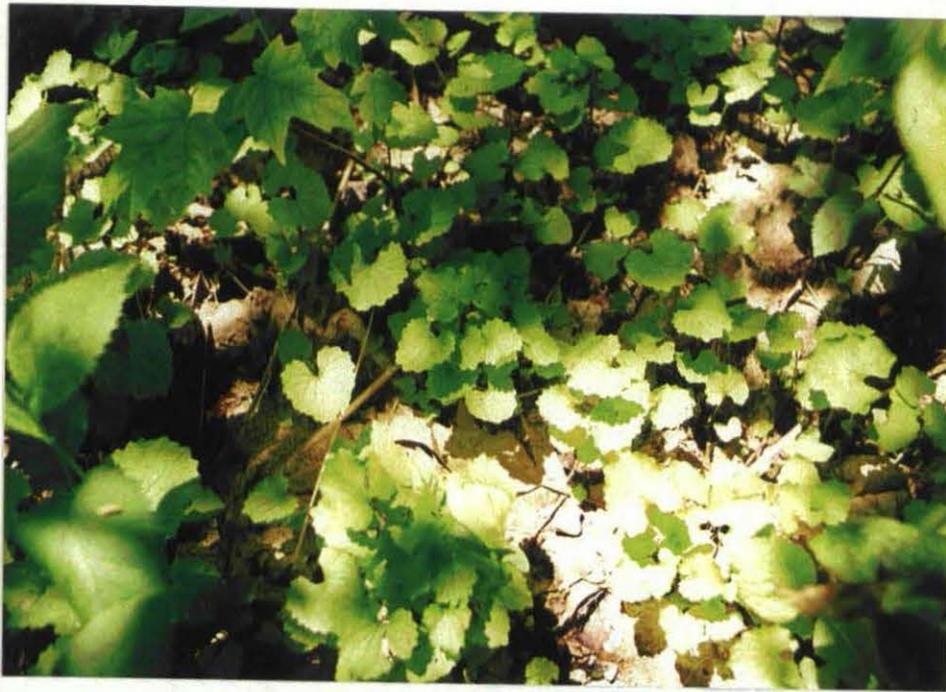
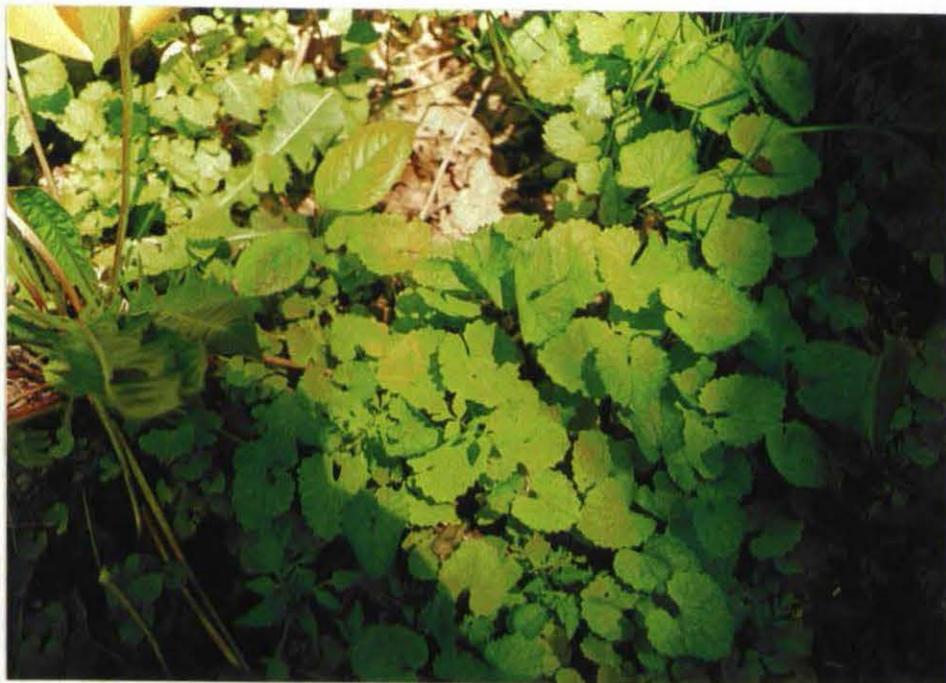
3. Garlic mustard (1<sup>st</sup> year plants)

4. Garlic mustard (1<sup>st</sup> year plants)

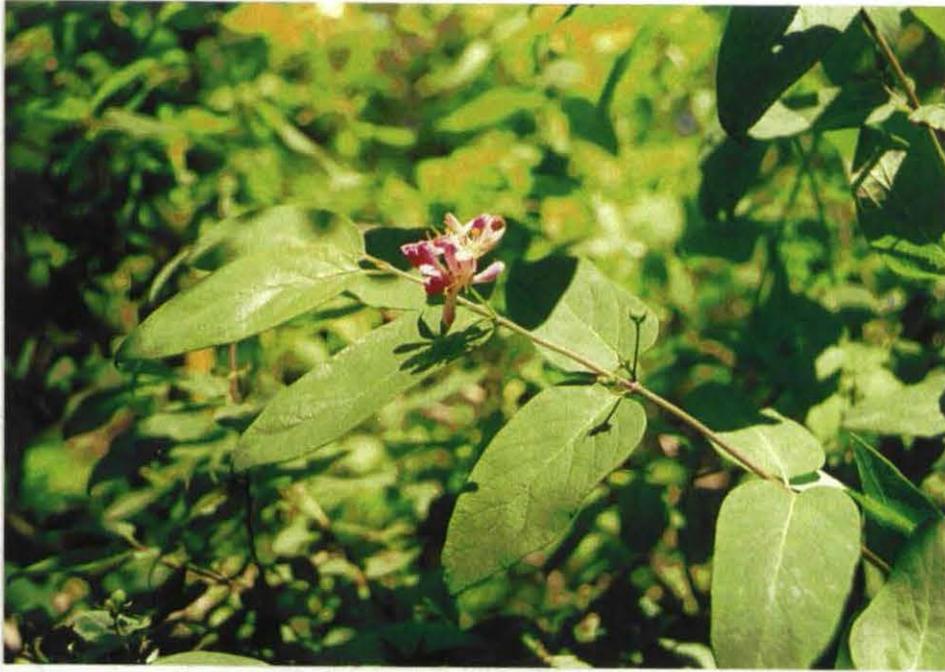
5. Bush Honeysuckle

Stems should be cut at or close to ground level and the exposed stumps painted with a 20 percent solution of glyphosate. This method can yield up to a 90 percent rate of success when administered properly. Several years may be needed to ensure a high rate of success due to seed germination and seedling growth. Pulling of seedlings is not recommended because of the disturbance factor to the substrate.

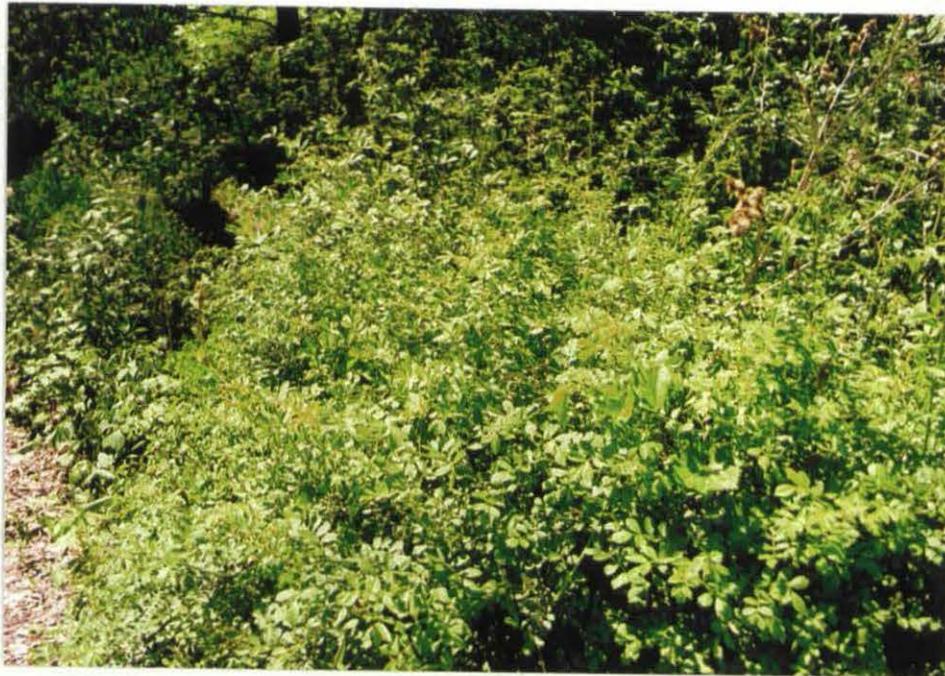
6. Multiflora Rose

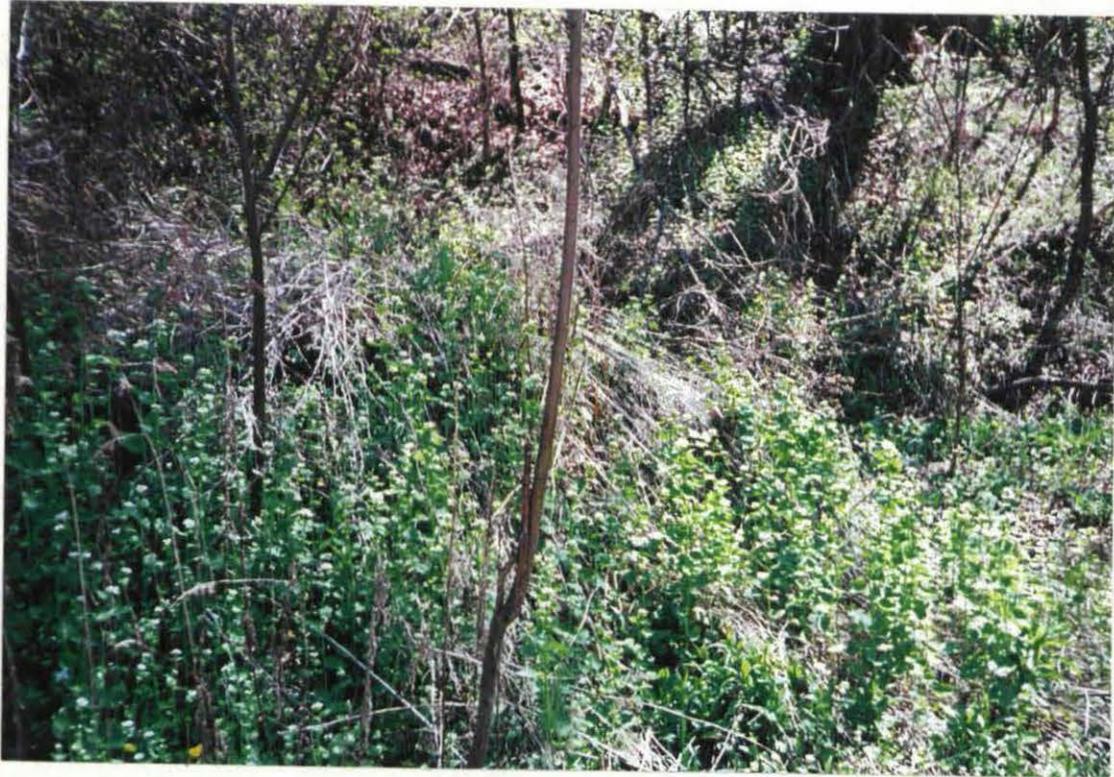
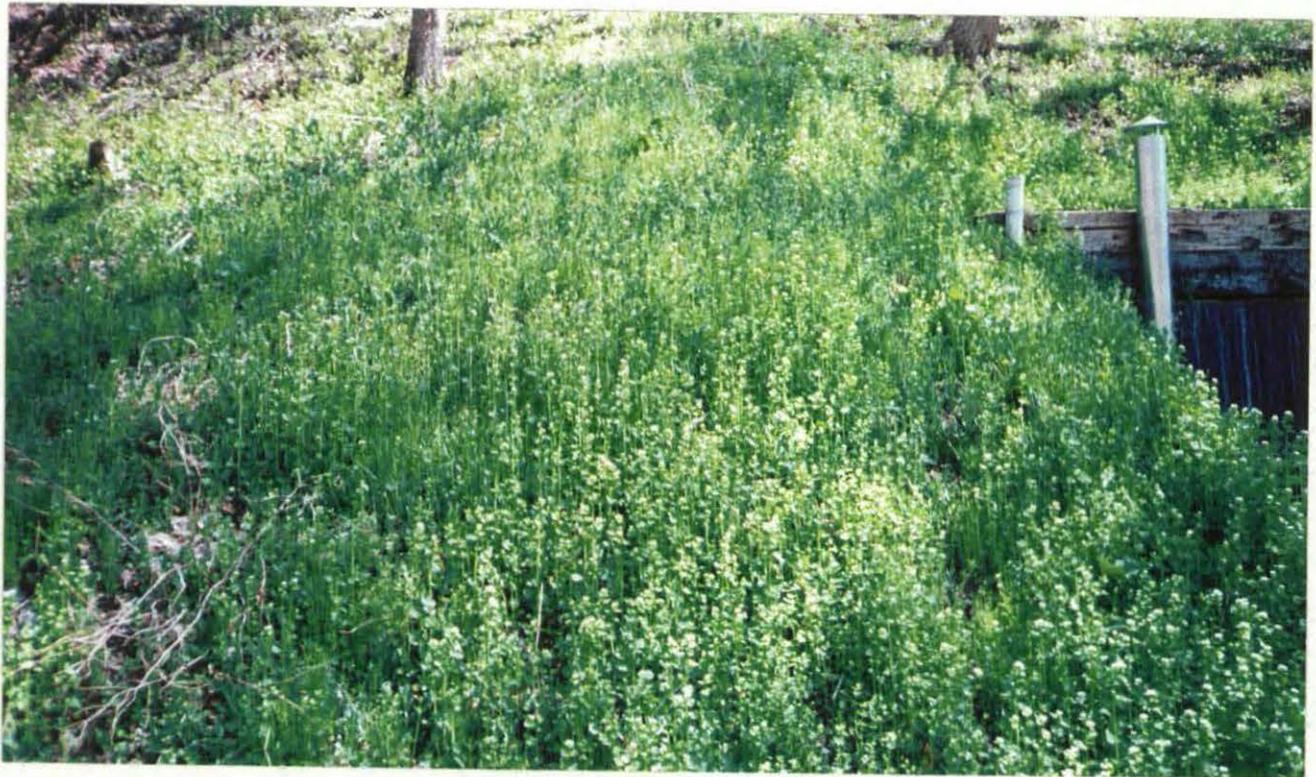
Garlic mustard occurs throughout most of the ravine, although levels of concentration vary from place to place. The heaviest concentration is along the west- and south-facing slopes. These slopes are generally less steep and yield a greater diversity of herbaceous plants than the north- and east-facing slopes. Additionally, the condition of the west- and south-facing slopes was influenced by the dumping of

**7. Examples of garlic mustard's abundance**

**8. Examples of garlic mustard's abundance**

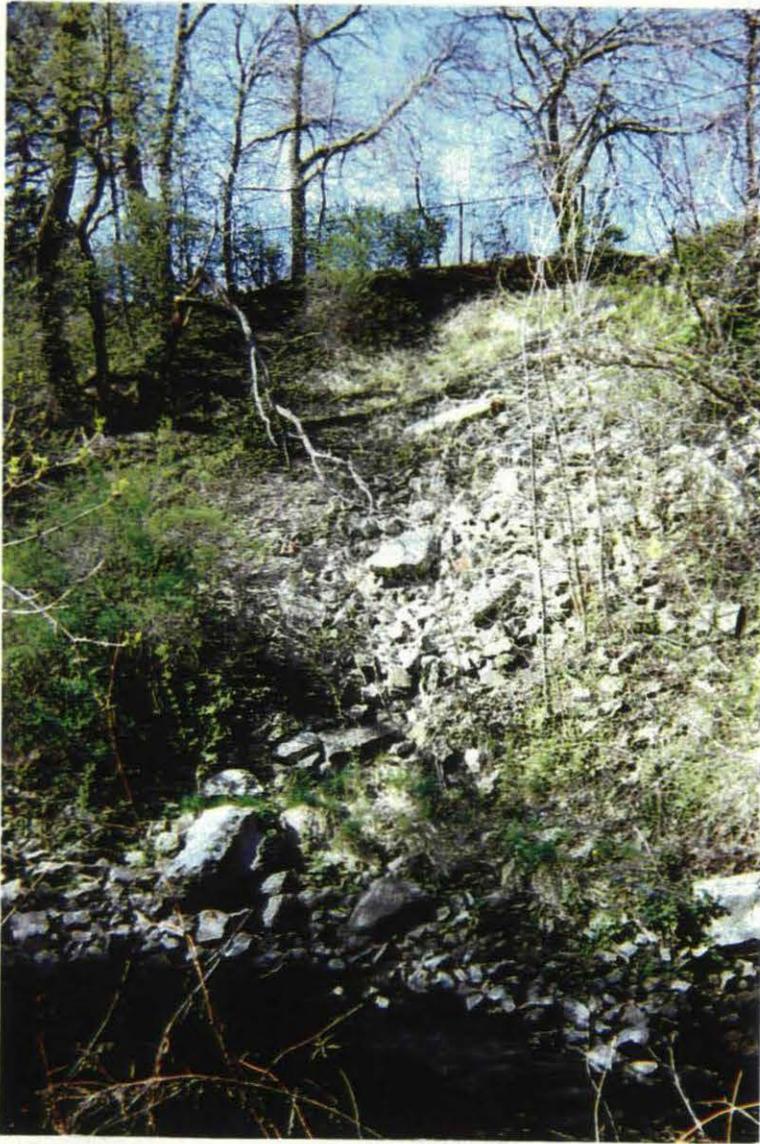
Location No. 1; Erosion gully.

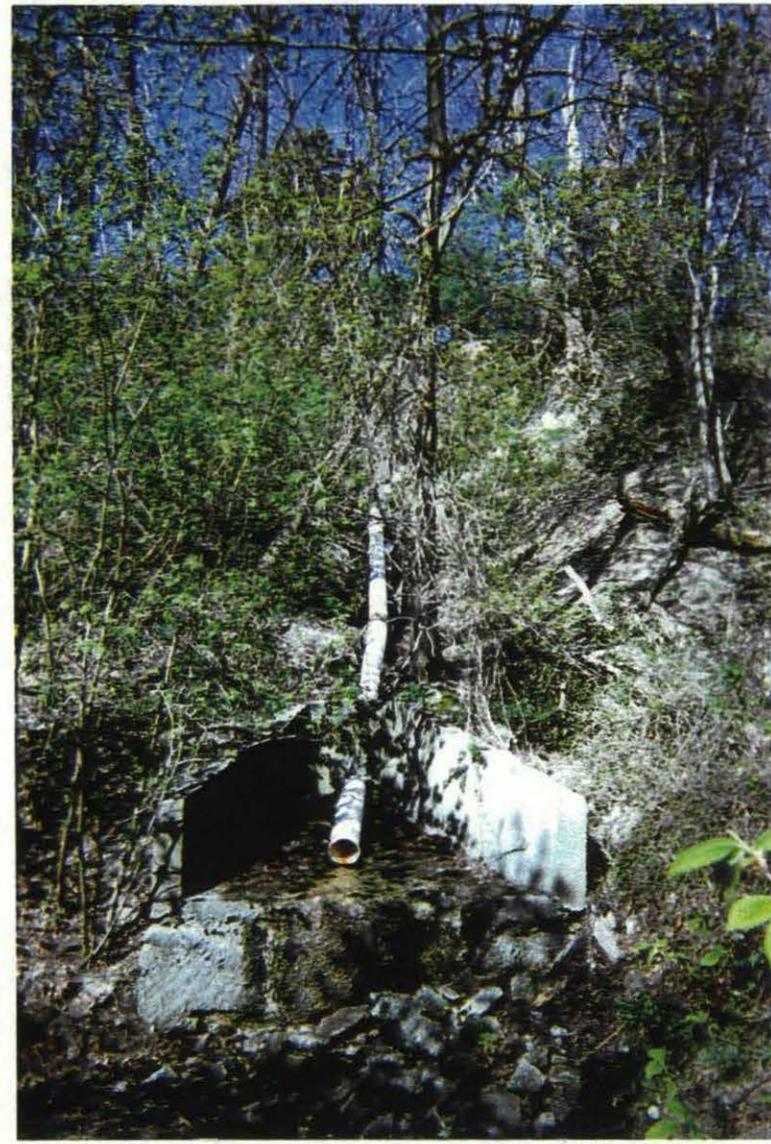
Location No. 2; Erosion gully.

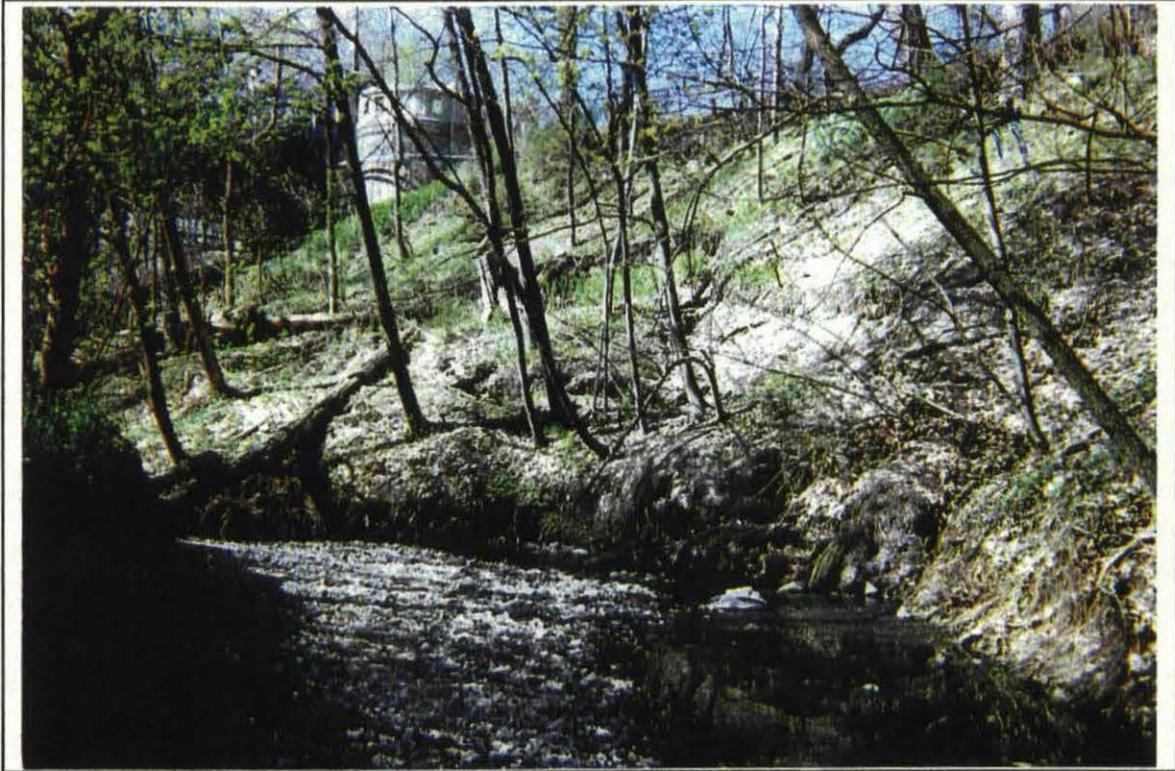
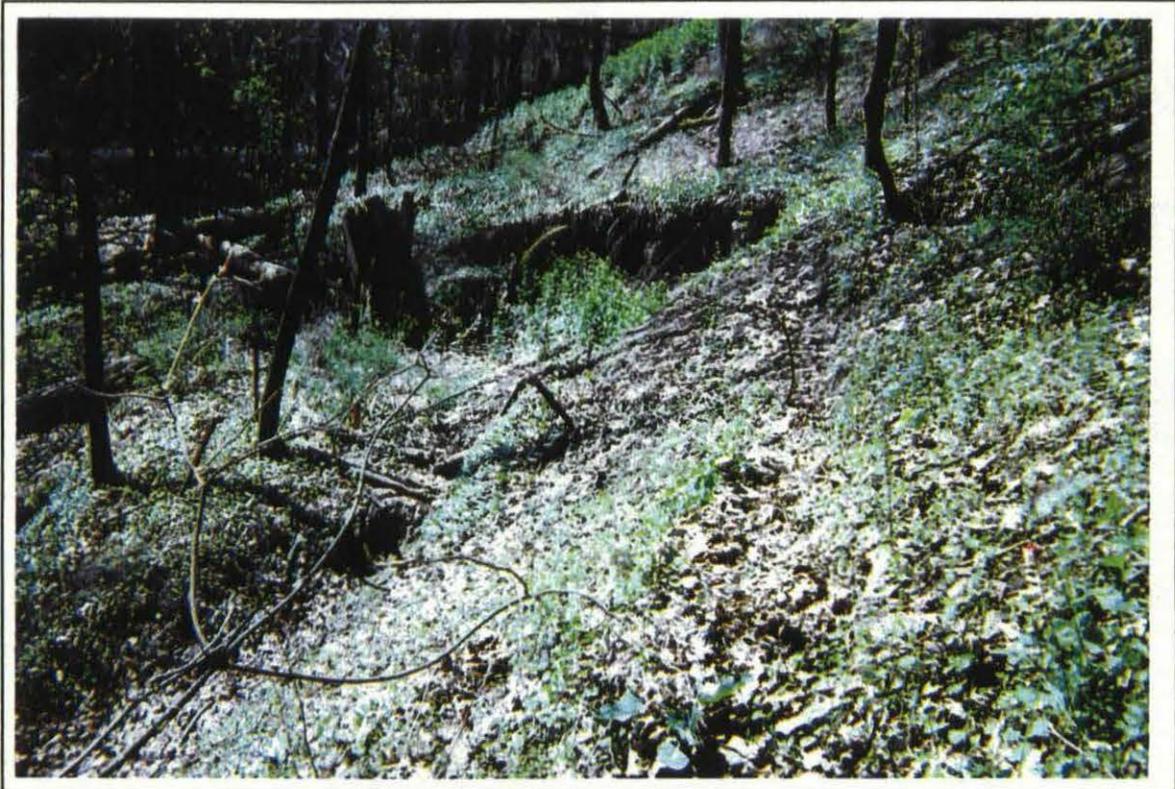
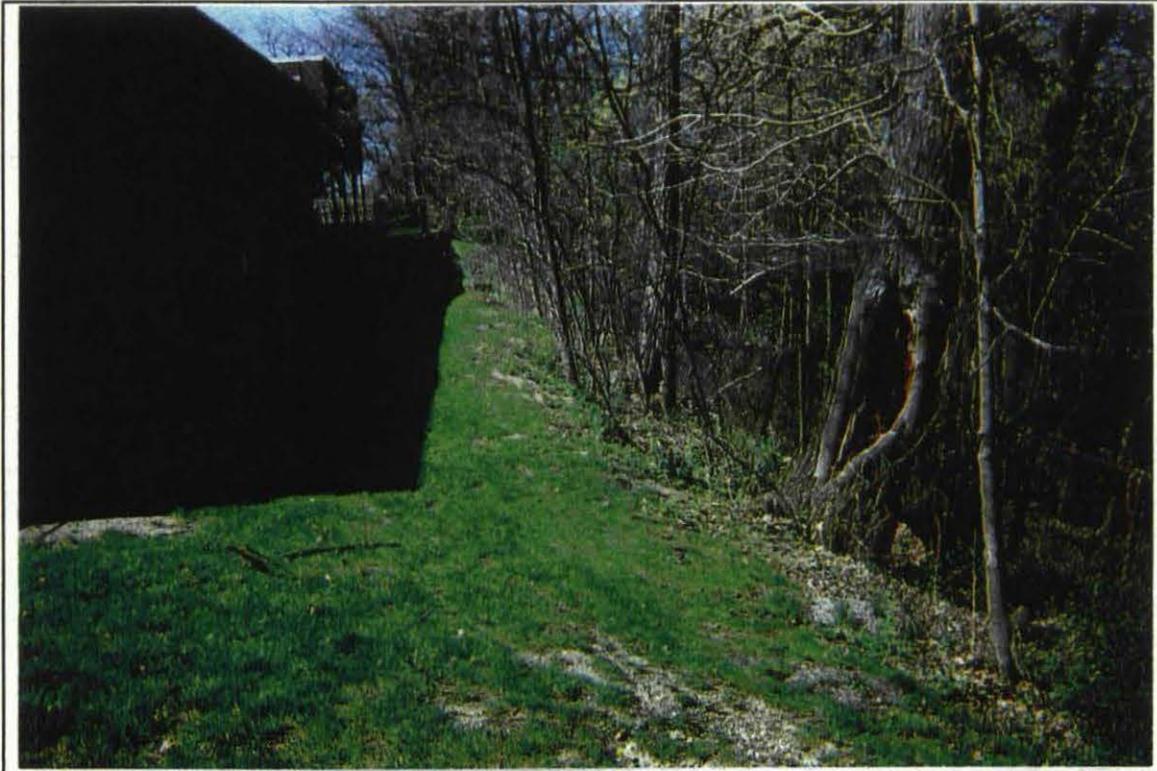
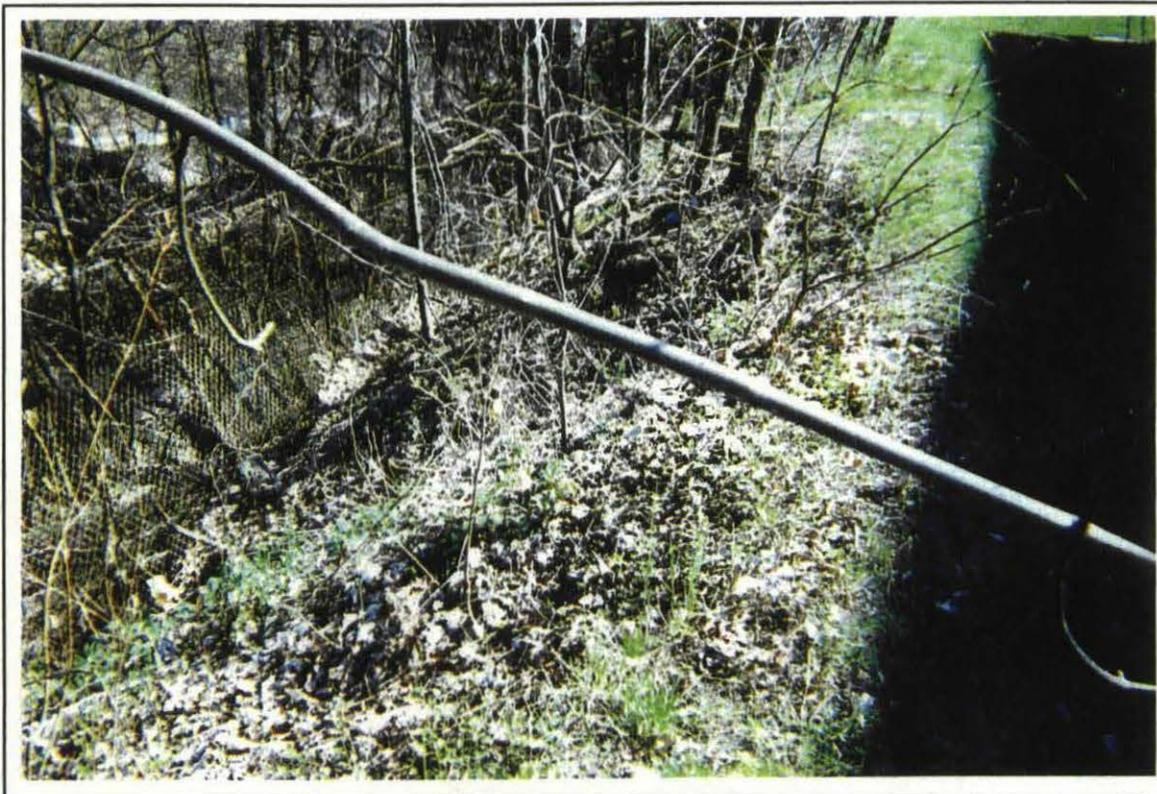
**Location No. 3; Failure below Building No. 42.**

**Location No. 3; Building No. 42 above failure.**

**Location No. 3; Top of slope above failure at Building No. 42.**

In areas of slope failure, such as Location No. 3, laboratory testing of soil samples obtained from the explorations would typically be required to obtain soil parameters for use in the design of slope repairs.

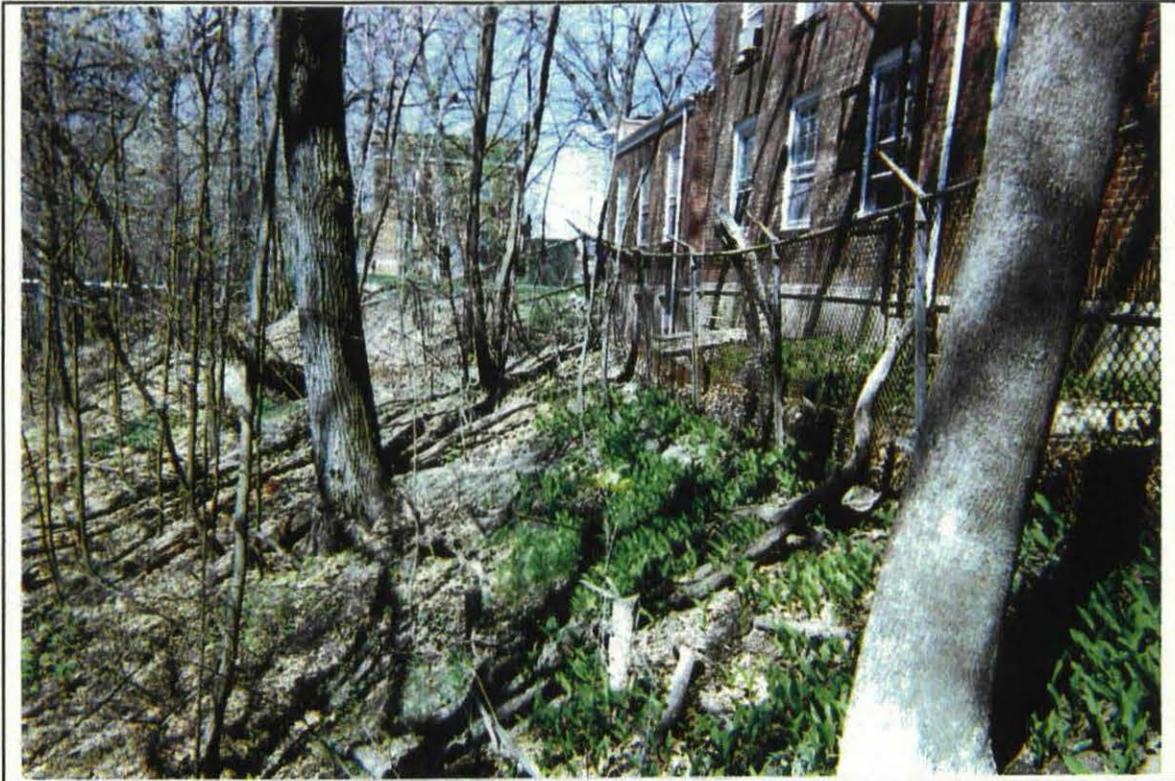
**Location No. 4; Top of slope behind Building No. 76.**

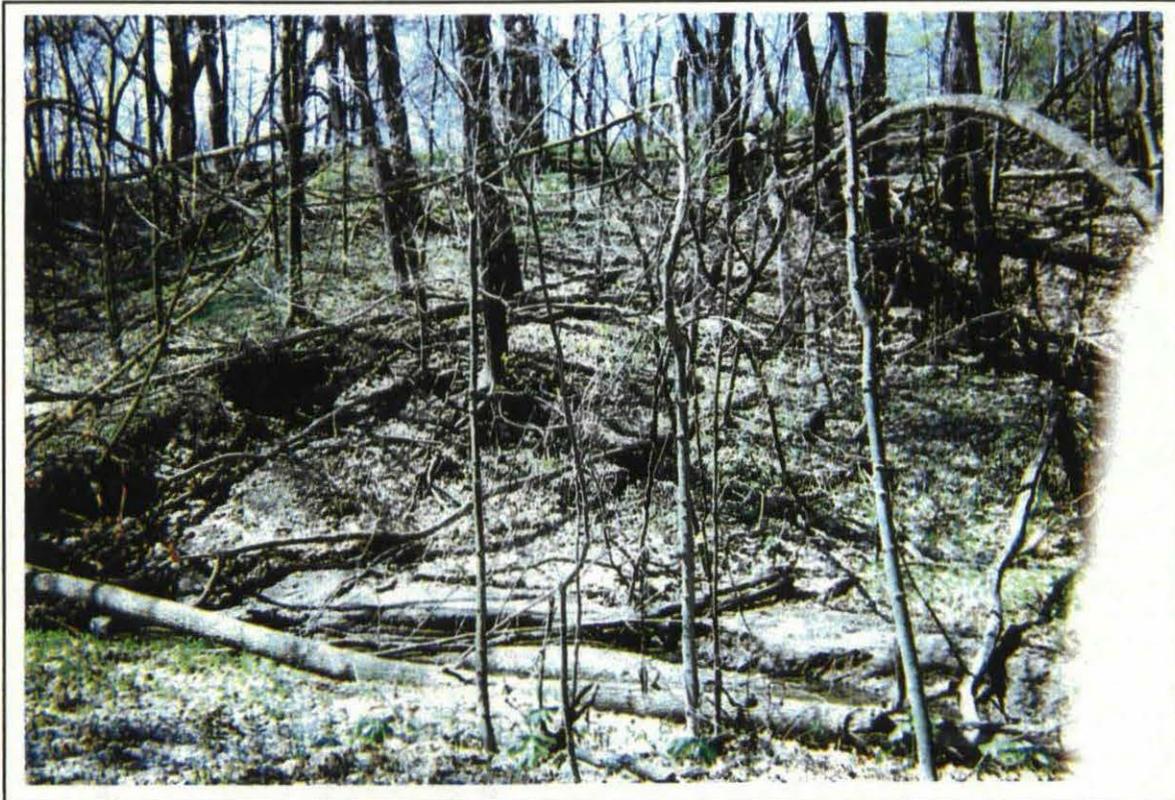
**Location No. 5; Small failure.**

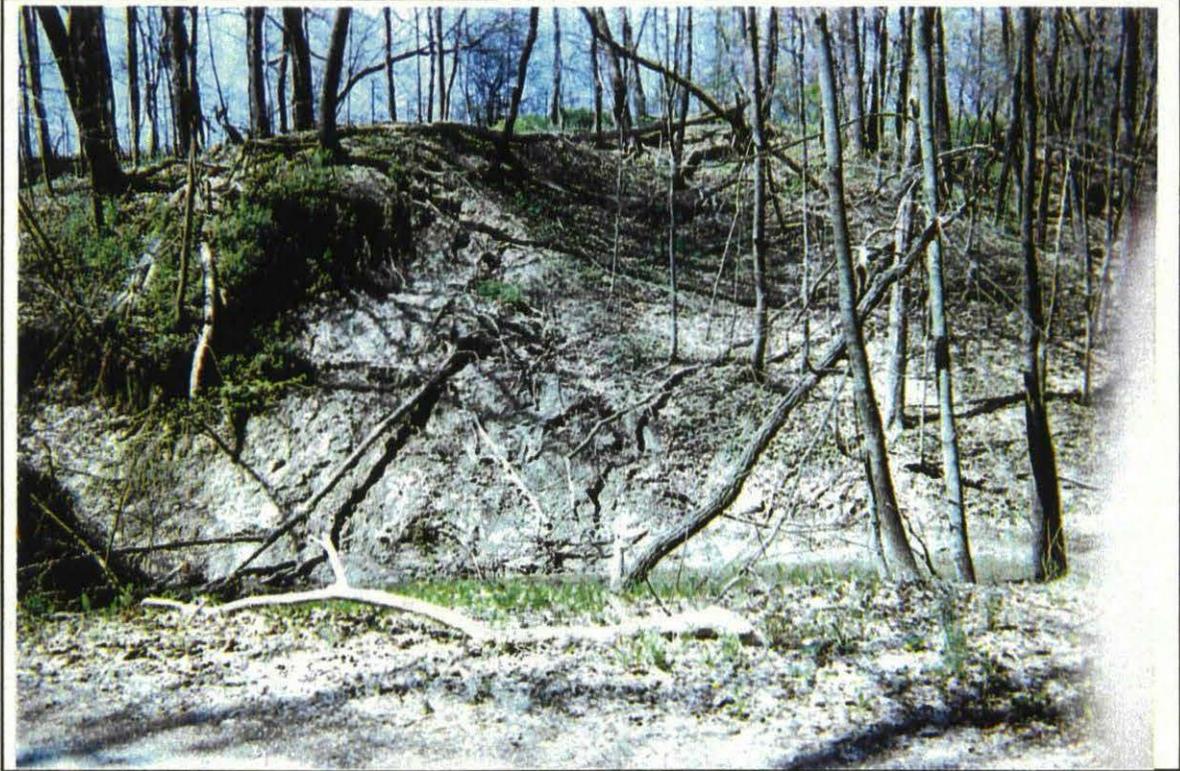
**Location No. 6; Small failure.**

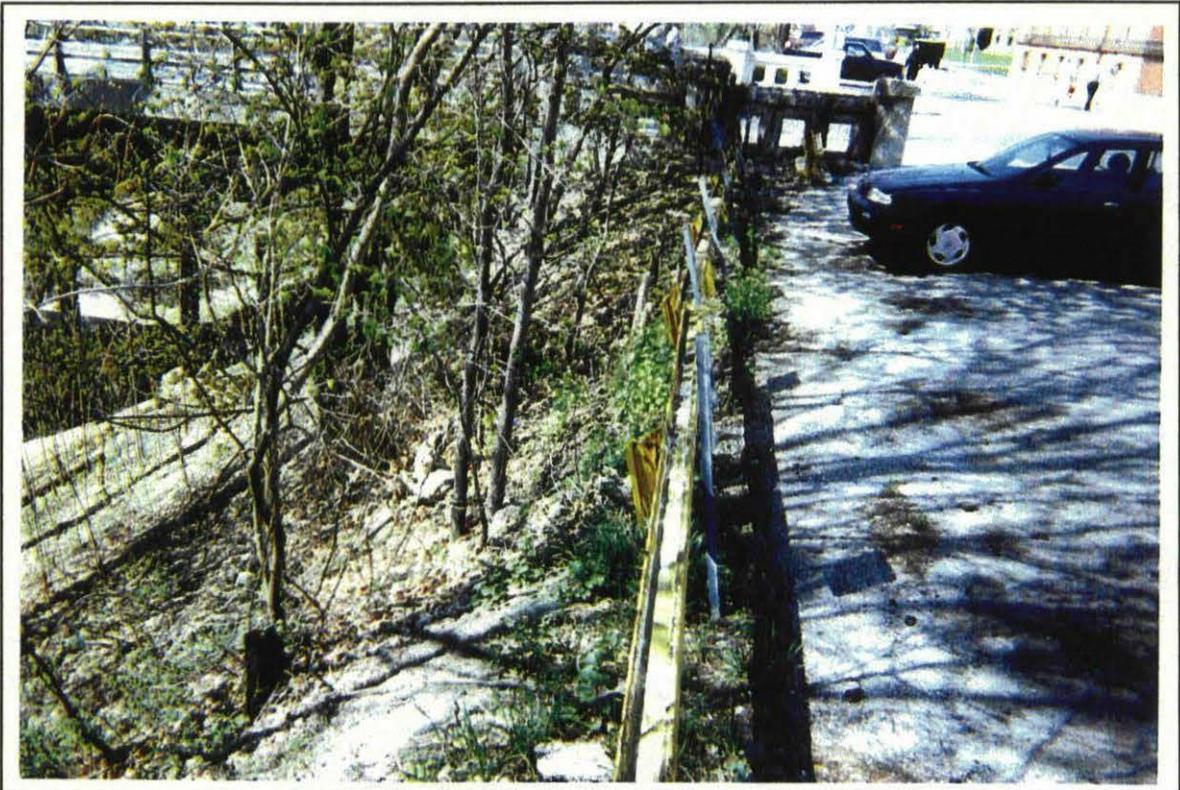
7	North slope of ravine adjacent to parking for Building No. 26.	Slope erosion and loss of support for parking pavement.	1A	Investigate, design and construct repair.
8	South slope of ravine adjacent to west side of Barry Road Bridge.	Surface sloughing extending to almost top of slope.	2B	Monitor.
9	South slope of ravine adjacent to east side of Barry Road Bridge.	Failed slope. Slope repairs in progress. Additional failure appears possible immediately east.	1A	Repair in progress.
10	South slope of ravine about 150 feet east of Location No. 9 and below steamline.	Failure at toe of slope.	1B	Monitor, investigate, design and construct repair.
11	North slope of ravine below Building No. 73.	Large "bowl"-shaped slope may be old failure. Currently appears stable.	2A	Monitor.

**Location No. 7; Top of slope adjacent to Building No. 26 parking.**

Each Category area should be addressed by a detailed investigation of current conditions leading to the design of slope repairs. This may include performing subsurface explorations to characterize the soil, such as at failed areas (e.g. Location No. 3), or a survey of existing ground surface elevations and drainage patterns, such as at Location No. 7.

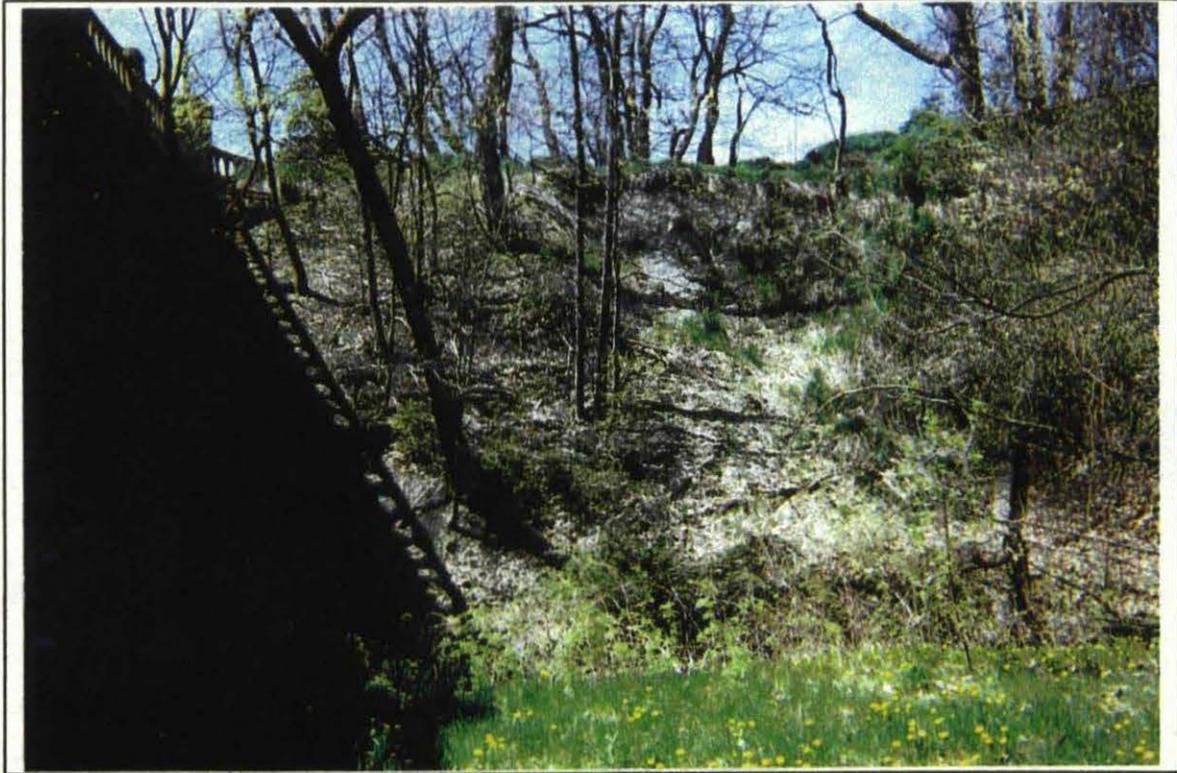
Location No. 8; Surface sloughing.

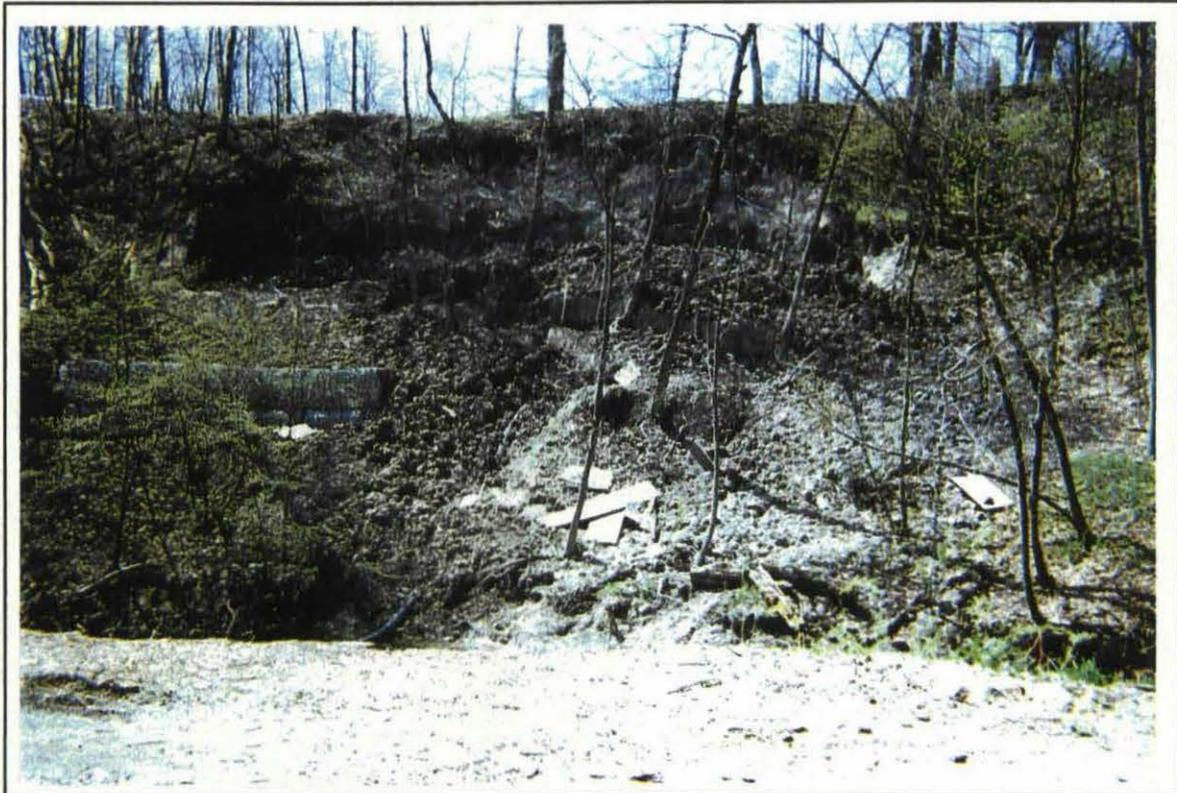
Location No. 9; Repairs in progress.

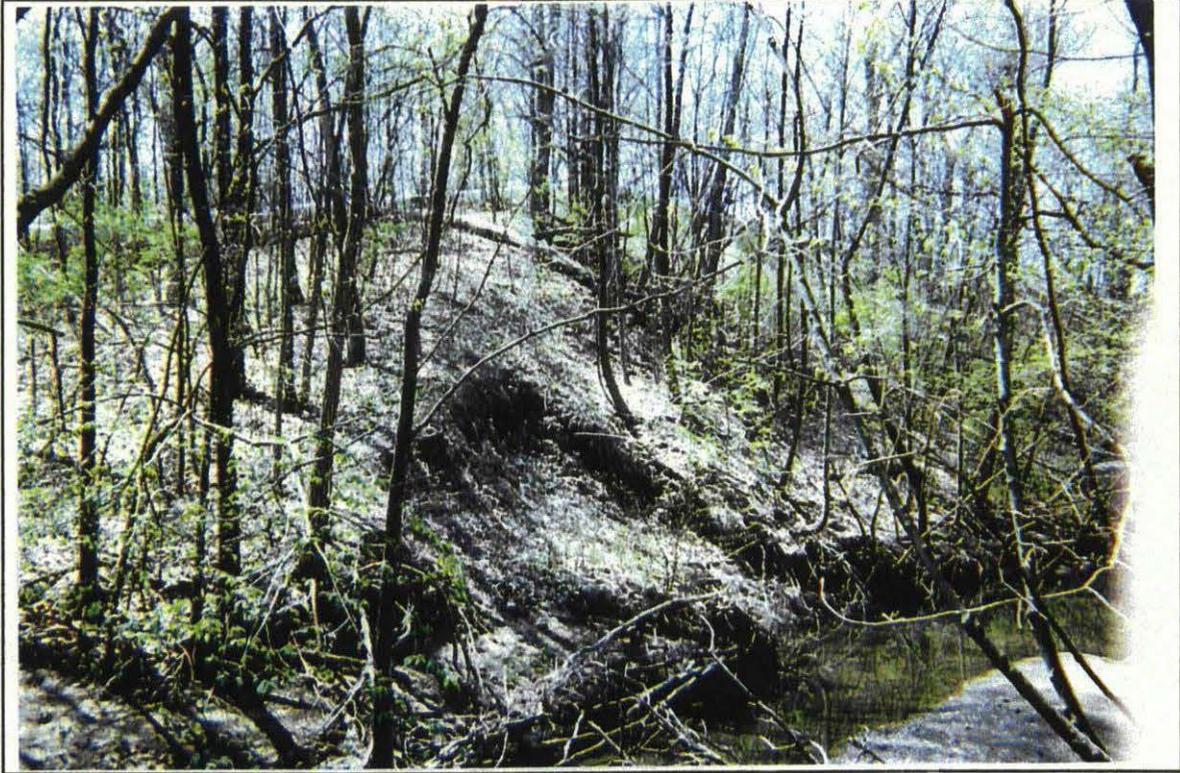
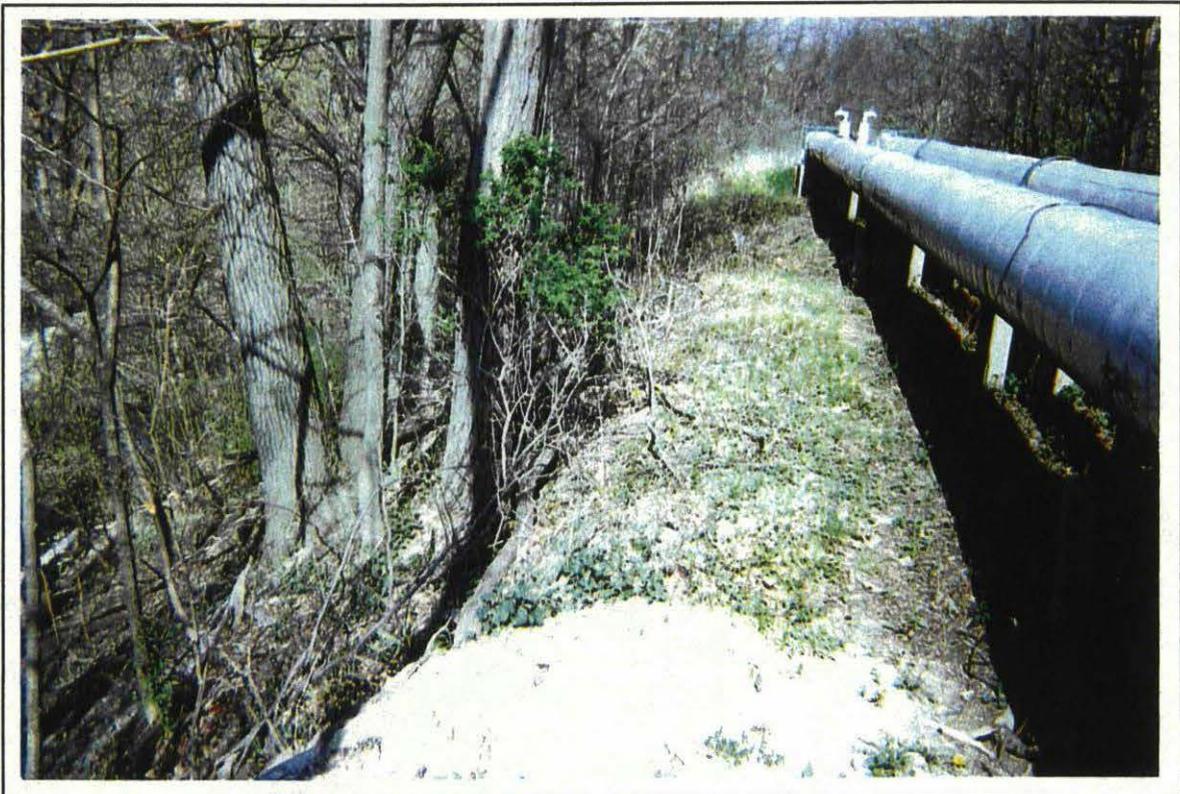
Location No. 10; Small failure.

Location No. 10; Steamline at the top of the slope above the failure.

report any changed conditions. Optical surveys to measure slope surface elevations and horizontal location could also be considered, however, this would be at an additional cost. An optical survey would be appropriate for monitoring the steamline, such as at Location No. 10.

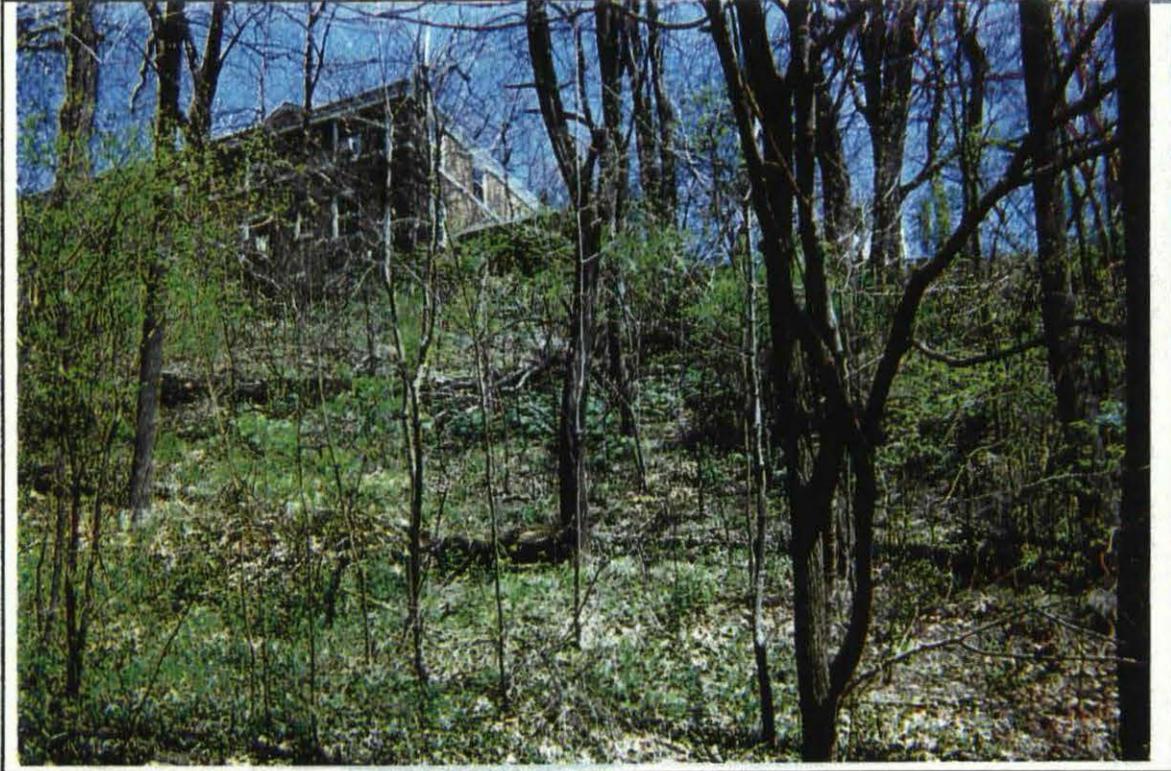
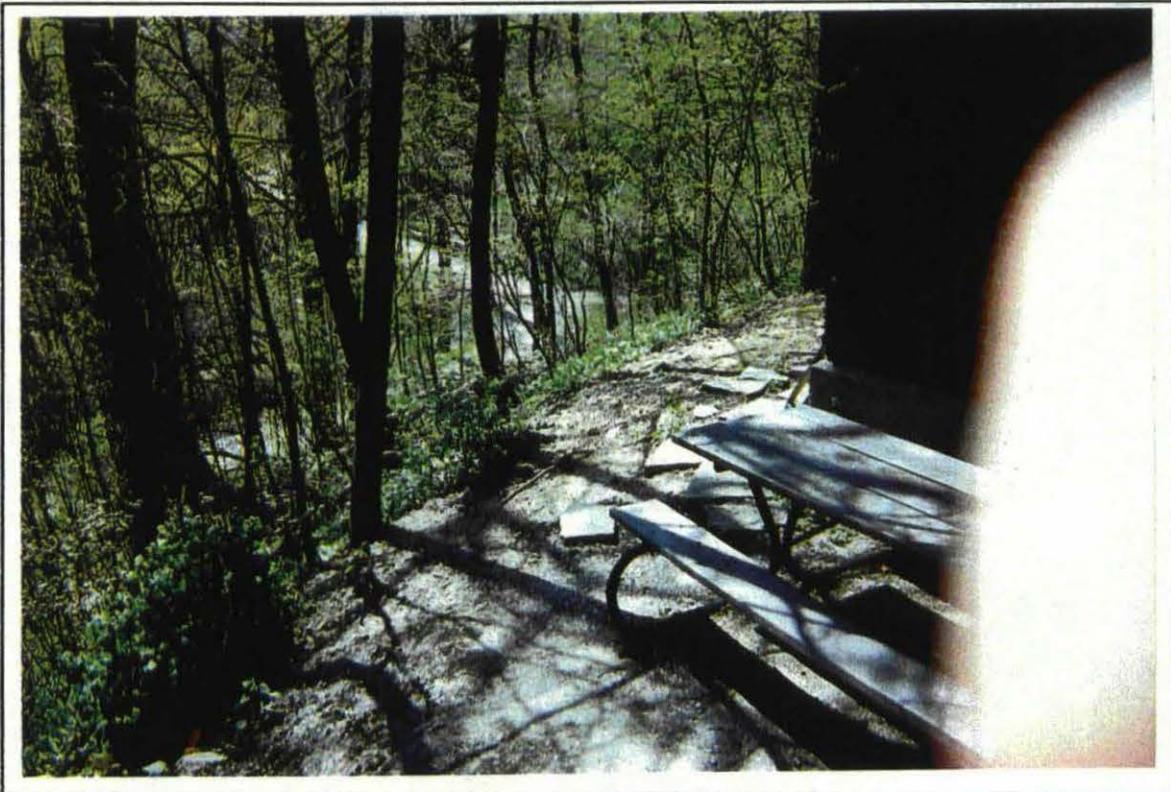
**Location No. 11; Possible old failure.**

**Location No. 11; Proximity of Building No. 73 to top of the slope.**

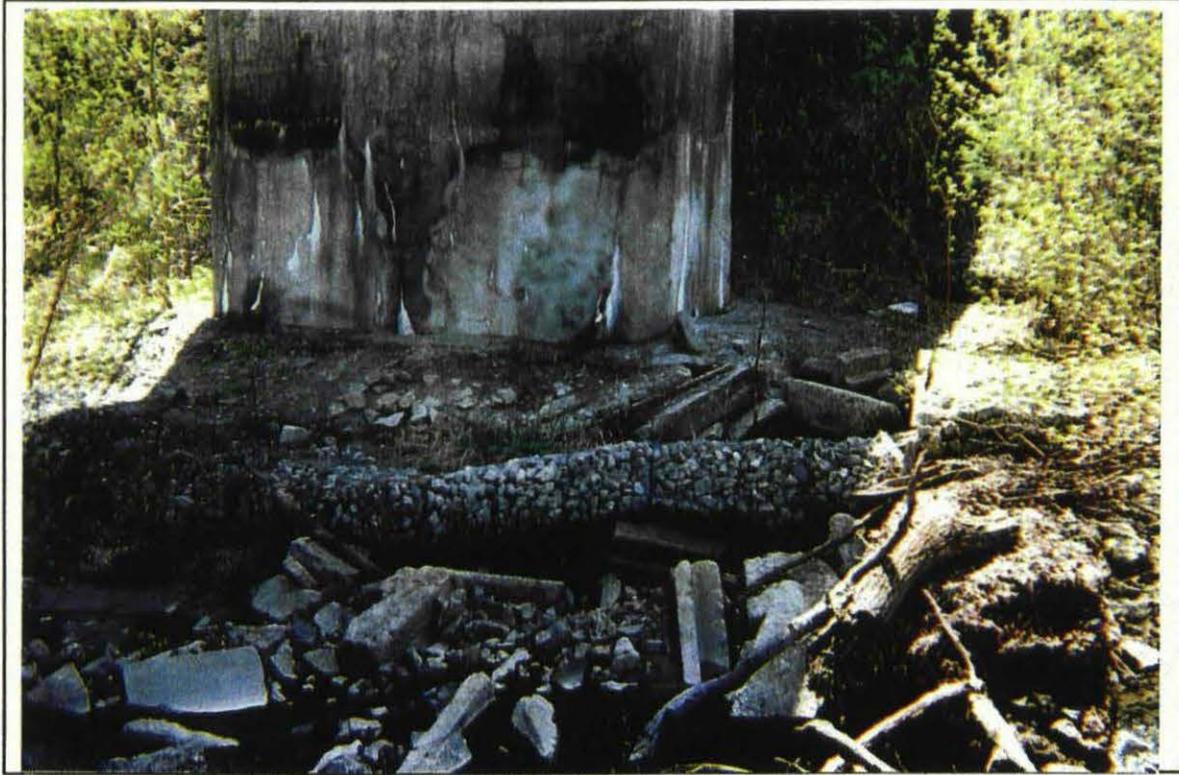
Location Designation No.	Location	Condition	Category	Conceptual Recommendation
12	South edge of creek in front of Sampson Road Bridge pier.	Gabion slope protection has failed.	1A	Investigate, design and construct repair.
13	South slope of ravine adjacent to west side of Sampson Road Bridge.	Fairly steep slope appears stable at this time.	2A	Monitor.
14	North slope of ravine below Building Nos. 142 and 143.	Erosion gullies formed.	1B	Monitor.
15	South slope of ravine below Building No. 14H.	Storm drain on slope has connection separated. No damage to bell and spigot; separation possibly due to general downslope movement.	2A	Repair drain pipe.

Location No. 12; Gabion wall failure.
