RESTORATION AND MAINTENANCE PLAN FOR PETTIBONE CREEK RAVINE NS GREAT  
LAKES IL  
7/1/2000  
ENVIRONMENTAL QUALITY MANAGEMENT, INC.

**RESTORATION AND MAINTENANCE PLAN  
FOR PETTIBONE CREEK RAVINE  
NAVAL TRAINING CENTER,  
GREAT LAKES, ILLINOIS**

July 2000

**ATTACHMENT 1  
ANALYSIS AND RECOMMENDATIONS  
FOR SUBSTRATE INSTABILITY**

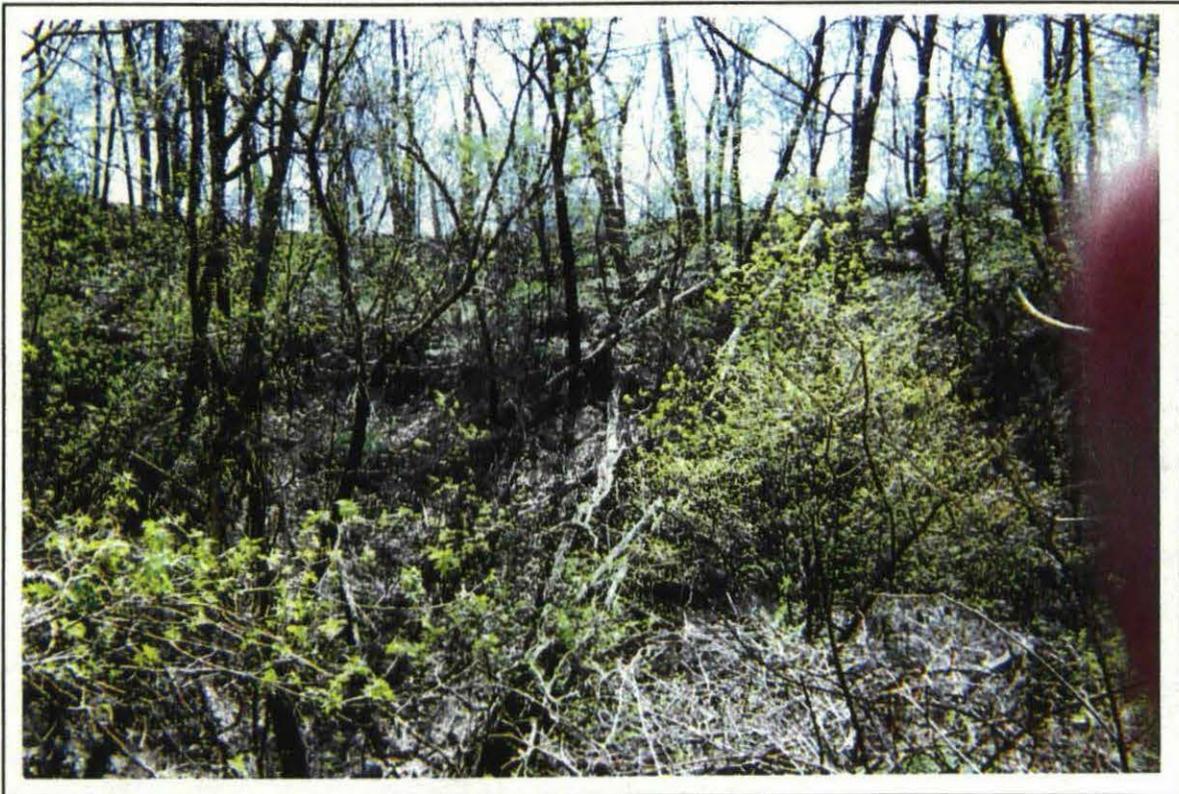
Location No. 13; Steep slope.

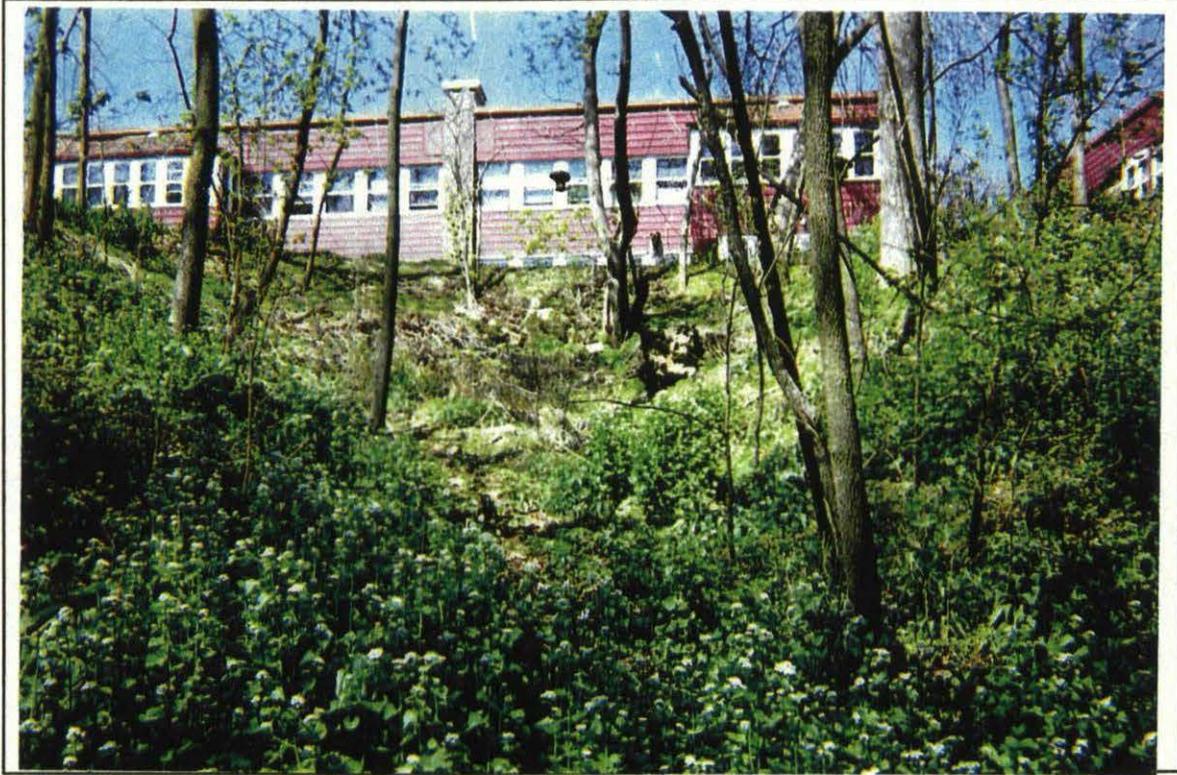
Location No. 14; Erosion gully.

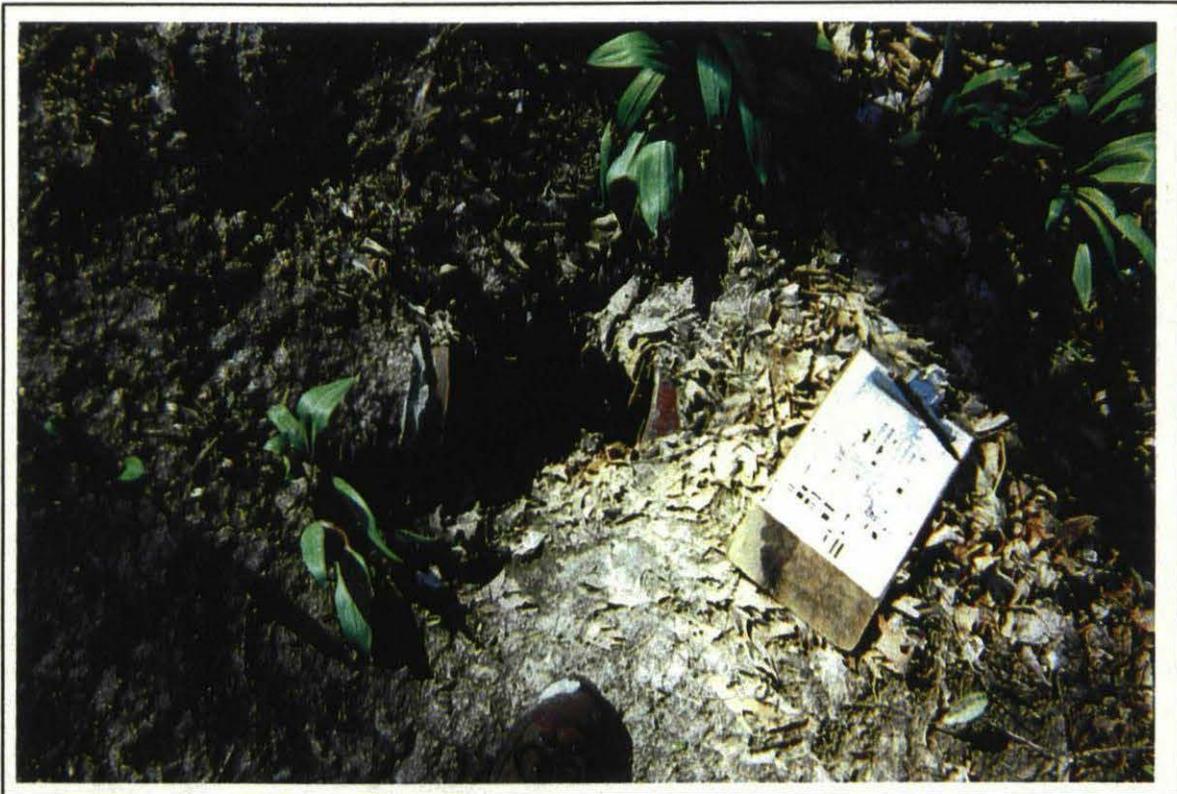
Location No. 15; Storm drain pipe separated on the slope.
