FINAL TECHNICAL MEMORANDUM FOR SUMMARY OF BASEWIDE WELL REPAIR AND  
ABANDONMENT ACTIVITIES AT SITES 7, 8, 9, 10, 11, 11A, 12, 13 AND SOLID WASTE  
MANAGEMENT UNIT 3 JEB LITTLE CREEK VA

**Summary of Basewide Well Repair and Abandonment  
Activities at Sites 7, 8, 9, 10, 11, 11a, 12, 13 and SWMU 3**

Joint Expeditionary Base (JEB) Little Creek-Fort Story  
JEB Little Creek  
Virginia Beach, Virginia

DATE: July 2011

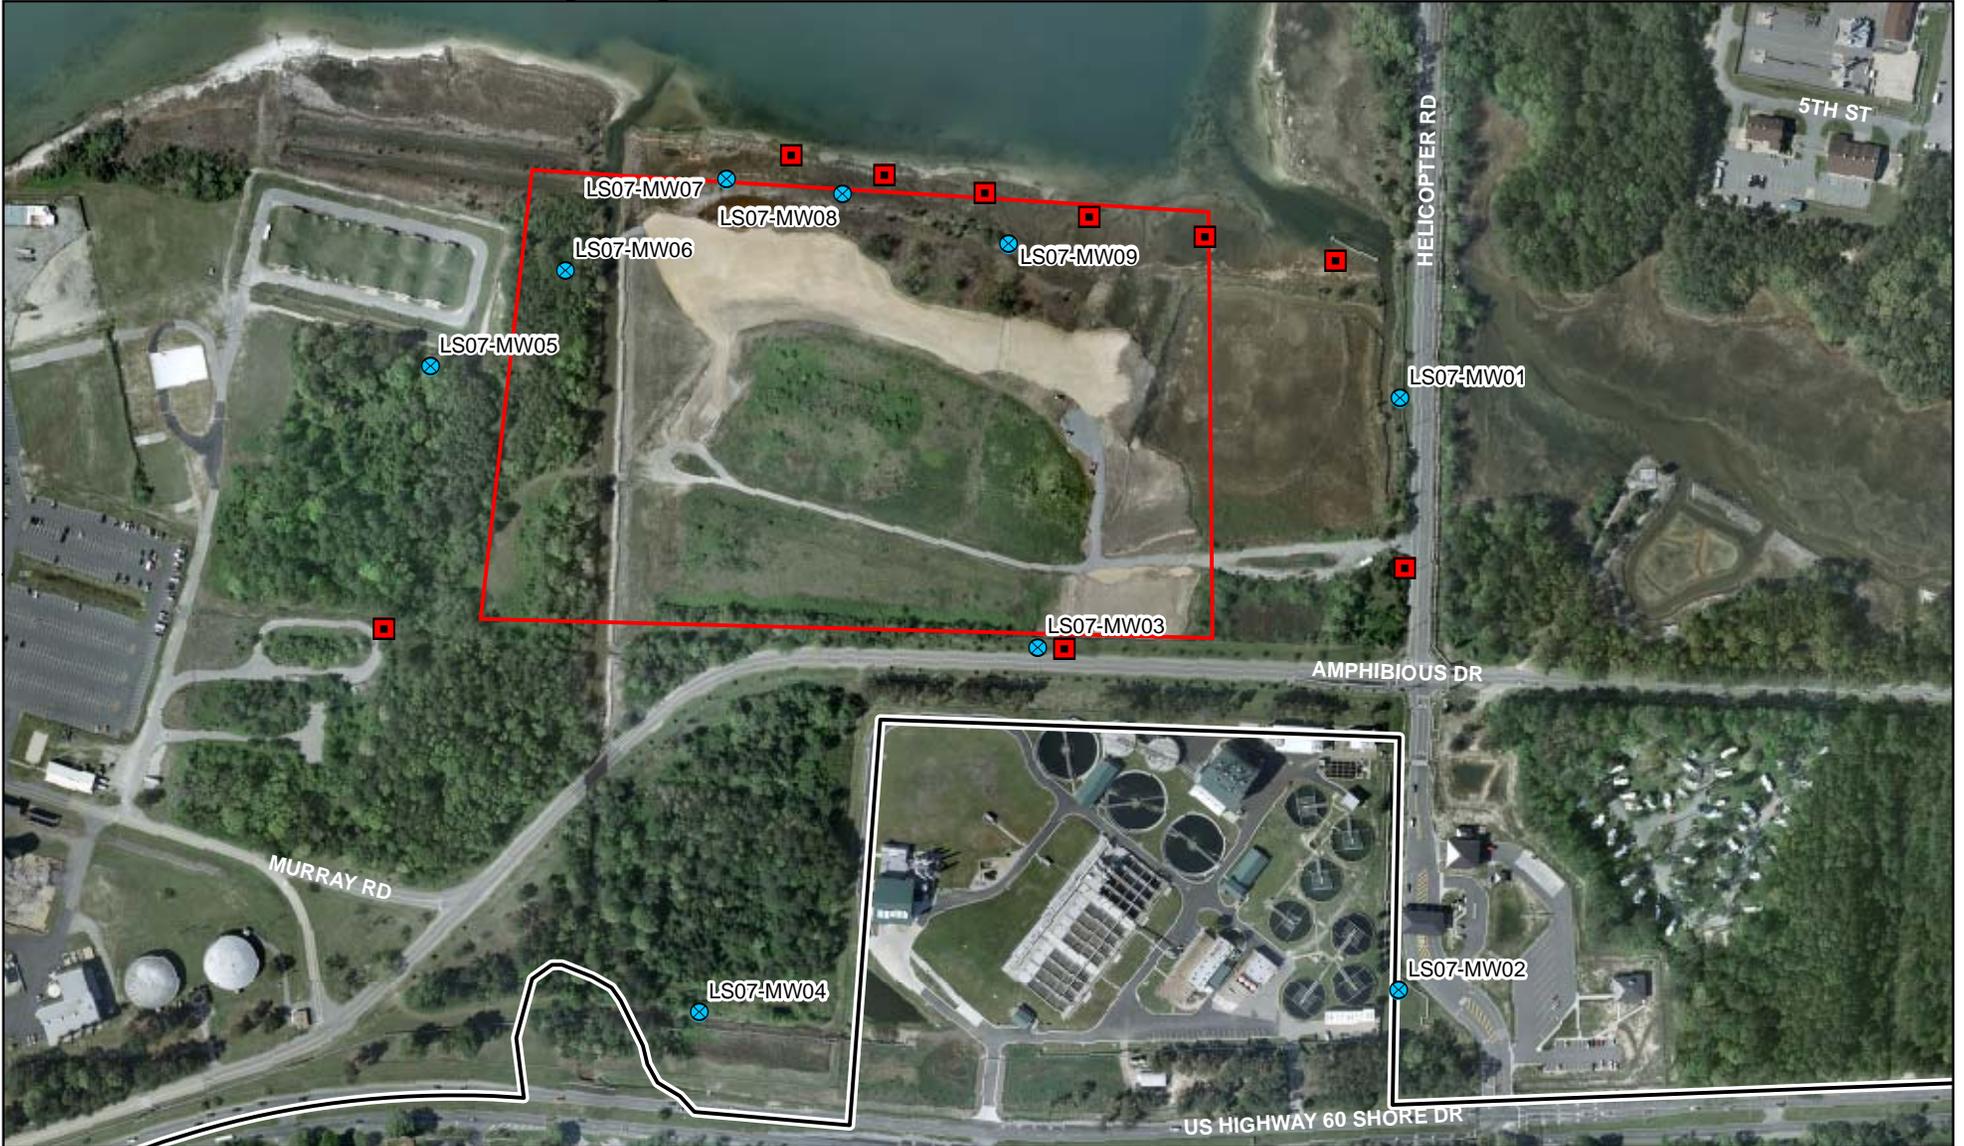
Figure 2  
Site 7 Amphibious Base Landfill  
Basewide Well Repair and Abandonment Summary  
JEB Little Creek  
Virginia Beach, Virginia

- **LS07-MW02 (Site 7)** – Bollards were not painted. The bollards are scheduled to be painted during the next round of quarterly site inspections.
- **LS07-MW04 (Site 7)** – Bollards were not painted. The bollards are scheduled to be painted during the next round of quarterly site inspections.

- **LS07-MW05 (Site 7)** – Bollards were not in optimal condition and require replacement. The bollards should be replaced and painted during the next appropriate field event.

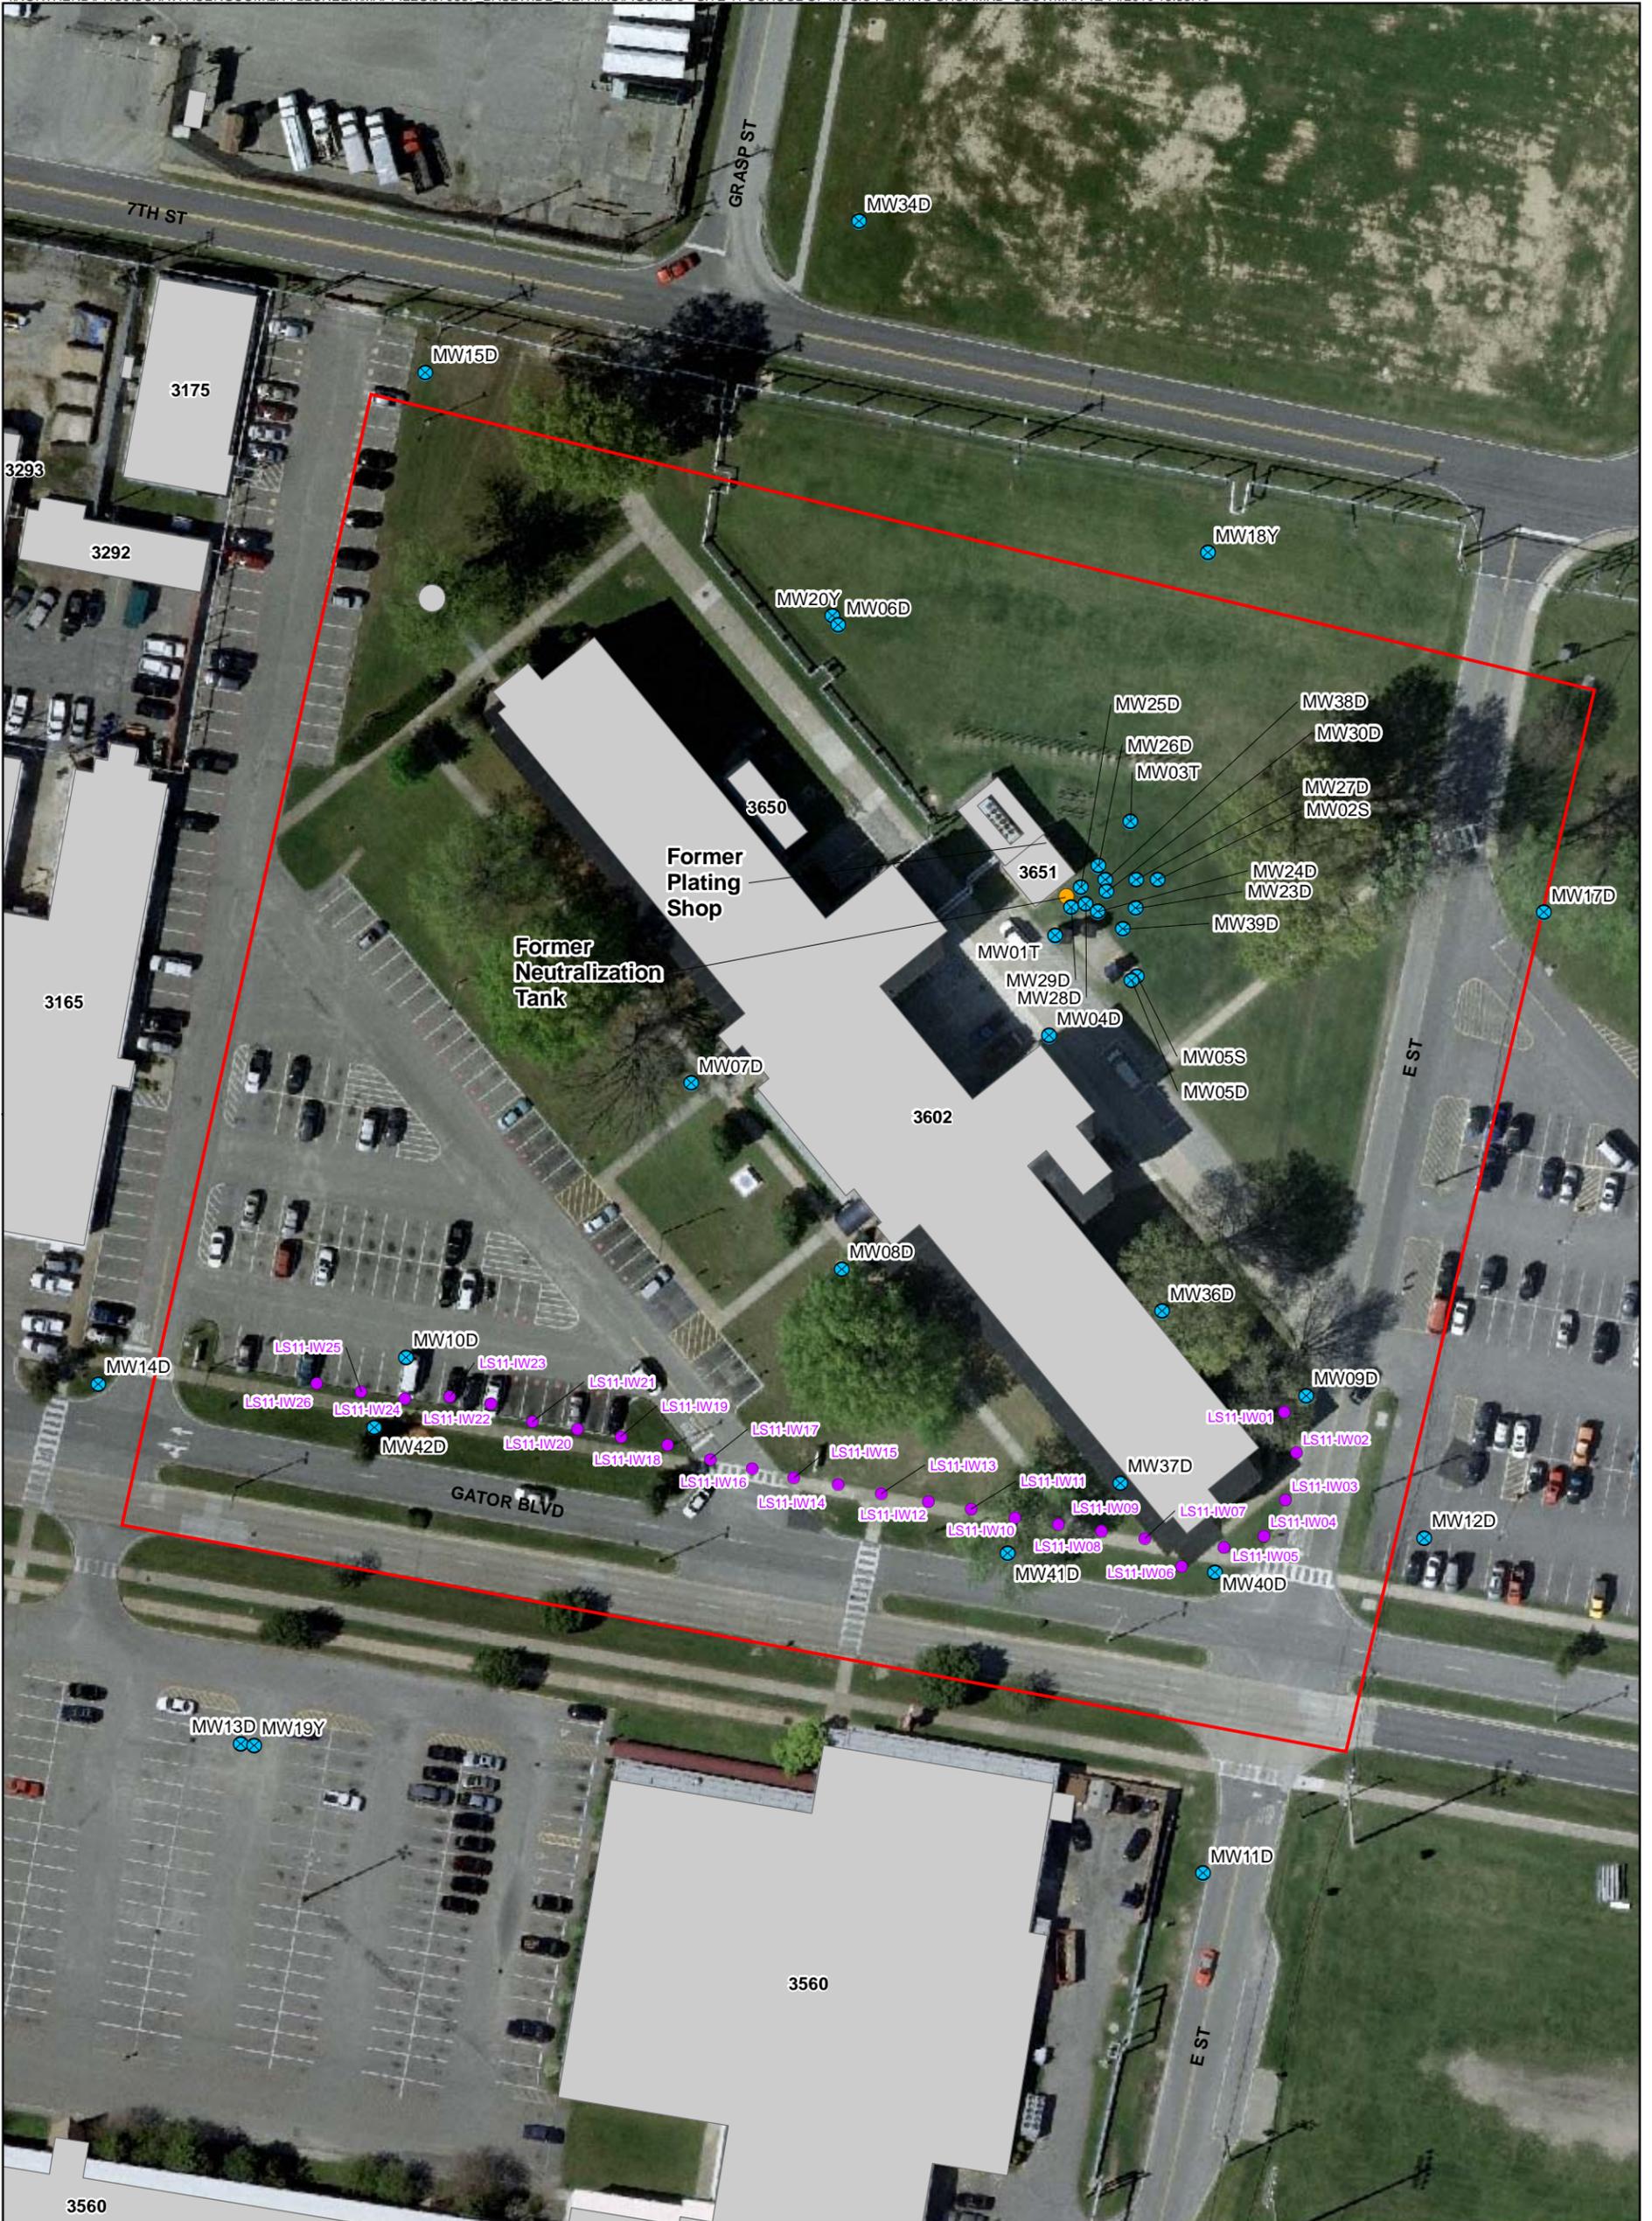
Figure 5  
 Site 11 School of Music Plating Shop  
 Basewide Well Repair and Abandonment Summary  
 JEB Little Creek  
 Virginia Beach, Virginia

- **LS11-MW05S (Site 11)** – Stripped flanges were identified and require repair. Stripped flanges should be repaired during the next appropriate field event.

- **LS11-MW06S (Site 11)** – A stripped flange was identified and requires repair. The stripped flange should be repaired during the next appropriate field event.

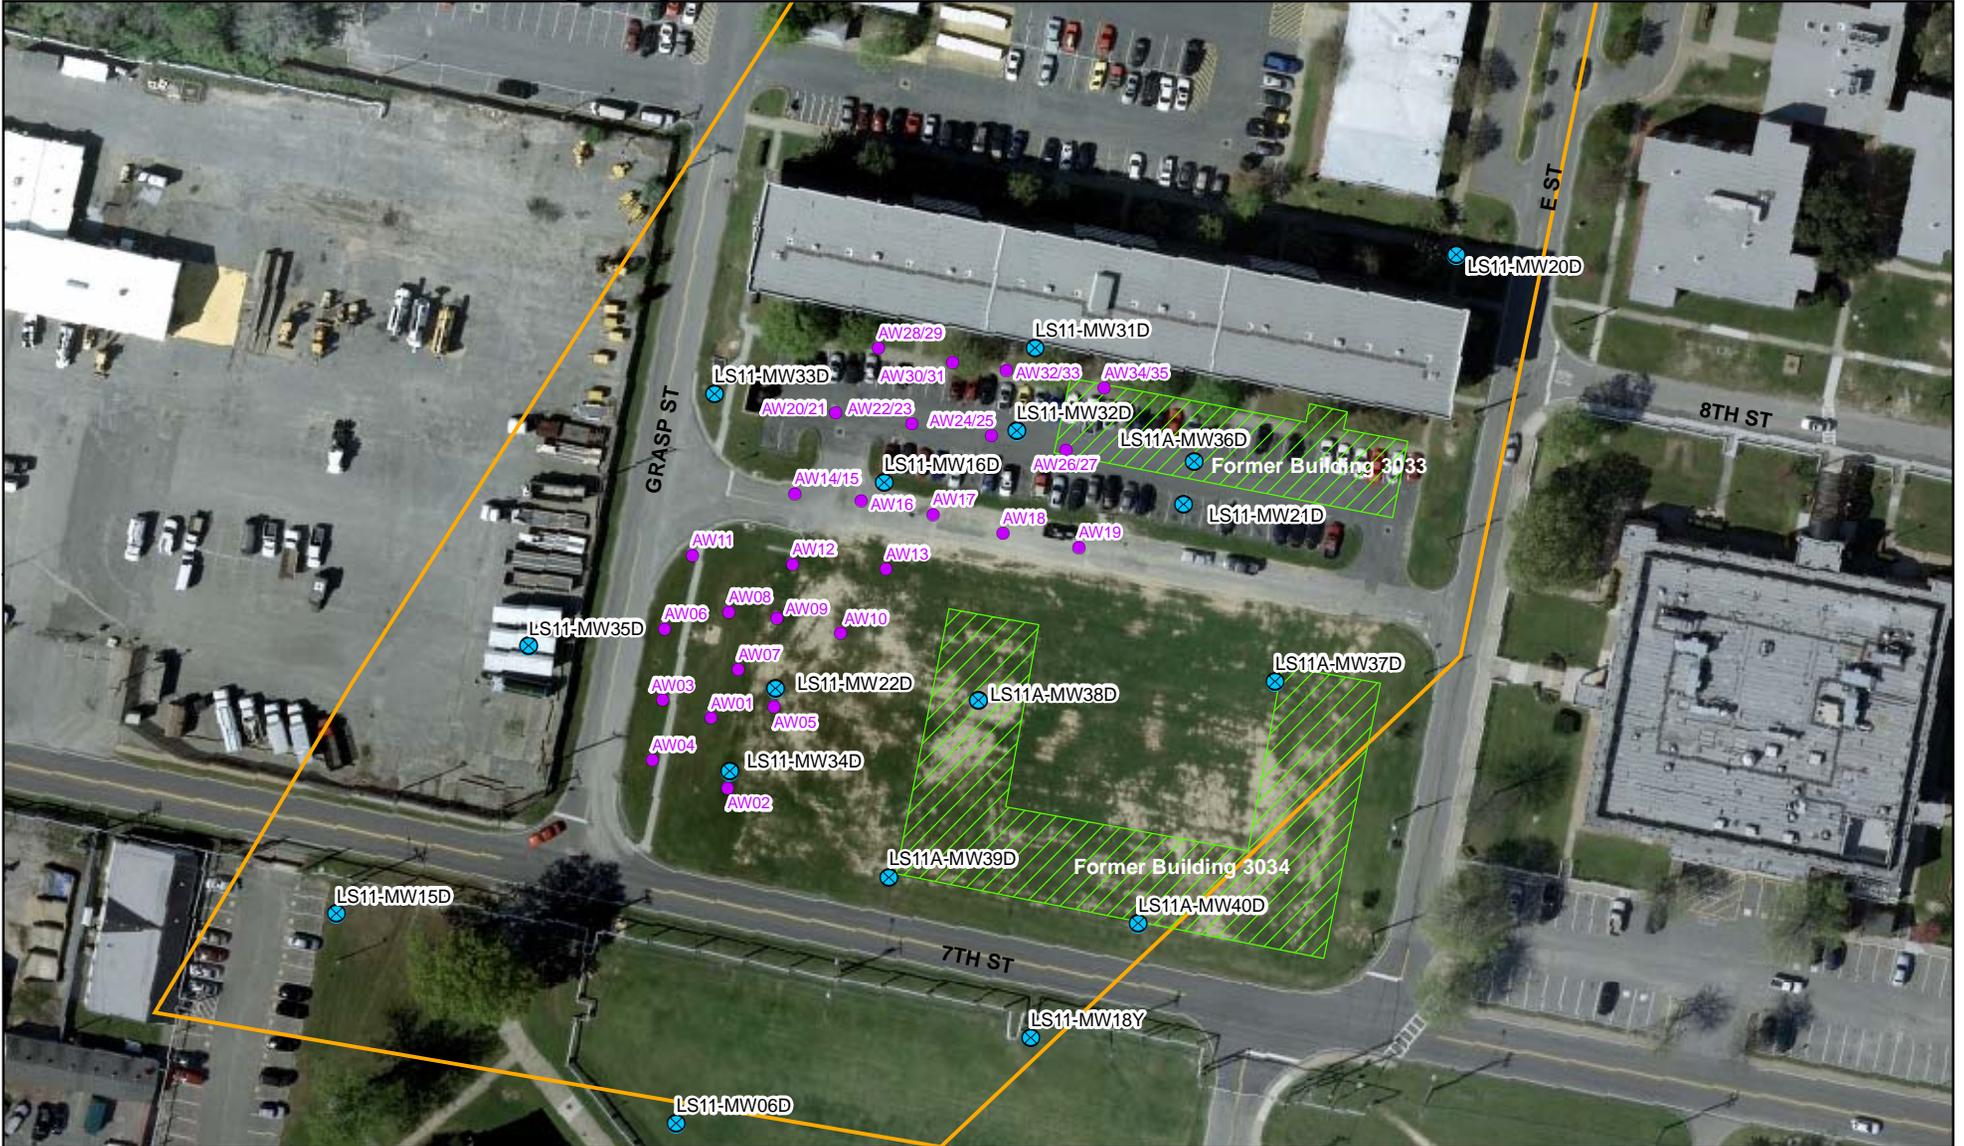
Figure 6  
Site 11a Building 3033 Former Waste Oil Tank  
Basewide Well Repair and Abandonment Summary  
JEB Little Creek  
Virginia Beach, Virginia

- **LS11A-AW17 (Site 11a)** – A vehicle was parked directly over the well throughout the repair activities and was not able to be relocated. As a result of access restriction, the abandonment of this application well was not completed. This well should be abandoned during the next appropriate field event. Until abandoned, this well should continue to be included in the ER inspections.

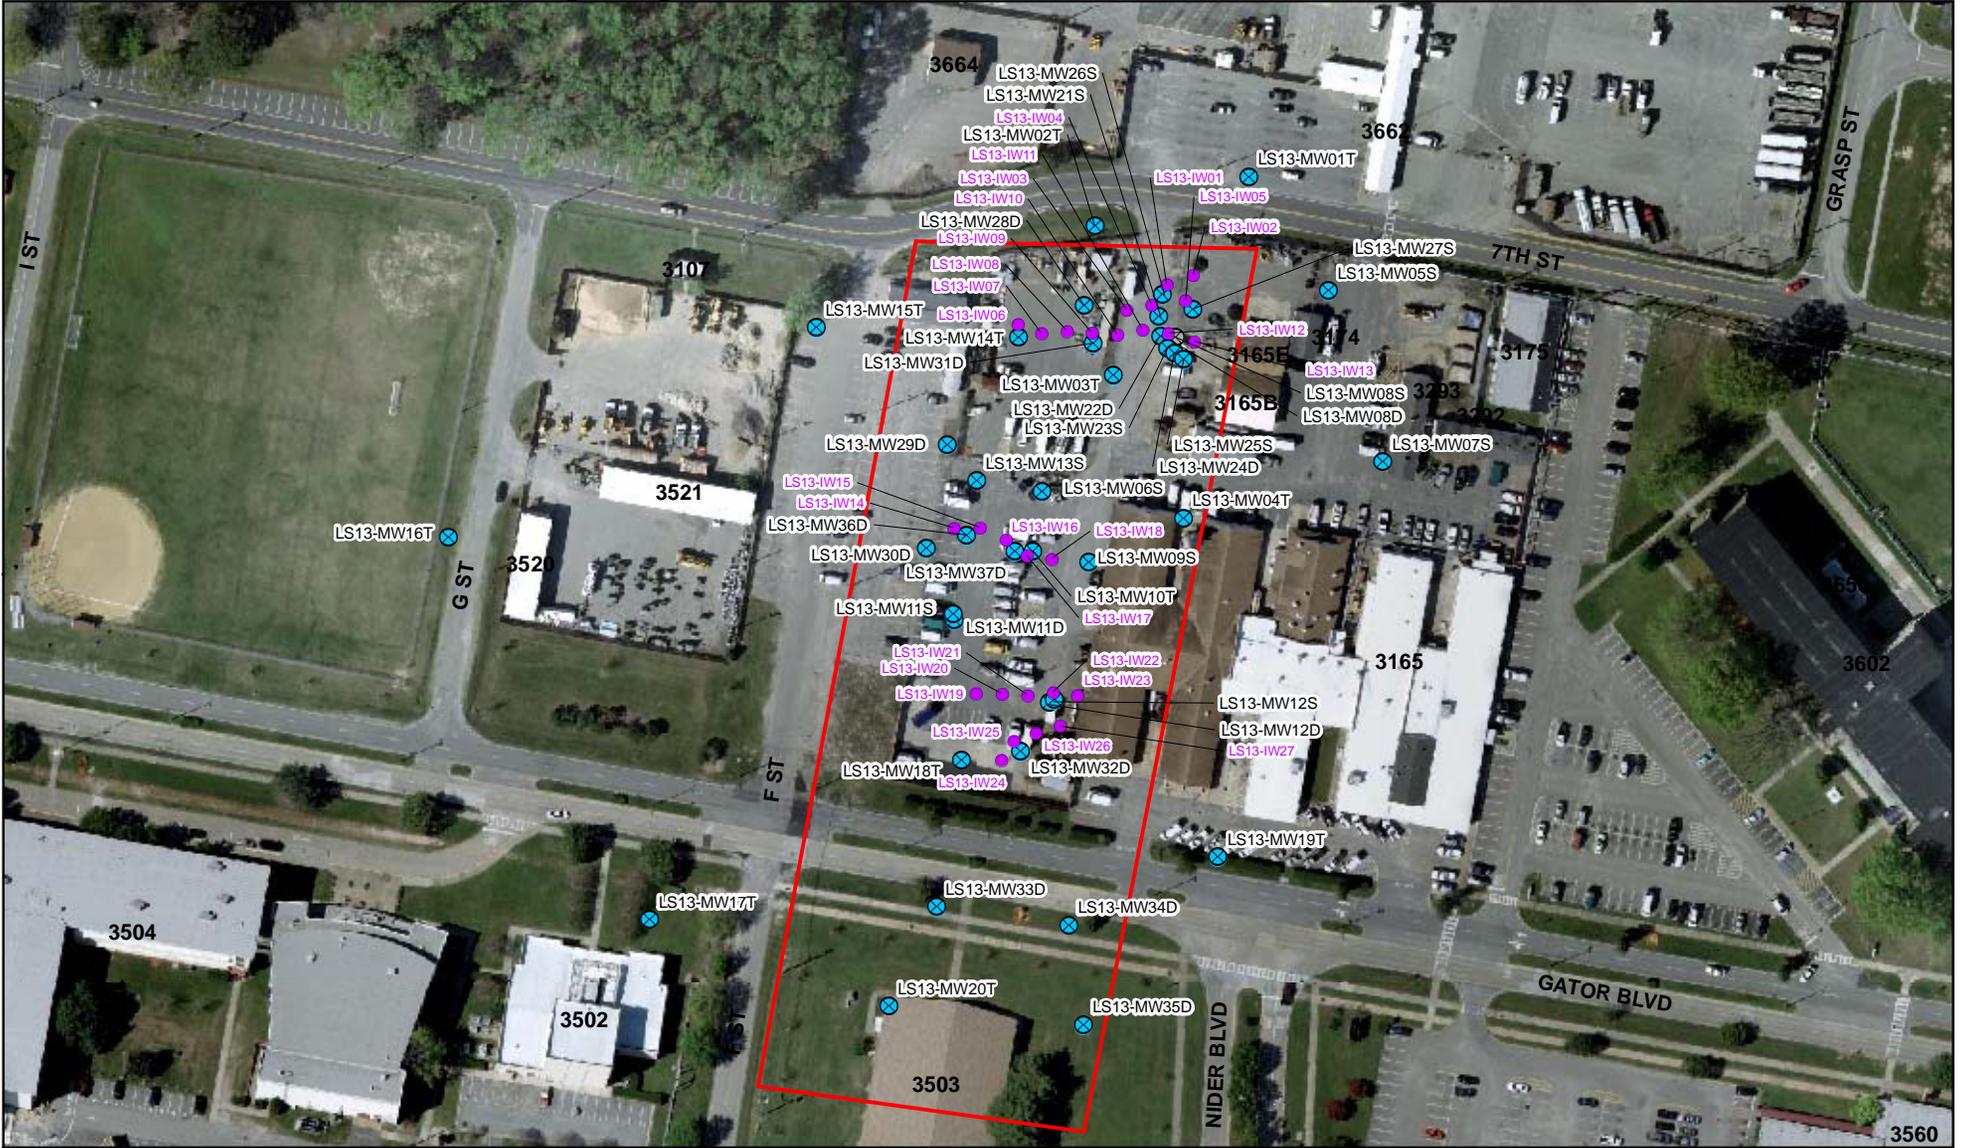
Figure 8  
 Site 13 Public Works PCP Dip Tank and Wash Rack  
 Basewide Well Repair and Abandonment Summary  
 JEB Little Creek  
 Virginia Beach, Virginia

- **LS12-MW09T (Site 12)** – Bollards were not present. Bollards should be installed and painted during the next appropriate field event.
- **LS13-MW08S/D (Site 13)** – Abandonment of these wells is documented in *Final Contractor Closeout Report for PCP Contaminated Soil Removal, Site 13, NAB Little Creek, Virginia Beach, VA (OHM, 1999)*. Therefore, no additional action is required.

- **All Wells (Site 13)** - Well labels were not applied to all Site 13 monitoring and injection wells due to time constraints. Site 13 well labels are scheduled to be applied to all Site 13 monitoring and injection wells during the next round of quarterly site inspections.

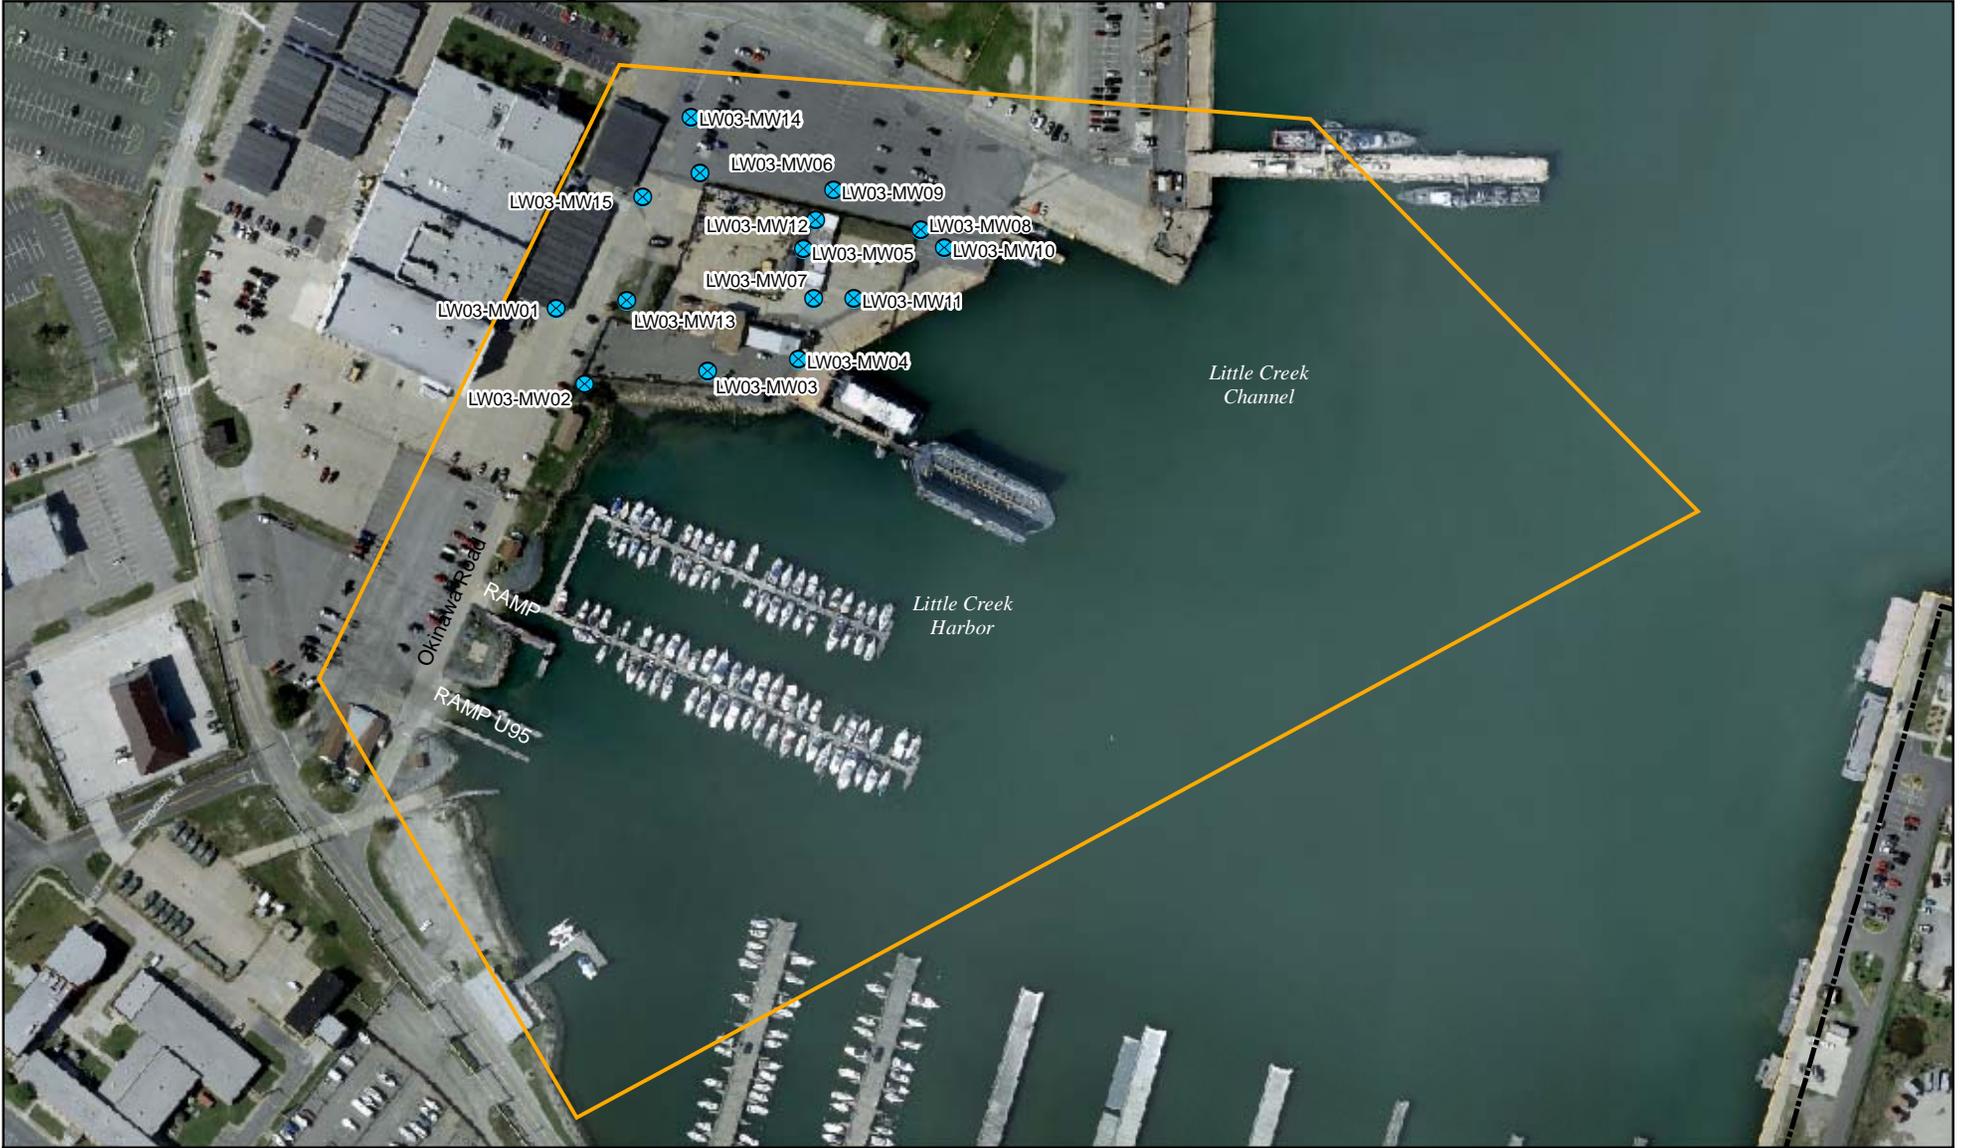
Figure 9  
SWMU 3 Pier 10 Sandblast Yard  
Basewide Well Repair and Abandonment Summary  
JEB Little Creek  
Virginia Beach, Virginia

- **LW03-MW01 (SWMU 3)** – A facility office trailer is positioned directly above the well, and relocation of the office trailer was not feasible during the time the repair activities were completed. As a result of the access restriction, the broken manhole casing was not replaced. This well should be included in the ER inspections until repair or abandonment is completed during the next appropriate field event.

- **LW03-MW05 (SWMU 3)** – This well was unable to be located during the repair activities; therefore the integrity of the well could not be assessed. This well should continue to be included in the ER inspections until it can be located and its functionality assessed.
