Annual Landfill Inspection Report for Goss Cove Landfill

**Naval Submarine Base
New London
Groton, Connecticut**

October 2005

Naval Submarine Base
New London, CT
Site 8 – Goss Cove Landfill
October 11, 2005

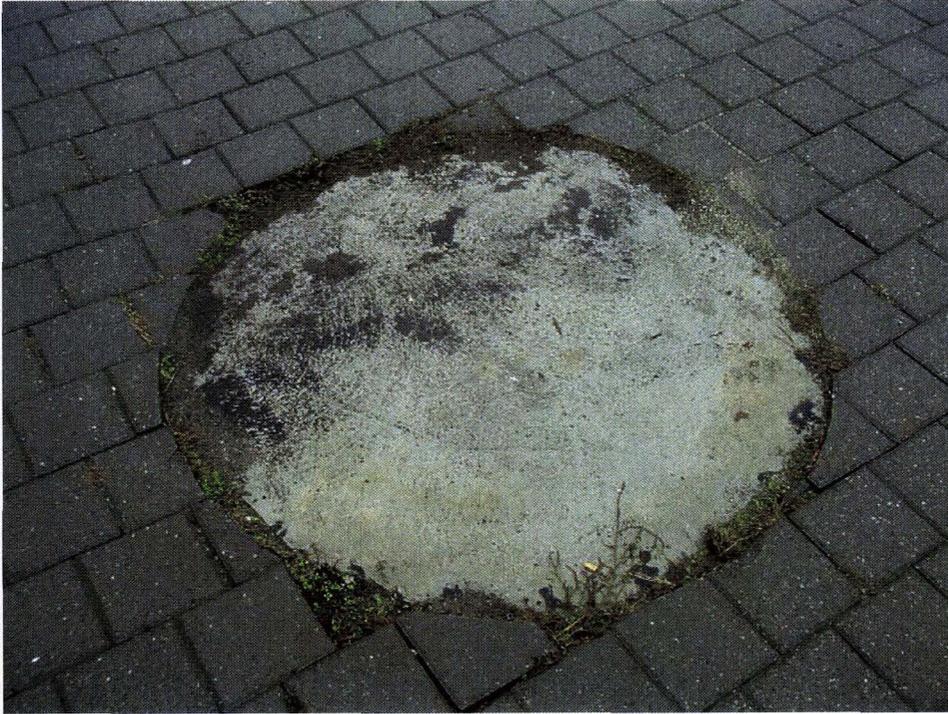
9) Gun Display					
<i>a) Conditions of Foundation Support</i>	<input type="checkbox"/>	<input type="checkbox"/>	<input type="checkbox"/>	<input type="checkbox"/>	Not observed, possibly removed, currently presents a trip hazard.
<i>b) Interface at Ground Surface and Foundations</i>	<input type="checkbox"/>	<input type="checkbox"/>	<input type="checkbox"/>	<input type="checkbox"/>	
<i>c) Observation of Exposed Cap Components</i>	<input type="checkbox"/>	<input type="checkbox"/>	<input type="checkbox"/>	<input type="checkbox"/>	
<i>d) Center Island Flagpoles (Poles A, B, and C)</i>	<input type="checkbox"/>	<input type="checkbox"/>	<input type="checkbox"/>	<input type="checkbox"/>	
<i>e) Retaining Wall on West Side</i>	<input type="checkbox"/>	<input type="checkbox"/>	<input type="checkbox"/>	<input type="checkbox"/>

Concrete pad near Missile Hatch Display that represent a potential trip hazard.

The gun display was not observed during the 11 October 2005 inspection. It is believed that the display may have been removed from the site. If the Navy can confirm the removal of this display, it should be removed from the inspection checklist for subsequent annual inspections.

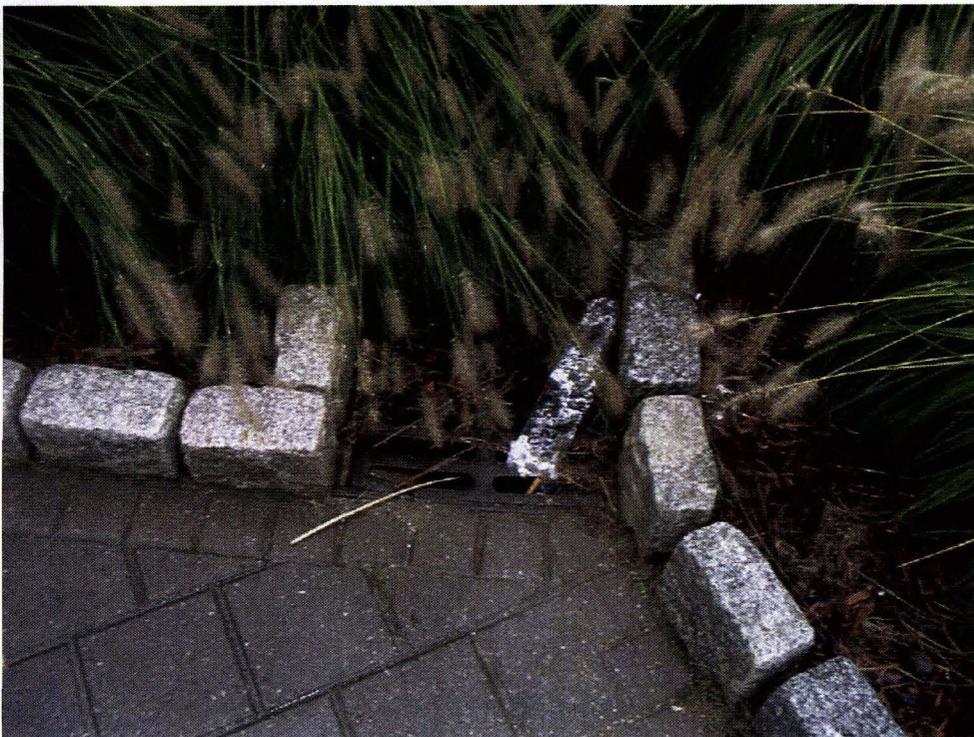
Yard drain 11A with grass and some trash on inlet.

Six yard drains were inspected to ensure that they were in good condition, that there were no obstructions at the inlet, and to ensure that there was not a significant amount of accumulated sediment in the drains. The yard drains were found to be in good working condition. A few of the yard drain covers were approximately half covered with leaf litter and grass. However, the surface runoff was still flowing freely in the drains and pipes. Sediment buildup in the bottom the yard drains was relatively minimal. It should be noted that yard drain 6A and 6B were too deep to be measured with the measuring device on the day of the inspection. Yard drain drainage structures should continue to be cleaned out on a routine basis to prevent sediment buildup.

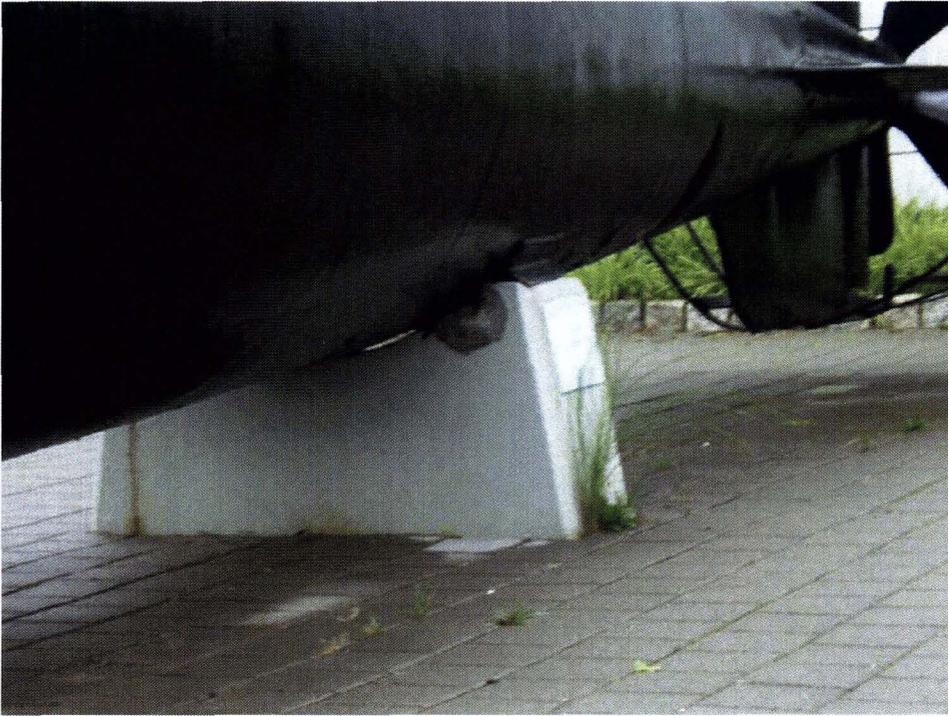
A total of four submarine displays were inspected; items included the concrete foundations and the interface at the foundation and ground surface. The supports appeared to be in good condition. Some chipping of the concrete was noted on the foundation of the western most submarine display. This chipping appears to be minor and is not impacting the overall integrity of the structure. This chipping will be monitored during subsequent inspections. No corrective measures are recommended at this time.

Chipped concrete on a submarine display.

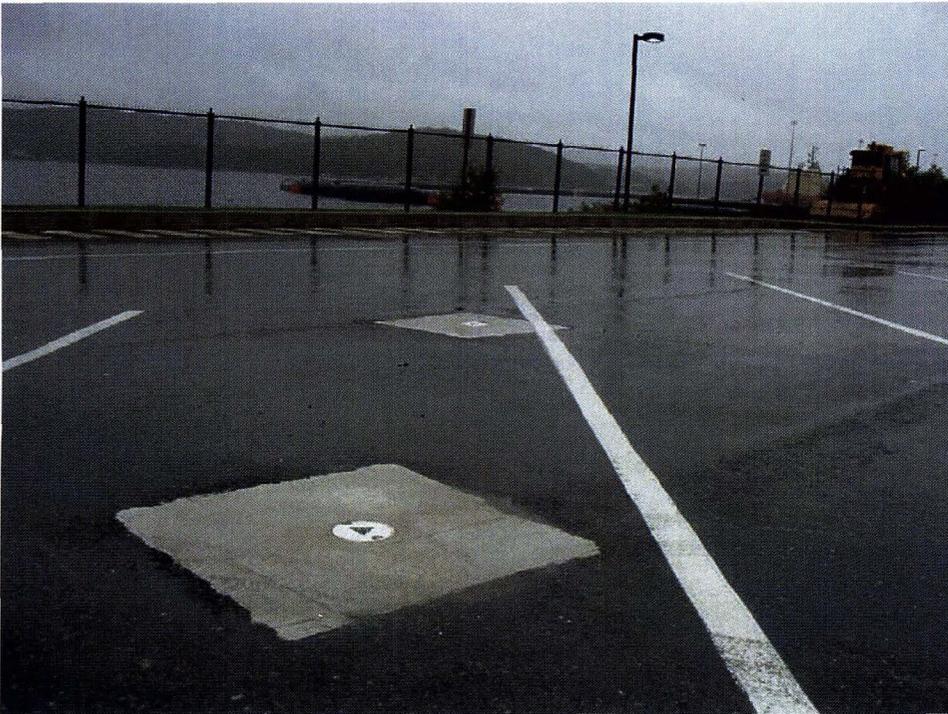
Recently replaced concrete and road boxes for 8MW2S and 8MW2D.
