IR Site Inspections - 2nd Quarter 2005

St. Juliens Creek Annex, Chesapeake, Virginia

DATE: June 27, 2005

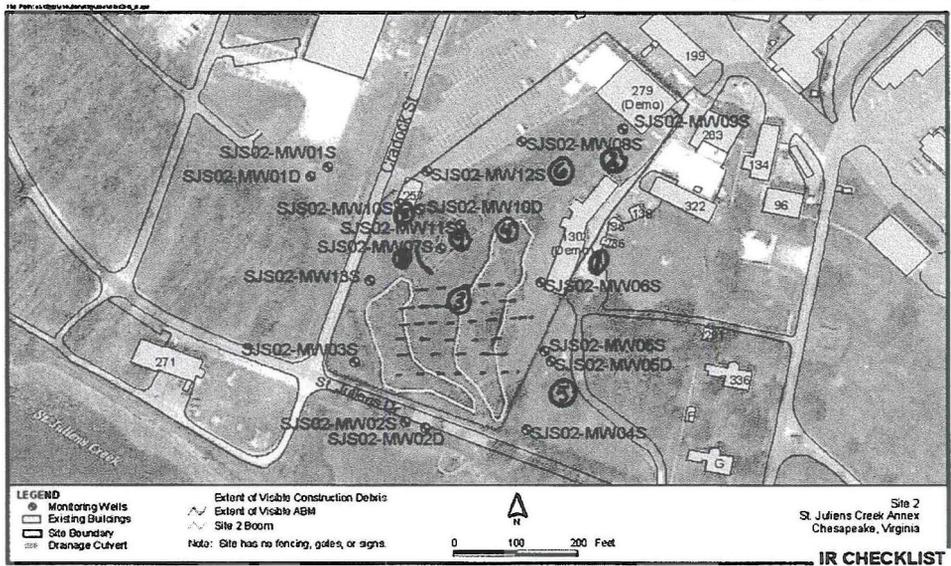
Site 2 - Waste Disposal Area B
St. Juliens Creek Annex, Chesapeake, Virginia

- One drum containing investigation-derived purge water and eighteen wood pallets from previous investigation-derived waste (IDW) staging was observed at Site 2. CH2M HILL will coordinate IDW disposal and removal of the pallets.
- There are tire ruts in the vicinity of the wooded area at Site 2. However, vegetation re-growth in this area is evident. This area should be assessed during the next quarterly site inspection to ensure the continuation of vegetative re-growth.
- Several areas of debris were observed:
 - A pile of wood debris was observed in the wooded area west of the inlet.
 - Concrete debris was observed in the proximity of SJS02-MW05D.

- Corrugated metal debris was observed in the inlet area south of SJS02-MW09S.
- Large wooden beams (1.5' diameter and 15' long) were observed in the area of SJS02-MW11S.
- Metal rods were observed in the vicinity of SJS02-MW10S.

- The monitoring wells were in good condition overall. The following potential issues were observed:
 - Protective casing and will not close completely: SJS02-MW02S
 - One bollard down: SJS02-MW05S

- ① Drum - purge water (2)
- ② 10 Total wood pallets + two railroad ties (3)
- ③ General rutting
- ④ Pile of wood debris in woods (3)
- ⑤ Concrete debris (3)
- ⑥ Corrugated metal debris (3)
- ⑦ Metal Rod debris (3)
- ⑧ Old silt fence
- ⑨ Wooden beams by MW1S

SJS02-MW02D: No bollards, located near roadway
 SJS02-MW02S: No bollards, located near roadway, hinge rusted - will not close all the way
 SJS02-MW05S: One bollard down

This debris appears to be part of the historical waste disposal activities at Site 2. The site should be assessed during the next quarterly site inspection to ensure that no additional waste disposal is occurring.

CH2M HILL is conducting a facility-wide monitoring well survey and will replace the protective casing lid at SJS02-MW02S and repair the downed bollard at SJS02-MW05S. The condition of the monitoring wells should be assessed during subsequent inspections.

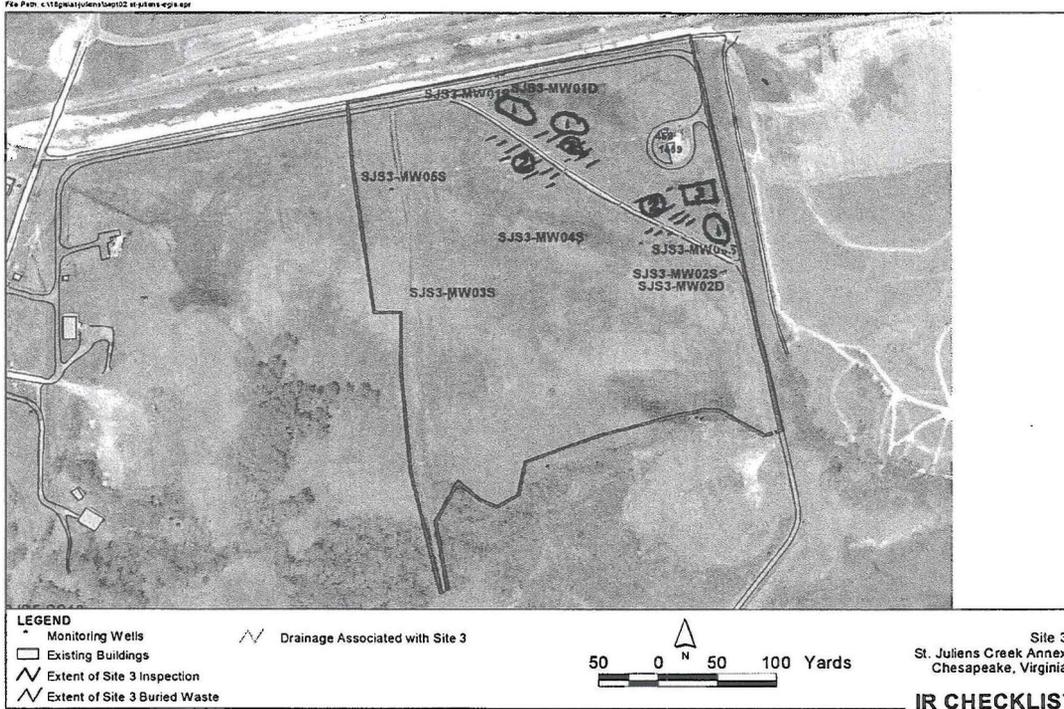
Site 3 - Waste Disposal Area C
St. Juliens Creek Annex, Chesapeake, Virginia

- Ponded surface water was observed in three locations paralleling the cut-through road at Site 3. It is recommended that these areas are assessed during subsequent inspections to evaluate if there is a need to fill the depressions or provide drainage from these areas to prevent potential impacts to the soil cover currently being installed at Site 4, located just south of Site 3.

- Various tire ruts were observed throughout the site. In some areas vegetation re-growth is evident. The area should be assessed during the next quarterly site inspection to ensure the continuation of vegetative re-growth.

- The monitoring wells were in good condition overall. The following potential issues were observed:
 - Two bollards are bent: SJS03-MW02D
 - Cap does not close: SJS03-MW03S

- One bollard is bent, hinge on protective casing lid is rusted away and the lid no longer attaches to protective casing: SJS03-MW04S
 - One bollard is down: SJS03-MW05S

① Ponded surface water (4)
 ② General rutting throughout site, some major
 ③ Construction trailer/staging area for Site 4 Remedial Action

Wells (5)
 SJS3-MW02P: 2 bent bollards, only 3 bollards
 -MW02S: only 3 bollards
 -MW03S: only 3 bollards, cap does not close
 -MW04S: only 3 bollards, one bent. Hinge rusted away, no longer attached
 -MW05S: one bollard down
 -MW06S: no bollards

CH2M HILL plans to abandon the monitoring wells as no further action has been determined for Site 3. The upgradient monitoring wells, SJS03-MW01S and SJS03-MW01D, will remain in-place as part of the facility-wide background monitoring well network.

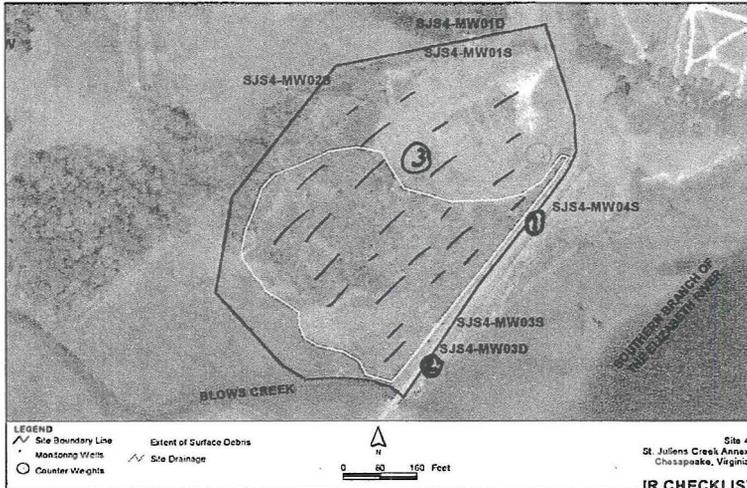
Site 4 - Landfill D

- Damage to the perimeter road in the vicinity of SJS04-MW04S was observed. It is recommended that the road be repaired when activities at Site 4 have concluded.
- Debris was observed between the facility fence and silt fence in the area of SJS04-MW03D. It is recommended that the debris be removed and properly disposed of off-site.
- The monitoring wells were in good condition overall. The following potential issues were observed:
 - Only three bollards: SJS04-MW01D
 - Only three bollards, one is down: SJS04-MW01S
 - Three bollards down: SJS04-MW02S
 - Hinge rusted off of protective casing lid: SJS04-MW03S

① Damage to road from heavy equipment (1)
 ② Debris between metal + silt fence (3)
 ③ Ongoing Remedial Action Construction - soil cover construction (1)
 Wells (5)

SJS04 - MW01D: only 3 bollards
 - MW01S: only 3 bollards + down
 - MW02S: 3 bollards down
 - MW03S: hinge rusted off

The condition of the monitoring wells will be assessed upon remedial action completion. At this time, it is recommended that the downed bollards and the rusted protective casing hinge be replaced. The condition of the wells should be monitored during subsequent inspections.

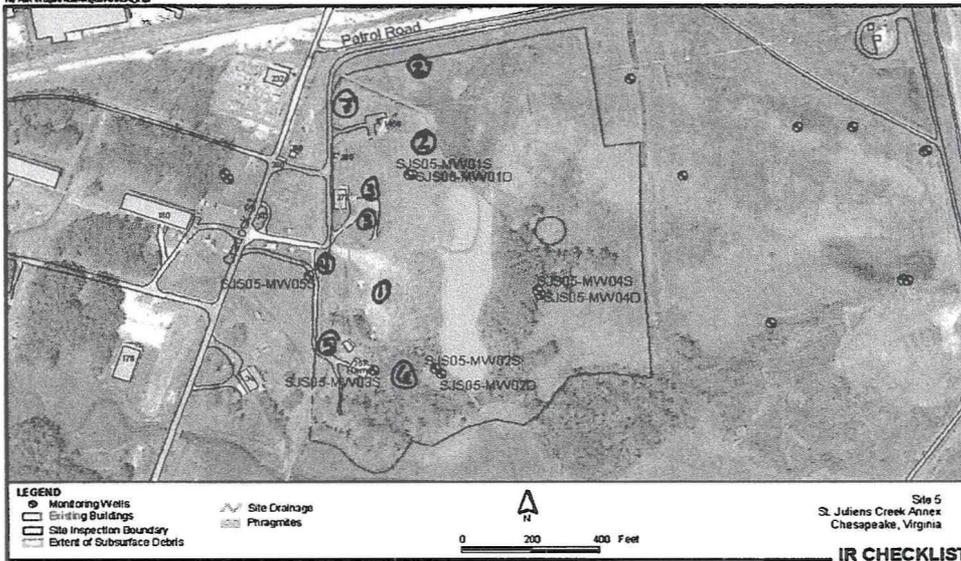
Site 5 - Burning Grounds
St. Juliens Creek Annex, Chesapeake, Virginia

- Uncovered concrete vaults (3' x 3') containing trash were observed south of Building 272. It is recommended that the trash be removed from these vaults and properly disposed of off-site. Furthermore, a cover should be placed over these vaults to prevent the further dumping of trash and to prevent any health and safety incidents from occurring.

- Several areas of debris were observed:
 - Metal debris, columns, and tires were observed in the clearing east of SJS05-MW05S.
 - Wood, concrete, and metal debris were observed in a depression west of SJS05-MW03S and metal debris was observed east of SJS05-MW03S.

- A dirt pile with metal debris was observed near the intersection of Cradock Street and the Patrol Road.

- The monitoring wells were in good condition. The following potential issues were observed:
 - Protective casing lid will not close securely: SJS05-MW02S and SJS05-MW02D
 - Wood base separated from pad: SJS05-MW05S

- ① Metal debris, columns, + tires in clearing (3)
- ② tire ruts (3)
- ③ Uncovered concrete vaults south of building 272, contains trash + presents safety concern (3)
- ④ Construction cone in ditch (3)
- ⑤ Wood debris in hole, some concrete + metal debris (3)
- ⑥ Metal debris (3)
- ⑦ Dirt Pile + Metal debris on top (3)

SJ505-MW010: no bollards
 - MW015: no bollards
 - MW070: no bollards, cap will not close

- MW075: No bollards, cap will not close
 - MW035: wood base separated from pad

CH2M HILL is conducting a facility-wide monitoring well survey and will replace the protective casing lids at SJS05-MW02S and SJS05-MW02D and remove the wood base from SJS05-MW05S as it does not affect the monitoring well integrity. The condition of the monitoring wells should be assessed during subsequent inspections.

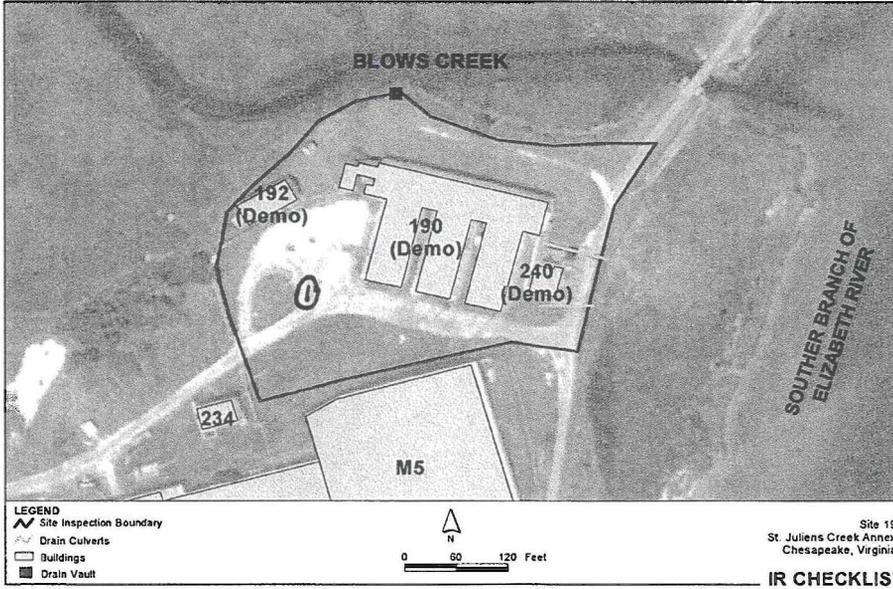
Site 19 - Building 190

- Tire ruts were observed in the grass field and vegetation re-growth is evident. The area should be assessed during the next quarterly site inspection to ensure the continuation of vegetative re-growth.
- The road is in poor condition. The area is no longer active and the road is not often utilized; therefore, it is recommended that the road condition be assessed during subsequent inspections.

- ① Some tire ruts
- ② Roads in poor condition

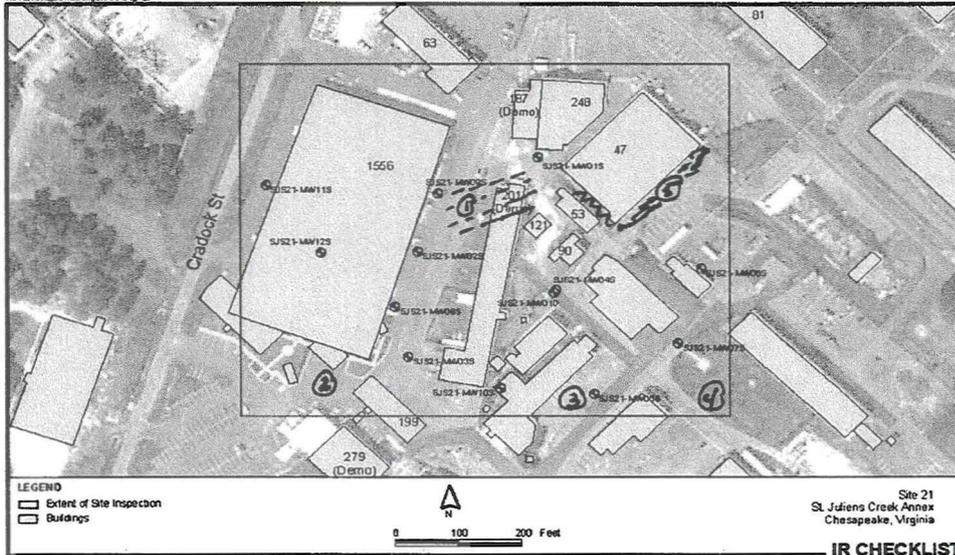
Site 21 - Building 187

- Construction equipment and an excavation (approximately 10' x 4' x 4') was observed east of monitoring well SJS21-MW09S. It appears that a sewer line repair is underway. The excavation is located in an area of potential groundwater contamination. No one was present at the time of the inspections. The groundwater data was provided to the Navy on June 8, 2005 and the data indicated that no risks have been identified in the immediate area of the excavation. As a health and safety precaution, air monitoring for VOCs was recommended. Additionally, an updated IR site map was created to encompass the entire Site 21 area and provided to the Navy on June 8, 2005.

- As the Site 21 area is active, there were several areas of storage and debris observed:
 - A roll-off dumpster, downed trees, and an old military truck were observed in the vicinity of SJS21-MW05S.

- A pile of sand was observed west of Building 1556.
 - Miscellaneous debris was observed in the southeast corner of the site.
 - Miscellaneous objects such as wire spools, telephone poles, and wood pallets were observed around Building 47.

- ① Construction equipment + hole dug. Appears to be sewer line repair (1)
- ② Pile of sand
- ③ Roll-off dumpster, downed trees, + old military truck (1)
- ④ Miscellaneous debris (1)
- ⑤ Building 47 appears active + has lots of miscellaneous objects around: wire spools, telephone poles, + wood pallets, etc. (1)

The area should be assessed during subsequent inspections to ensure there are no potential impacts to Site 21.
