## IR Site Inspections – 3<sup>rd</sup> Quarter 2005

### St. Juliens Creek Annex, Chesapeake, Virginia

**DATE:** September 21, 2005

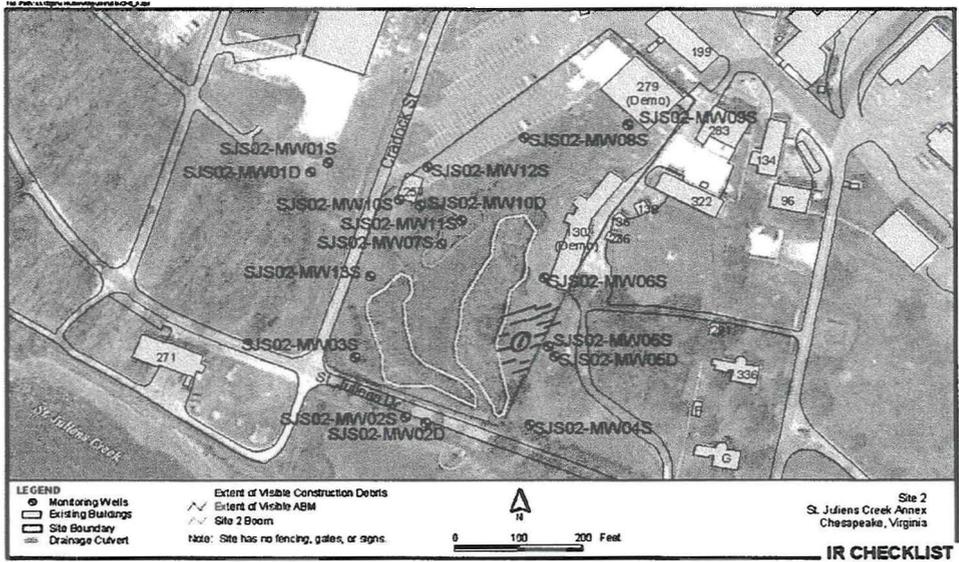
**Site 2 - Waste Disposal Area B**  
**St. Juliens Creek Annex, Chesapeake, Virginia**

- There are tire ruts in the vicinity of the wooded area at Site 2. However, vegetation re-growth in this area is evident. This area should be assessed during the next quarterly site inspection to ensure the continuation of vegetative re-growth.
- The monitoring wells were in good condition overall. The following potential concerns were observed:
  - Protective casing will not close completely: SJS02-MW02S
  - One bollard down: SJS02-MW05S

-All Environmental signs in good condition

① general rutting in field

Monitoring well issues:

MW02S - protective casing will not close completely  
 MW05S - one ballard down

CH2M HILL has conducted a facility-wide monitoring well survey and will replace the protective casing lid at SJS02-MW02S and repair the downed bollard at SJS02-MW05S in

October/November 2005. The condition of the monitoring wells should be assessed during subsequent inspections.

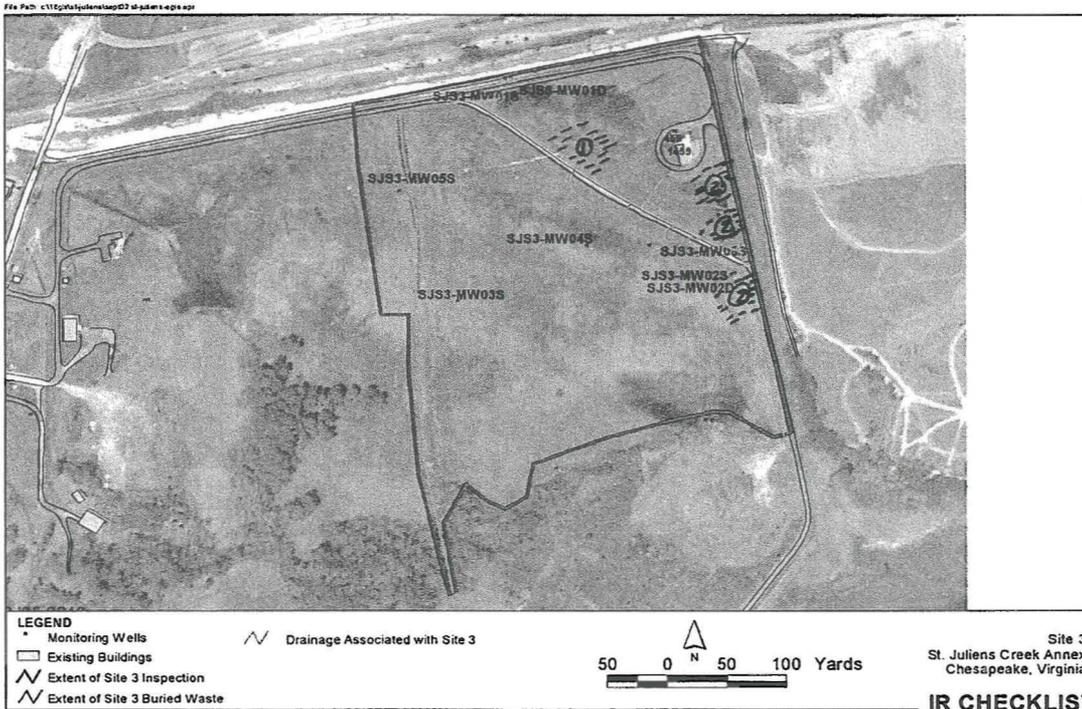
**Site 3 - Waste Disposal Area C**  
**St. Juliens Creek Annex, Chesapeake, Virginia**

- Ponded surface water was observed in three locations paralleling the cut-through road at Site 3. At the southern end of the Site 3 eastern drainage ditch the culvert appears to be clogged and not draining. It is recommended that the culvert be unclogged or replaced to promote Site 3 drainage and prevent potential impacts to the soil cover currently being installed at Site 4, located just south of Site 3.

- Various tire ruts were observed throughout the site. In some areas vegetation re-growth is evident. The area should be assessed during the next quarterly site inspection to ensure the continuation of vegetative re-growth.

- The monitoring wells were in good condition overall. The following potential concerns were observed:
  - Two bollards are bent: SJS03-MW02D
  - Cap does not close: SJS03-MW03S

- One bollard is bent, hinge on protective casing lid is rusted away and the lid no longer attaches to protective casing: SJS03-MW04S
  - One bollard is down: SJS03-MW05S

① - general rutting from tires

② - Ponding on-site due to poor site drainage. Southern end of Site 3 Eastern drainage ditch... the culvert appears to be clogged + is not draining.

Monitoring wells: MW027, MW045, MW055 - bollards down or bent, MW035 - cap does not close

CH2M HILL plans to abandon the monitoring wells in October/November 2005 as no further action has been determined for Site 3. The upgradient monitoring wells, SJS03-MW01S and SJS03-MW01D, will remain in-place as part of the facility-wide background monitoring well network.

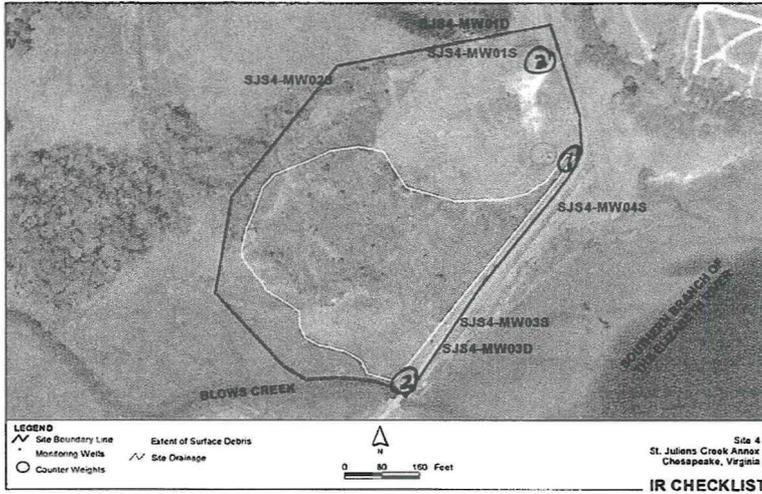
**Site 4 - Landfill D**

- Damage to the perimeter road in the vicinity of SJS04-MW04S and south of SJS4-MW03D was observed. It is recommended that the road be repaired when activities at Site 4 have concluded.
- Three drums of Investigation Derived Waste (IDW) were observed near the entrance to the Site 4 soil cover. The drums contain soil cuttings and water from monitoring well installation activities at Site 4. The IDW is scheduled to be removed by the end of September.
- The monitoring wells were in good condition overall. The following potential concerns were observed:
  - Only three bollards: SJS04-MW01D
  - Only three bollards, one is down: SJS04-MW01S
  - Three bollards down: SJS04-MW02S
  - Hinge rusted off of protective casing lid: SJS04-MW03S

① - Dirt on road at bend, needs cleanup. Road needs repair.  
 ② - Right before bridge, severe wear + tear of road.  
 ③ - Three IDW drums from Site 4 Activities; 2 H<sub>2</sub>O + 1 soil  
 Note: construction is on-going at Site 4. site still needs to be seeded  
 - Bollard down @ mw01s/02s/01D; pipe noted off of MW03S

The condition of the monitoring wells will be assessed upon remedial action completion. At this time, it is recommended that the downed bollards and the rusted protective casing hinge be considered for replacement based on site conditions. The condition of the wells should be monitored during subsequent inspections.

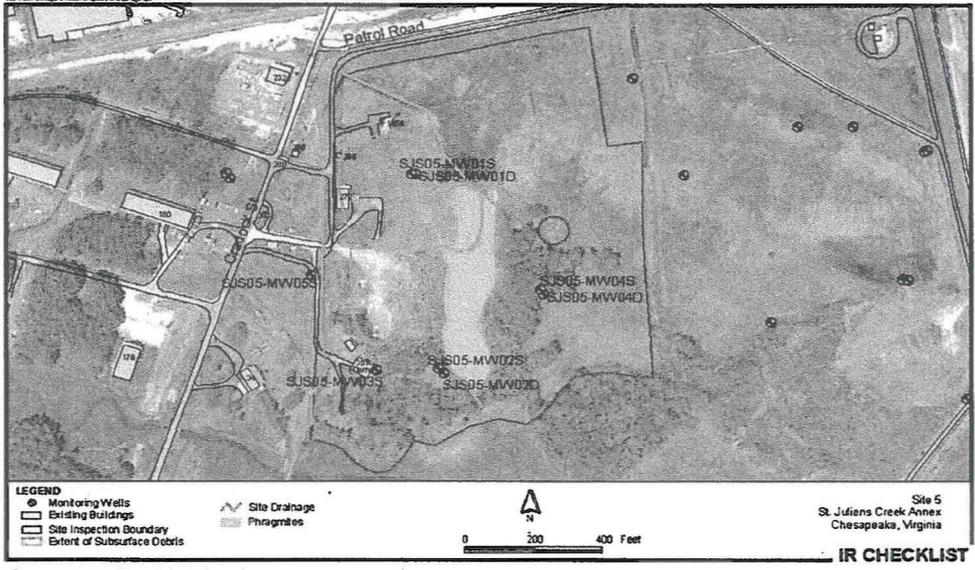
**Site 5 - Burning Grounds**  
**St. Juliens Creek Annex, Chesapeake, Virginia**

- The monitoring wells were in good condition. The following potential concerns were observed:
  - Protective casing lid will not close securely: SJS05-MW02S and SJS05-MW02D
  - Wood base separated from pad and one bollard down at: SJS05-MW05S

One bollard down at MW055.  
 Protective casing will not close seemingly @ MW025 / MW020

CH2M HILL has conducted a facility-wide monitoring well survey and will replace the protective casing lids at SJS05-MW02S and SJS05-MW02D, repair the bollard at SJS05-MW05S, and remove the wood base from SJS05-MW05S, as it does not affect the monitoring well integrity, in October/November 2005. The condition of the monitoring wells should be assessed during subsequent inspections.

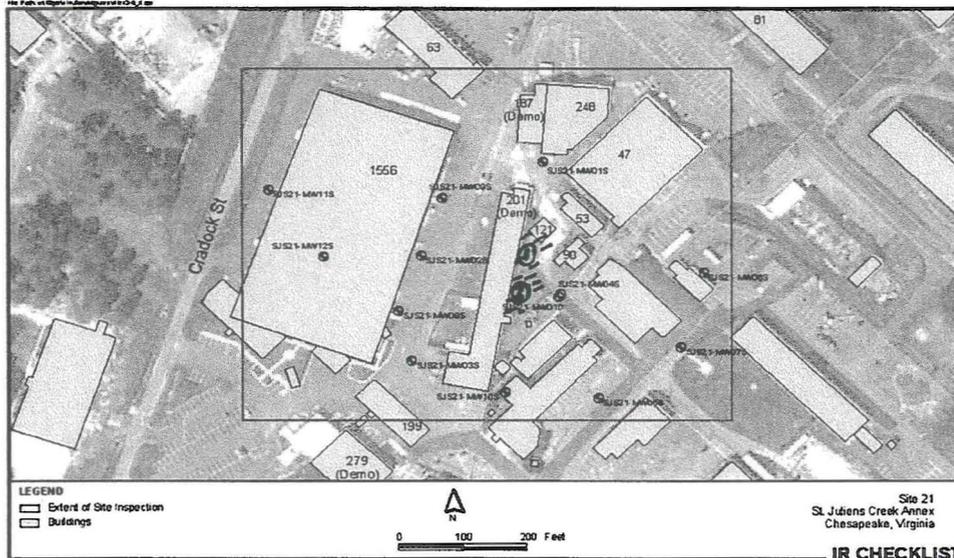
**Site 21 - Building 187**  
**St. Juliens Creek Annex, Chesapeake, Virginia**

Construction equipment and two open excavations (approximately 15' x 5' x 5' and 12' x 8' x 5') were observed east of monitoring well SJS21-MW09S. According to the workers on site, a storm water line repair is underway. The excavation is located in an area of potential groundwater contamination. The existing groundwater and storm water analytical data, and a comparison of the groundwater data to non-hazardous disposal criteria were provided to the Navy on September 6, 2005.

①/2 - Construction still ongoing between Bldg. 54 + 155G. Two holes have been dug for stormwater line repair. First hole approximately 15' x 5' + 8' x 12'. ② has possible groundwater in it.
