IR Site Inspections – 4th Quarter 2005

St. Juliens Creek Annex, Chesapeake, Virginia

DATE: January 5, 2006

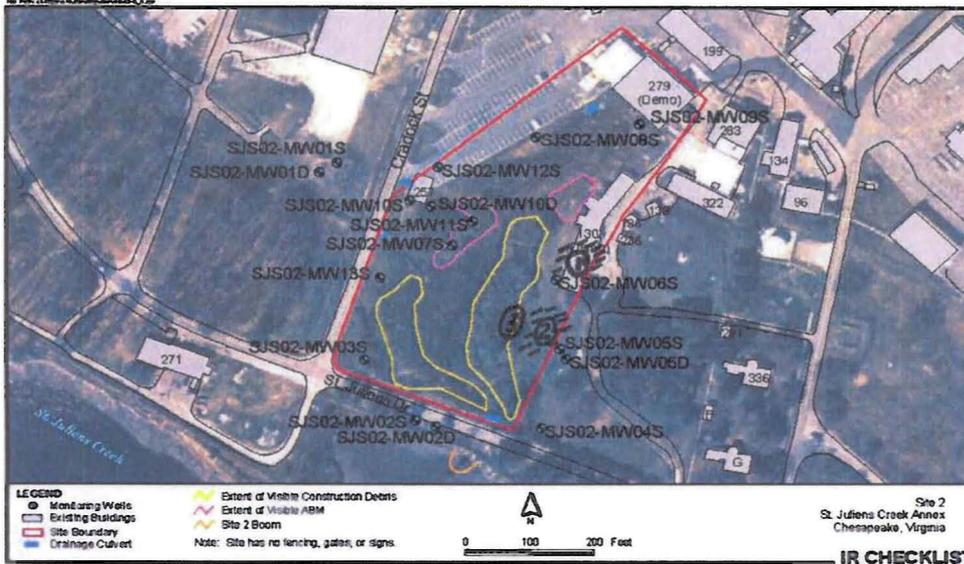
Site 2 - Waste Disposal Area B
St. Juliens Creek Annex, Chesapeake, Virginia

At the time of the inspection, there were no signs of unauthorized intrusive activities within the site or in the vicinity. Soil disturbances in the form of tire ruts were noted in the field adjacent to monitoring wells SJS02-MW05S and SJS02-MW05D. However, vegetative regrowth in this area is evident. This area should be assessed during the next quarterly site inspection to ensure the continuation of vegetative re-growth. A wood pallet was also observed in the same vicinity.

Nine drums of investigation derived waste (IDW) (4 hazardous water, 3 non-hazardous water, 2 non-hazardous soil) from the Site 21 temporary and monitoring well installation activities conducted in October and November 2005 are currently being staged on pallets as indicated on the IR checklist. These drums are scheduled to be removed by an IDW subcontractor by the end of January 2006.

- ① IDW drums staged on pallets from site 21 well installation activities - Quest. 2
- ② General rutting in field - Quest. 3
- ③ Wood pallet - Quest. 3

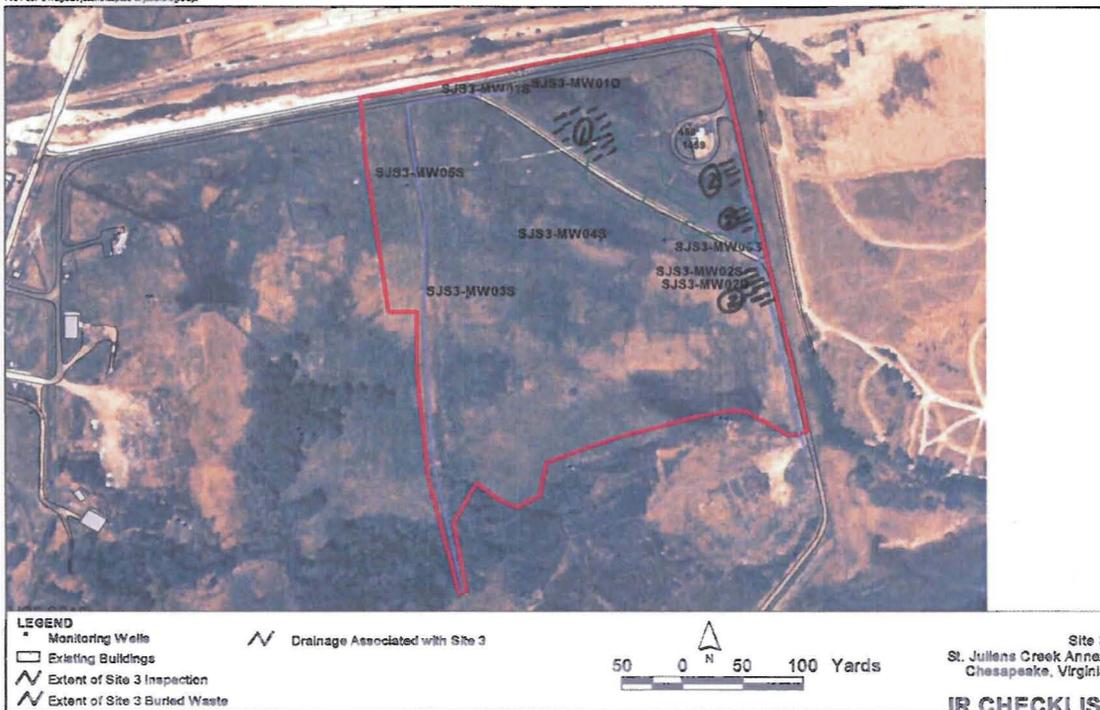
Site 3 - Waste Disposal Area C
St. Juliens Creek Annex, Chesapeake, Virginia

At the time of the inspection, there were no signs of unauthorized intrusive activities and no IDW storage was observed within the site or in the vicinity. Various tire ruts were observed throughout the site. However, vegetative re-growth is evident. The area should be assessed during the next quarterly site inspection to ensure the continuation of vegetative re-growth.

Ponded surface water was observed in three locations paralleling the cut-through road at Site 3. At the southern end of the Site 3 eastern drainage ditch, the culvert appears to be clogged and not draining. It is recommended that the culvert be unclogged or replaced to promote Site 3 drainage and prevent potential impacts to the soil cover at Site 4, located just south of Site 3.

- ① General tire rutting - Quest. 3
- ② Ponding on-site due to poor drainage - Quest. 4

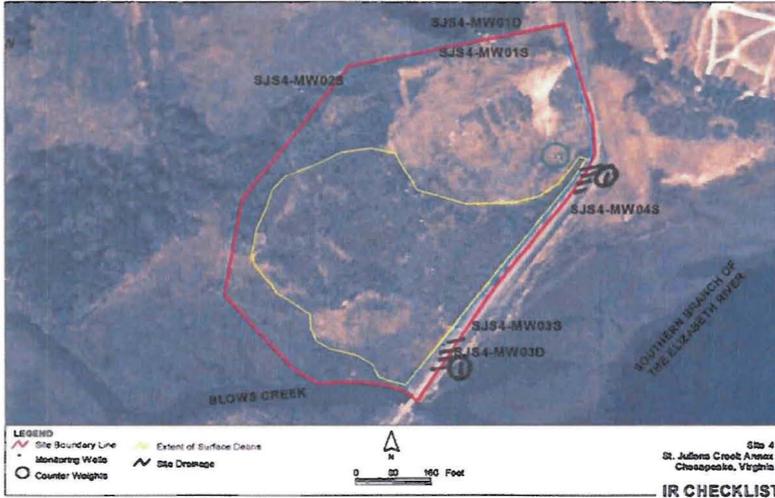
Site 4 - Landfill D

At the time of the inspection, there were no signs of unauthorized intrusive activities and no IDW storage was observed within the site or in the vicinity. The soil cover at Site 4 was completed in October 2005. Damage to the perimeter road in the vicinity of SJS04-MW04S and south of SJS04-MW03D was observed. The perimeter road leads to an impassible bridge and is therefore not regularly used in this location. In addition, the condition of the road has no impact on the environmental status of the site. Therefore, repairs are not recommended at this time.

① Road needs repair - Quest. 3

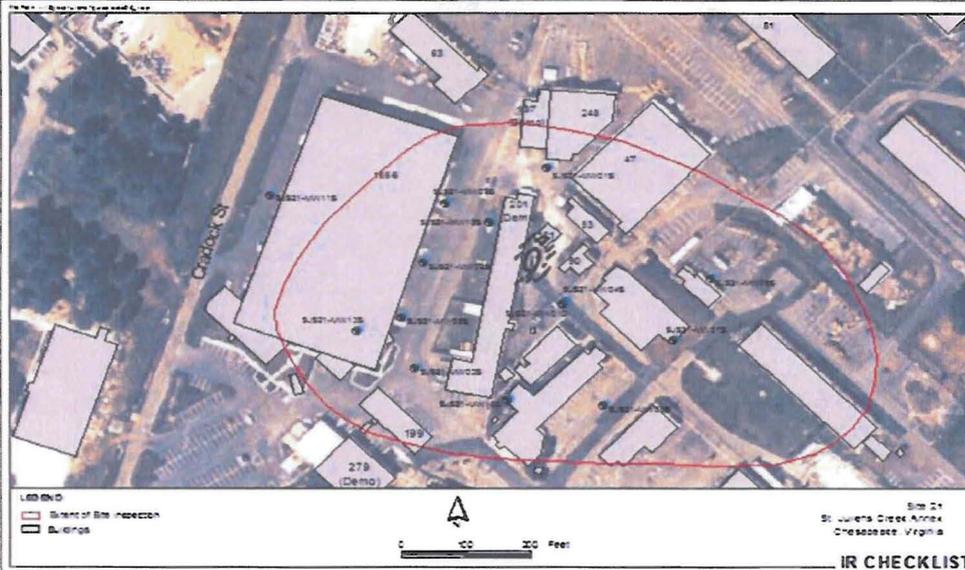
Site 21 - Building 187

At the time of the inspection, there was evidence of intrusive activities within the site boundary. Construction equipment and one open excavation (approximately 12' x 8' x 5') was observed east of monitoring well SJS21-MW09S. Replacement of the Site 21 storm water grates is also being conducted. According to the workers on site, a storm water line repair is underway. The excavation is located in an area of potential groundwater contamination. The existing groundwater and storm water analytical data, and a comparison of the groundwater data to non-hazardous disposal criteria were provided to the Navy on September 6, 2005. The most recent data, collected in October and November 2005 has also been provided to the Navy.

① Construction still ongoing adjacent to building 121 for stormwater line repair. It also appears that the stormwater grates are being replaced. The excavation hole is approximately 12'x8'x5'. - Quest. 1
