IR Site Inspections – 3rd Quarter 2006

St. Juliens Creek Annex, Chesapeake, Virginia

DATE: September 29, 2006

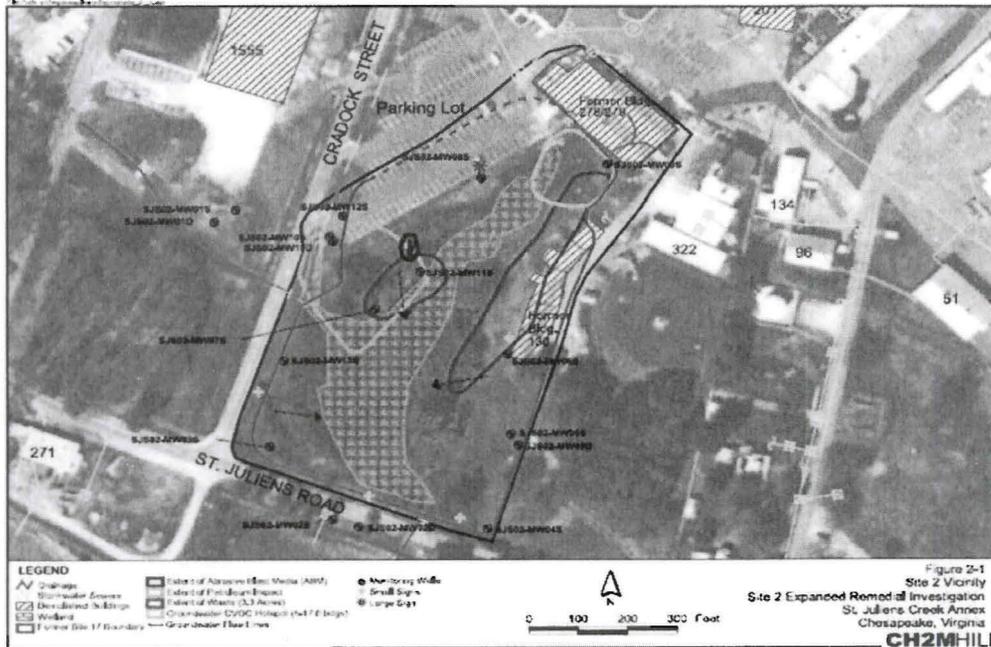
Site 2 - Waste Disposal Area B

The site was free of Investigation Derived Waste (IDW) and signs of dumping of chemicals. However, two wooden beams, also observed during previous inspections, remain on site near monitoring well SJS02-MW11S. Four wood pallets utilized during previous field investigation activities were observed adjacent to the site, near the southeastern corner of previously demolished Building 130. They will be utilized during upcoming activities at Site 21 and taken off-site at the demobilization of the project.

① - two large wood beams - Quest. #3

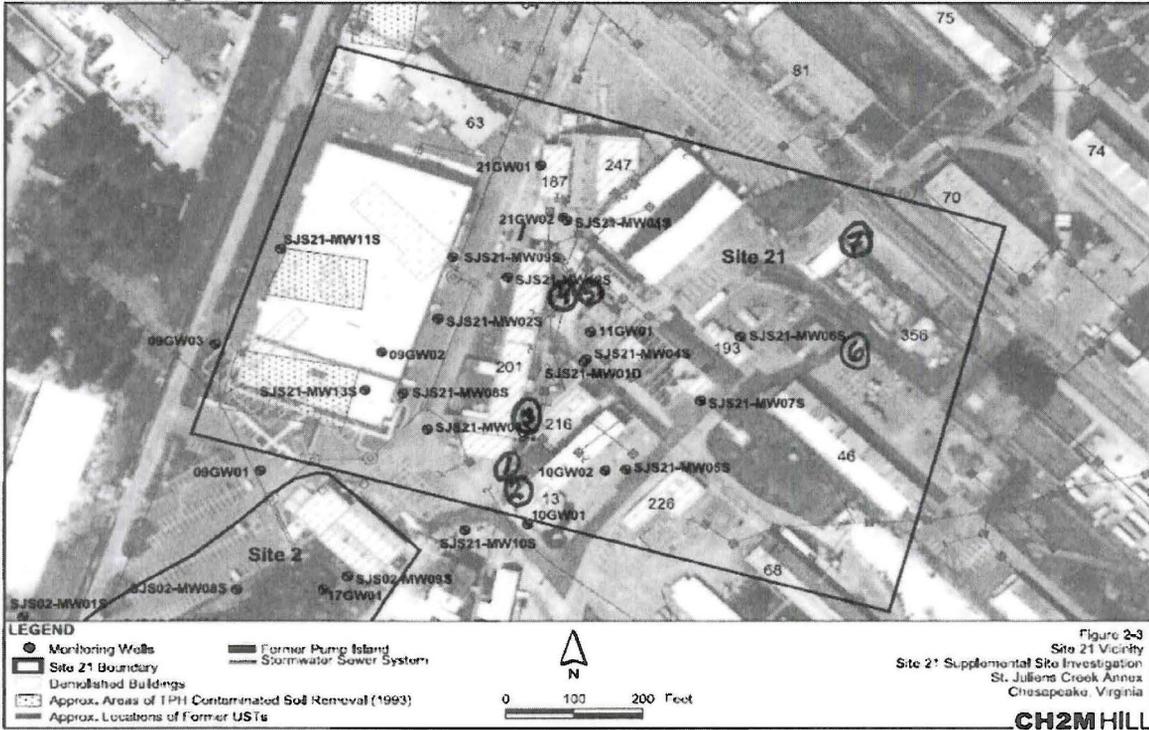
Site 21 - Industrial Area
St. Juliens Creek Annex, Chesapeake, Virginia

At the time of the inspection, evidence of intrusive activities was observed within the site boundary. Two open excavations, also noted during previous site inspections, were present in the vicinity of former Building 201. The northern excavation (approximately 12' x 8' x 5') and southern excavation (approximately 4' x 4' x 8') appeared to be in similar condition as during the previous inspection, although the northern excavation contained standing water. Facility Operations personnel have indicated that the excavations are a result of ongoing storm sewer line repairs and will be backfilled when repairs are complete. The extent of the northern excavation will not change, but the southern excavation will be extended approximately 20 feet west into the parking lot towards Building 1556 to repair the drop inlet and connected piping. The excavations are located in an area of potential groundwater contamination. The existing groundwater and storm water analytical data, and a comparison of the groundwater data to non-hazardous disposal criteria were provided to the NAVFAC Mid-Atlantic Remedial Project Manager (RPM). The RPM will coordinate with Facilities Operations as necessary through the remaining repair activities.

An unidentifiable steel drum, approximately 20 gallons, was observed near the southeast corner of former Building 201. The drum was sitting directly on the ground surface without containment. Although the drum was labeled, the label was not legible. Facility Operations personnel, Kim Mazur, was contacted and arrived on site to inspect the drum. The drum will be removed by Base Environmental and its contents will be made available to the RPM. A drum identified as containing diesel fuel and three bags of soiled rags were observed on the ramp outside of Building T134. The Facility Operations personnel was also informed of the diesel fuel drum. Construction debris, consisting of concrete rubble, metal cable, and bricks was present near demolished Building 13 and a gravel pile (approximately 2' x 2' x 2') was present near former Building 54. Approximately seven wooden pallets were observed stacked up in the corner of the parking lot located southeast of demolished Building 356.

- Comments: (Provide related question number for each comment)
- 1- Unidentifiable steel drum, label corroded, ~ 20 gallons - Quest. 3
 - 2- Construction debris: concrete rubble, metal cable, bricks - Quest. 3
 - 3- Excavation for storm water: 5' x 5' x 8'; appears abandoned - Quest. 1
 - 4- Excavation for storm water: 12' x 7' x 5' upstanding H₂O; abandoned - Quest. 1
 - 5- Gravel pile: approximately 2' x 2' x 2' - Quest. 3
 - 6- Wood pallets (approx. 7) - Quest. 3
 - 7- Drum of diesel fuel + 3 bags of soiled rags outside T754 - Quest. 3

During the inspections, the RPM identified locations for signs to be placed in areas of concern indicating the presence of an environmental site. The signs will be installed during the field investigation at Site 21 planned in October 2006. All site monitoring wells, including casings and bollards, were in good condition.
