IR Site Inspections – 2nd Quarter 2007

St. Juliens Creek Annex, Chesapeake, Virginia

DATE: June 20, 2007

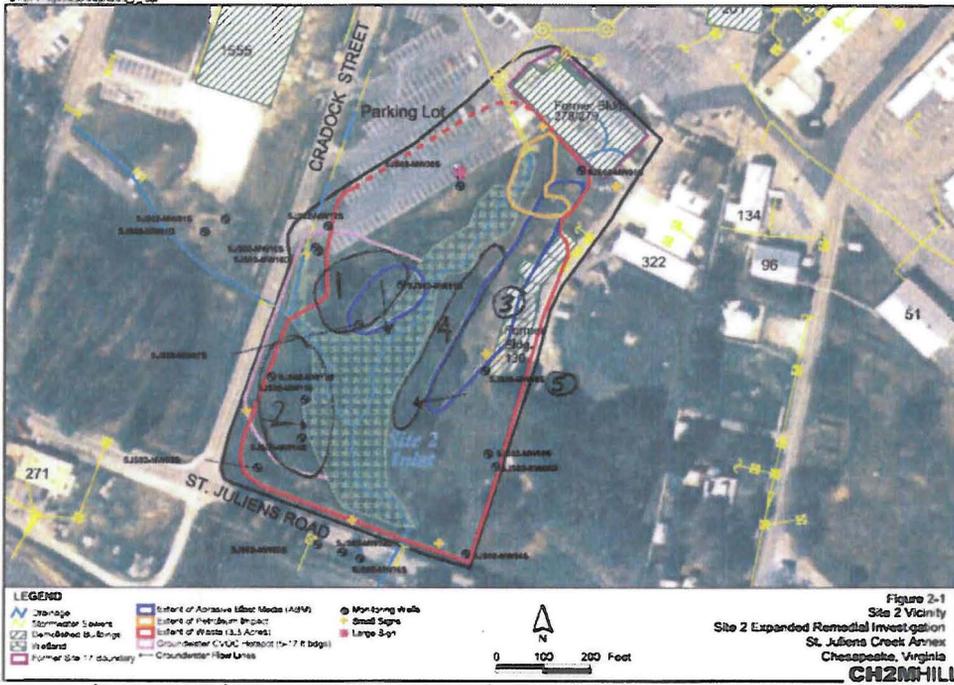
At the time of the inspection, there were signs of intrusive activities, including vegetation removal and tire ruts, from the Triad Investigation conducted in April through June 2007. The areas will be monitored to ensure that vegetative re-growth is successful.

IDW resulting from sampling activities at Sites 2 and 4, conducted in April through June 2007, was located on the site in the vicinity of former Building 130. The IDW was stored on secondary containment, properly labeled, and is pending analysis and disposal. No signs of dumping of chemicals were observed. However, concrete and wood debris, also observed during previous inspections, remain in the wooded areas of the site. A couch and two railroad ties, first noted during the first quarter 2007 inspection, were still present adjacent to the site, near the southeastern corner of previously demolished Building 130. The wooden pallet previously observed is currently in use and will be disposed of along with the IDW.

The flanges for the flush-mount well casing of monitoring well SJS02-MW12S are damaged, prohibiting bolts from functioning properly, and replacement will be considered in coordination with future site activities. The damage does not pose an immediate threat to the integrity of the well. Monitoring wells SJS02-MW05D, MW14S, MW15S, and MW16S were without locks at the time of the inspection, although new locks were been placed at

- ① Soil borings & tire ruts evident from Triad Investigation activities - Question 1. Concrete & wood debris - Question 3.
- ② Soil borings & tire ruts evident from Triad Investigation activities - Question 1. Concrete & wood debris - Question 3.
- ③ IDW staging area: Drums staged on secondary containment area & properly labeled - Question 2.
- ④ Soil borings & tire ruts evident from Triad Investigation activities - Question 1. Concrete & wood debris - Question 3.
- ⑤ Concrete & wood debris - Question 3.
- ⑥ RWIS, HWIS, MWIS, & MWSP need new locks. MWIS needs new well flanges.

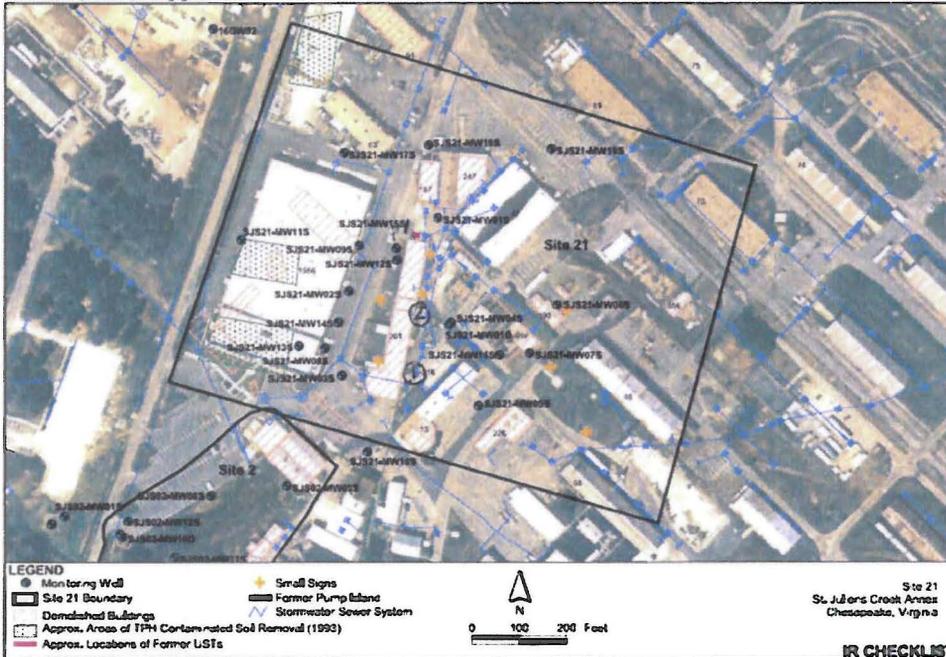
At the time of the inspection, evidence of intrusive activities was observed within the site boundary. Two open excavations, also noted during previous site inspections, were present in the vicinity of former Building 201. The northern excavation (approximately 12' x 8' x 5'), noted during the first IR site inspections conducted during the second quarter 2005, and southern excavation (approximately 4' x 4' x 8'), first noted during the first quarter 2006 inspection, appeared to be in similar condition as during the previous inspection. Both excavations contained standing water. Facility Operations personnel have indicated that the excavations are a result of ongoing storm sewer line repairs and will be backfilled when repairs are complete. The extent of the northern excavation will not change, but the southern excavation will be extended approximately 20 feet west into the parking lot towards Building 1556 to repair the drop inlet and connected piping. The excavations are located in an area of potential groundwater contamination. The existing groundwater and storm water analytical data, and a comparison of the groundwater data to non-hazardous disposal criteria were provided to the NAVFAC Mid-Atlantic Remedial Project Manager (RPM). The RPM will coordinate with Facilities Operations as necessary through the remaining repair activities.

- ① Storm sewer excavation: 5'x5'x8', with standing water, appears abandoned - Question 1.
- ② Storm sewer excavation: 12'x7'x5', with standing water, appears abandoned - Question 1.
