IR Site Inspections – 3rd Quarter 2007

St. Juliens Creek Annex, Chesapeake, Virginia

PREPARED FOR: Tim Reisch/NAVFAV Mid-Atlantic
INSPECTIONS CONDUCTED BY: Adrienne Jones/CH2M HILL
DATE: October 9, 2007

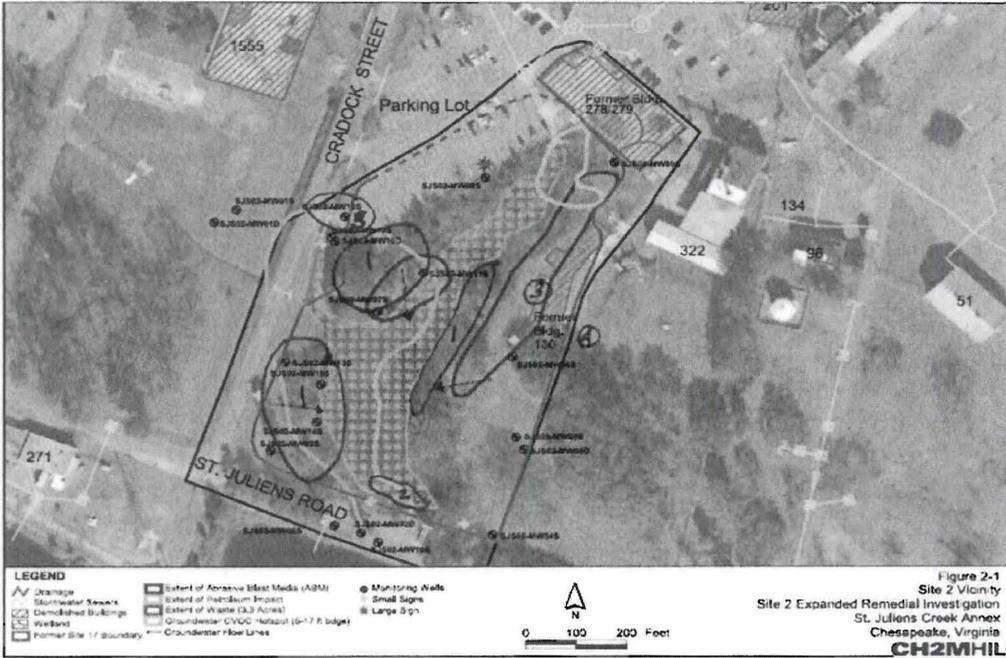
Figure 2-1
Site 2 Vicinity
Site 2 Expanded Remedial Investigation
St. Juliens Creek Annex
Chesapeake, Virginia
CH2MHILL

At the time of the inspection, there were signs of intrusive activities, including vegetation removal and tire ruts, from the Triad Investigation conducted in April through June 2007. Vegetative re-growth was observed in those areas, and will continue to be monitored to ensure re-growth is successful.

No IDW or signs of dumping of chemicals were observed within the site or in the vicinity. However, concrete and wood debris, also observed during previous inspections, remain in the wooded areas of the site. A couch and two railroad ties, first noted during the first quarter 2007 inspection, were still present adjacent to the site, near the southeastern corner of previously demolished Building 130. The wooden pallet previously observed is no longer in use but remains on site, along with additional pallets used during the Triad Investigation. The pallets will be disposed of along with the IDW generated during the November 2007 Voluntary Groundwater Performance Monitoring at Site 4.

All of the Site 2 monitoring wells, including casings, bollards, and locks, were in good condition, with the exception of monitoring well SJS02-MW12S. The flanges for the flush-mount well casing of SJS02-MW12S are damaged, prohibiting bolts from functioning properly, and replacement will be considered in coordination with future site activities. The signs indicating the site boundary were in good condition.

- ① Five mts & vegetation removal evident from Triad Investigation activities - Question 1
(concrete & wood debris present - Question 3)
- ② Concrete present - Question 3
- ③ Wood pallets present - Question 3
- ④ Couch & 2 railroad ties discarded adjacent to site boundary - Question 3
- ⑤ MW12s needs new well flanges - Question 4

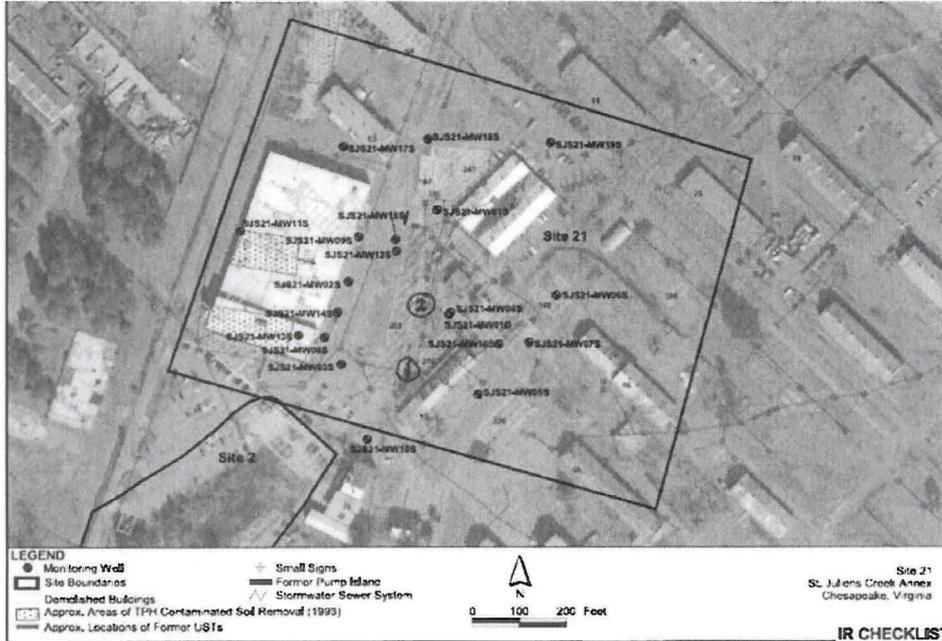
At the time of the inspection, evidence of intrusive activities was observed within the site boundary. Two open excavations, also noted during previous site inspections, were present in the vicinity of former Building 201. The northern excavation (approximately 12' x 8' x 5'), noted during the first IR site inspections conducted during the second quarter 2005, and southern excavation (approximately 4' x 4' x 8'), first noted during the first quarter 2006 inspection, appeared to be in similar condition as during the previous inspection. Both excavations contained standing water. Facility Operations personnel have indicated that the excavations are a result of ongoing storm sewer line repairs and will be backfilled when repairs are complete. The extent of the northern excavation will not change, but the southern excavation will be extended approximately 20 feet west into the parking lot towards Building 1556 to repair the drop inlet and connected piping. The excavations are located in an area of potential groundwater contamination. The existing groundwater and storm water analytical data, and a comparison of the groundwater data to non-hazardous disposal criteria were provided to the NAVFAC Mid-Atlantic Remedial Project Manager (RPM). The RPM will coordinate with Facilities Operations as necessary through the remaining repair activities.

- ① Storm sewer excavation: 5'x5'x 8', with standing water, appears abandoned - Question 1
- ② Storm sewer excavation: 12'x7'x 5', with standing water, appears abandoned - Question 1
