IR Site Inspections – 4th Quarter 2007

St. Juliens Creek Annex, Chesapeake, Virginia

PREPARED FOR: Tim Reisch/NAVFAV Mid-Atlantic
INSPECTIONS CONDUCTED BY: Adrienne Jones, Stephanie Dragoo/CH2M HILL
DATE: January 14, 2008

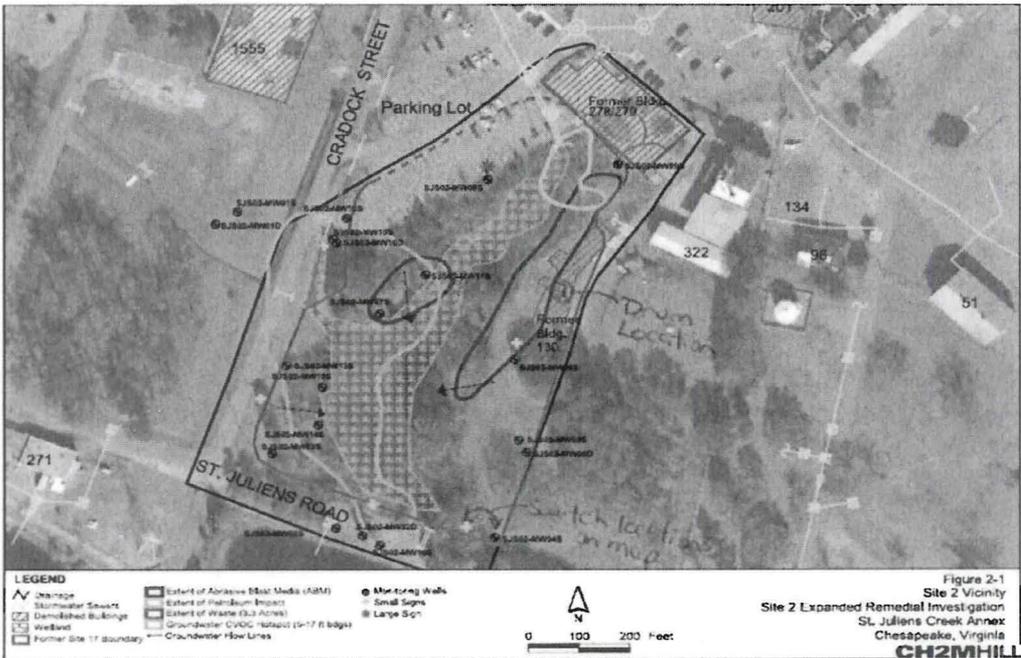
Site 2 - Waste Disposal Area B

One drum of investigation-derived waste (IDW) was observed on the site. The drum contains aqueous IDW generated during groundwater sampling activities at Site 21 and Site 4, conducted in November and December 2007. The drum is in secondary containment, in good condition, and properly labeled. Concrete and wood debris, also observed during previous inspections, remain in the wooded areas of the site. A couch and two railroad ties, first noted during the first quarter 2007 inspection, were still present adjacent to the site, near the southeastern corner of previously demolished Building 130. Wooden pallets used during the Triad investigation were located on the site; however, they will be disposed of along with the IDW generated during the Site 21 and Site 4 groundwater sampling events.

All of the Site 2 monitoring wells, including casings, bollards, and locks, were in good condition, with the exception of monitoring well SJS02-MW12S. The flanges for the flush-mount well casing of SJS02-MW12S are damaged, prohibiting bolts from functioning properly, and replacement will be considered in coordination with future site activities.

The signs indicating the site boundary were in good condition; however, they need to be updated with the correct contact phone number.

② 1 drum filled with groundwater is located on the site in the location indicated above. The drum is in Secondary Containment and is labeled properly
 * MW125 needs two bolts
 * Contact signs need to be updated with the current phone number

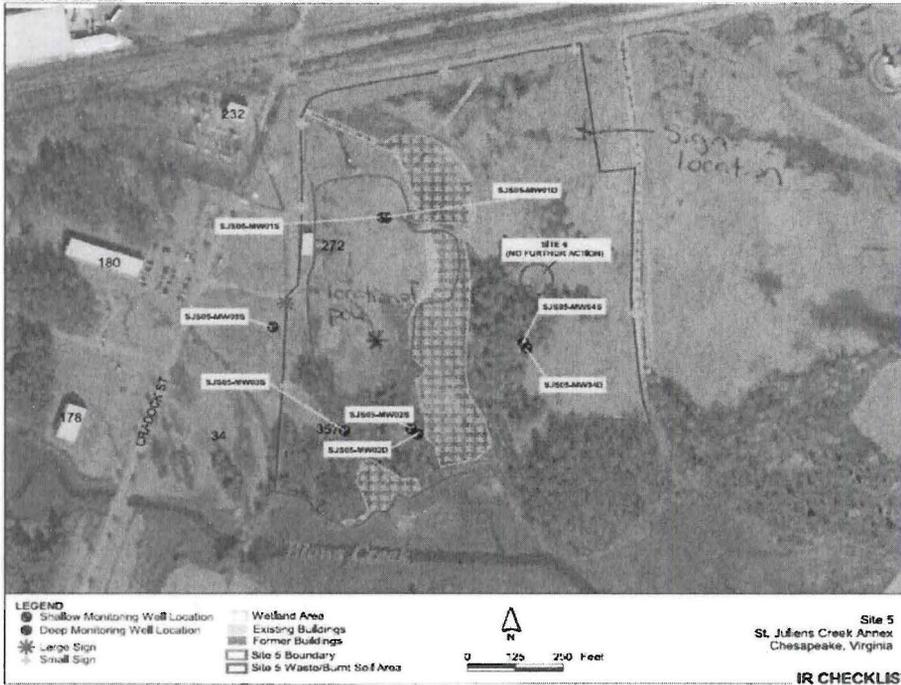
Site 5 - Burning Grounds

At the time of the inspection, there were no signs of intrusive activities or dumping of chemicals, and no IDW storage was observed within the site or in the vicinity. A pallet and pile of soil were observed in the southwestern area of the site and a concrete pole, a tire, and some scrap metal were observed in the clearing east of SJS05-MW05S. These items have been observed at the site during previous site visits. These items will be removed during the upcoming removal action. All of the Site 5 monitoring wells, including casings, bollards, and locks, were in good condition. The signs indicating the site boundary were in good condition; however, they need to be updated with the correct contact phone number.

- * An additional sign needs to be added to the map as indicated on the above map
- * a concrete pole, scrap metal & a tire were observed at the location indicated above, however they appear to have been there for some time.
- * Contact signs need to be updated with the current phone number

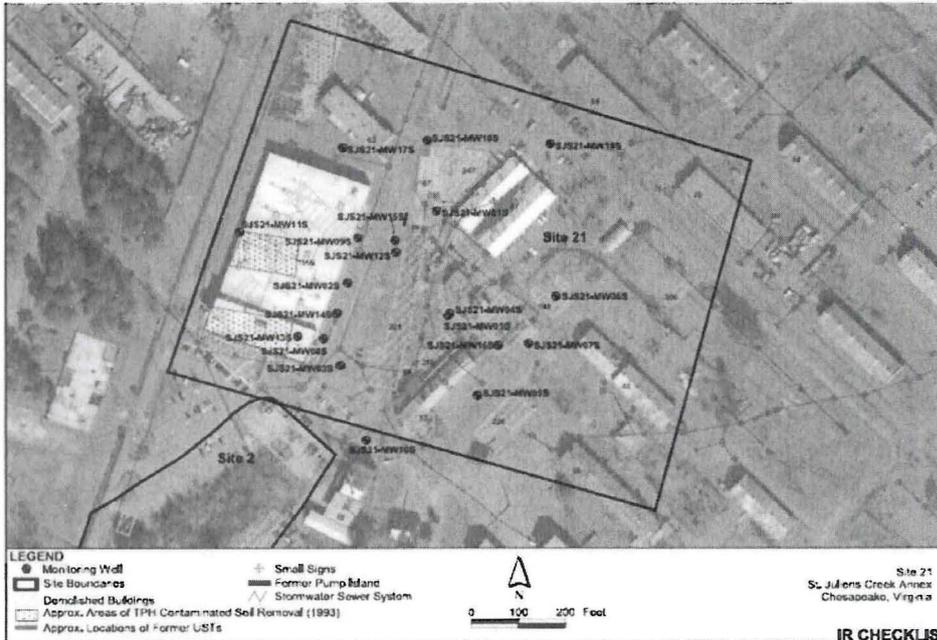
Site 21 - Industrial Area

At the time of the inspection, evidence of intrusive activities was observed within the site boundary. Two open excavations, also noted during previous site inspections, were present in the vicinity of former Building 201. The northern excavation (approximately 12' x 8' x 5'), noted during the first IR site inspections conducted during the second quarter 2005, and southern excavation (approximately 4' x 4' x 8'), first noted during the first quarter 2006 inspection, appeared to be in similar condition as during the previous inspection. Both excavations contained vegetation and standing water. Facility Operations personnel have indicated that the excavations are a result of ongoing storm sewer line repairs and will be backfilled when repairs are complete. The extent of the northern excavation will not change, but the southern excavation will be extended approximately 20 feet west into the parking lot towards Building 1556 to repair the drop inlet and connected piping. The excavations are located in an area of potential groundwater contamination. The existing groundwater and storm water analytical data, and a comparison of the groundwater data to non-hazardous disposal criteria were provided to the NAVFAC Mid-Atlantic Remedial Project Manager (RPM). The RPM will coordinate with Facilities Operations as necessary through the remaining repair activities.

* The two excavations observed during previous inspections are in the same condition as they were previously except they are more overgrown with weeds, ect.

* Contact signs need to be updated with current phone number
