## IR Site Inspections – 1st Quarter 2008

### St. Juliens Creek Annex, Chesapeake, Virginia

DATE: March 27, 2008

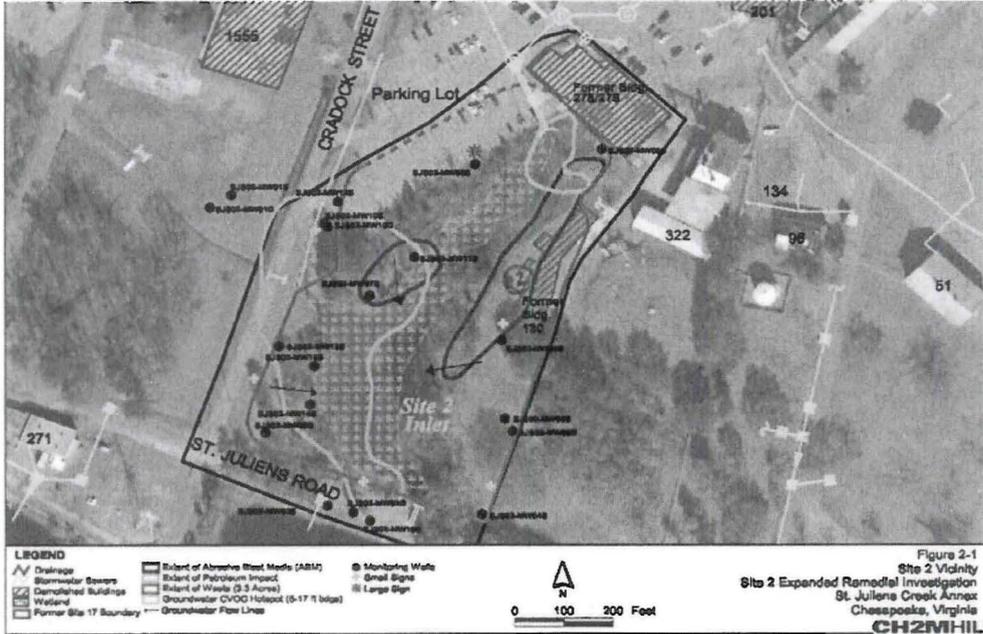
**Site 2 - Waste Disposal Area B**

One drum of investigation-derived waste (IDW) was observed on the site. The drum contains aqueous IDW generated during groundwater sampling activities at Site 4, conducted in February 2008. The drum is in secondary containment, in good condition, and properly labeled. Concrete and wood debris, also observed during previous inspections, remain in the wooded areas of the site. The couch and two railroad ties, previously noted near the southeastern corner of the former location of Building 130, were no longer present. Wooden pallets used during the Triad investigation were located at the IDW staging area during the last inspection. The pallets not currently in use were removed from the site and disposed on February 27, 2008.

All of the Site 2 monitoring wells, including casings, bollards, and locks, were in good condition, with the exception of monitoring well SJS02-MW12S. The flanges for the flush-mount well casing of SJS02-MW12S are damaged, prohibiting bolts from functioning properly, and replacement is recommended during future site activities. The signs indicating the site boundary were in good condition; however, they need to be updated with the correct contact phone number.

② One IDW does not properly labeled and staged on secondary containment

④ MW12S needs new flanges

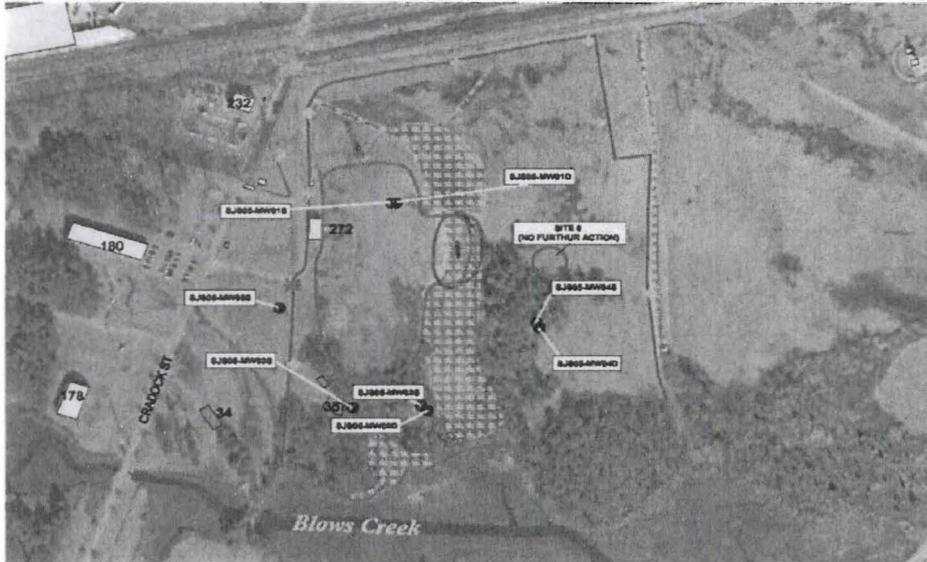
Site 5  
St. Juliens Creek Annex  
Chesapeake, Virginia

At the time of the inspection, there was evidence of recent intrusive activities within the site. These activities are associated with the removal action and consist of the installation of safety and silt fences and vegetation clearing within the waste/burnt soil area. No dumping of chemicals or IDW storage was observed within the site or in the vicinity. A pallet and pile of soil were observed in the southwestern area of the site and a concrete pole, a tire, and some scrap metal were observed in the clearing east of SJS05-MW05S. These items have been observed at the site during previous site visits and will be removed during the removal action.

① Vegetation in portion of wetland cleared and silt and safety fences installed along the perimeter of the waste/burnt soil and site boundary areas.

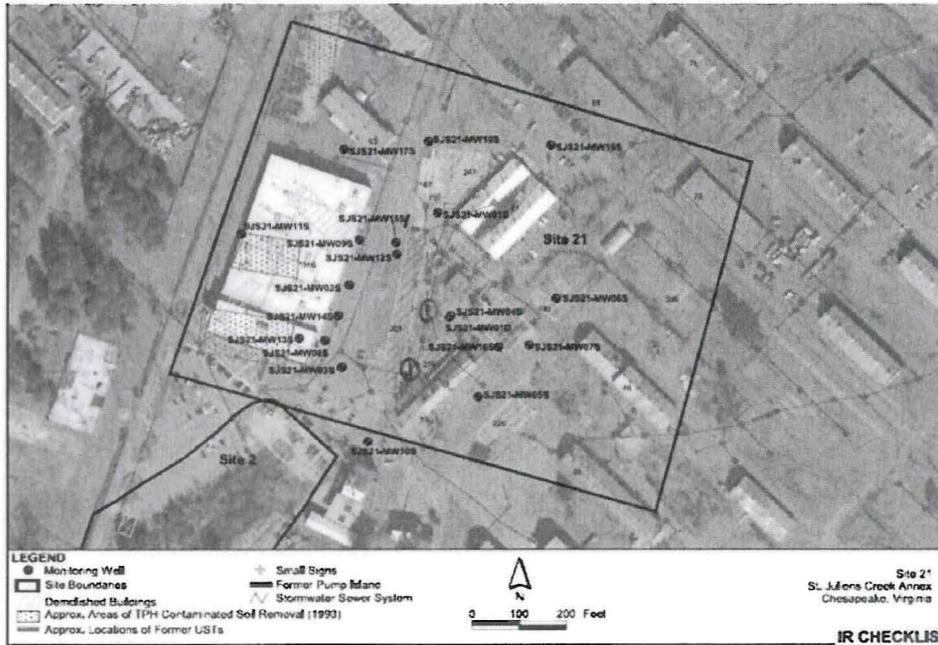
**Site 21 - Industrial Area**

At the time of the inspection, evidence of intrusive activities was observed within the site boundary. Two open excavations, also noted during previous site inspections, were present in the vicinity of the former location of Building 201. The northern excavation (approximately 12' x 8' x 5'), noted during the first IR site inspections conducted during the second quarter 2005, and southern excavation (approximately 4' x 4' x 8'), first noted during the first quarter 2006 inspection, appeared to be in similar condition as during the previous inspection. Both excavations contained vegetation and standing water. Facility Operations personnel have indicated that the excavations are a result of ongoing storm sewer line repairs and will be backfilled when repairs are complete. The extent of the northern excavation will not change, but the southern excavation will be extended approximately 20 feet west into the parking lot towards Building 1556 to repair the drop inlet and connected piping. The excavations are located in an area of potential groundwater contamination. The existing groundwater and storm water analytical data, and a comparison of the groundwater data to non-hazardous disposal criteria were provided to the NAVFAC Mid-Atlantic Remedial Project Manager (RPM). The RPM will coordinate with Facilities Operations as necessary through the remaining repair activities.

① Storm sewer excavations noted during previous investigations are in the same condition.
