IR Site Inspections – 2nd Quarter 2008

St. Juliens Creek Annex, Chesapeake, Virginia

DATE: June 23, 2008

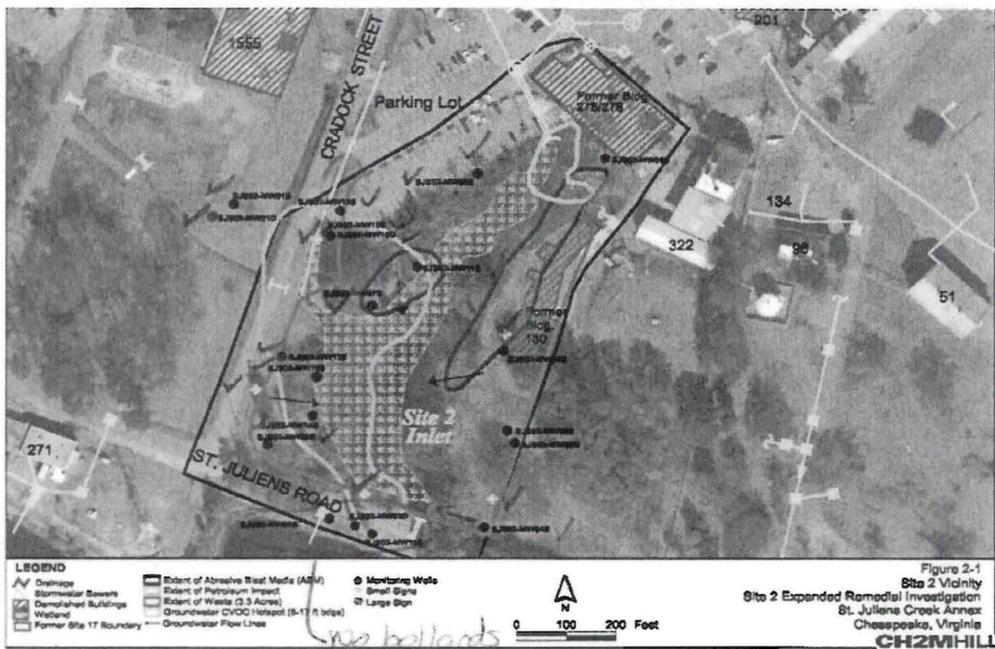
Site 2 - Waste Disposal Area B

② IDW on site site 4181 Purge water generated 5/29/08 properly labeled

inw013 & 17 doesn't have protective bollards also inw035 inw025 doesn't have bollards

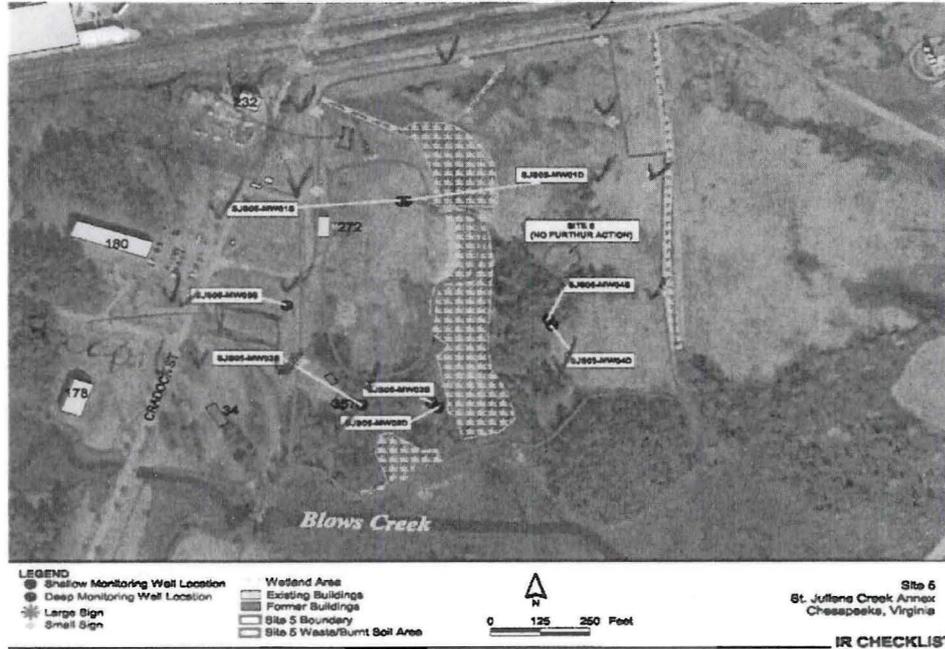
Site 5 - Burning Grounds

5. Heavy orange safety fence installed work trailer on site, see map

Large pile of soil located off-site next to site
