ER Site Inspections – 3rd Quarter 2008

St. Juliens Creek Annex, Chesapeake, Virginia

DATE: October 1, 2008

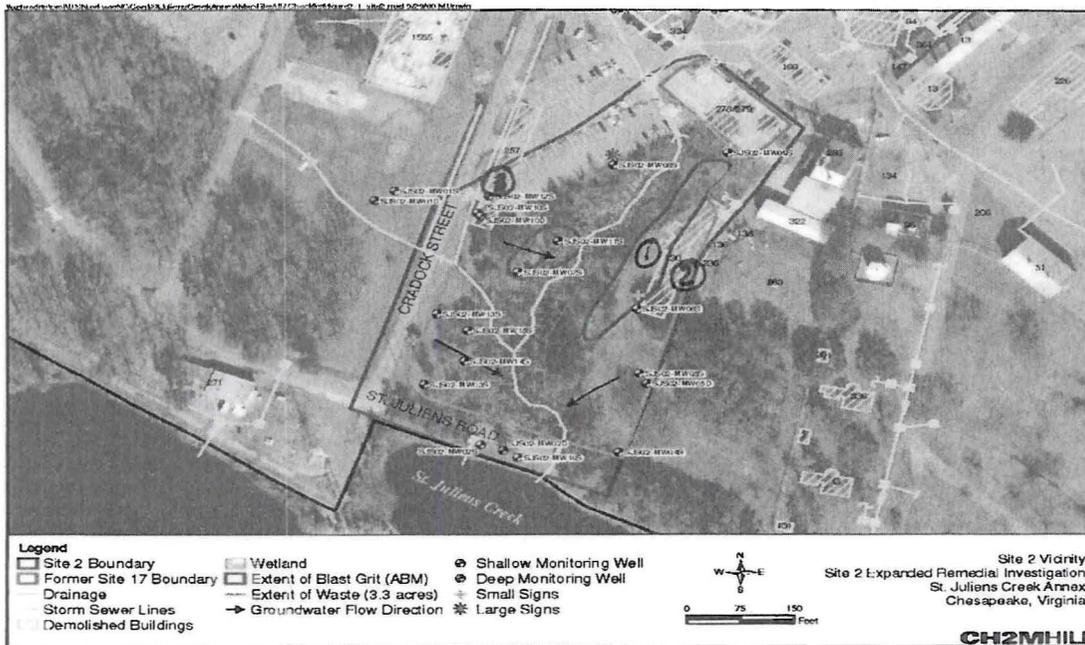
Site 2 - Waste Disposal Area B

Several drums of investigation-derived waste (IDW) were observed on the site. The drums contain aqueous IDW generated by CH2M HILL during groundwater sampling activities at Sites 4 and soil and aqueous IDW generated by Geosyntec during well installation at Site 21 for the Environmental Security Technology Certification Program (ESTCP) project. The drums are staged in secondary containment, in good condition, and properly labeled. Four empty drums were also observed in the vicinity.

Concrete and wood debris, also observed during previous inspections, remain in the wooded areas of the site. Additionally, miscellaneous debris, including a couch, a box, wood, and bottles, was observed on the eastern edge of the site near the IDW staging area.

All of the Site 2 monitoring wells, including casings, bollards, and locks, were in good condition, with the exception of monitoring well SJS02-MW12S. The flanges for the flush-mount well casing of SJS02-MW12S are damaged, prohibiting bolts from functioning properly, and replacement is recommended during future site activities. The signs indicating the site boundary were in good condition; however, they need to be updated with the correct contact phone number.

- ① IDW - CH2MHILL SITE 4, GEOSYNTEC SITE 21 - ALL LABELED & IN SECONDARY CONTAINMENT EXCEPT 4 EMPTY DRUMS - QUESTION 2
- ② DEBRIS OBSERVED (COUCH, WOOD, BOX, BOTTLES) - QUESTION 5
- ③ BOLTS MISSING FROM MW12S - CANNOT BE SECURED - QUESTION 3
- ④ 5-GAL BUCKET OF BENTONITE & NEIL SCREENS OBSERVED - LIKELY BELONG TO GEOSYNTEC/ESTEP PROJECT - QUESTION 5

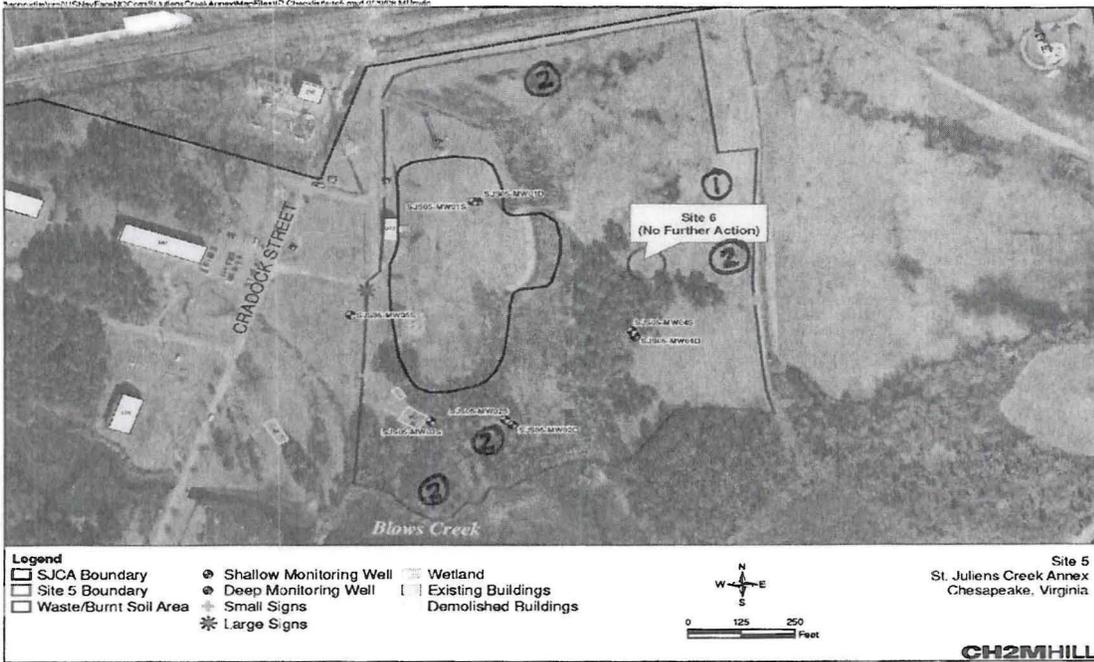
Site 5 - Burning Grounds

At the time of the inspection, there was evidence of recent intrusive activities within the site. These activities are associated with the ongoing removal action. Erosion and sediment controls are in place and functioning for the disturbed areas. Damage to silt fence in the southern portion of the site was observed and should be corrected by the removal action contractor. No dumping of chemicals or IDW storage was observed within the site or in the vicinity.

Site 5 monitoring wells, including casings, bollards, and locks, were in good condition. Monitoring wells SJS05-MW01S and SJS05-MW01D were not inspected, as they fall within a restricted access area due to the munitions and explosives of concern (MEC) encountered in January 2008. The signs indicating the site boundary were in good condition, with the exception of a sign on the eastern boundary of the site that was removed during the removal action. The phone number on the signs needs to be updated with the correct contact phone number.

- ① SIGN MISSING, - ON GROUND - APPEARS TO HAVE BEEN REMOVED BY REMOVAL ACTION CONTRACTOR. - QUESTION 5
- ② SIGNS OF REMOVAL ACTION ACTIVITIES. - QUESTION 1
- ③ MWOIS & MWOID NOT INSPECTED. ACCESS PROHIBITED DUE TO MEC ENCOUNTERED (ESS PENDING). - QUESTION 4

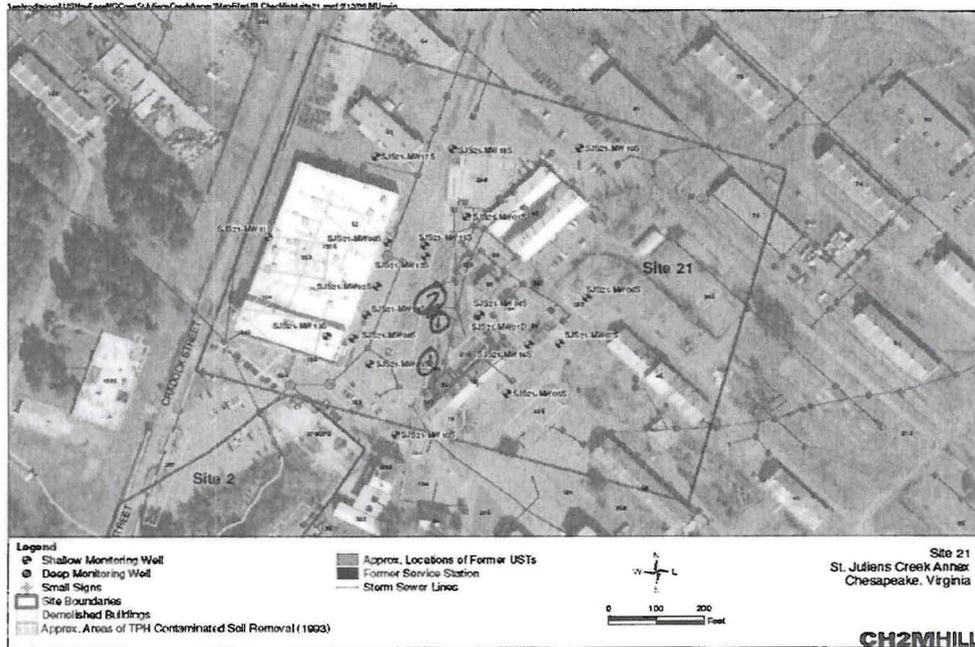
Site 21 - Industrial Area
St. Juliens Creek Annex, Chesapeake, Virginia

At the time of the inspection, evidence of intrusive activities was observed within the site boundary. Two open excavations, also noted during previous site inspections, were present in the vicinity of the former location of Building 201. The northern excavation (approximately 12' x 8' x 5'), noted during the first IR site inspections conducted during the second quarter 2005, and southern excavation (approximately 4' x 4' x 8'), first noted during the first quarter 2006 inspection, appeared to be in similar condition as during the previous inspection. Both excavations contained vegetation and standing water. Facility Operations personnel have indicated that the excavations are a result of ongoing storm sewer line repairs and will be backfilled when repairs are complete. The extent of the northern excavation will not change, but the southern excavation will be extended approximately 20 feet west into the parking lot towards Building 1556 to repair the drop inlet and connected piping. The excavations are located in an area of potential groundwater contamination. The existing groundwater and storm water analytical data, and a comparison of the groundwater data to non-hazardous disposal criteria were provided to the NAVFAC Mid-Atlantic Remedial Project Manager (RPM). The RPM will coordinate with Facilities Operations as necessary through the remaining repair activities.

① OPEN EXCAVATION - UTILITY REPAIR - QUESTION 1

② ESTCP PROJECT IN PROGRESS - QUESTION 1

③ MATERIAL STAGED THROUGHOUT SITE - ACTIVE INDUSTRIAL AREA

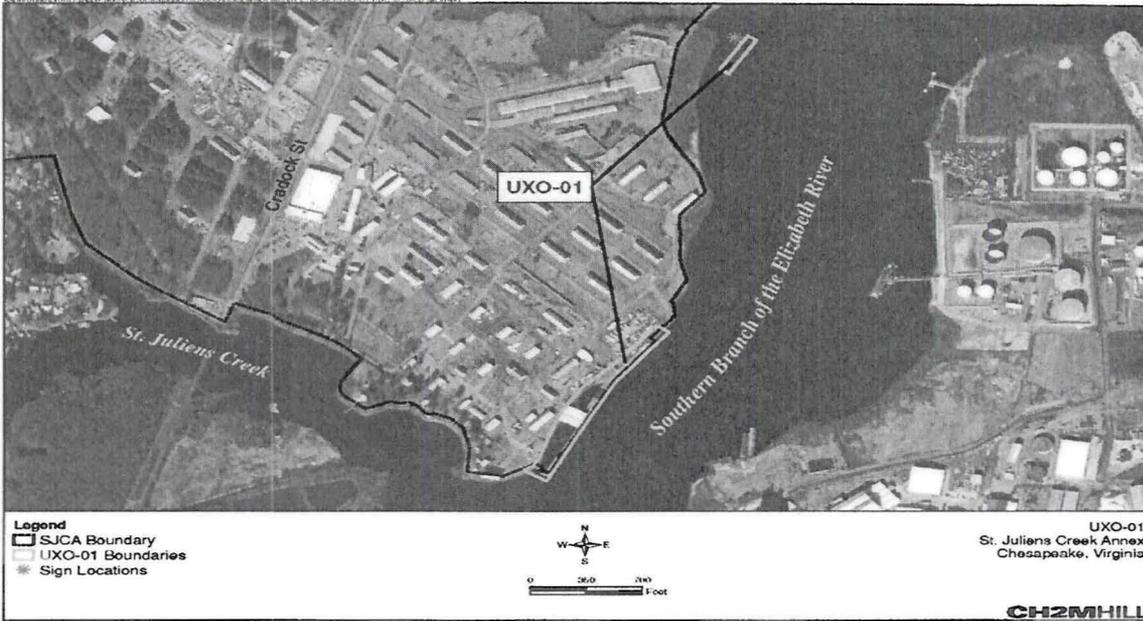
UXO 1 - WHARF AREA SEDIMENTS

No intrusive activities, IDW, or debris were observed at the site during the inspection. The signs indicating the site boundary were in good condition; however, they need to be updated with the current contact phone number and to reflect the new site information (i.e., MR Site UXO 1 instead of IR Site 20). When updating the signs, placement of signs in the vicinity of the southern wharf area should be considered.

SIGNS SHOULD BE REVISED. IR SITE 20 TO MR SITE UXO-1. CORRECT PHONE NUMBER. ALSO, CONSIDER POSTING IN SOUTH AREA.
