## ER Site Inspections - 4th Quarter 2008

### St. Juliens Creek Annex, Chesapeake, Virginia

DATE: January 2, 2008

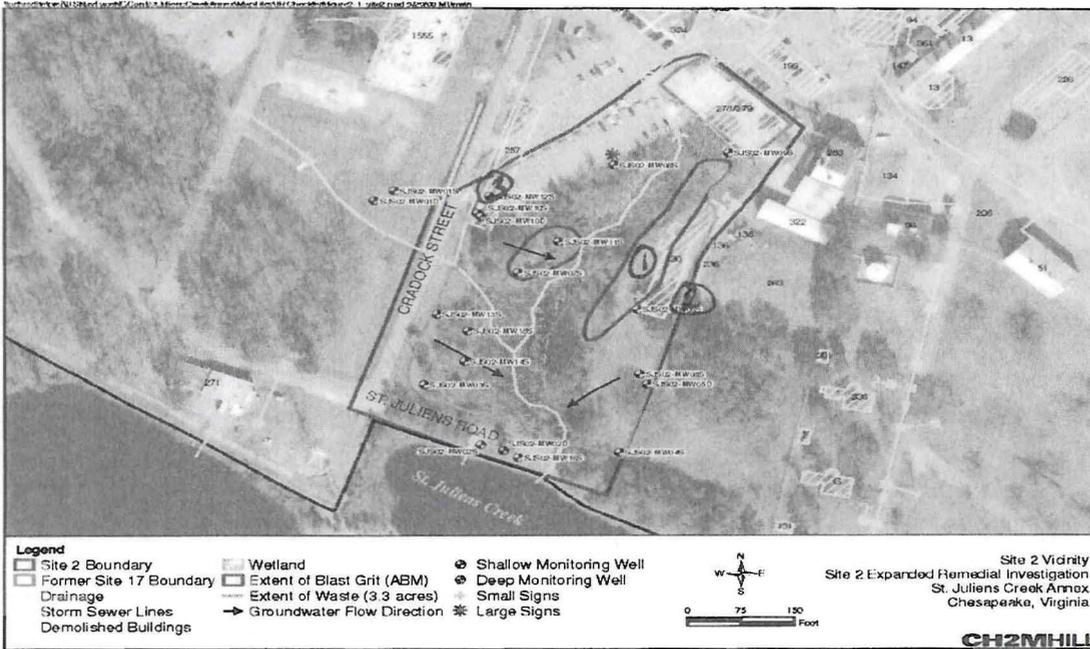
**Site 2 - Waste Disposal Area B**

At the time of the inspection, there were no signs of recent intrusive activities. Approximately 56 drums of investigation-derived waste (IDW) were observed on the site. The drums contain soil and aqueous IDW generated by Geosyntec during well installation at Site 21 for the Environmental Security Technology Certification Program (ESTCP) project. The drums are staged in secondary containment and properly labeled. One drum was observed to have had a lid that was not properly secured to the drum. One secondary containment cell is empty and needs to be removed.

Concrete and wood debris, also observed during previous inspections, remain in the wooded areas of the site. Additionally, miscellaneous debris, including a couch, a box, wood, and bottles, was observed on the eastern edge of the site near the IDW staging area. The 5-gallon bucket of bentonite pellets and two boxes of well screens previously identified at the site were not observed in the area. These items have since been removed.

All of the Site 2 monitoring wells, including casings, bollards, and locks, were in good condition, with the exception of monitoring well SJS02-MW12S. The flanges for the flush-mount well casing of SJS02-MW12S are damaged, prohibiting bolts from functioning properly, and replacement is recommended during future site activities. The signs indicating the site boundary were in good condition; however, they need to be updated with the correct contact phone number.

① IDW - APPROX. 56 DRUMS OF IDW AND SEVERAL EMPTY DRUMS OBSERVED. 1st SECONDARY CONTAINMENT WITH PROPER LABELS. NOTED AT LEAST ONE DRUM WITH LED NOT PROPERLY SECURED. - QUESTION 2

② DEBRIS OBSERVED (COUCH, WOOD, BOTTLES, ETC) - QUESTION 3

③ BOLTS MESSING FROM NW 125 - QUESTION 4

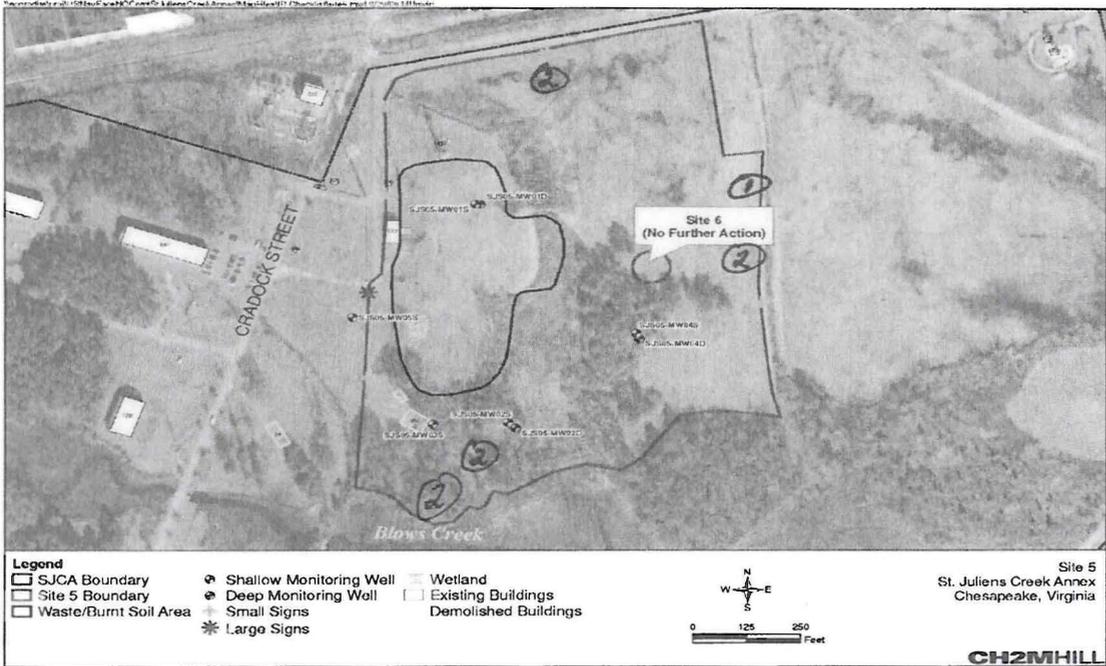
**Site 5 - Burning Grounds**

At the time of the inspection, there was evidence of recent intrusive activities within the site. These activities are associated with the ongoing removal action. Erosion and sediment controls are in place and functioning for the disturbed areas. The Silt fence around the waste/burnt soil area is falling down and should be repaired prior to initiation of land-disturbing activities. No dumping of chemicals or IDW storage was observed within the site or in the vicinity.

Site 5 monitoring wells, including casings, bollards, and locks, were in good condition. Monitoring wells SJS05-MW01S and SJS05-MW01D were not inspected, as they fall within a restricted access area due to the munitions and explosives of concern (MEC) encountered in January 2008. The signs indicating the site boundary were in good condition, with the exception of a sign on the eastern boundary of the site that was removed during the removal action. The phone number on the signs needs to be updated with the correct contact phone number.

- ① SIGNS MESSING - ON GROUND - QUESTION 5
- ② SIGNS OF REMOVAL ACTION - QUESTION 1

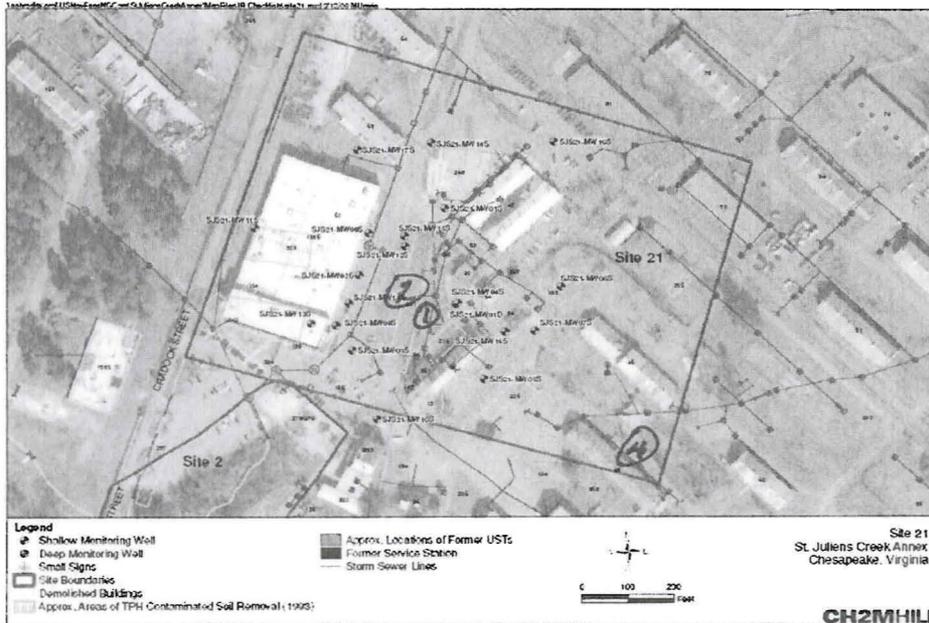
**Site 21 - Industrial Area**  
**St. Juliens Creek Annex, Chesapeake, Virginia**

At the time of the inspection, evidence of intrusive activities was observed within the site boundary. Two open excavations, also noted during previous site inspections, were present in the vicinity of the former location of Building 201. The northern excavation (approximately 12' x 8' x 5'), noted during the first IR site inspections conducted during the second quarter 2005, and southern excavation (approximately 4' x 4' x 8'), first noted during the first quarter 2006 inspection, appeared to be in similar condition as during the previous inspection. Both excavations contained vegetation and standing water. Facility Operations personnel have indicated that the excavations are a result of ongoing storm sewer line repairs and will be backfilled when repairs are complete. The extent of the northern excavation will not change, but the southern excavation will be extended approximately 20 feet west into the parking lot towards Building 1556 to repair the drop inlet and connected piping. The excavations are located in an area of potential groundwater contamination. The existing groundwater and storm water analytical data, and a comparison of the groundwater data to non-hazardous disposal criteria were provided to the NAVFAC Mid-Atlantic Remedial Project Manager (RPM). The RPM will coordinate with Facilities Operations as necessary through the remaining repair activities.

A 55-gallon steel drum was observed in the southeast corner of the site near Building 68. The drum was in poor condition, with holes on the top and sides, and the bung hole on the drum was open. The drum was labeled "Dyed Kerosene 216". The drum was not in secondary containment and staining on the asphalt around the drum was observed. Facility Operations personnel was contacted to inspect and have the drum properly labeled and/or disposed of and will notify the RPM of the drum's contents.

Miscellaneous construction and wood debris were observed throughout the site, but are expected due to the industrial use of the site. All of the Site 21 monitoring wells were in good condition. The signs indicating the site boundary were in good condition; however, they need to be updated with the current contact phone number.

- ① GEN EXCAVATION - UTILITY REPAIR - QUESTION!
- ② ESTCP PROJECT IN PROGRESS - QUESTION!
- ③ MATERIAL & DEBRIS STAGED THROUGHOUT THE SITE - ACTIVE INDUSTRIAL AREA
- ④ 1-55 GALLON DRUM (OLD) IDENTIFIED. NOT PROPERLY LABELED. HOLES IN TOP AND SIDES. SOME LIQUID INSIDE. LABELED "DYED KEROSENE Z16" NOT IN SECONDARY CONT.

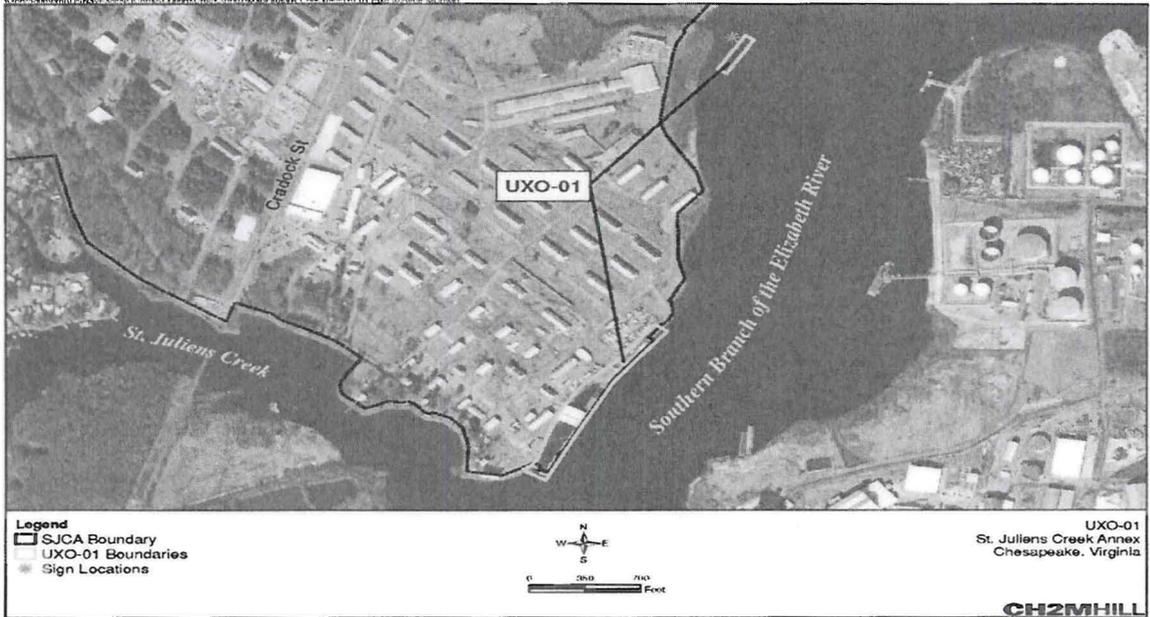
**UXO 1 -**

No intrusive activities, IDW, or debris were observed at the site during the inspection. The signs indicating the site boundary were in good condition; however, they need to be updated with the current contact phone number and to reflect the new site information (i.e., MR Site UXO 1 instead of IR Site 20). When updating the signs, placement of signs in the vicinity of the southern wharf area should be considered.

SIGNS VISIBLE, NAME & CONTACT NUMBER STILL TO BE UPDATED, ALSO CONSIDER POSTING ON SOUTH PIER.
