ER Site Inspections – 1st Quarter 2009

St. Juliens Creek Annex, Chesapeake, Virginia

DATE: April 7, 2009

Site 2 - Waste Disposal Area B

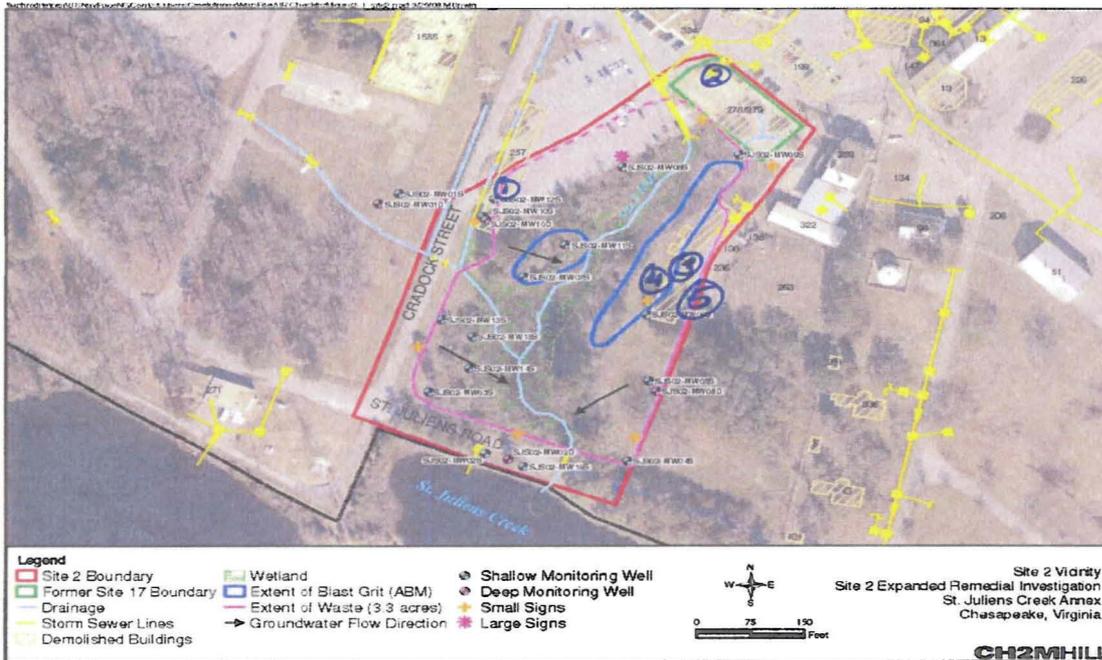
At the time of the inspection, there were no signs of unauthorized intrusive activities within the site or in the vicinity. Soil disturbances caused by tire ruts were observed in the field adjacent to the former investigation-derived waste (IDW) staging area. This area should be assessed during the next quarterly site inspection to ensure vegetative re-growth.

Concrete and wood debris, observed during previous inspections, remain in the wooded areas of the site. Miscellaneous debris; including a couch, a box, wood, and bottles, also observed during previous inspections, remain on the eastern edge of the site near the IDW staging area.

All of the Site 2 monitoring wells, including casings, bollards, and locks, were in good condition, with the exception of monitoring well SJS02-MW12S. The flanges for the flush-mount well casing of SJS02-MW12S are damaged, prohibiting bolts from functioning properly, and replacement is recommended during future site activities. The signs indicating the site boundary were in good condition; however, they need to be updated with the correct contact phone number.

① BOLTS MISSING FROM MW 125 - QUESTION 4
 ② IDW STAGED IN SECONDARY CONT. 3 DRUMS - 2 EMPTY, 1 MARKED AS GEOSYNTEC IDW.
 ③ FORMER IDW STAGING AREA. 6 DRUMS STILL HERE, 3 MARKED AS GEOSYNTEC IDW, 2 AS CHRM HELL IDW, AND 1 EMPTY DRUM. ALL DRUMS ARE IN SECONDARY CONTAINMENT. STACK OF PALLETS NEXT TO IDW NEEDS TO BE REMOVED.
 ④ TREE KUTS APPROX. 8" DEEP THROUGH THIS AREA - QUESTION 3
 ⑤ DEBRIS OBSERVED (COUCH, WOOD, BOTTLES, ETC) - QUESTION 1

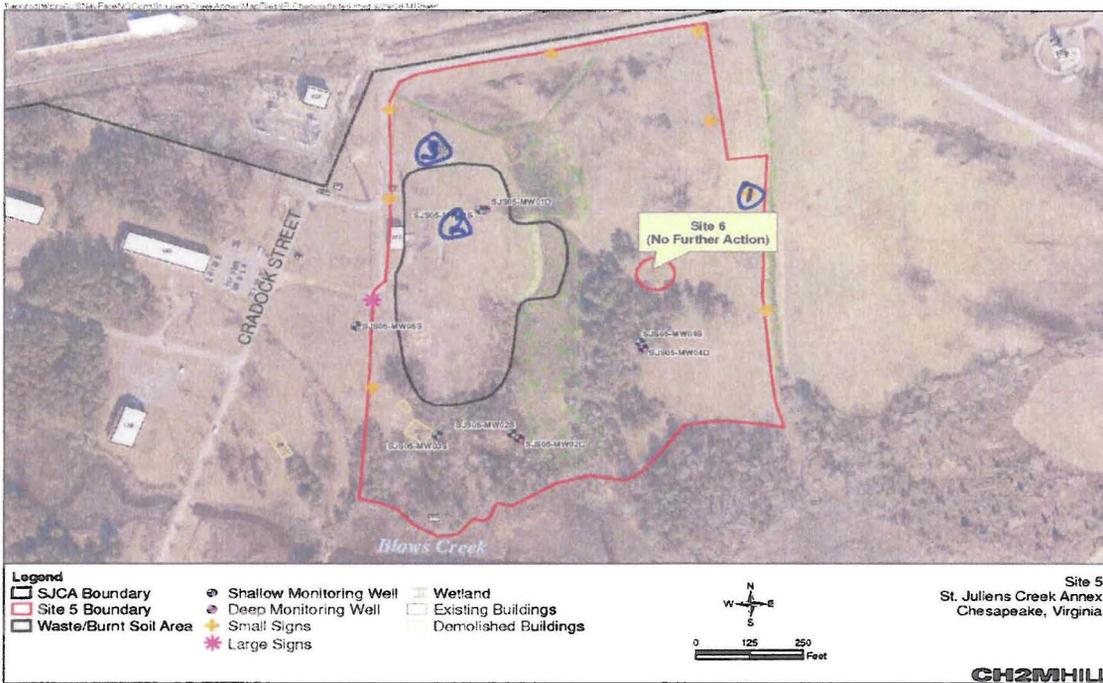
Site 5 - Burning Grounds

At the time of the inspection, there was evidence of recent intrusive activities within the site. These activities are associated with the ongoing removal action. Erosion and sediment controls are in place and functioning for the disturbed areas. The silt fence around portions of the waste/burnt soil area is falling down and should be repaired prior to initiation of land-disturbing activities. No dumping of chemicals was observed within the site or in the vicinity. An empty drum was observed near the radio tower in front of Building 1456.

Only monitoring well SJS05-MW05S was inspected, all other monitoring wells fall within a restricted access area due to the munitions and explosives of concern (MEC) encountered at the site. Monitoring well SJS05-MW05S, including the casing, bollards, and lock, was in good condition. The signs indicating the site boundary were in good condition, with the exception of a sign on the eastern boundary of the site that was removed during the removal action. The phone number on the signs needs to be updated with the correct contact phone number.

① SIGN MISSING - ON GROUND - QUESTION 5
 ② SIGNS OF REMOVAL ACTION - QUESTION 1
 ③ DRUM IN FRONT OF BUILDING 1456, POSSIBLY EMPTY BUT LABELED AS "20% (PHRYSOZITE?) 'ACM - NON FRIABLE' SJCA - 2/17/09 NAVFAC - SITE 5"
 NOTE: WELLS WITHIN SITE NOT INSPECTED DUE TO EXPLOSIVE SAFETY HAZARDS ASSOCIATED WITH THE SITE.

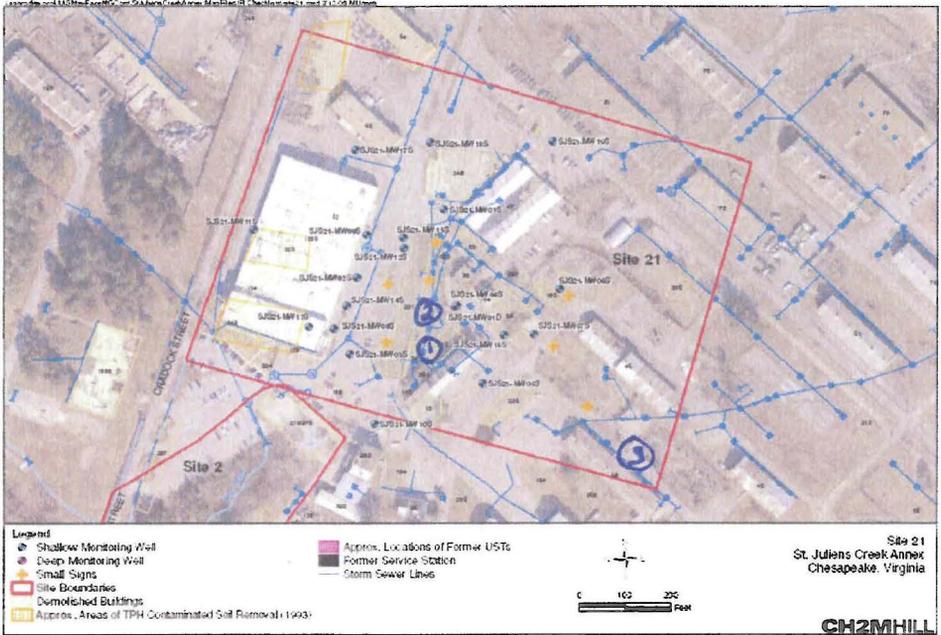
Site 21 - Industrial Area
St. Juliens Creek Annex, Chesapeake, Virginia

At the time of the inspection, evidence of intrusive activities was observed within the site boundary. Two open excavations, also noted during previous site inspections, were present in the vicinity of the former location of Building 201. The northern excavation (approximately 12' x 8' x 5'), noted during the first IR site inspections conducted during the second quarter 2005, and southern excavation (approximately 4' x 4' x 8'), first noted during the first quarter 2006 inspection, appeared to be in similar condition as during the previous inspection. Both excavations contained vegetation and standing water. Facility Operations personnel have indicated that the excavations are a result of ongoing storm sewer line repairs and will be backfilled when repairs are complete. The extent of the northern excavation will not change, but the southern excavation will be extended approximately 20 feet west into the parking lot towards Building 1556 to repair the drop inlet and connected piping. The excavations are located in an area of groundwater contamination. The existing groundwater and storm water analytical data, and a comparison of the groundwater data to non-hazardous disposal criteria were provided to the NAVFAC Mid-Atlantic Remedial Project Manager (RPM). The RPM will coordinate with Facilities Operations as necessary through the remaining repair activities.

The 55-gallon steel drum previously observed in the southeast corner of the site near Building 68 was no longer present. However, a larger drum was located in the same location and appeared to be used as an overpack for the previously identified drum. It was labeled as “Kerosene and Water” and noted “leaking 55-gallon drum overpacked into 85-gallon drum”. The overpack was observed to be in good condition. No additional containment was needed. Facility Operations personnel was contacted to inspect and have the drum properly labeled and/or disposed of and will notify the RPM of the drum’s contents.

Miscellaneous construction and wood debris were observed throughout the site, but are expected due to the industrial use of the site. All of the Site 21 monitoring wells were in good condition. The signs indicating the site boundary were in good condition; however, they need to be updated with the current contact phone number.

- ① OPEN EXCAVATION - UTILITY REPAIR - QUESTION 1
- ② ESTOP PROJECT IN PROGRESS - QUESTION 1
- ③ GREEN DRUM LABELED KEROSENE AND WATER DATED: 1/9/09 NOTE: "LEAKING 55 GALLON DRUM OVERPACKED INTO 85 GALLON DRUM" PROPERTY OF PNC NAVFAC - QUESTION 2
- ④ MATERIAL & DEBRIS STAGED THROUGHOUT SITE - ACTIVE INDUSTRIAL AREA.
