**NAVAL AIR STATION
FORT WORTH JRB
CARSWELL FIELD
TEXAS**

RCRA Permit Part B Number HW50289

SUMMARY OF PERMIT SITES

Prepared By
U.S. Army Corps Of Engineers
Fort Worth District

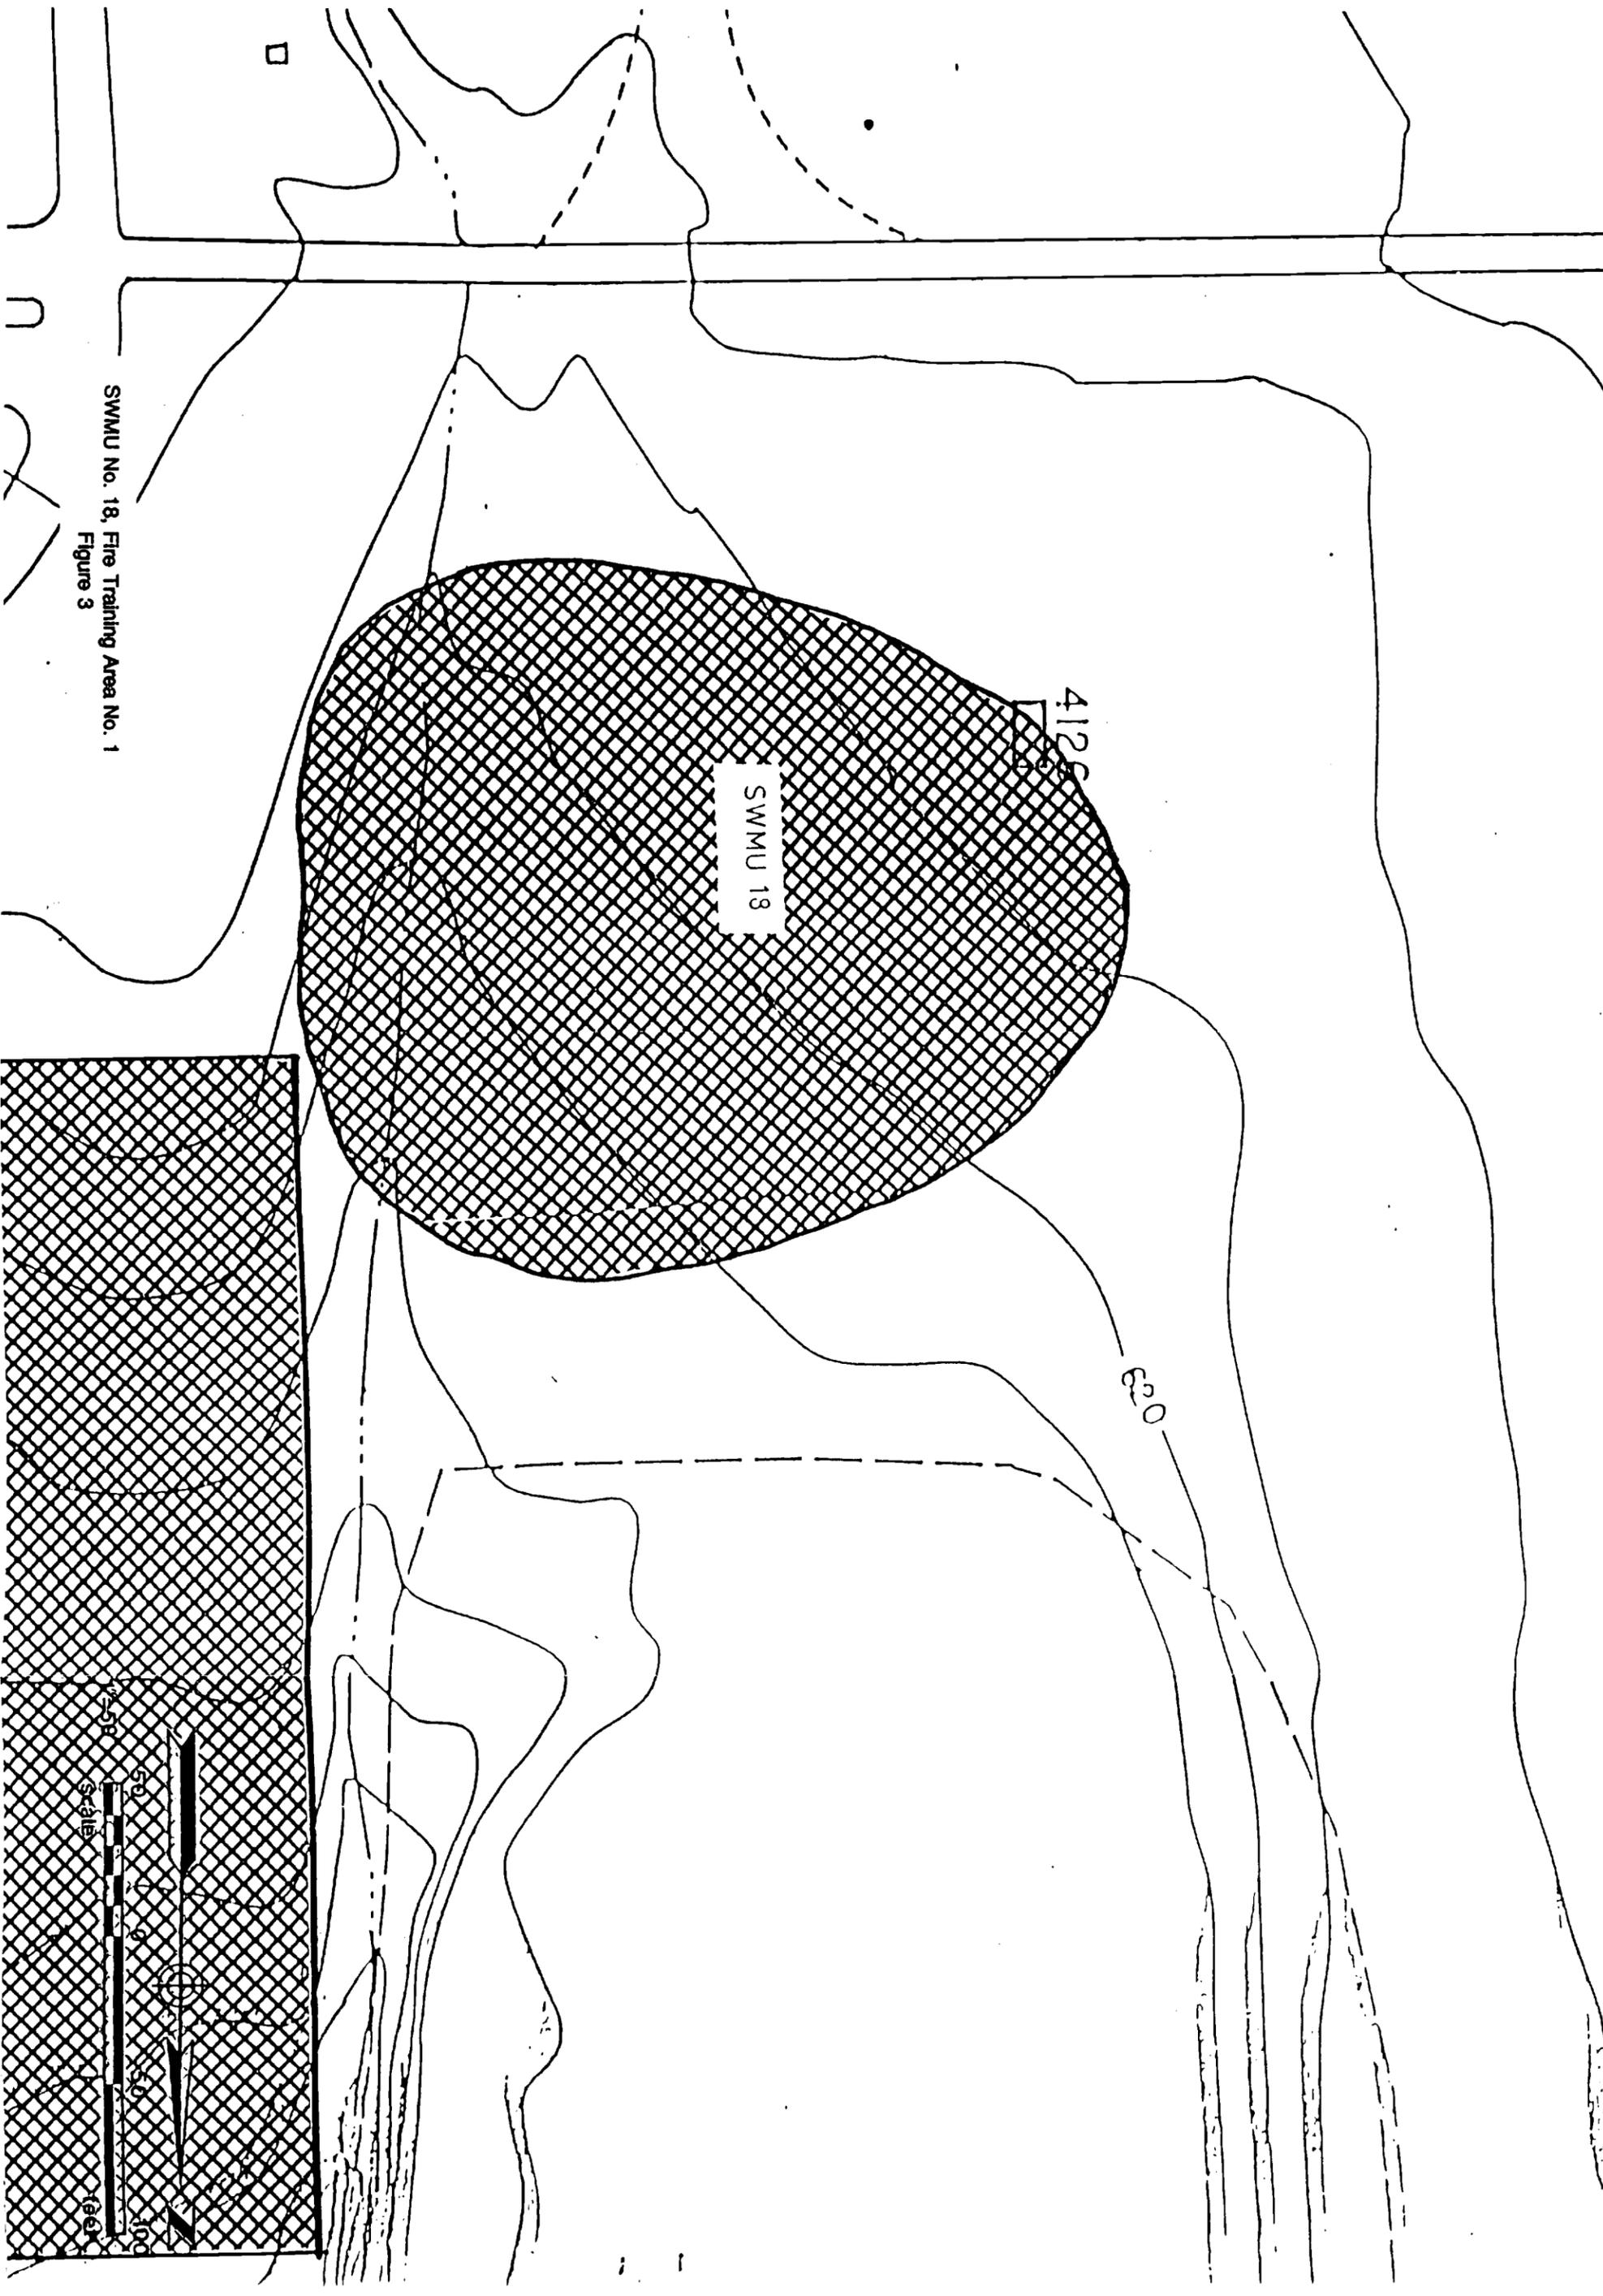
SWMU No. 18, Fire Training Area No. 1
Figure 3

SWMU No. 18 is located north of Landfill 5 and was the primary fire pit prior to 1963. The pit was gravel-lined, and had a low concrete curb around its perimeter and reportedly was adjacent to a small tributary of Farmers Branch. Several fire training exercises are reported to have taken place at this site each month, with waste oils and contaminated fuels being the primary flammable liquids used in the exercises. Small quantities of solvents are also reported to have been used in these exercises. The site now consists of a level, gravel-surfaced area on a drainage divide between an unnamed tributary of Farmers Branch and Farmers Branch.

Samples of ground water were collected and analyzed from the two wells in two sampling rounds. Parameters analyzed were water quality indicators, heavy metals, petroleum hydrocarbons, purgeable halocarbons, purgeable aromatics, and extractable priority pollutants. Total dissolved solids ranged from 570 mg/L to 820 mg/L during the two sampling rounds. Maximum contaminant levels were exceeded by arsenic in both sampling rounds at only one well. Chromium also surpassed MCLs at the same well in the second round. Iron and manganese exceeded MCLGs during both sampling rounds at both wells. Lead was found in levels above the MCL at one well, but this was not confirmed with the graphite atomic absorption test. Petroleum hydrocarbons were not detected at the two wells. Purgeable halocarbons were not detected in the ground water at the site. Toluene was found in all ground water samples, ranging from 0.6 ug/L to 19 ug/L. Concentrations increased at both wells from the first to the second rounds, but were under the toluene MCLG of 2.0 mg/L. Several priority pollutants were detected in one well, however, the substances detected were at low levels and occasionally were detected in the reagent blank samples. Results of the Stage 2 investigations indicated low levels of TCE (range from none detected to 0.249 mg/Kg) were detected in one well at the site, located just north of SWMU No. 23, Landfill 5.

Samples of soil were collected during monitor well installation and at one hand-augered boring at the center of the site. Soil analysis consisted of metals, oil and grease, and volatile organic compounds (Methods 601 and 602). TCE

was detected at the hand augered boring and at the up gradient monitor well (range 0.249 - 0.257 mg/Kg). All other parameters were found to be within normal limits.

It is recommended that the two wells should continue to be monitored, primarily due to their proximity to the TCE plume in the ground water south of the site. Monitoring parameters should include volatile organic compounds, metals, and general water quality parameters. Results of the Stage 2 investigation indicates that there is no further action necessary at this time for SWMU No. 18. A detailed request for no further action will be submitted at a later date.

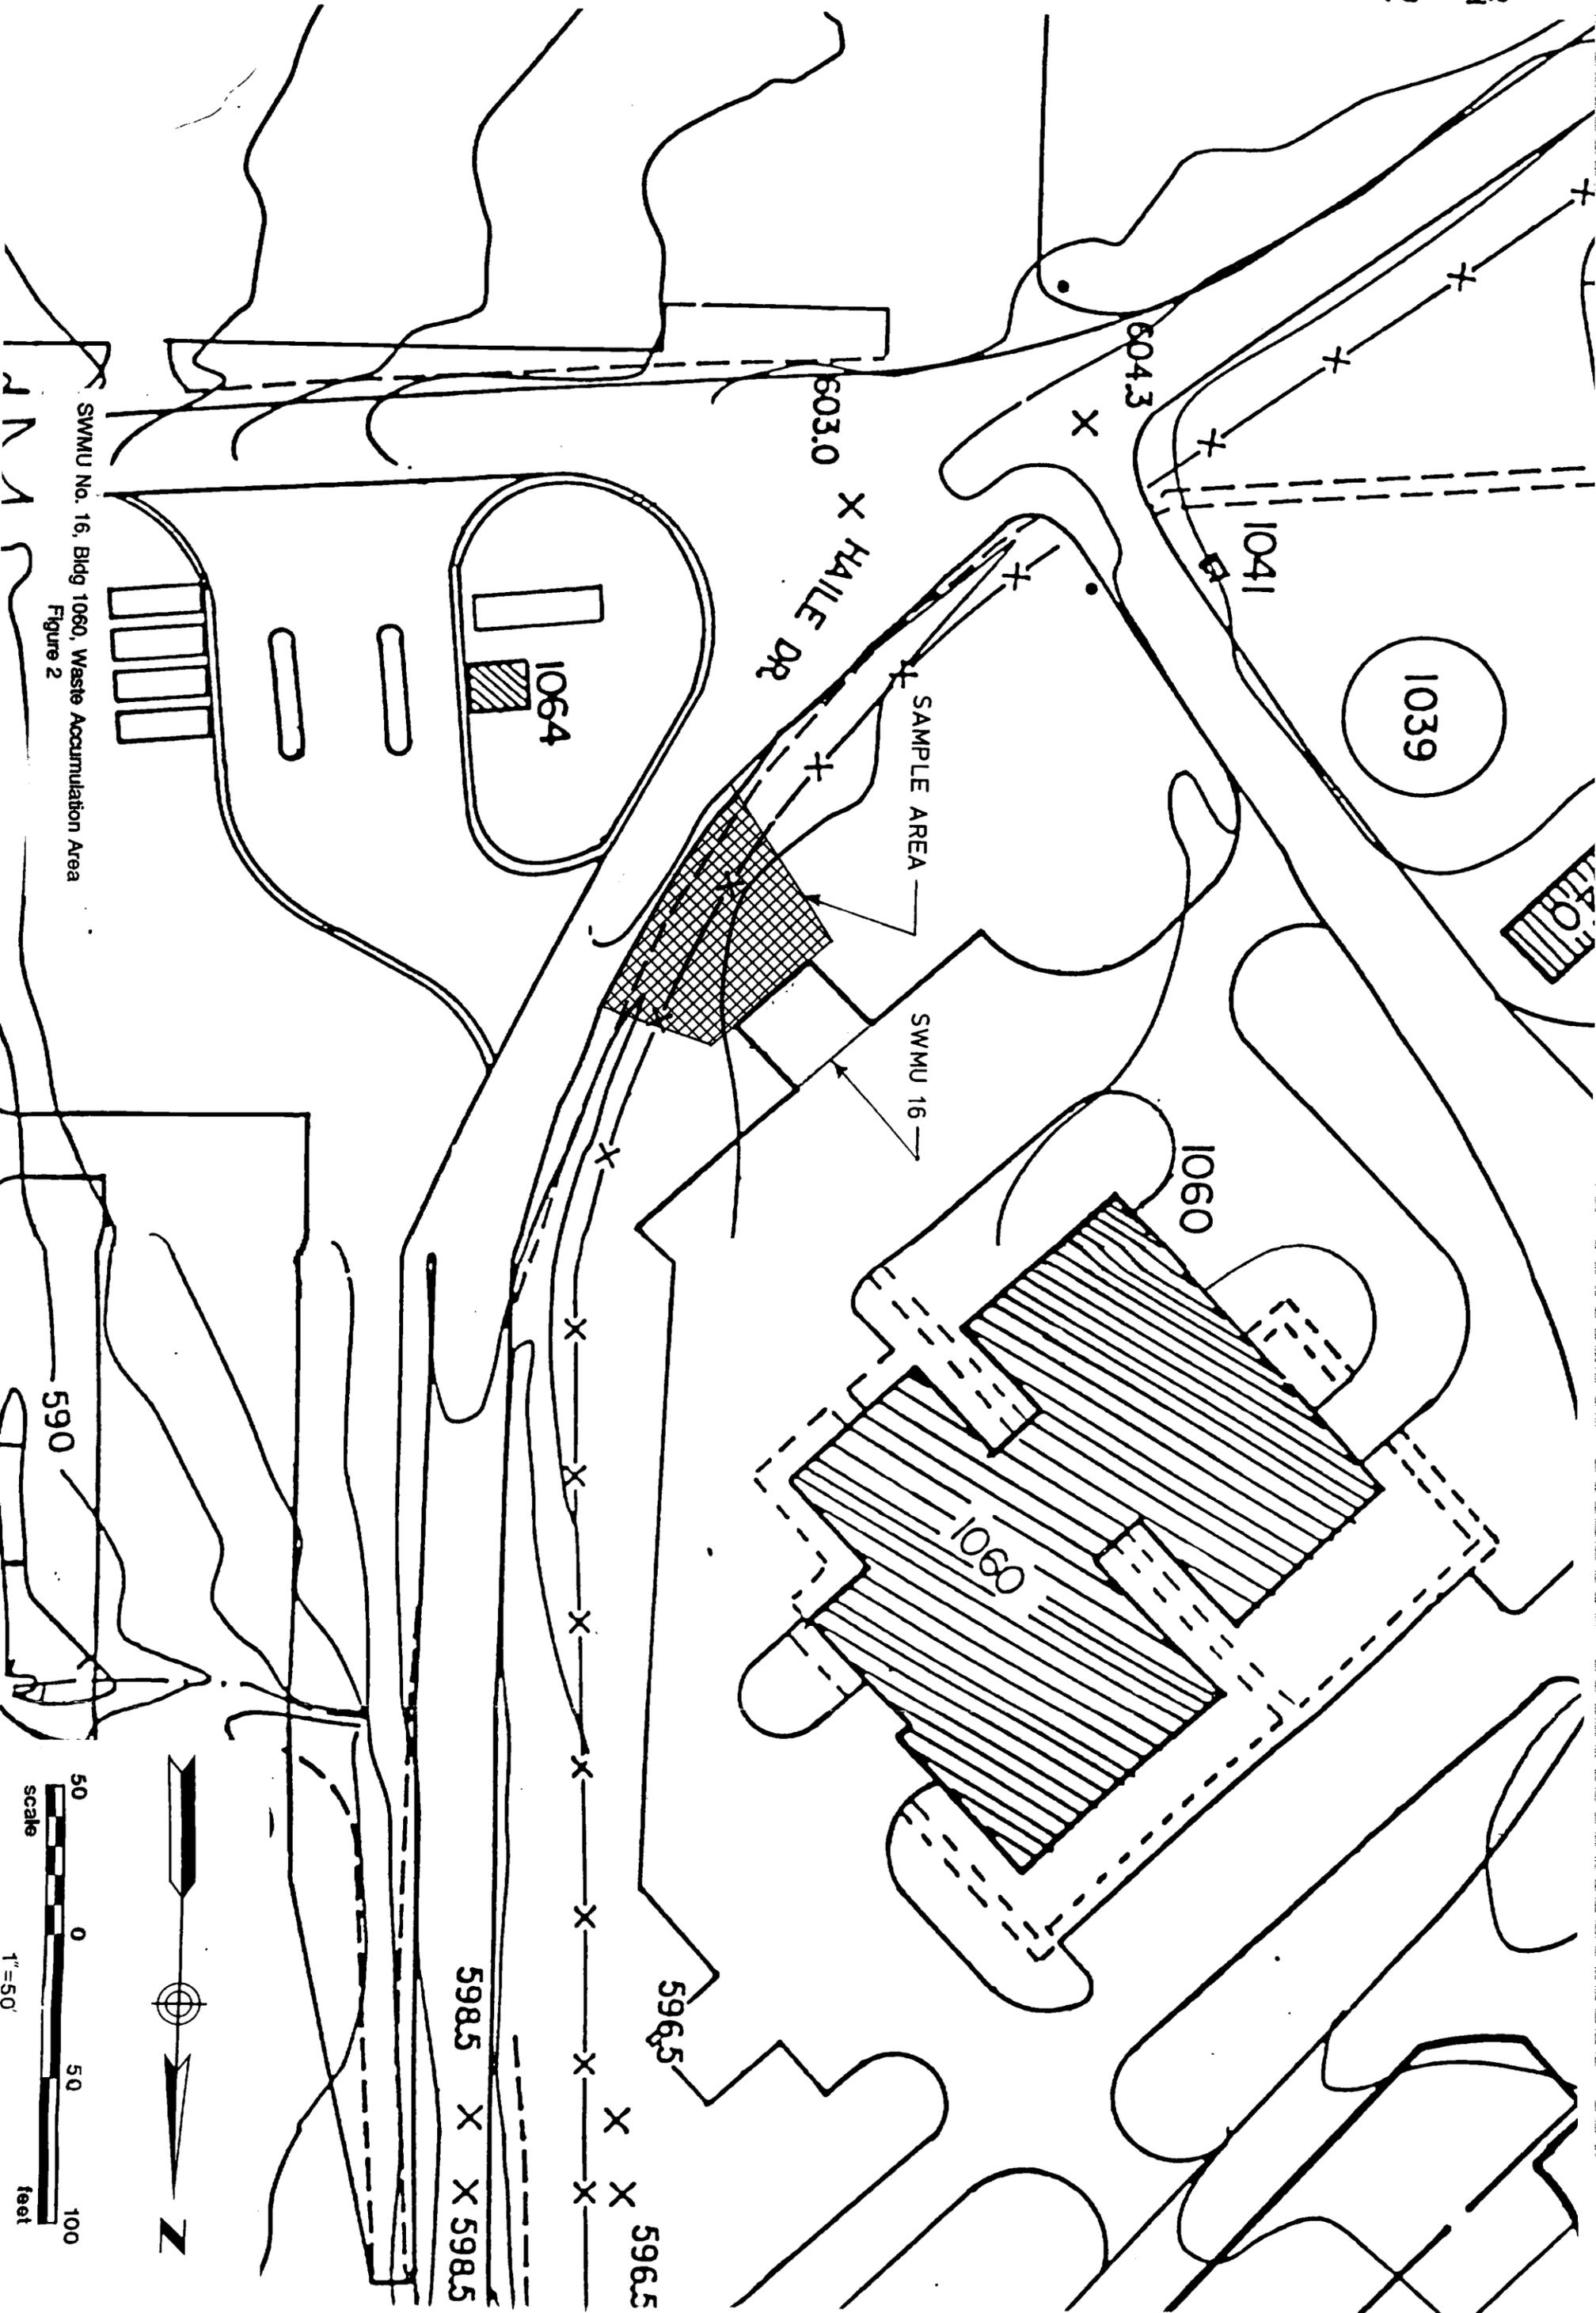
SWMU No. 16, Bldg 1060, Waste Accumulation Area
Figure 2

At the time of the visual site inspection in February 1989, a dark stain on the soil was observed at the corner of the unit. The stain extended to a shallow storm water drainage feature approximately 20 feet from the unit. Staining was also observed near the edge of the drums.

Samples will be taken in and around the area of the old stain to determine if any soil contamination exists. Samples will be analyzed for total petroleum hydrocarbons, purgeable halocarbons, and purgeable aromatic hydrocarbons. If any contamination is found, the affected soil will be removed, properly disposed of, and replaced; clearance samples will also be taken. There is no documented history of releases to groundwater, therefore, groundwater will not be sampled unless soil sample results indicate possible groundwater contamination. A detailed preliminary remedial action plan will be submitted at a later date.

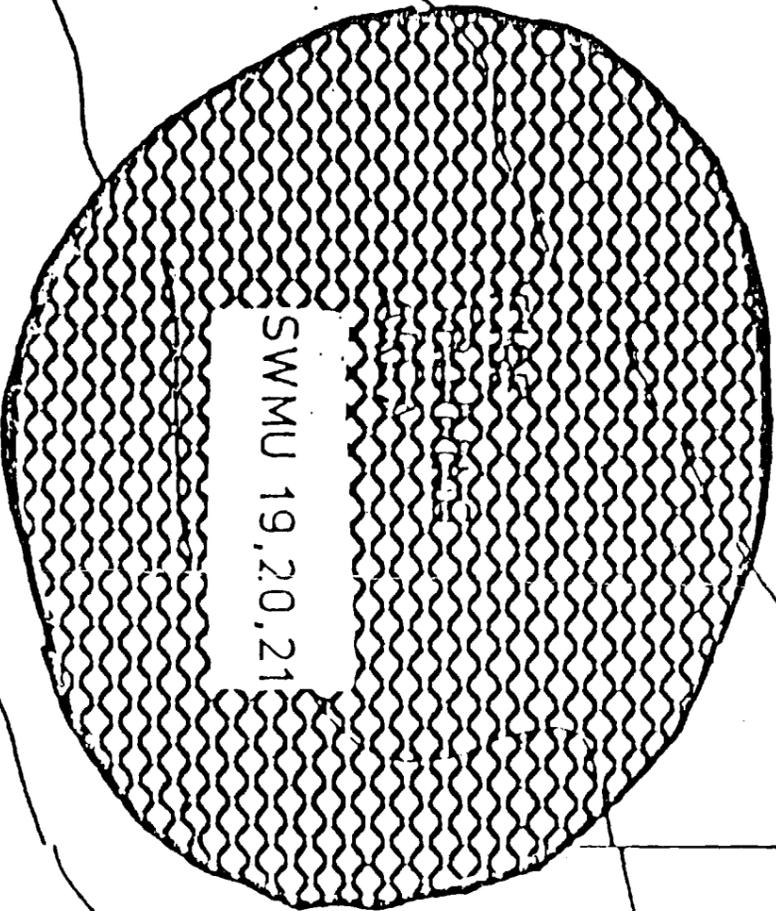
SWMU No. 19, Fire Training Area No. 2
 SWMU No. 20, Waste Fuel Storage Tank
 SWMU No. 21, Waste Oil Tank
 Figure 4

Split-spoon samples from five soil borings and two monitor wells were collected and visually examined for evidence of contamination. Samples were selected for analysis of moisture content, heavy metals, petroleum hydrocarbons, volatile organic compounds, and semivolatle organic compounds. Heavy metals were detected at the normal ranges, with the exception of selenium in three borings (30-70 mg/Kg) and lead (20 mg/Kg) in one boring. Petroleum hydrocarbons were encountered at five boreholes. Samples analyzed from various depths showed an apparent trend of decreasing petroleum hydrocarbon concentrations with depth until sand was encountered (19-21 feet below ground surface), where the highest values were detected. TCE was not detected in any of the soil samples. 1,1,2,2-tetrachloroethane was

estimated at 1,300 ug/Kg in one hole in the sand layer. Maximum concentrations for the same hole included 370 ug/Kg for benzene and 37,000 ug/Kg for total xylenes (both in the first two feet of soil) and 5,000 ug/Kg for ethylbenzene (in the sand layer). Semivolatile organic compounds were encountered in only two bore holes with the following results: 2-methylnaphthalene (11,000 ug/Kg), 4-methylphenol (4,200 ug/Kg), phenol (500 ug/Kg), naphthalene (4,700 ug/Kg). The trend in concentration for naphthalene and 2-methylnaphthalene was high concentrations at the surface, decreasing concentrations with depth and then maximum concentrations in the sand zone at 19 feet below land surface. Phenol and methylphenol concentrations were highest at the surface, but were not detected at depth.

Samples of ground water were collected and analyzed from the two wells in two sampling rounds. Parameters analyzed were water quality indicators, heavy metals, petroleum hydrocarbons, purgeable halocarbons, purgeable aromatics, and extractable priority pollutants. Total dissolved solids ranged from 380 mg/L to 590 mg/L during the two sampling rounds. Concentrations of several metals were above federal regulatory limits for drinking water. Arsenic (3 wells), lead (4 wells), cadmium (1 well) and chromium (4 wells) exceeded MCLs in the first round. In the second sampling round, arsenic (2 wells), lead (4 wells), cadmium (1 well) and chromium (4 wells) concentrations exceeded MCLs. MCLGs were exceeded by iron and manganese in every ground water sample from the site. The only detection of petroleum hydrocarbons was in one monitor well (0.60 mg/L) in first round. Purgeable halocarbons were detected in all samples except for the first round sample in one well. TCE concentrations in two wells, tetrachloroethene in one well and vinyl chloride in one well were above their respective MCLs. Several purgeable aromatic compounds were detected in low levels in the ground water, however, all values were below MCLs. 1,2-dichlorobenzene was found in low levels in one well in the second sampling round.

The Stage 2 investigations confirmed the findings of Stage 1. Although the site is upgradient of the Flightline Area TCE plume, ground water at some wells contained metals and volatile aromatic hydrocarbon compounds in concentrations exceeding federal MCLs. Petroleum hydrocarbons occur in the upper zone soil profile, both at and near the surface and at depths coinciding with a laterally continuous sand stratum and represent a potential source of ground water contamination downgradient of the site. Current plans are to remove and properly dispose the contaminated soil and construct a fully contained, concrete lined site for future fire department training. A remediation plan will be submitted concerning the contaminated soil. The remediation of the contaminated groundwater will be included with the flightline area preliminary action plan. This preliminary remediation action plan encompass SWMU No's, 19, Fire Department Training Area 2, 22, Landfill No. 4, SWMU No. 23, Landfill

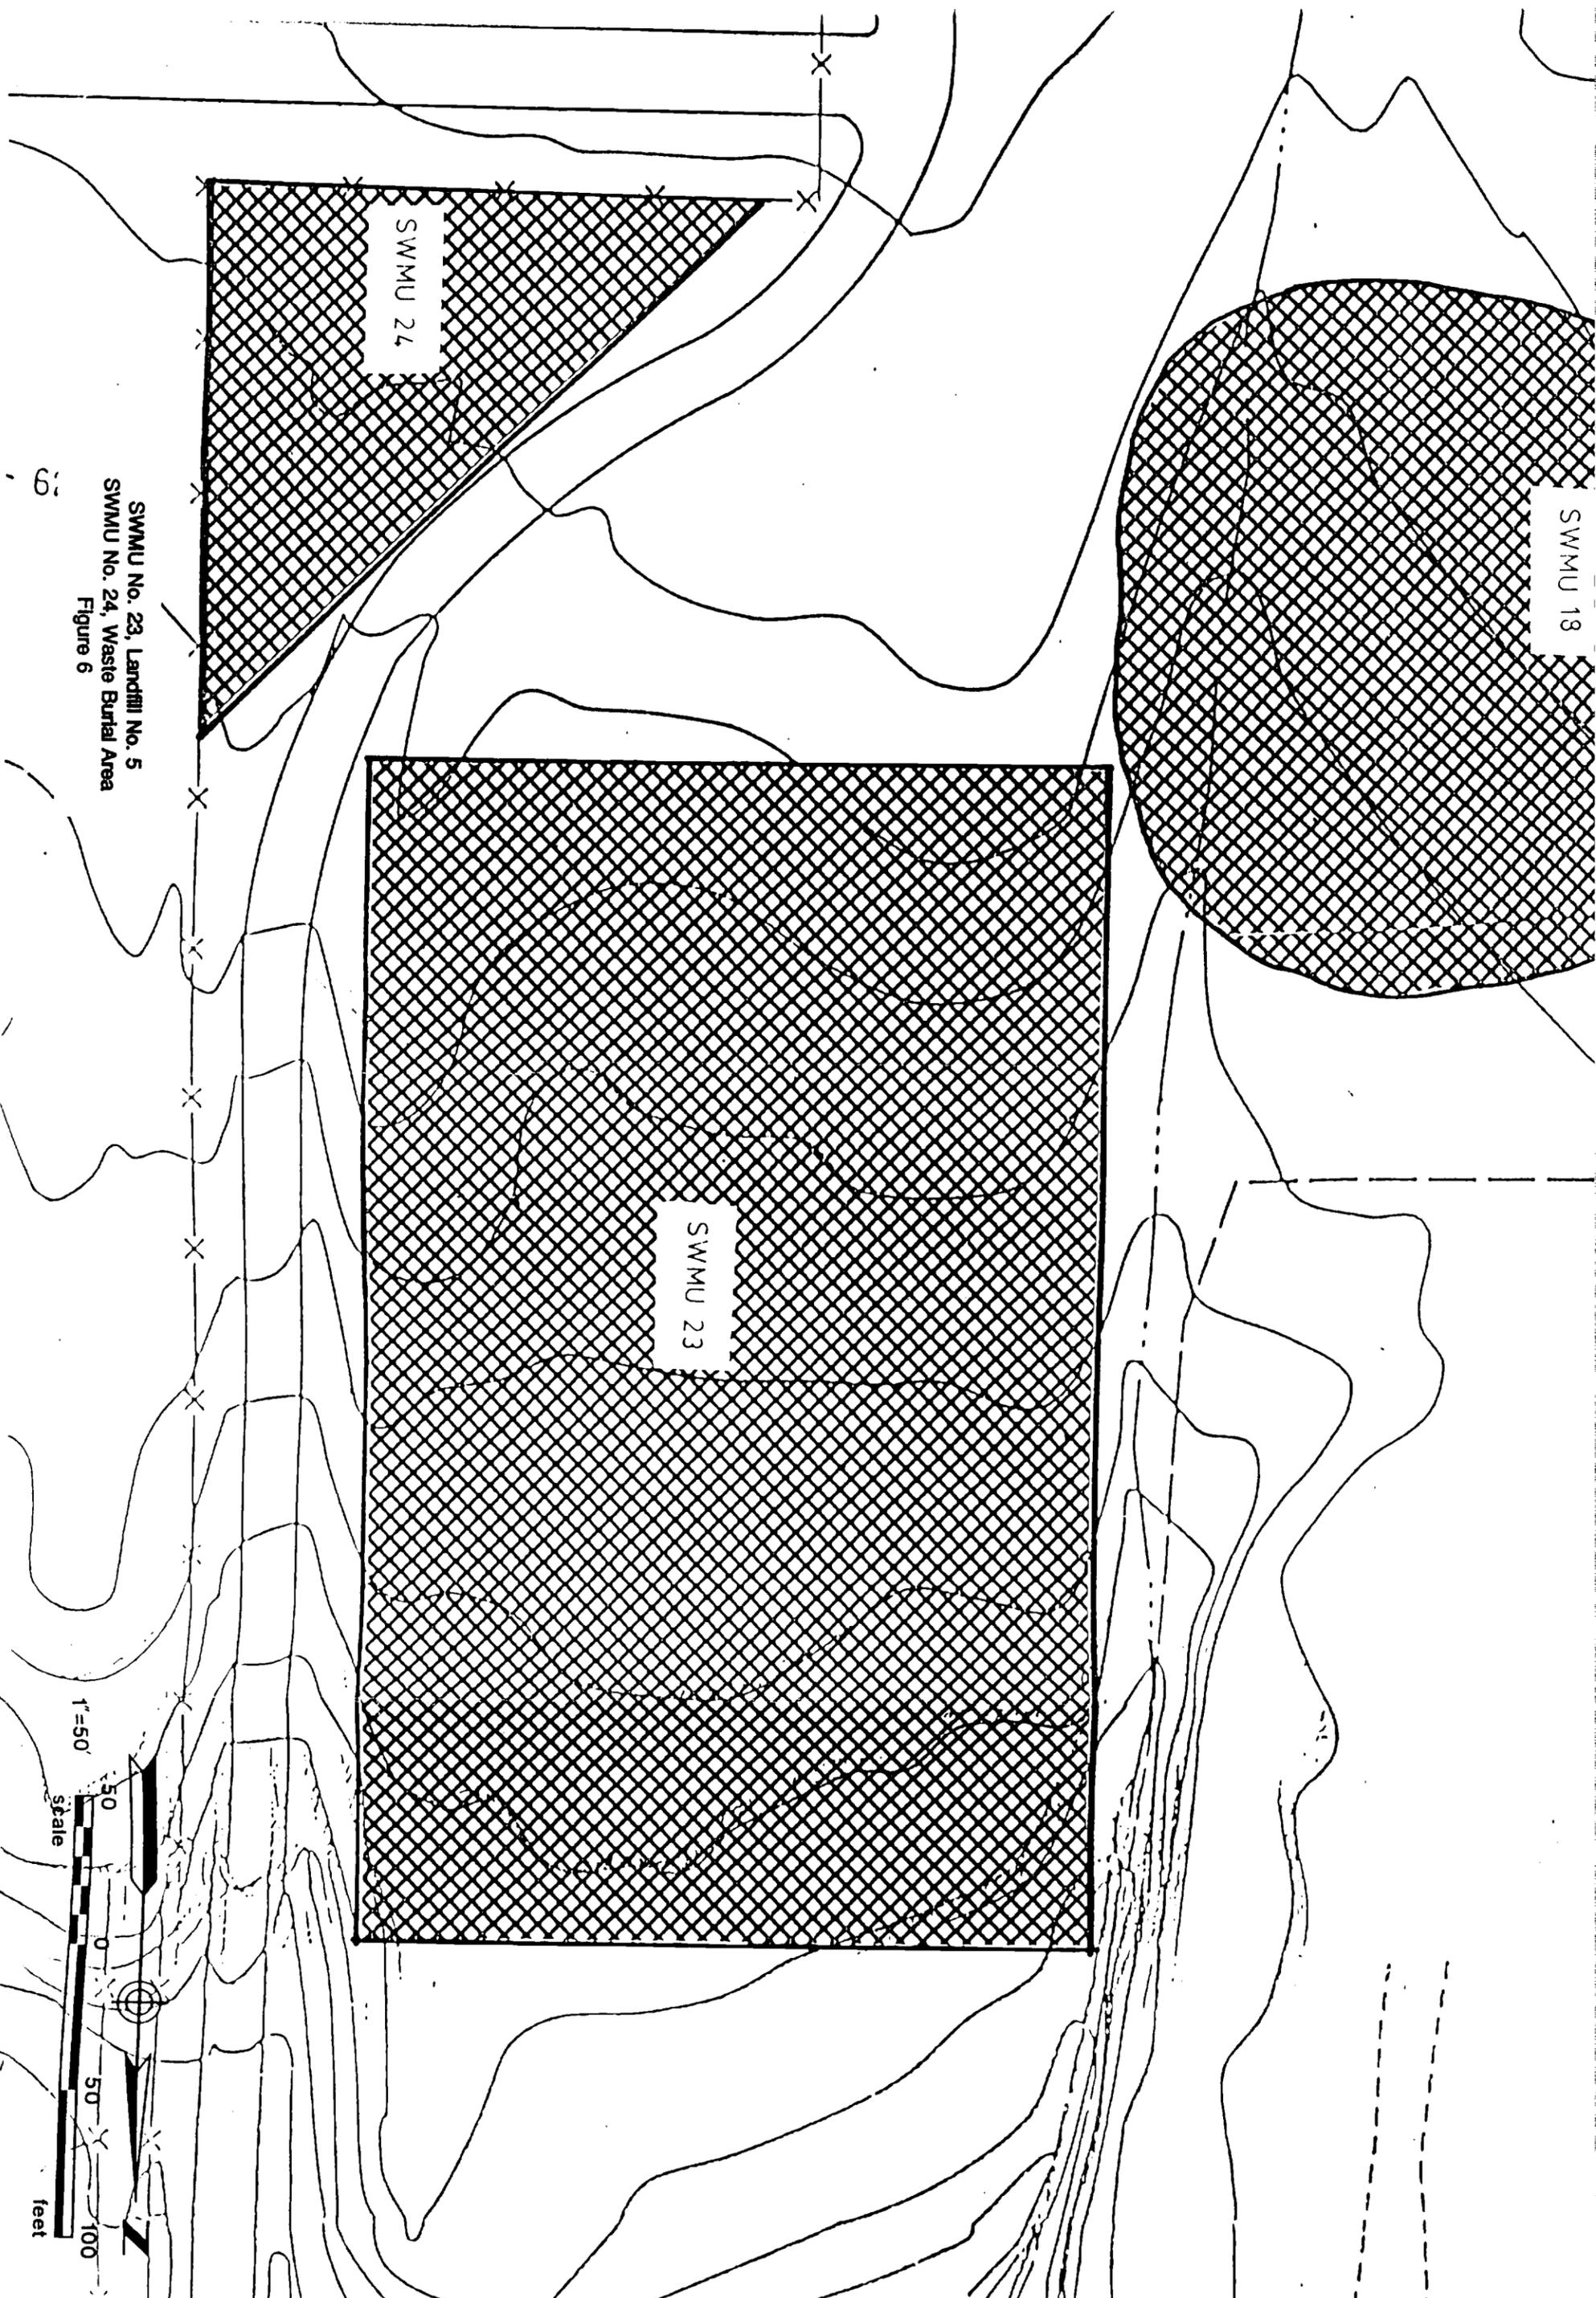
SWMU No. 23, Landfill No. 5
SWMU No. 24, Waste Burial Area
Figure 6

Split-spoon samples were collected in five of the borings and visually examined for evidence on contamination and samples were selected for analysis of moisture content, metals, oil and grease, volatile and semivolatile organic compounds. Heavy metals were detected at the normal ranges, with the exception of silver (1.8 mg/Kg) in two holes and arsenic (13 mg/Kg) in one hole. Oil and grease were only detected in one hole with a value of 15.0 mg/Kg. TCE was only revealed at one boring with a value of 22 ug/Kg. Soil samples contained toluene (up to 31 ug/Kg) in five of the seven samples analyzed. Several phthalate compounds and acetone were detected in the soil samples at the site. These compounds varied in concentrations of 100 to 800 ug/Kg.

Ground water was sampled for chemical analysis twice in 1988. Samples were analyzed for water quality indicators, heavy metals, purgeable halocarbons, purgeable aromatics, and extractable priority pollutants. The total dissolved solids (TDS) ranged from 380 mg/L to 770 mg/L. Except for two wells, there was a noticeable increase in TDS values between the two sampling events. Nitrate and sulfate concentrations increased in every well also. MCLs were exceeded in Round 1 for arsenic, lead and chromium. Round 2 results indicated that arsenic, lead, chromium and barium concentrations surpassed MCLs. Iron and manganese exceeded MCLGs during both sampling rounds. Purgeable halocarbons were detected in every monitor well at the site. The principal ground water contaminant is trichloroethene (TCE). TCE was detected in every sample from the monitor wells, except one. The TCE concentration ranged from 52 to 3,800 ug/L. 1,1,1-trichloroethane was detected (67 ug/L) in the first round at one well. Other purgeable halocarbons detected above MCL values included

vinyl chloride and trans-1,2-dichloroethene. The only detected purgeable aromatic was benzene, which was detected only in the first round and at one well. Water samples were analyzed for extractable priority pollutants and bis(2-ethylhexyl) phthalate was detected in low levels (5.2 ug/L).

Ground water samples were sampled for chemical analysis in two rounds of sampling. Samples were analyzed for water quality indicators, heavy metals, oil and grease, petroleum hydrocarbons, phenols, purgeable halocarbons, purgeable aromatics, organochlorine pesticides and herbicides. Total dissolved solids concentrations were fairly uniform through the two sampling rounds, ranging from 510 to 670 mg/L. Water samples were found to exceed MCLs for chromium at one well during both rounds of sampling. Chromium also exceeded MCLs at a second well during the first round and at a third well during the second round of sampling. Iron and manganese exceeded MCLGs at the three wells during both sampling rounds. Ground water analyses detected oil and grease in all three monitor wells in Round 1. Values ranged from 0.3 mg/L to 1 mg/L. However in Round 2, oil and grease were not detected at any of the wells. Petroleum hydrocarbons were detected (0.40 and 0.60 mg/L) in the first

round, however, no petroleum hydrocarbons were detected in the second round. Phenols were detected in the first round and confirmed by a second column analysis. Concentrations of 2,4-dinitrophenol, 2-chlorophenol, and 2-methyl,-4,6-dinitrophenol were detected in the first round, but not the second round of sampling. Trichloroethene (TCE) was detected in concentrations greater than the MCL in all ground water sampled at the site. Values ranged from 1,900 ug/L to 11,000 ug/L. Chloroethene was detected at 850 ug/L in one well in the first round, but was not detected in the second round. Purgeable aromatics pesticides nor herbicides were not detected in the ground water at the site.

A geophysical survey was conducted by Ecology and Environment, inc., in February 1991 to determine/confirm the presence of buried drums at the site. The survey confirmed the location of approximately 9 drums located near the surface. A sample of one of the drums indicated the contents of the drums to be TCE. An RCRA Facility Investigation/ Remediation plan for the removal of buried drums and a suspected Underground storage tank is being prepared and will be submitted to TWC on 7 May 1991. A preliminary remedial action plan addressing the ground water contamination will be submitted at a later date.

SWMU No. 23, as discussed previously with SWMU No. 22, appears to be best treated as a combined site with SWMU No's 22 and 24 in dealing with the problem of TCE in the ground water. A detailed preliminary remedial action plan for the combined site will be submitted at a later date.

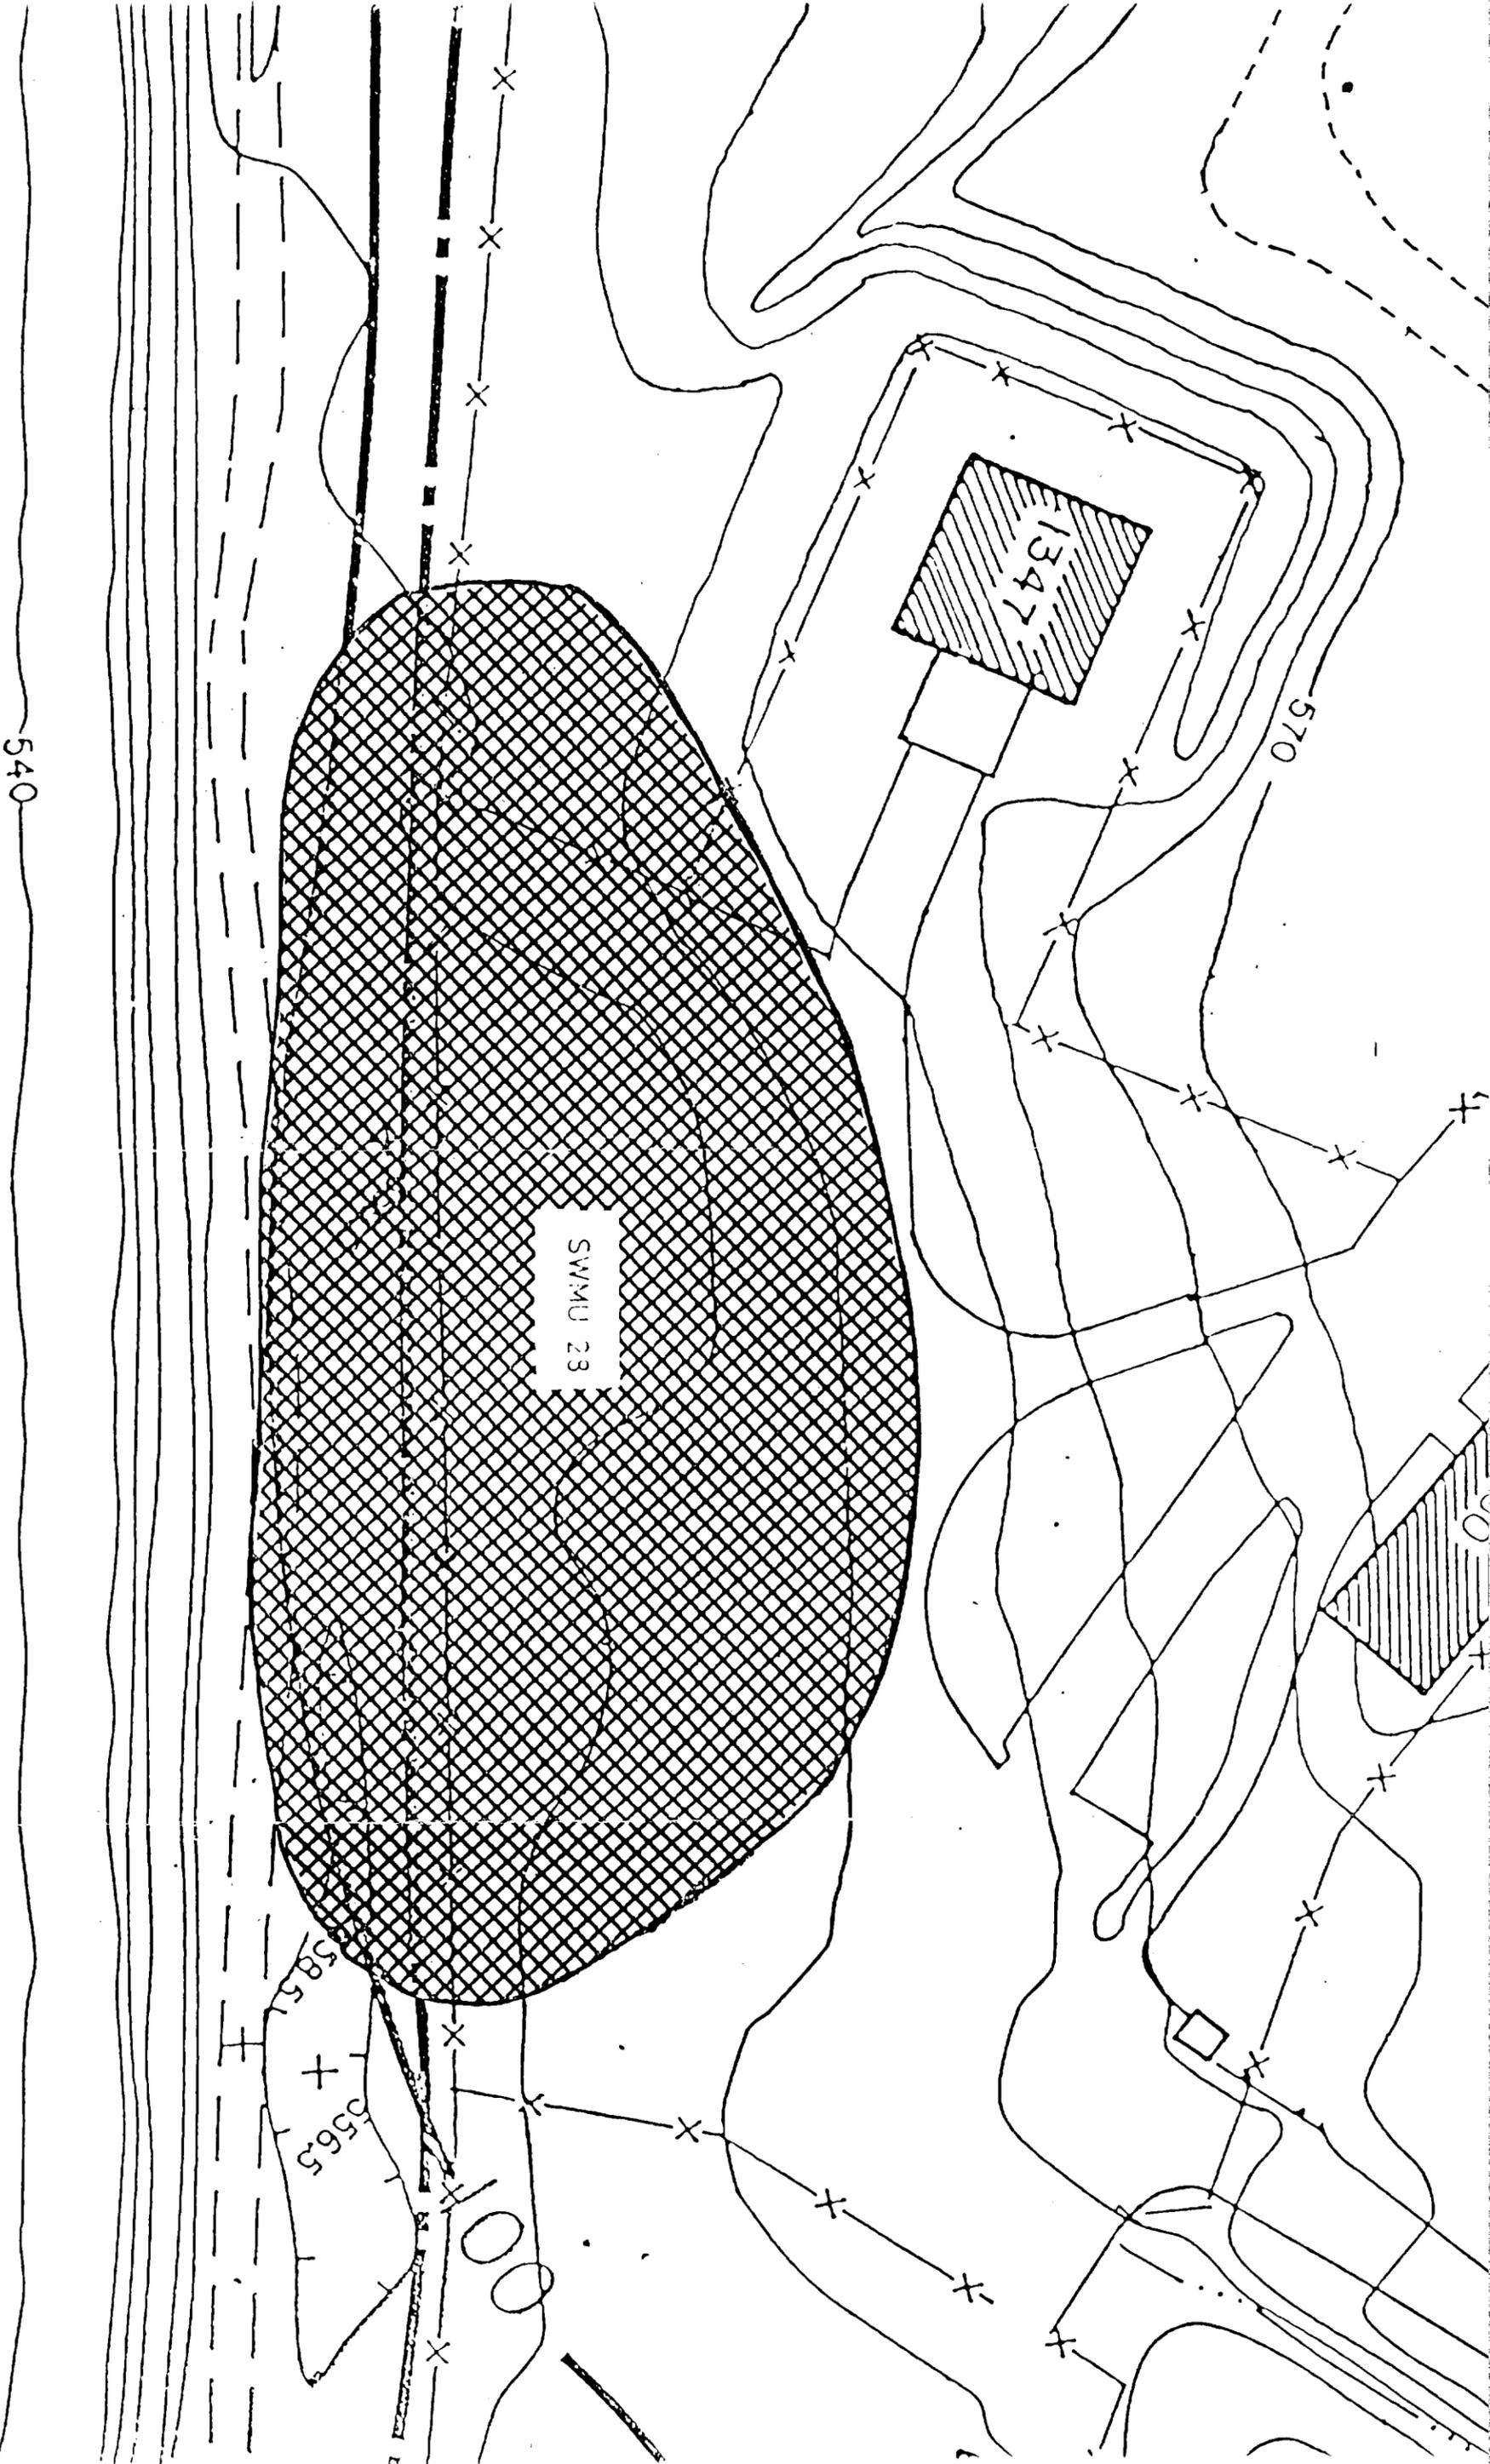
SWMU No. 28, Landfill No. 1
Figure 7

Soil samples from two wells were collected and analyzed for moisture content, heavy metals, oil and grease, volatile organic compounds, and semivolatile organic compounds. Heavy metals were compared with mean values of metal concentrations in U.S. soils and detected at above normal ranges for arsenic, cadmium and silver. Oil and grease were not detected. Toluene was detected in both wells sampled. Di-n-butylphthalate was confirmed in soil samples at both locations, with a maximum concentration of 380 ug/Kg.

Ground water was sampled for chemical analysis twice in 1988. Samples were analyzed for water quality indicators, heavy metals, oil and grease, purgeable halocarbons, purgeable aromatics, and extractable priority pollutants. Total dissolved solids concentrations for most samples were approximately 500 mg/L, with the exception of two wells in Round 1 with values of 1,100 mg/L and 1,300 mg/L. Sulfate concentrations that exceeded recommended standards were detected in one well for both rounds (460 mg/L and 360 mg/L, respectively). Water samples were found to exceed MCLs for arsenic, barium, cadmium, chromium, lead and selenium. Iron and manganese exceeded MCLGs during both sampling rounds for all wells. Other MCLGs that were surpassed are lead (one well) and cadmium (two wells). Oil and grease were found in concentrations less than 1 mg/L in ground water samples in the first round, from four wells, however, no detectable concentrations of oil and grease were detected in the second round. Trichloroethene exceeded the MCLGs in two wells (0.70 ug/L and 0.30 ug/L) and vinyl chloride was detected in one well with

a value of 0.40 ug/L which also exceeded the MCLGs. Toluene was detected during both sampling rounds in five wells with a maximum value of 26 ug/L. The only other purgeable aromatic compound detected was chlorobenzene during both sampling rounds at one well. Bis(2-ethylhexyl)phthalate was detected in two wells and di-n-butylphthalate was found in the second round of one well. 26

The soil investigation of this area did not indicate the presence of contaminants or waste materials. The Stage 1 study provided inconclusive evidence of disposal activities at this site. Based on the subsurface investigations and chemical analysis of Stage 2, the site does not appear to be a source of contaminants in the subsurface. Some metals concentrations above MCLs were detected in ground water and should continue to be monitored. Recommended monitoring parameters should include volatile halogenated organic compounds, metals, and general water quality parameters. Results of Stage 2 investigation show concentrations of metals in several downgradient wells in excess of the federal MCLs. No other contaminants were detected in soil or ground water samples at the site. Continuation of collecting and analyzing the ground water from the existing well network is recommended. Samples should be analyzed for volatile organic compounds, metals, and general water quality parameters. A detailed preliminary remediation action plan will be submitted at a later date.
