**NAVAL AIR STATION
FORT WORTH JRB
CARSWELL FIELD
TEXAS**

RCRA Permit Part B Number HW50289

SUMMARY OF PERMIT SITES

Prepared By
U.S. Army Corps Of Engineers
Fort Worth District

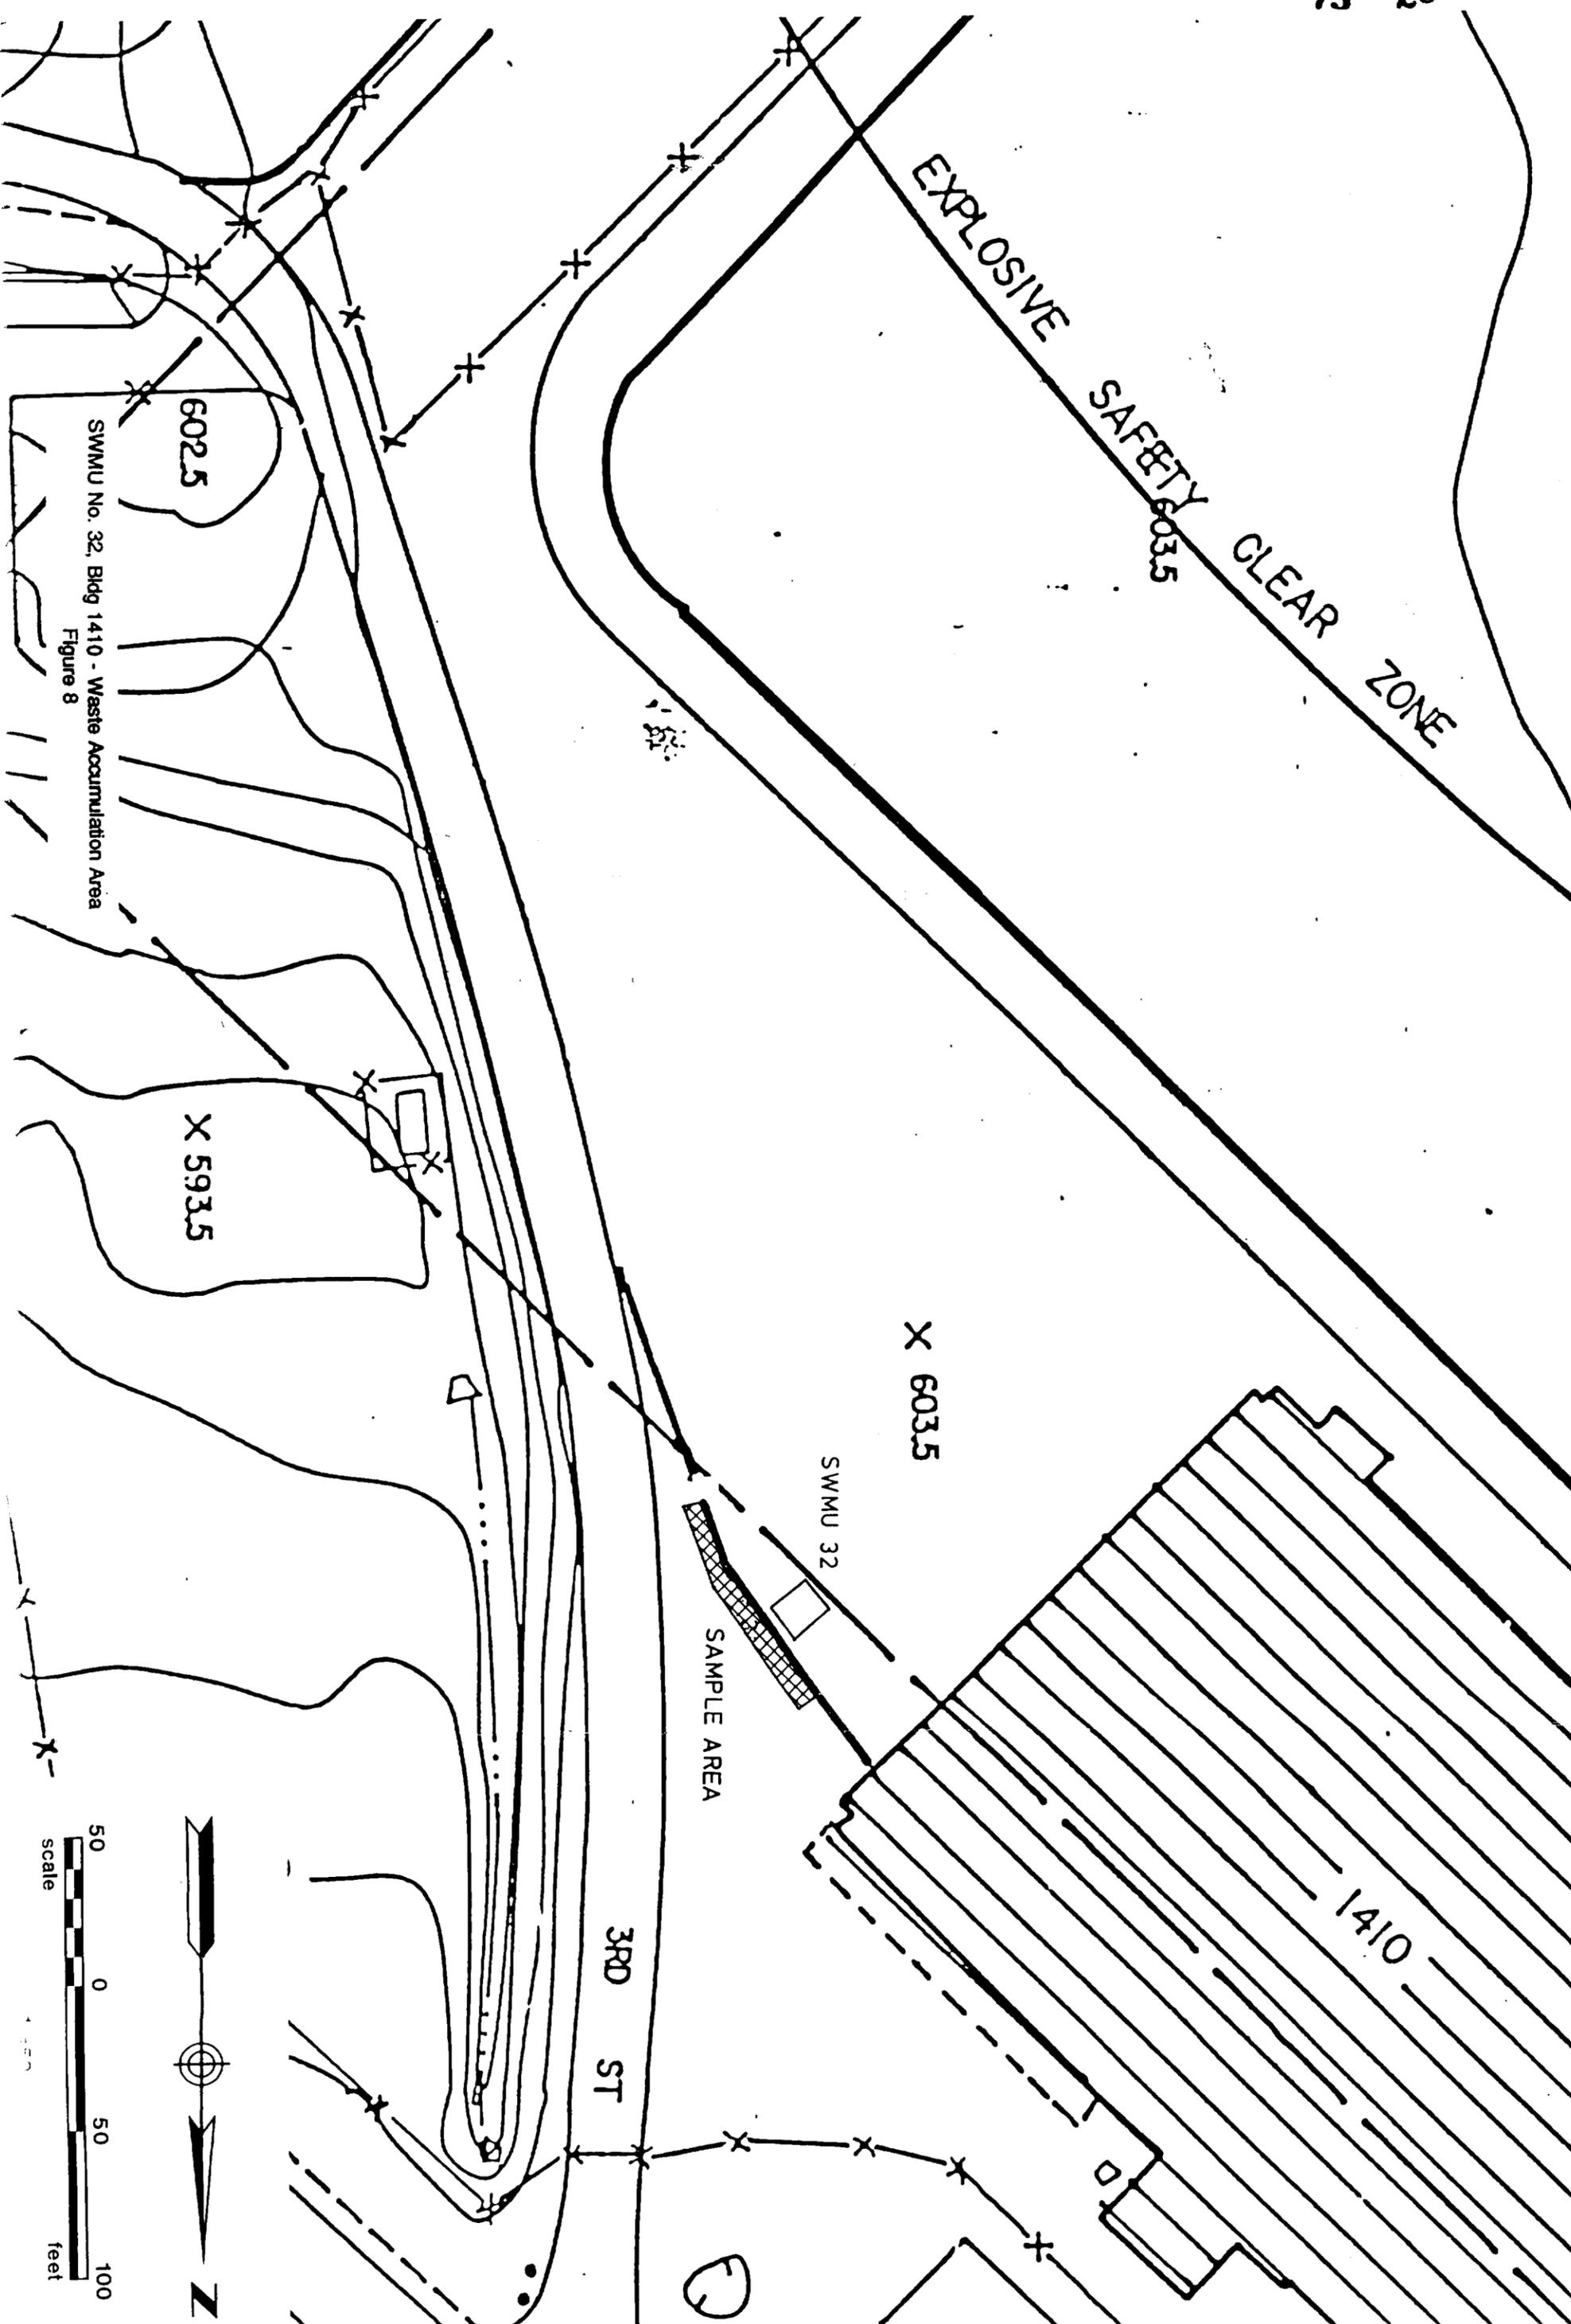
SWMU No. 32, Bldg 1410 - Waste Accumulation Area
Figure 8

There is no documented history of releases for this unit, but during the visual site inspection conducted in February 1989, the concrete within, and to some extent outside the sand bags, was stained with oily material that had either leaked from a drum or been spilled at this unit.

Soil samples will be taken to accurately define the area and depth of contamination that requires clean-up. Samples will be analyzed for Total Petroleum Hydrocarbons, BTEX, and TCLP for lead and chromium. Upon completion of the sampling, the contaminated soil will be removed, properly disposed of and replaced; clearance samples will also be taken. There is no documented history of releases to ground water; therefore, groundwater will not be sampled unless soil sample results indicate possible groundwater contamination. A detailed preliminary action plan will be submitted at a later date.

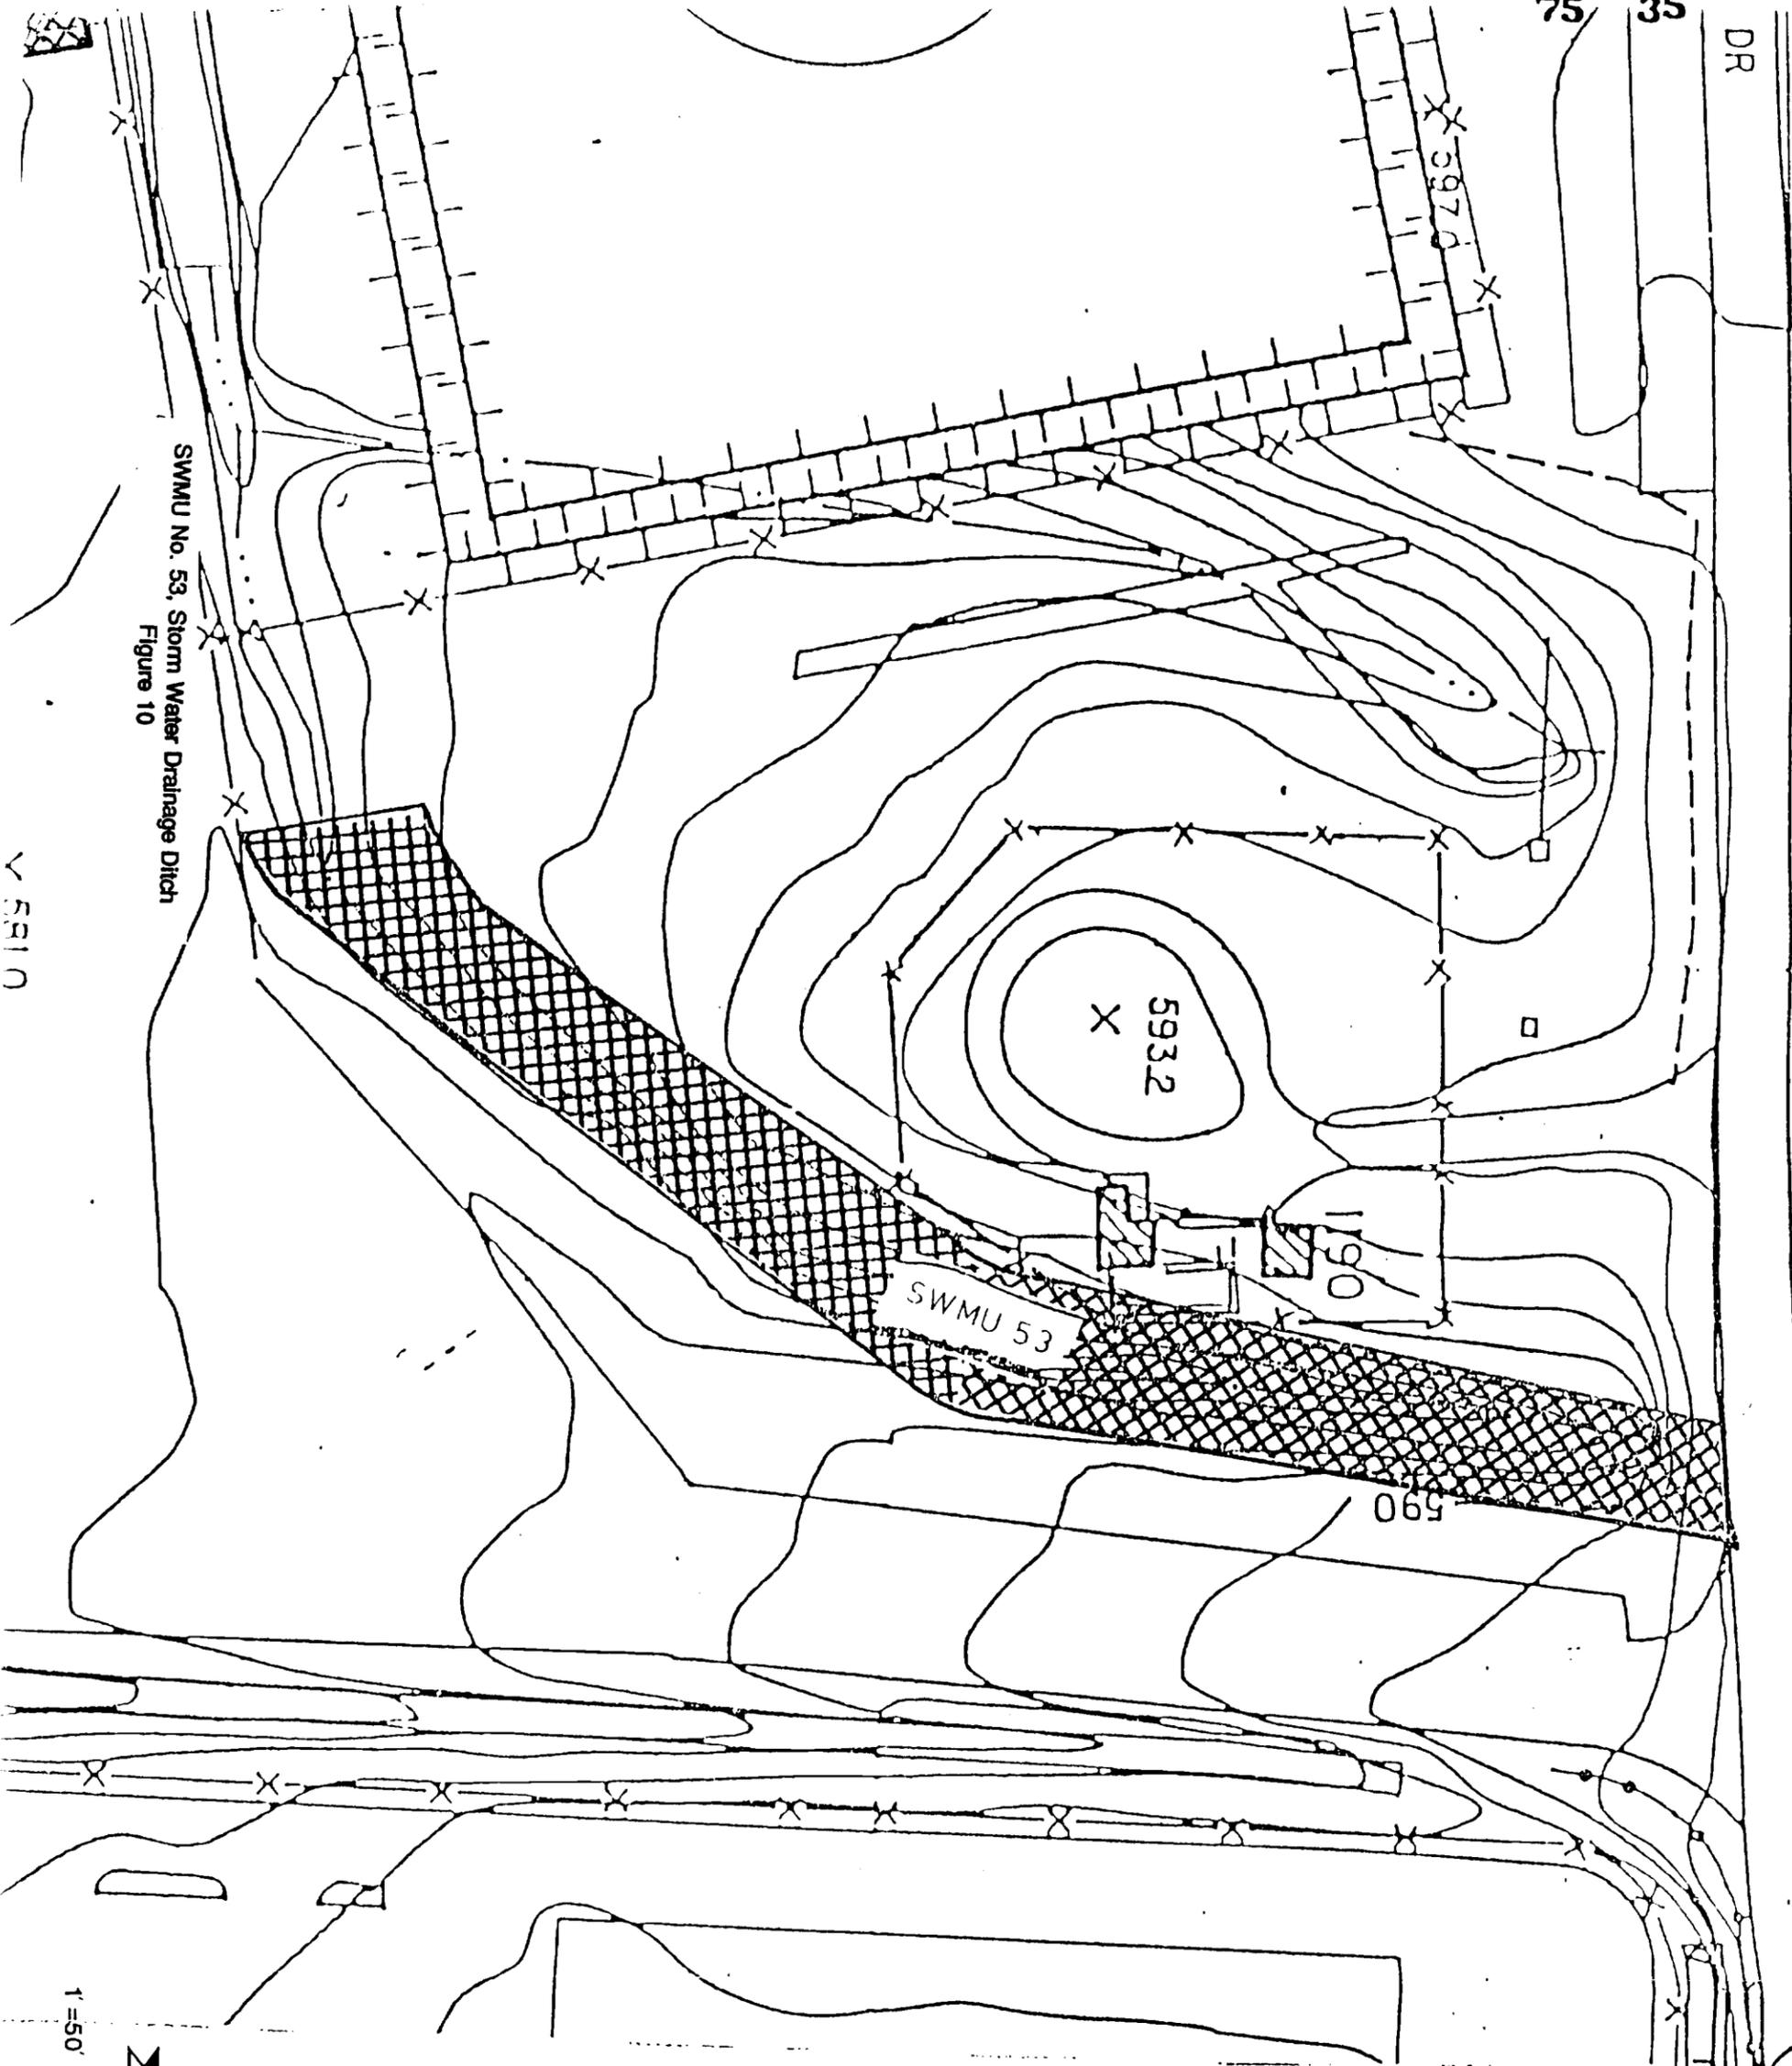
SWMU No. 53, Storm Water Drainage Ditch
Figure 10

Surface soil samples were collected in two rounds approximately one month apart. Soils were tested for moisture content, heavy metals, petroleum hydrocarbons, volatile organic compounds and semivolatile organic compounds. Cadmium, lead and selenium were above normal ranges in most samples analyzed. Arsenic was detected at elevated levels during the first round of sampling in four of the five locations. However, arsenic was not detected in any samples from the second round of samples. Petroleum hydrocarbons were detected in every soil sample from the site. The highest values detected were 1,320 mg/Kg in the first round and 3,500 mg/Kg in the second round. The lowest concentration of petroleum hydrocarbons was in the first round with a value of 34 mg/Kg near the upstream limit of the ditch.

Benzene, ethylbenzene, toluene, and total xylenes were the volatile organic compounds detected in most samples. Benzene concentrations decreased between the first and second rounds and were generally less than 10 ug/Kg. Ethylbenzene was usually estimated at values below detection limits, with the exception of a concentration of 750 ug/Kg in the first round at one location. Toluene was found in all soil samples in concentrations ranging from 8.3 ug/Kg to 3,000 ug/Kg. Total xylenes were detected in every soil sample, with the exception of one location in the second round. There were numerous detections of semivolatile organic compounds at the site. In addition, there was an apparent trend between sampling events of decreasing concentrations at the upgradient location, while all other locations show increasing concentrations of semivolatiles.

Stage 1 and 2 findings confirm the presence of petroleum hydrocarbon compounds and other organic compounds in the sediment of the drainage ditch. Trends of increasing or decreasing concentrations between sampling rounds and at different locations in the ditch may be attributed to conditions of variable stream flow, possible pooling or trapping of contaminants in some segments of the ditch and intermittent discharges of fuels or runoff that would influence the distribution of contaminants.

Prior to formal corrective action, the ditch should be dredged and contaminated soil and sediment removed. This action will remove a possible source of future contamination. The recommended corrective action for SWMU No. 53 is to concrete line the ditch, similar to the lined portion of the ditch as it flows through the POL Tank Farm. A detailed remedial action plan will be submitted at a later date.

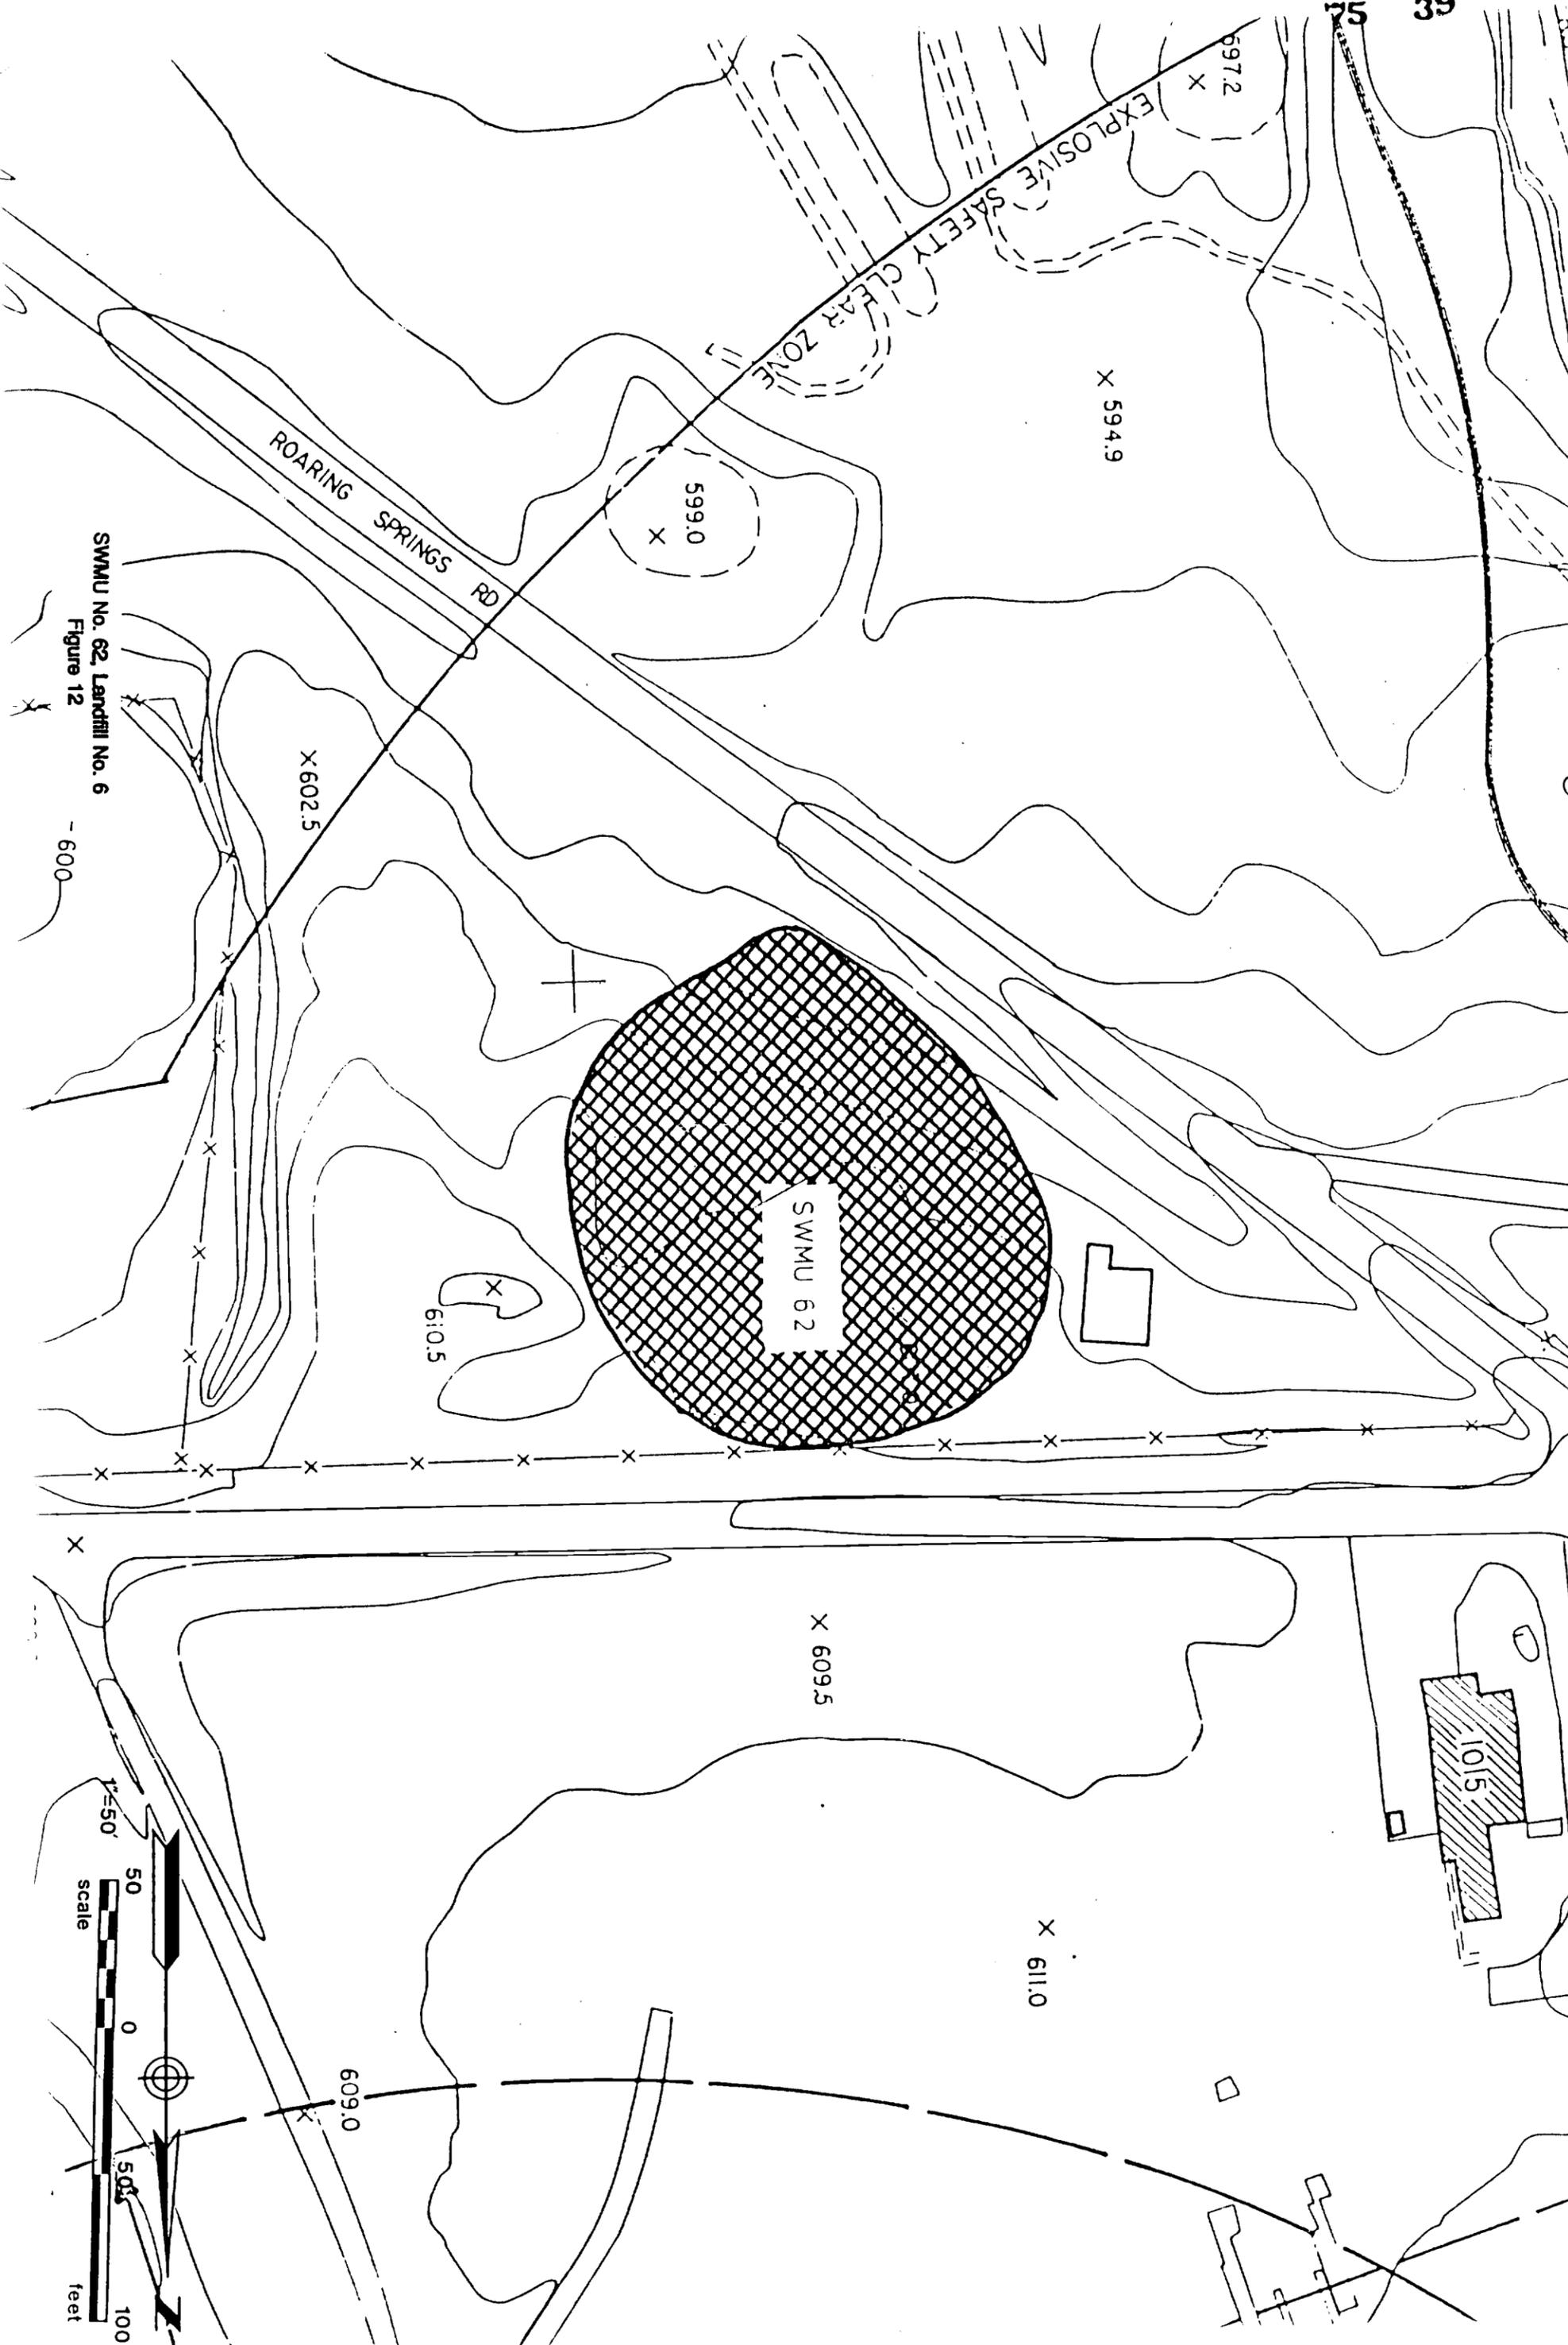
SWMU No. 62, Landfill No. 6
Figure 12

Landfill No. 6 was originally a gravel pit used for base construction activities. After the gravel had been removed, the site was used for the burial of construction rubble, trees, and miscellaneous trash. Several drums of hydraulic fluid were reportedly buried in a centrally located pit used for the collection of groundwater. Due to the proximity of SWMU No. 62 to the flightline shop, small quantities of other hazardous materials are also suspected to being buried there.

Monitoring wells will be installed to determine if contamination exists. If contamination is found then a thorough site investigation will be performed to determine extent of contamination and possible remediation alternatives. A detailed work plan will be submitted at a later date.

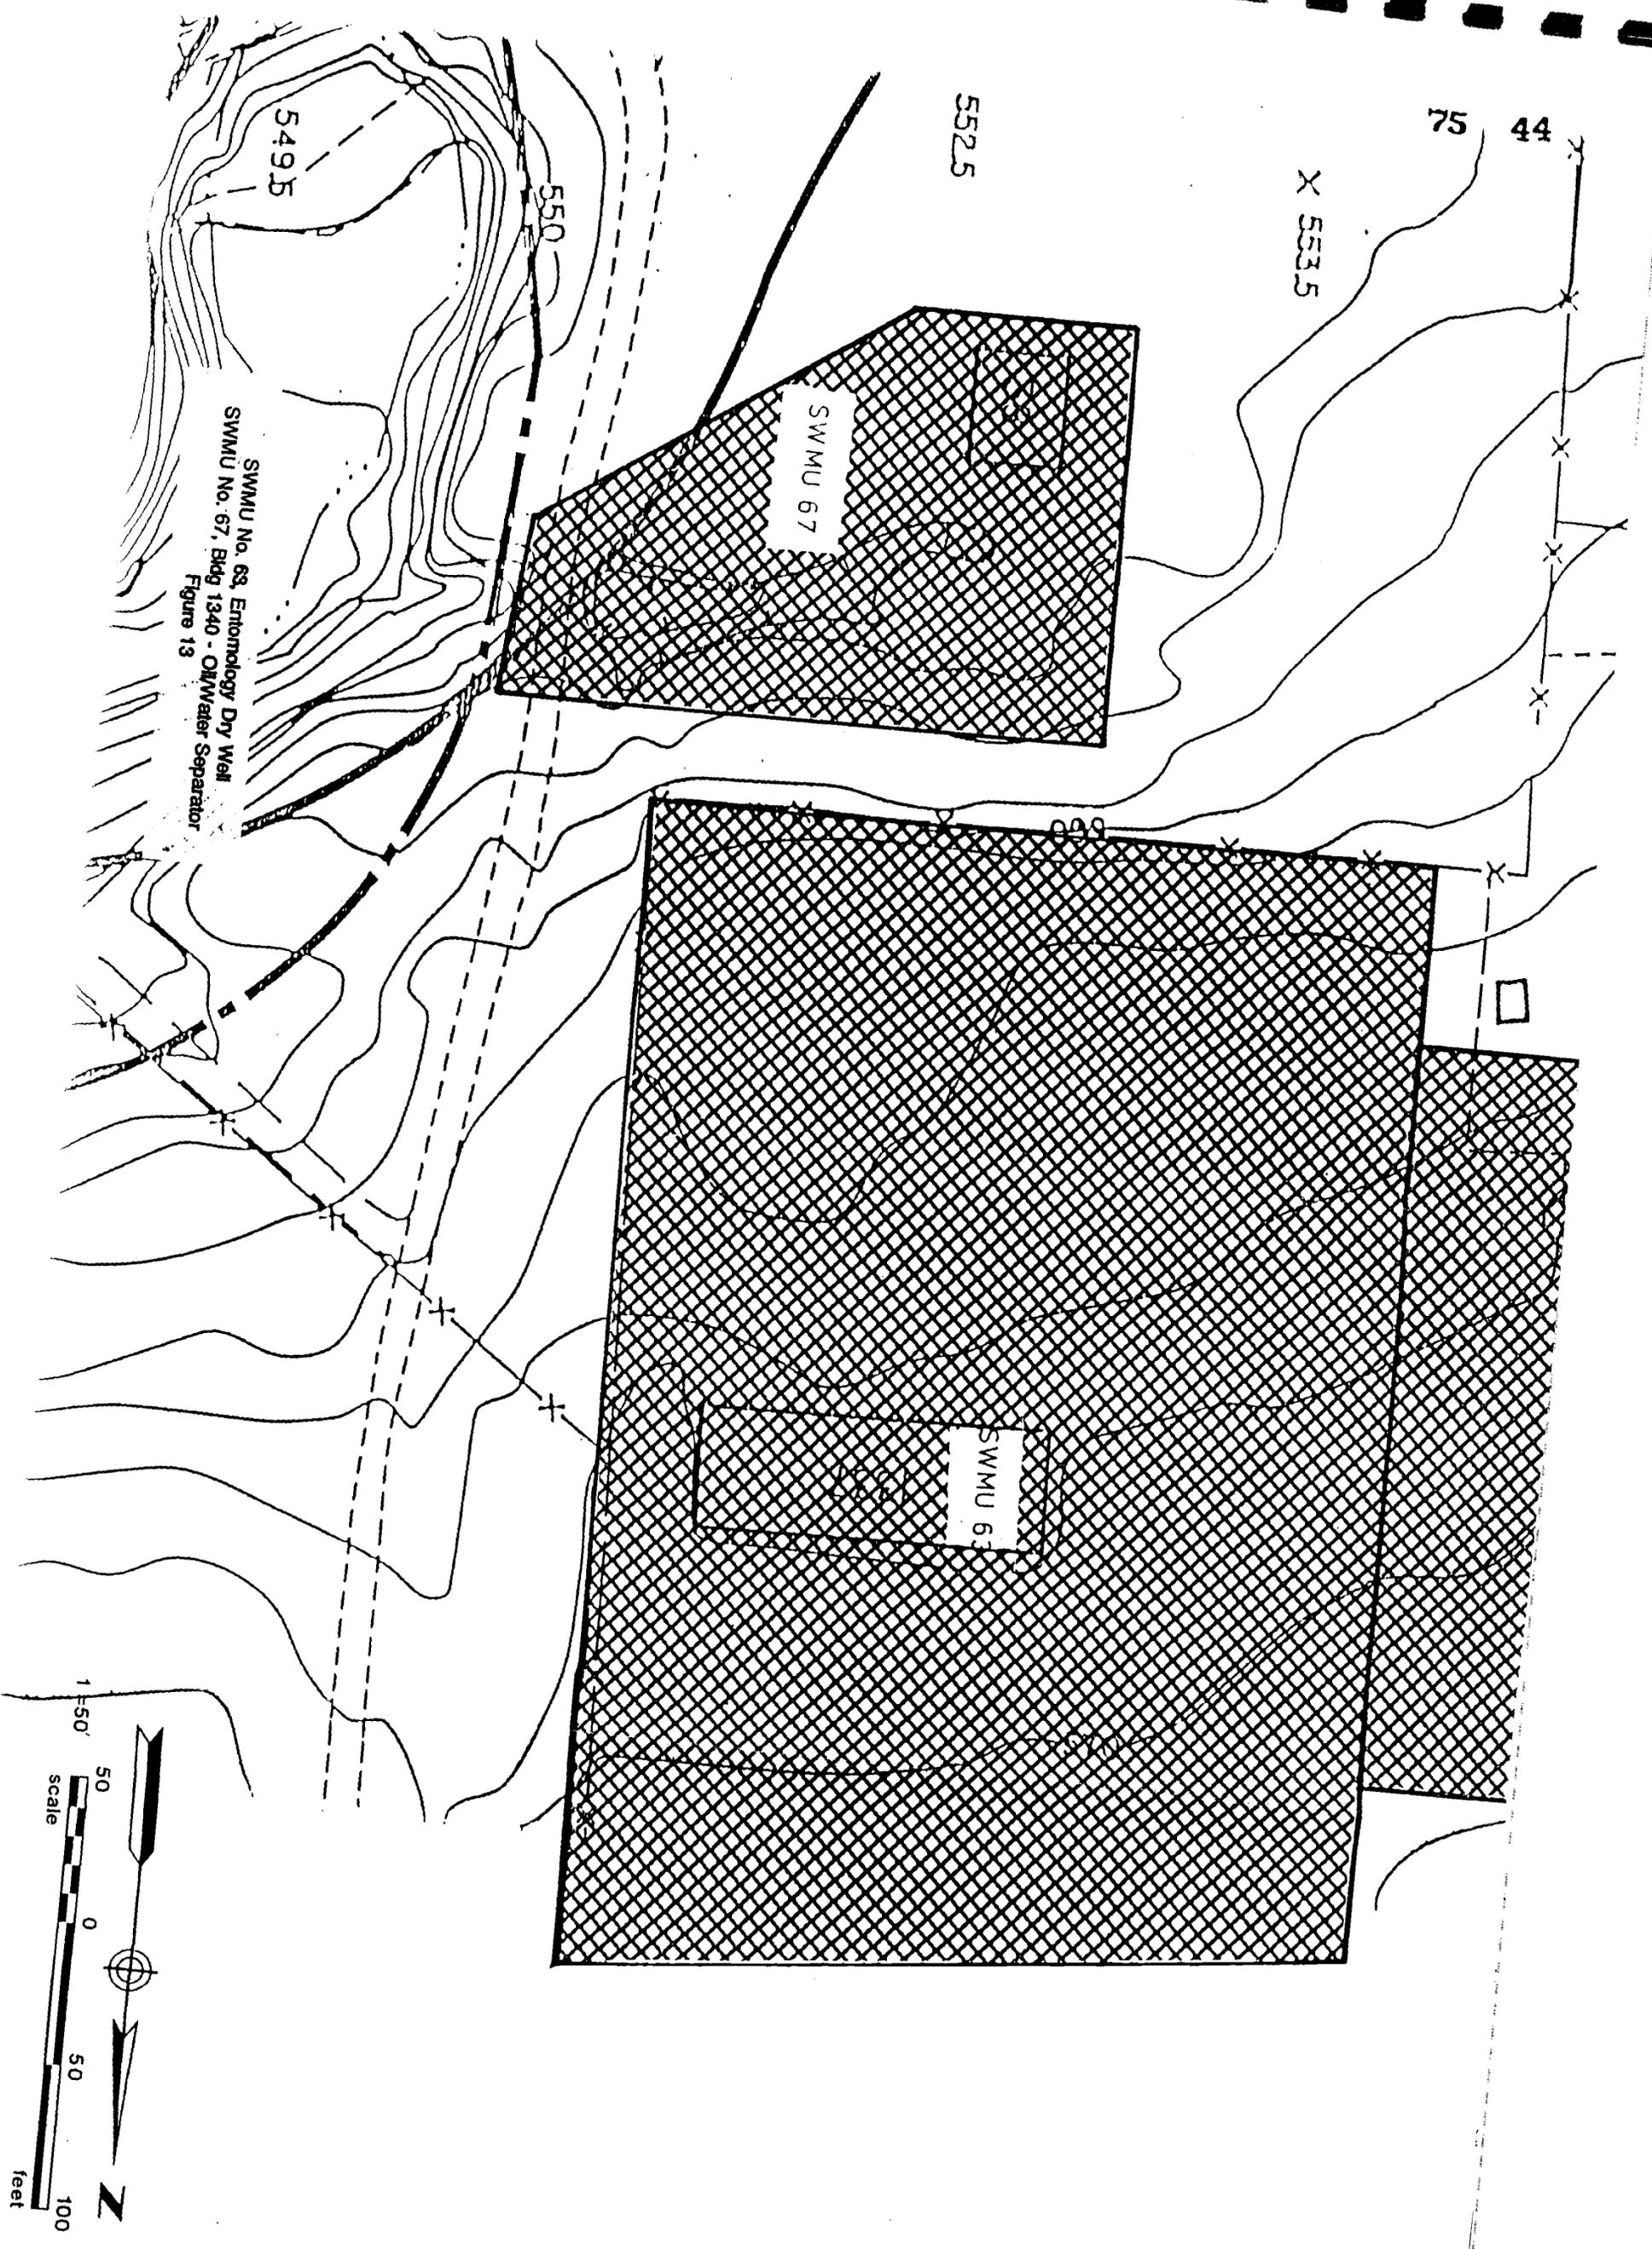
SWMU No. 68, Entomology Dry Well
SWMU No. 67, Bldg 1340 - Oil/Water Separator
Figure 13

Soil samples were collected from four hand augered borings along the Unnamed Stream during Stage 1. All samples had values of selenium (9.1-24 mg/Kg) higher than the range of normally found in soils. The lead content of the shallow soil samples (18-20 mg/Kg) is at the high end of the normal range and higher than the lead content of most other soils analyzed at Carswell AFB. Oil and grease values were found to be high in almost all of the soil samples analyzed (27-240 mg/Kg). The concentrations were highest closest to the oil water separator and generally decrease with the distance downstream.

Results of the Stage 2 investigation indicates that the Unnamed Stream is receiving quantities of petroleum hydrocarbons. The decreasing concentrations of these contaminants with increasing distance downstream can be attributed to volatilization losses of these compounds to the atmosphere. Therefore, all contaminants in the stream can be attributed directly to the oil/water separator.

It is recommended that the stream should continue to be monitored and additional wells be installed in the vicinity of the old gasoline station. These wells should be screened in the upper zone, with water quality samples collected and analyzed for volatile organic compounds, petroleum hydrocarbons, metals, and general water quality parameters. A detailed work plan will be submitted at a later date.

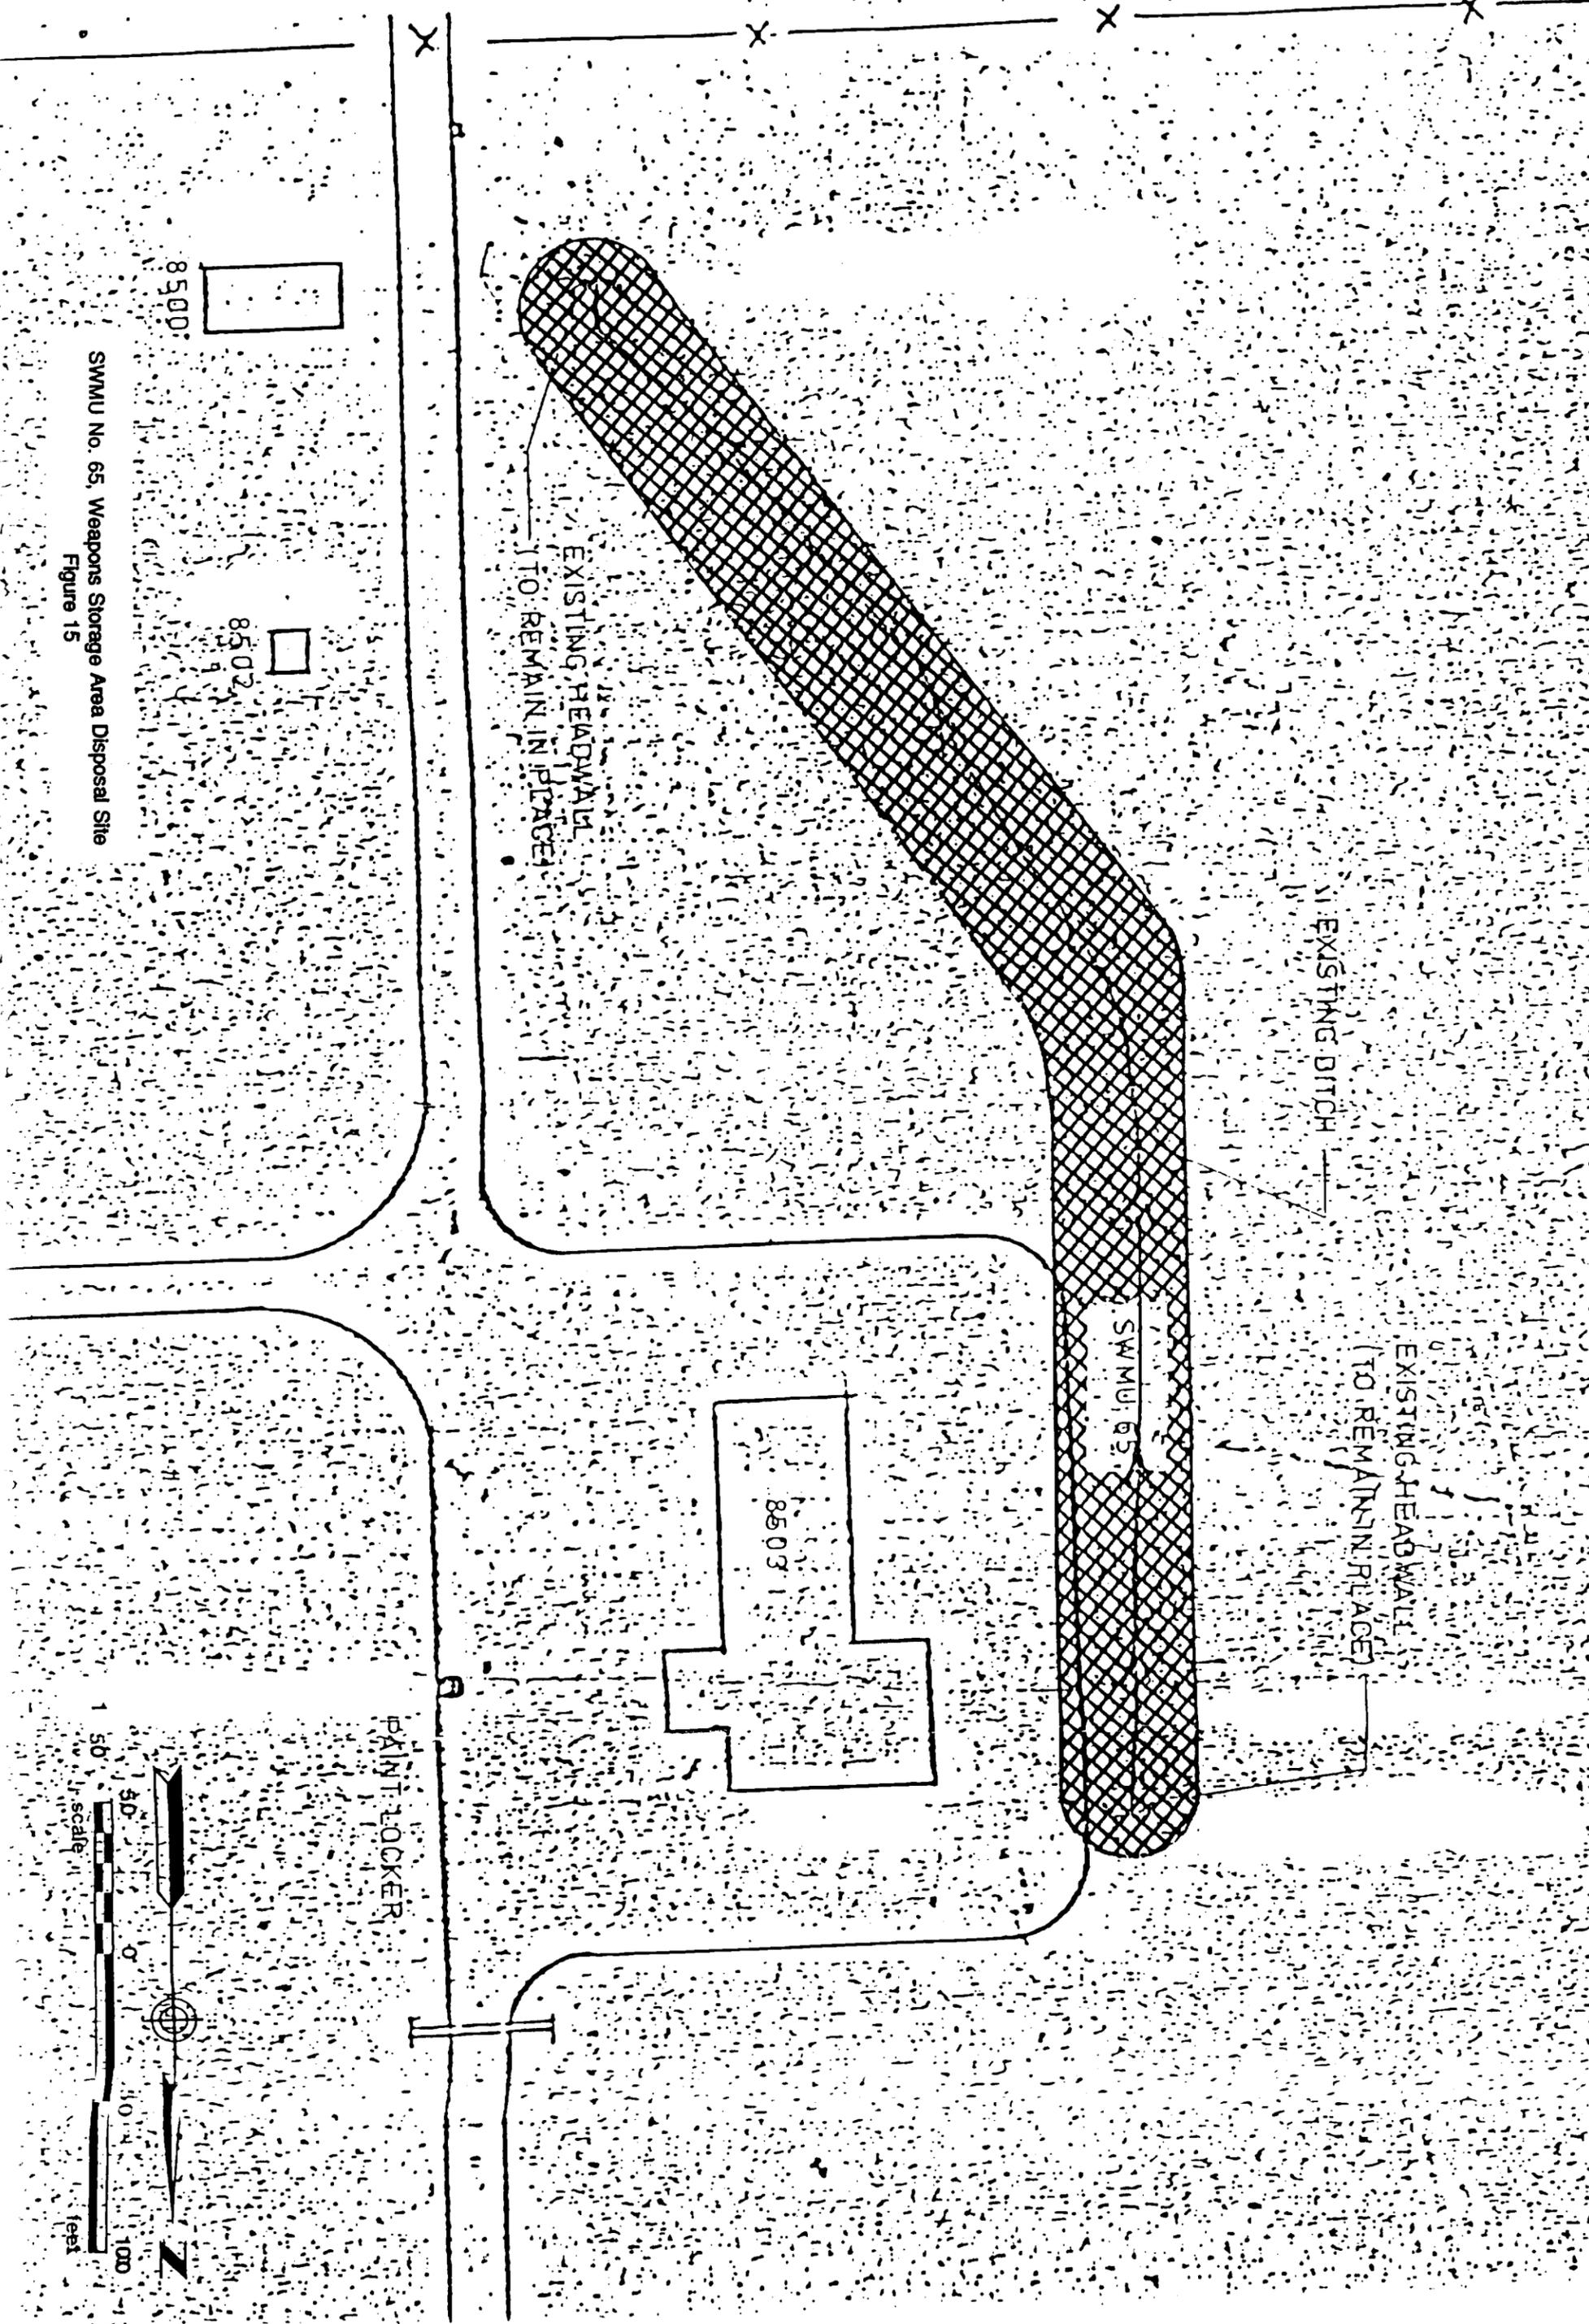
SWMU No. 65, Weapons Storage Area Disposal Site
Figure 15

The eight borings were drilled in order to determine the impact of the suspected disposal of waste cleaners and solvents in the shop area. Twelve samples were analyzed for volatile and semi-volatile organic compounds. Benzene was detected in only one sample at the site. The concentration was 1.2 ug/Kg and the potential emissions of benzene from the site can be considered insignificant. Toluene was detected in several soil samples in concentrations ranging from 2.8 ug/Kg to 49 ug/Kg. Toluene is not a potential carcinogen and the potential emissions can be considered insignificant.

Previous studies found that the ground water from the potable supply well contained total radium (8.5 pCi/L) in excess of Federal Standards for drinking water (5.0 pCi/L). In addition, analysis of soil west of the Inspection Shop revealed the presence of TCE (range from none detected to 0.0619 mg/Kg). Field studies at the site should be considered complete and it is recommended that the feasibility study be completed for the occurrence of TCE in the shallow soil. A remedial action plan will be submitted at a later date.
