LETTER REGARDING REMEDIAL STATUS UPDATE AT OPERABLE UNIT 3 (OU 3) STUDY
AREAS 8 AND 9 NTC ORLANDO FL
8/4/1998
HARDING LAWSON ASSOCIATES

SUBJECT: Status Update
Operable Unit 3 (Study Areas 8 and 9), NTC Orlando
Contract N62467-89-D-0317/CTO 107

REMEDIAL INVESTIGATION
OPERABLE UNIT 3
NAVAL TRAINING CENTER
ORLANDO, FLORIDA

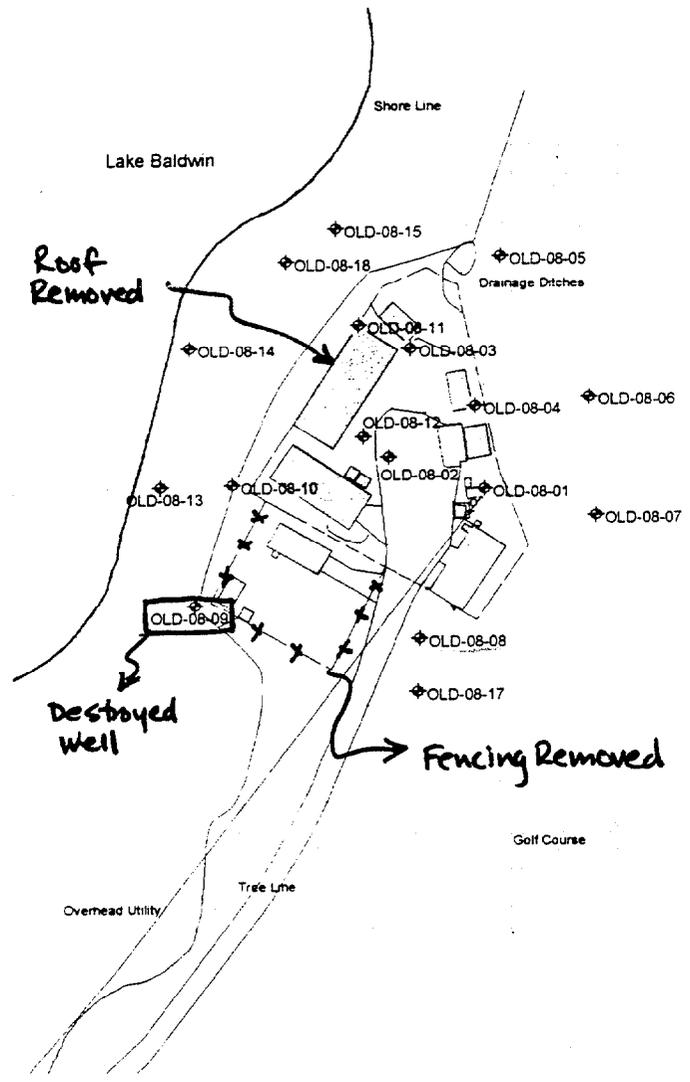
Figure Attachment

On July 30, 1998, while HLA personnel were recording water level measurements at the OU, it was observed that microwell OLD-08-09 had been destroyed (see attached figure). Apparently, earlier in the month of July, the chain-link fence surrounding the southern end of the Greenskeeper compound and the roof of the covered parking area within the larger fenced area at the SA8 were removed (see attached figure).

It appears that microwell OLD-08-09 was destroyed during removal of the fence. The well pad was flipped over and pushed off to the edge of the brush. The microwell riser was broken off at the first casing joint, approximately two feet below land surface (bls). At that time, HLA personnel attempted to abandon the well, however, this was difficult due to the depth of the break in the well and the soft nature of the soil in the area.

Therefore, HLA personnel returned to the SA on August 4, 1998 with a metal detector and were able to locate the remains of the microwell. The top two feet of soil surrounding the microwell was excavated, and an attempt was made to extricate the microwell screen from the ground. After several attempts at pulling the microwell with ropes, a jack, and a lever, HLA was only able to retrieve one three-foot length of microwell screen. The remaining 6 feet of microwell screen remained firmly stuck in the ground. Therefore, the remaining microwell screen had to be abandoned in place, and, subsequently, the microwell screen and borehole were backfilled with granular bentonite. The excavation was then backfilled to approximately 1 foot bls, and the remaining excavation was covered with native soil. The microwell location was marked with a piece of galvanized pipe.
