ENVIRONMENTAL CONDITIONS REPORT

BUILDING 121 REMEDIATION
U.S. NAVAL STATION ROOSEVELT ROADS
PUERTO RICO

20 January 1994
OHM Project No. 15591

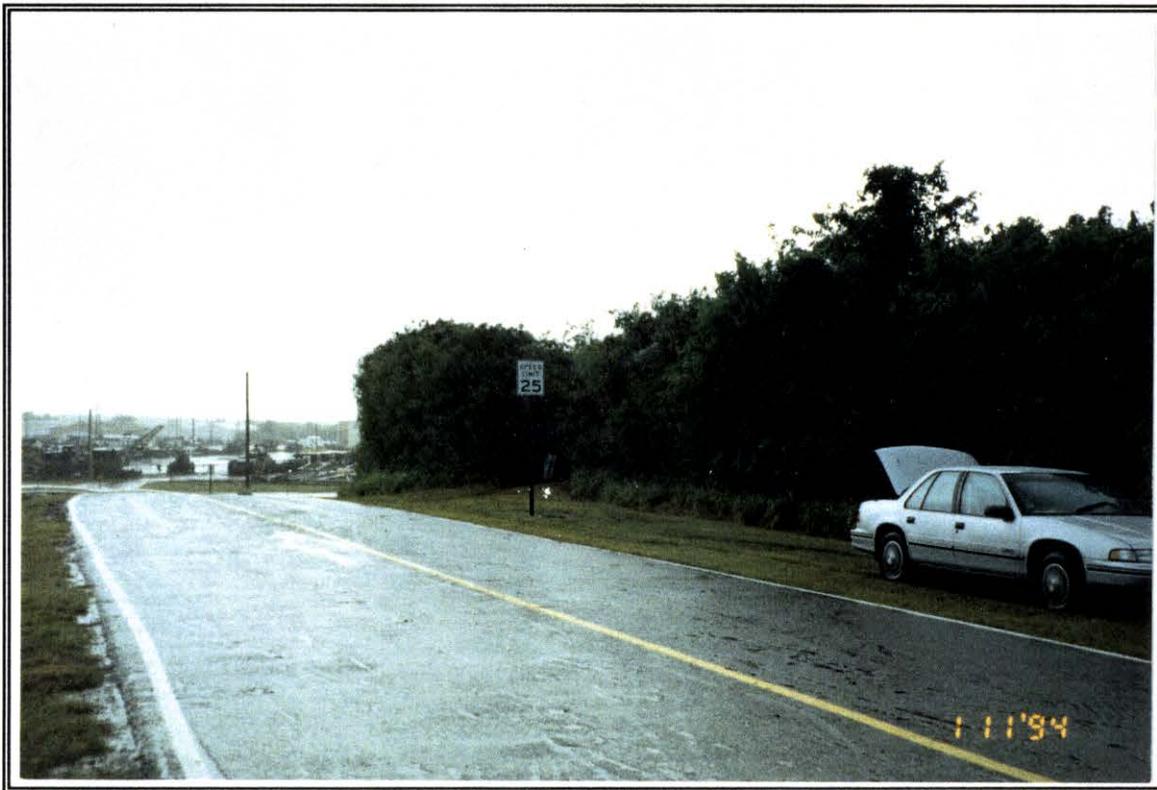
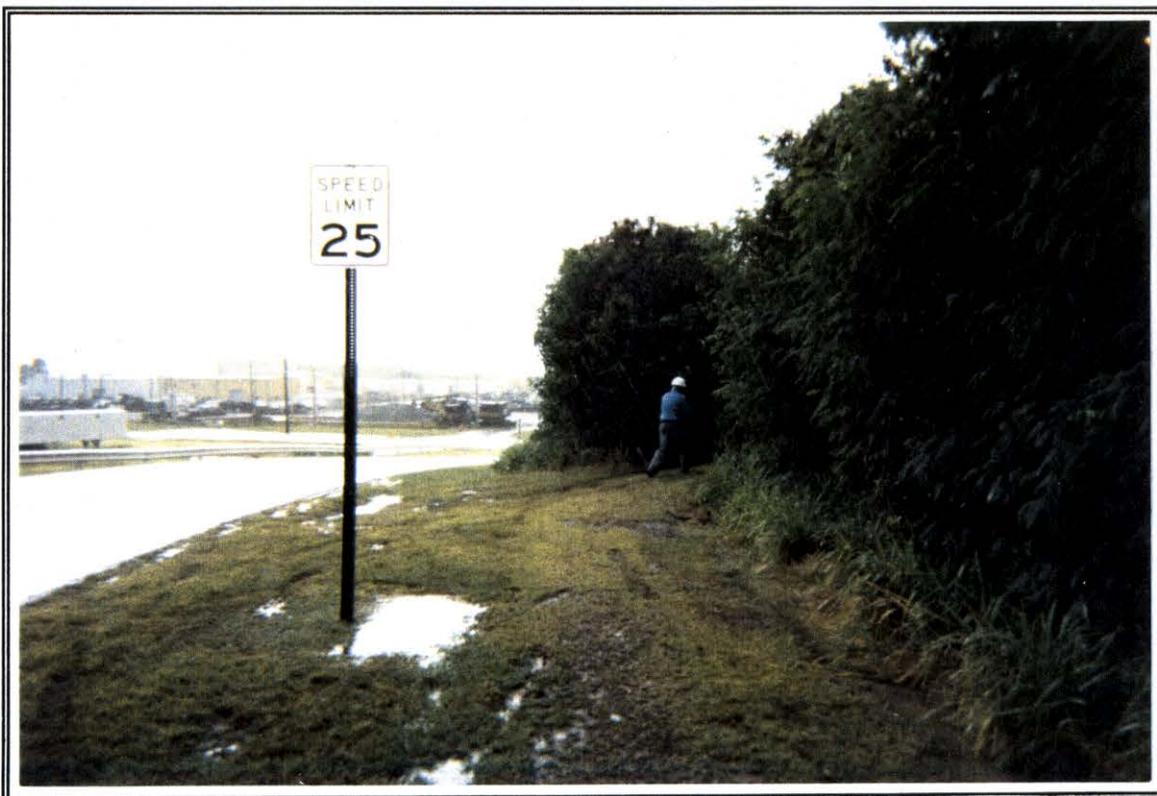
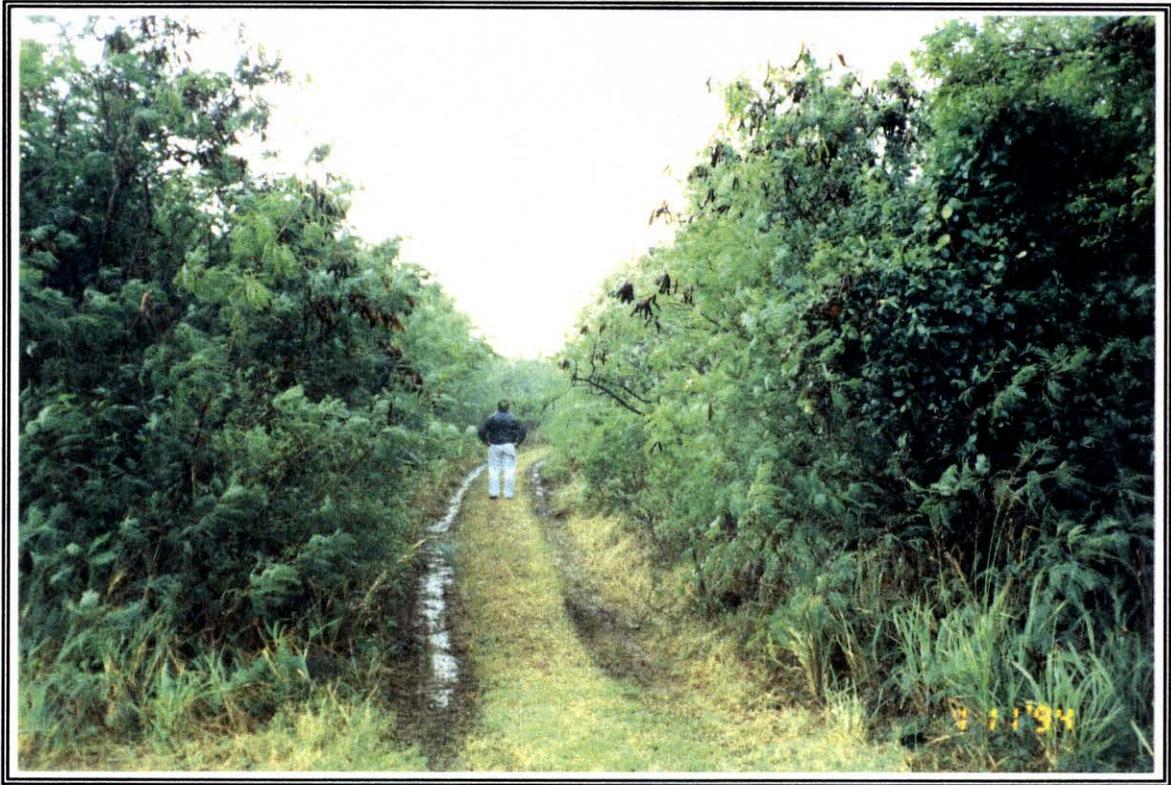
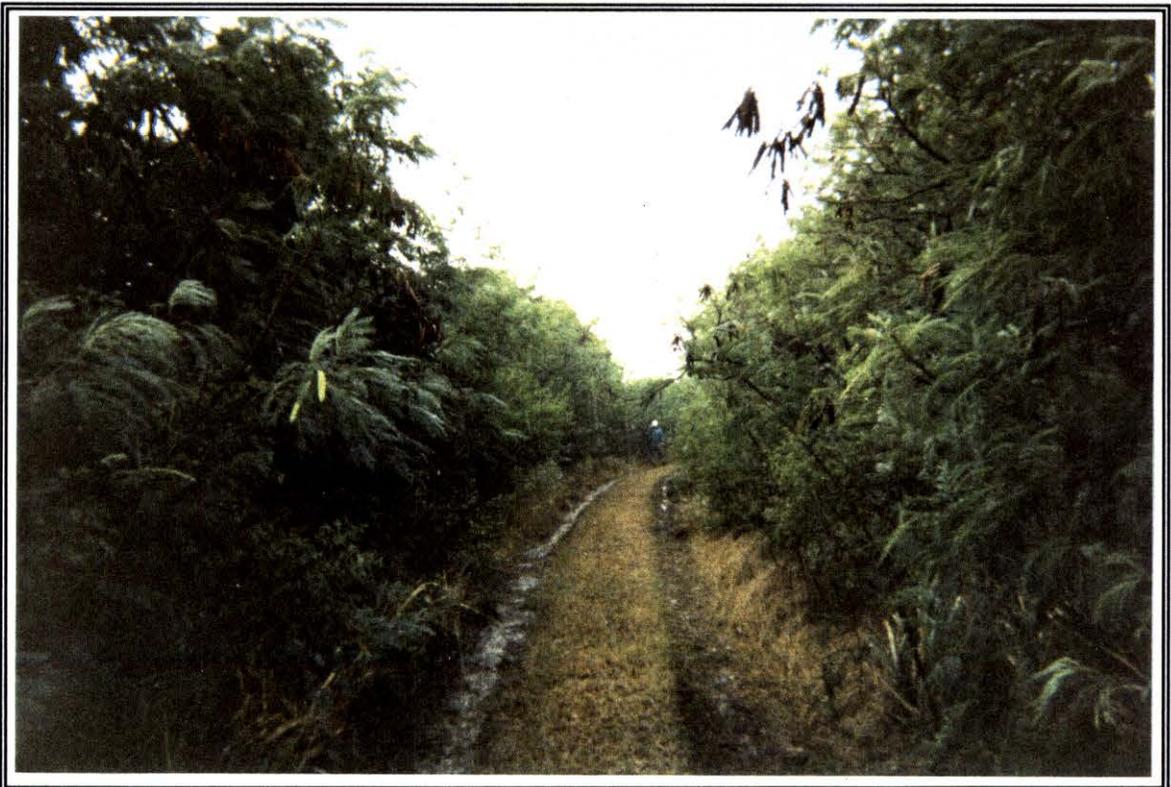
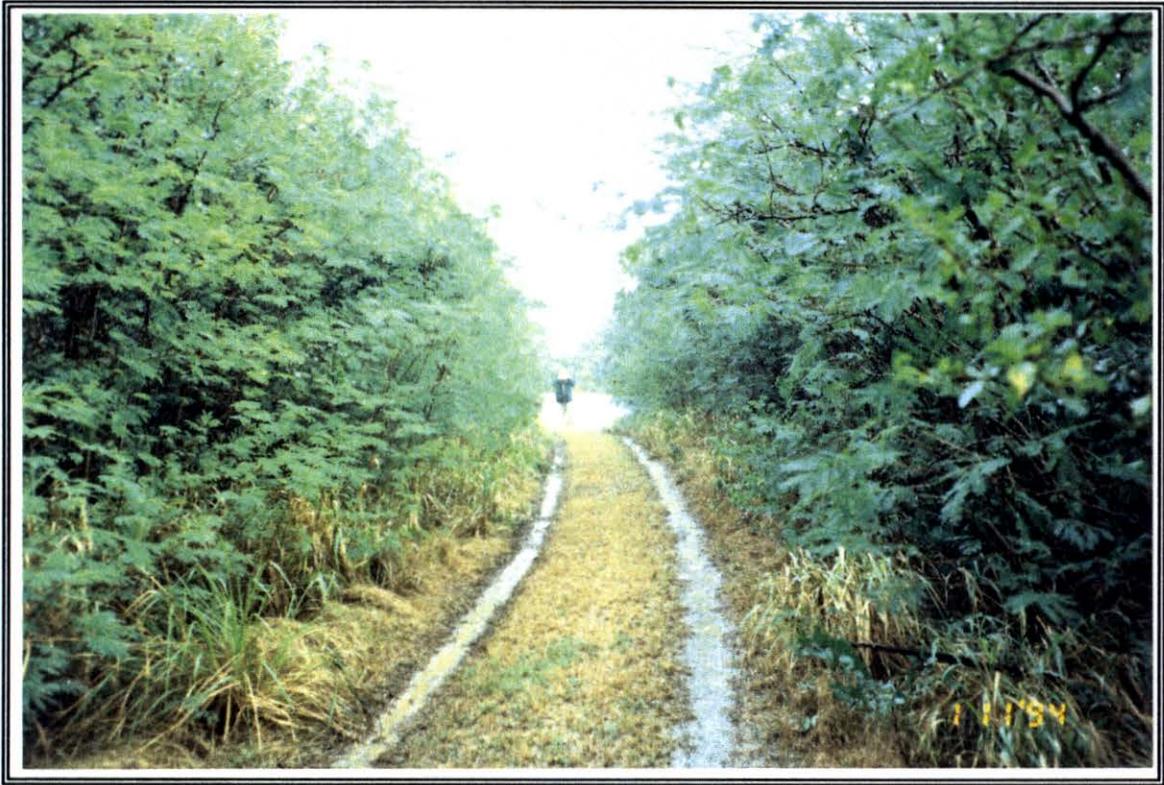
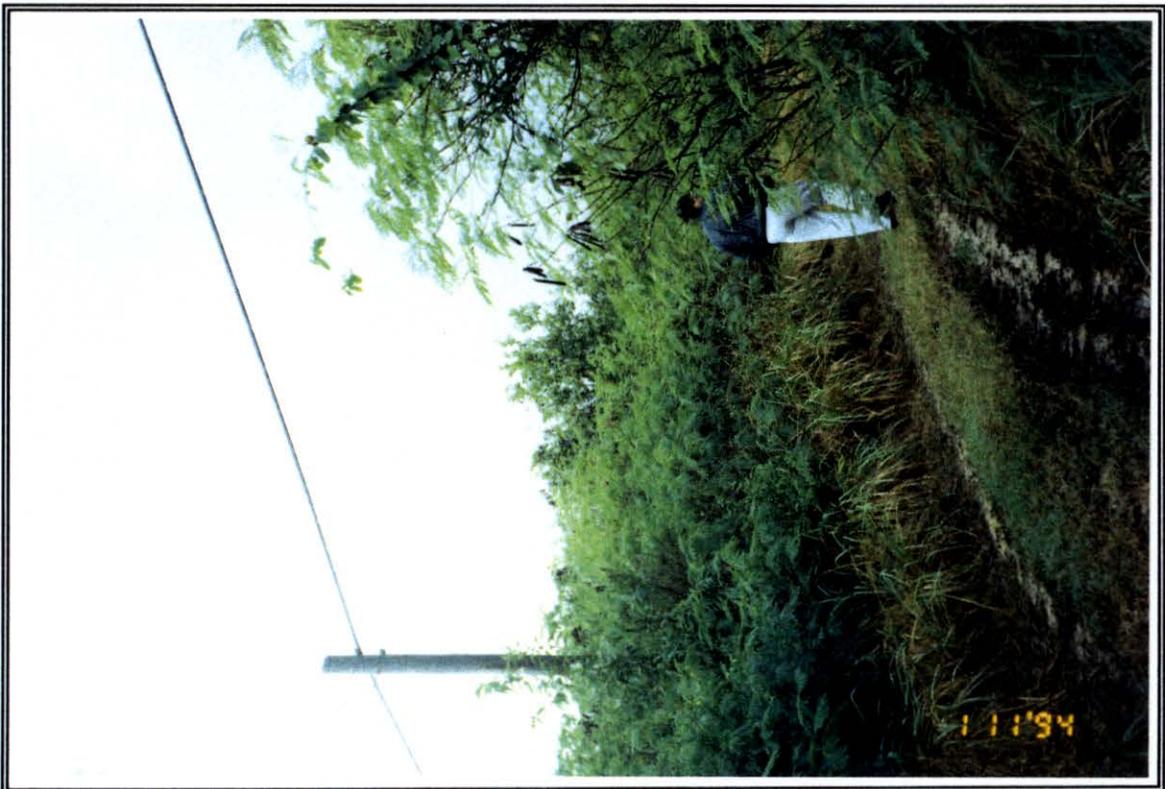
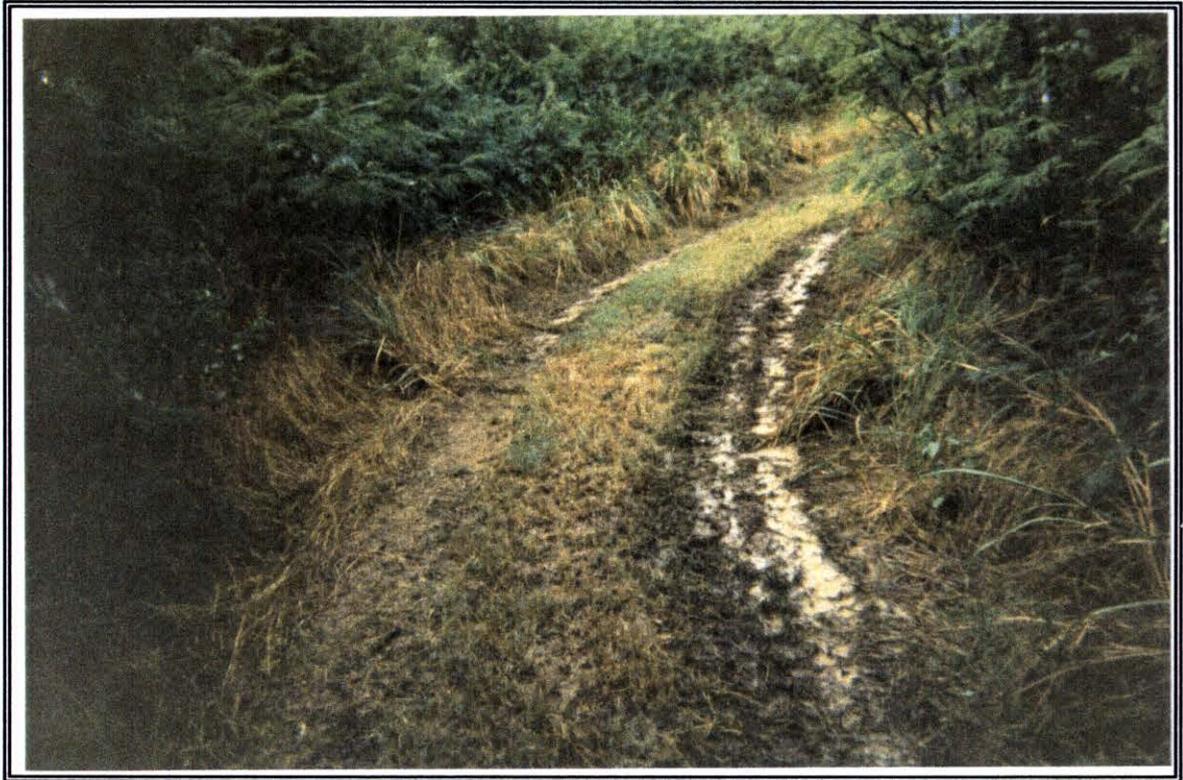
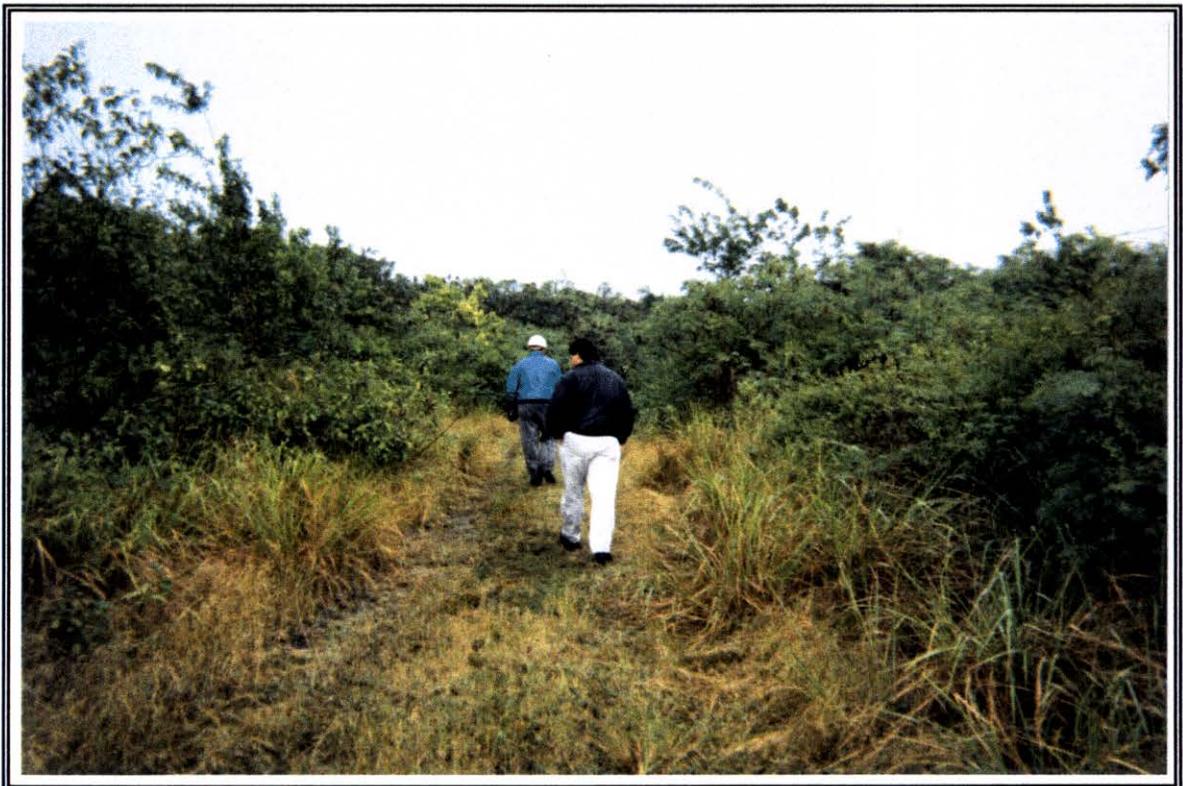
The approximately 300-foot-long, unpaved access road is about 8 feet wide and closely bordered with heavy vegetation 12 feet high on both sides for most of its distance. It is made of compact native soil, is level sideways but slightly rutted, and moderately sloped with a grade readily passable in a passenger car. The turning radius at bends is wide enough for trucks to negotiate. It is slippery underfoot when wet. The access road is shown in Pictures 1 through 9.

1. Entrance to site access road (SW)

2. Entrance to site access road (S)

3. Site access road (W)

4. Site access road (W)

5. Site access road (E)

6. Site access road (NW)

7. Site access road (closeup)

8. Site access road (N)

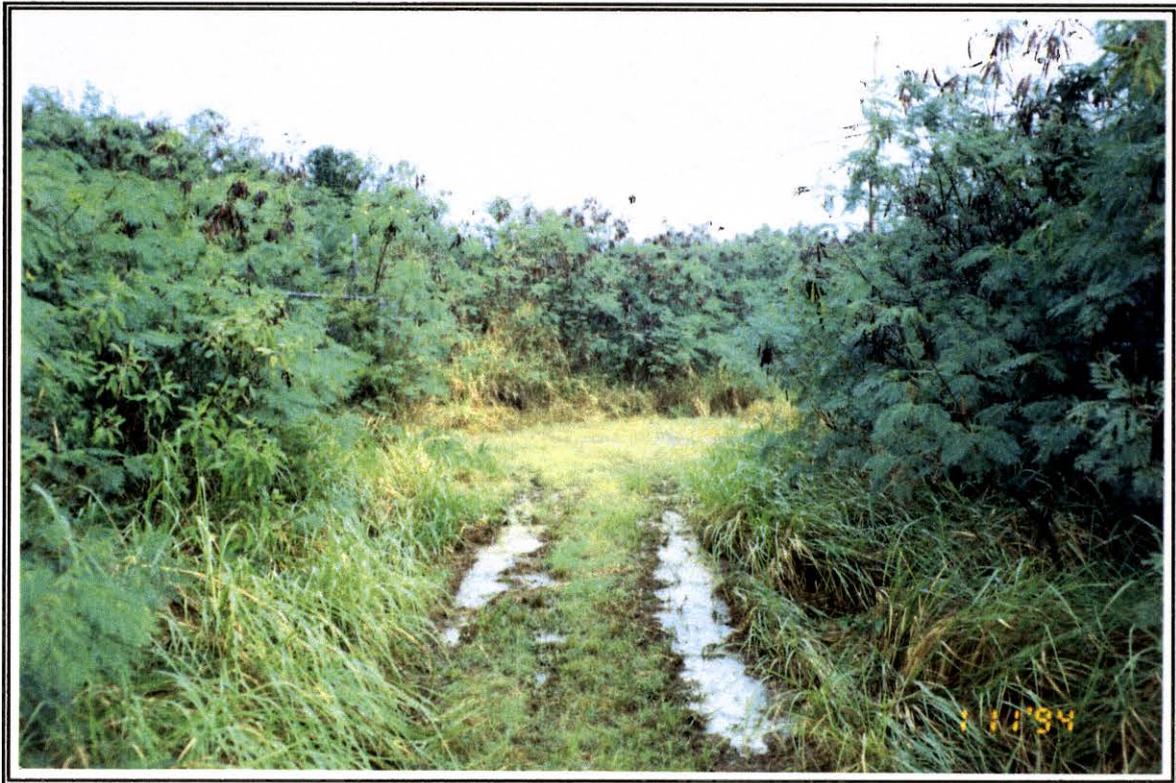
9. Site access road and soil excavation area (N)

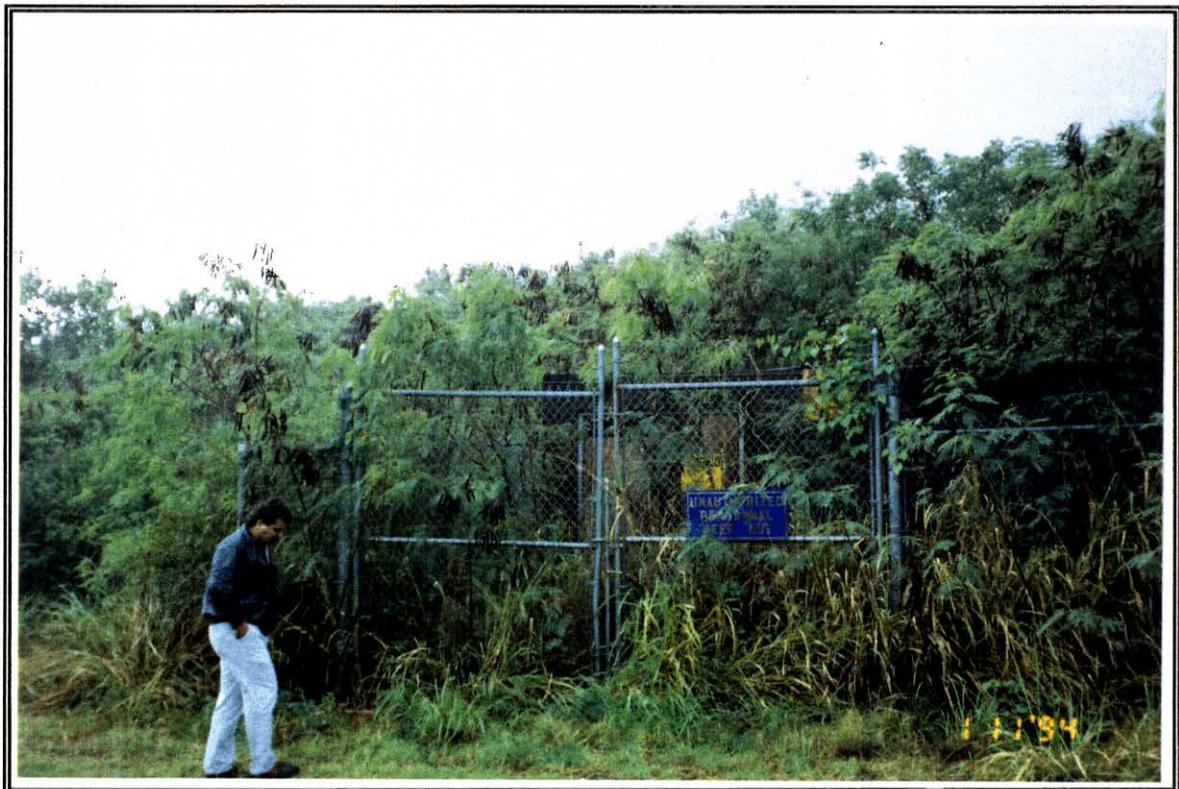
the time of the site inspection the gate was pad locked. The gate had a metal lacquered warning sign reading "UNAUTHORIZED PERSONNEL KEEP OUT." Photographs 10, and 16 through 19 show the existing fence and gate.

No aerial electric or other utility wires were observed connected to the building. The concrete walkway in front of the east door was not readily visible and its presence was not verified. The fence gate appears to be about 5 feet east of the door. Photographs 10, and 17 through 22 show the exterior of Building 121.

10. Fence - Gate (W)

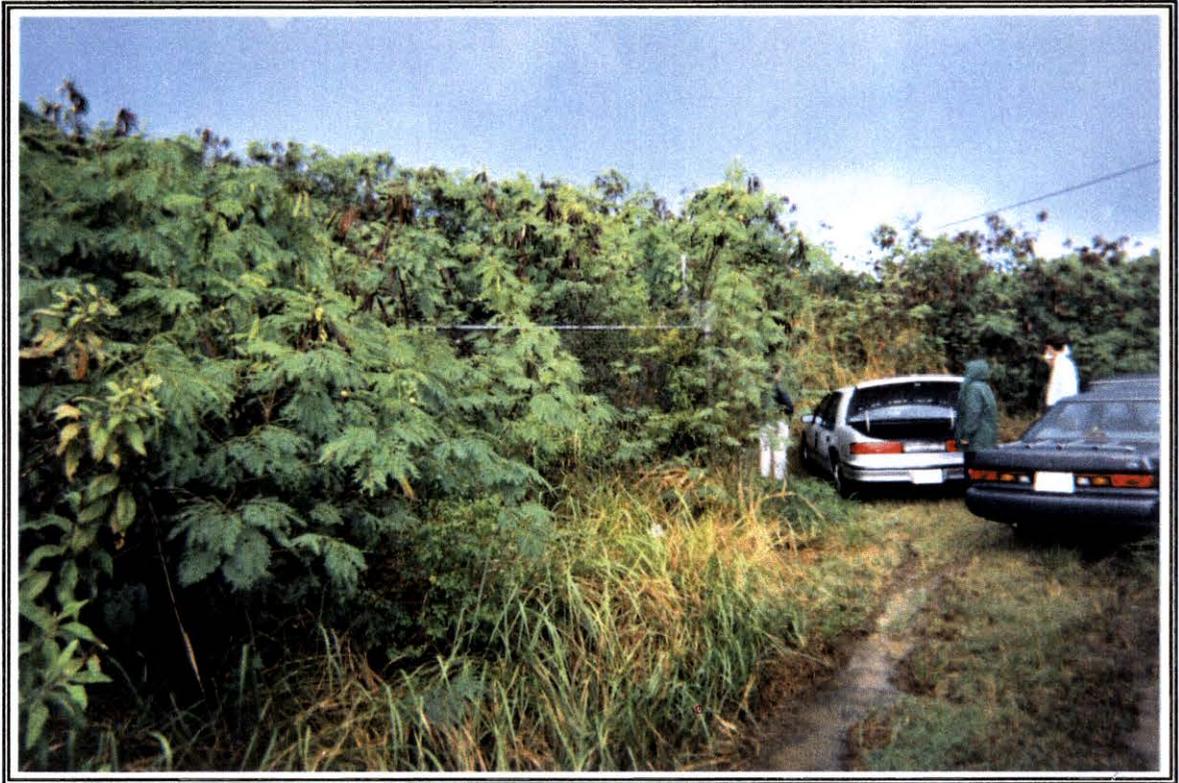
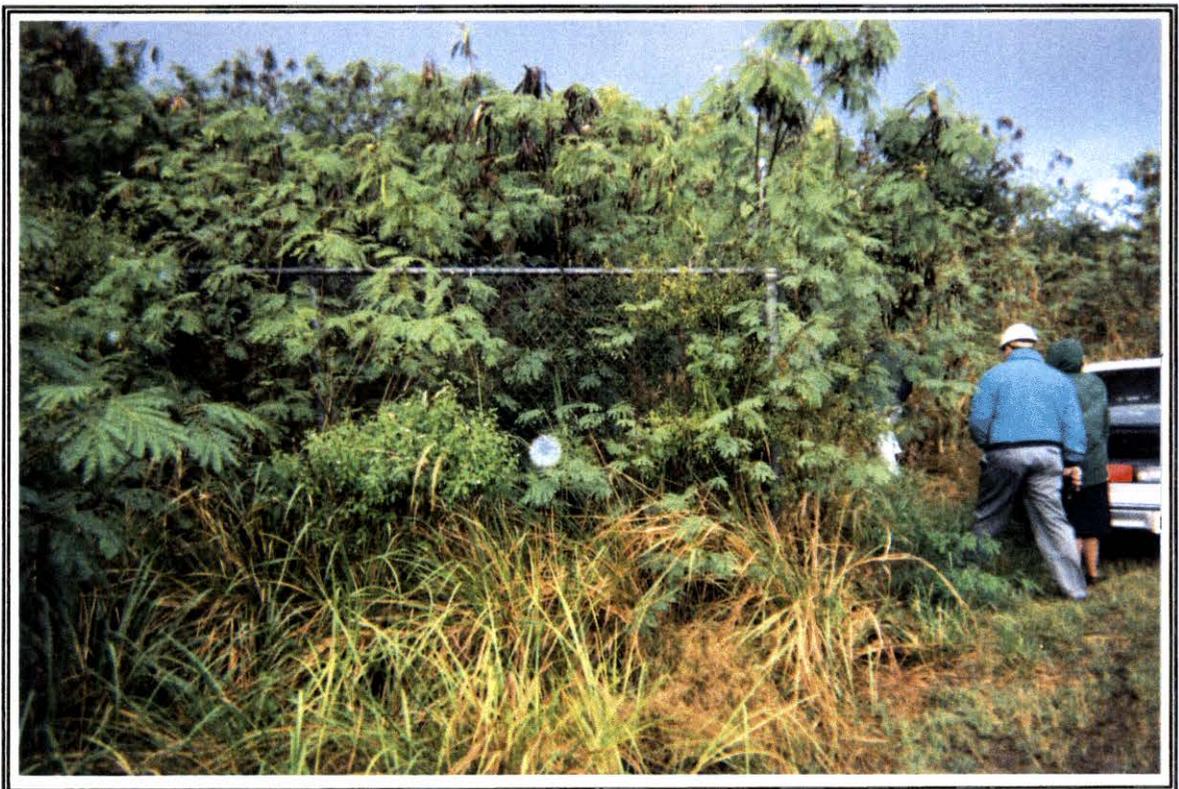
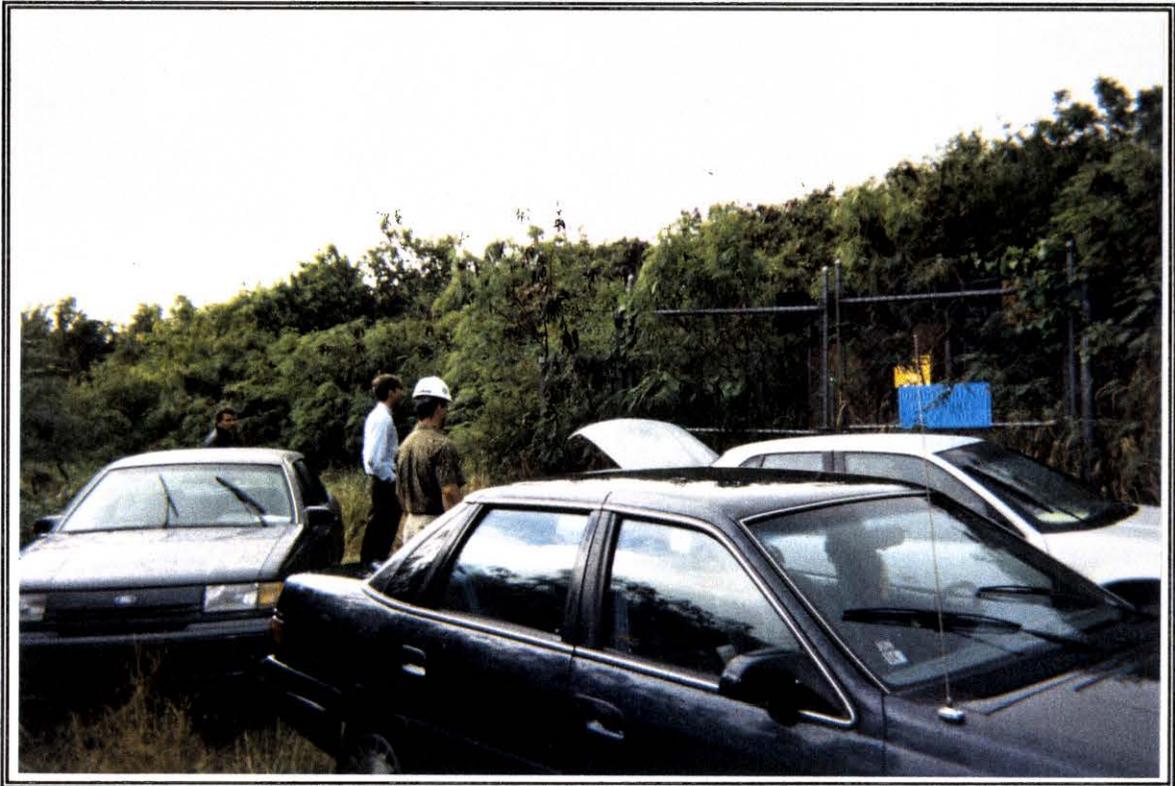
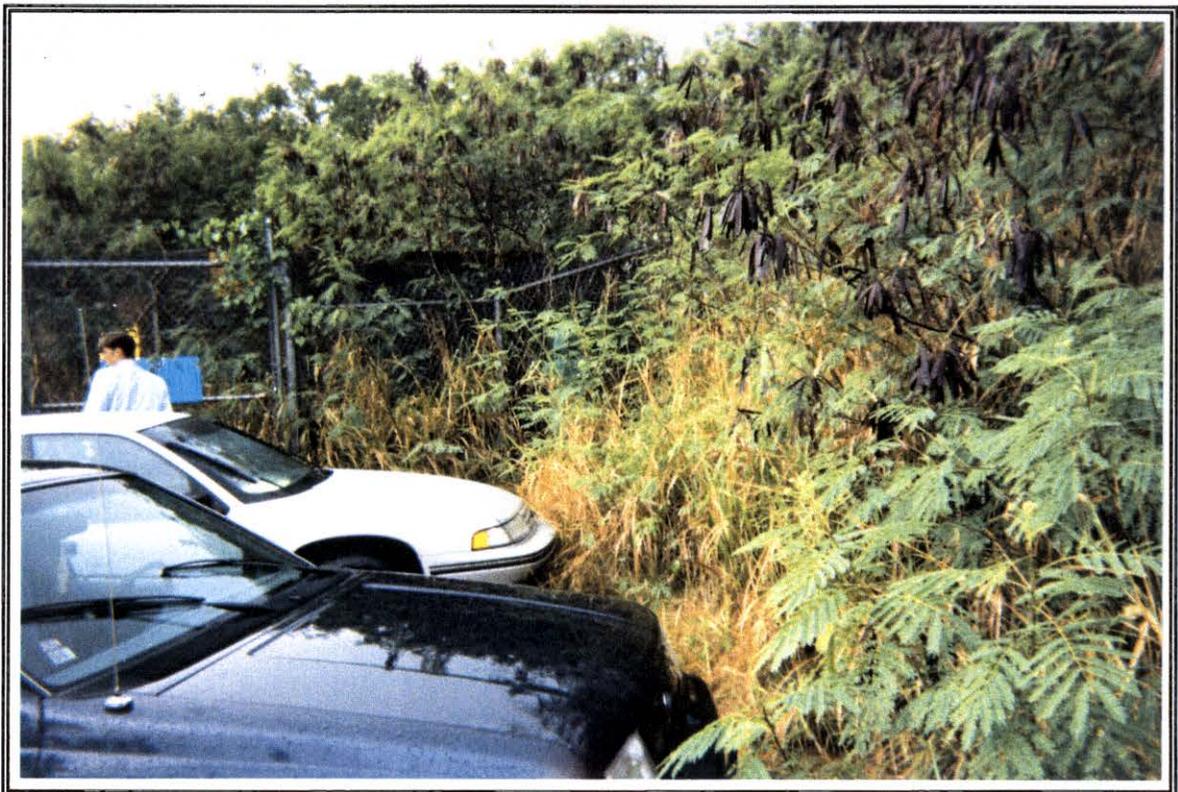
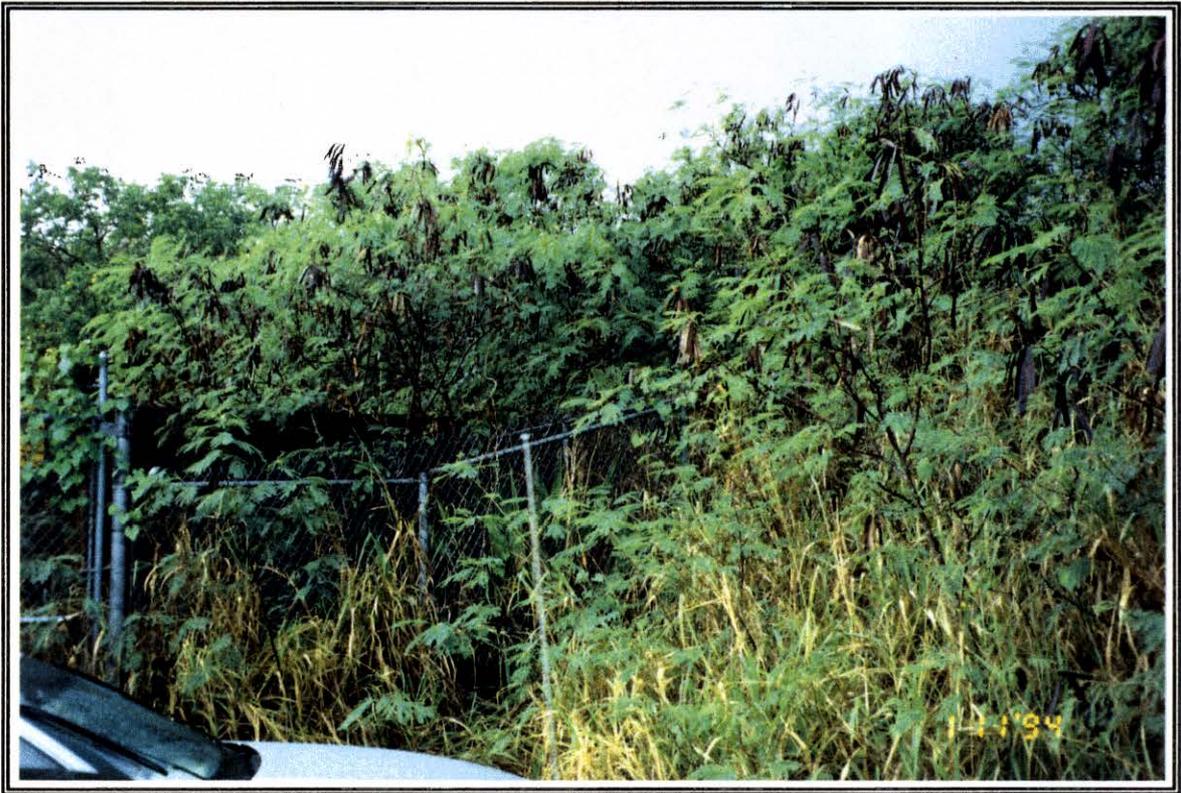
The area to the south of Building 121 and west of the access road appears to be relatively level but is also heavily vegetated. No drums, debris, or other items were noticed in the general work area. An electric power pole is located about 140 feet south of the building near the bend in the access road (Photograph No. 6) and another power pole is located about 50 feet east of the building. Photographs 10 through 16 show the general work area.

11. General area south of Building 121 (N)

12. General area south of Building 121 (N)

13. General area south of Building 121 (W)

14. General area north of Building 121 (W)

15. General area north of Building 121 (W)

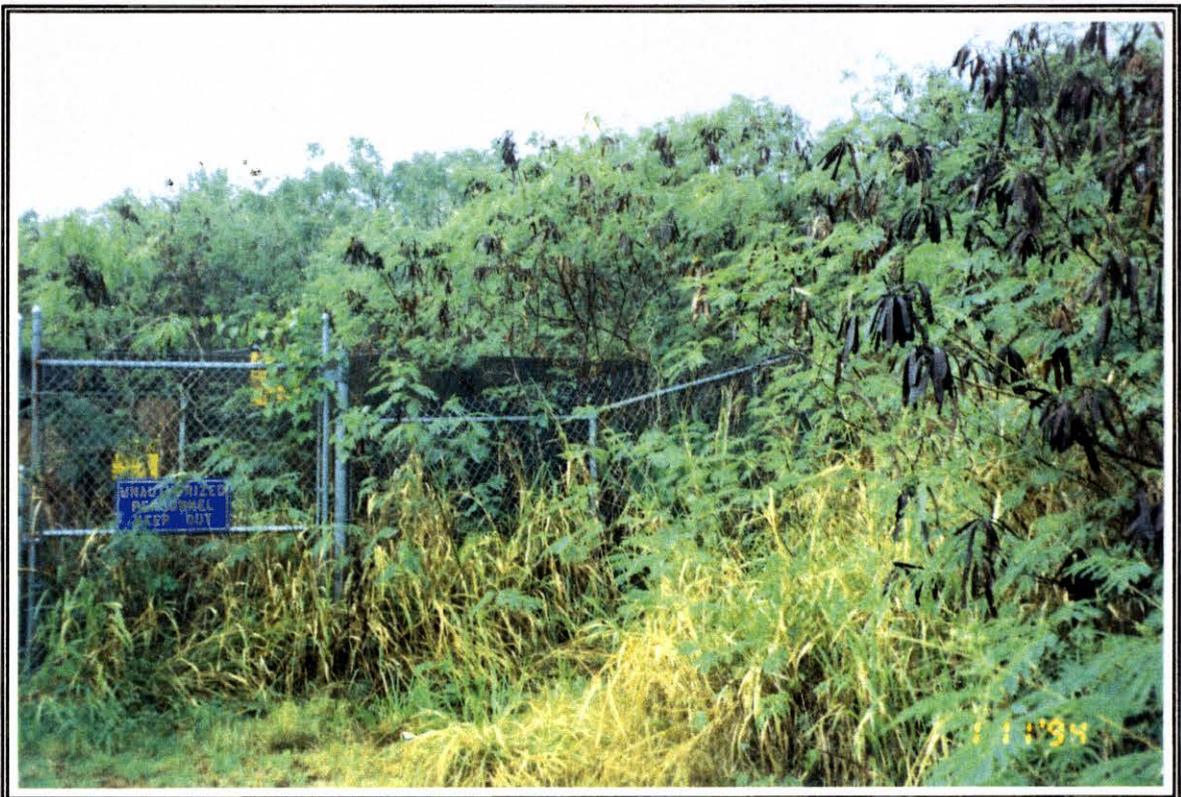
A standard cyclone fence was observed in good condition on the south, north, and east sides of Building 121. It is 6 feet high on the south and north sides with an 8-foot-high, 12-foot-wide double swing gate and triple-barbed wire on the east side. At

16. Fence - North and east sides (W)

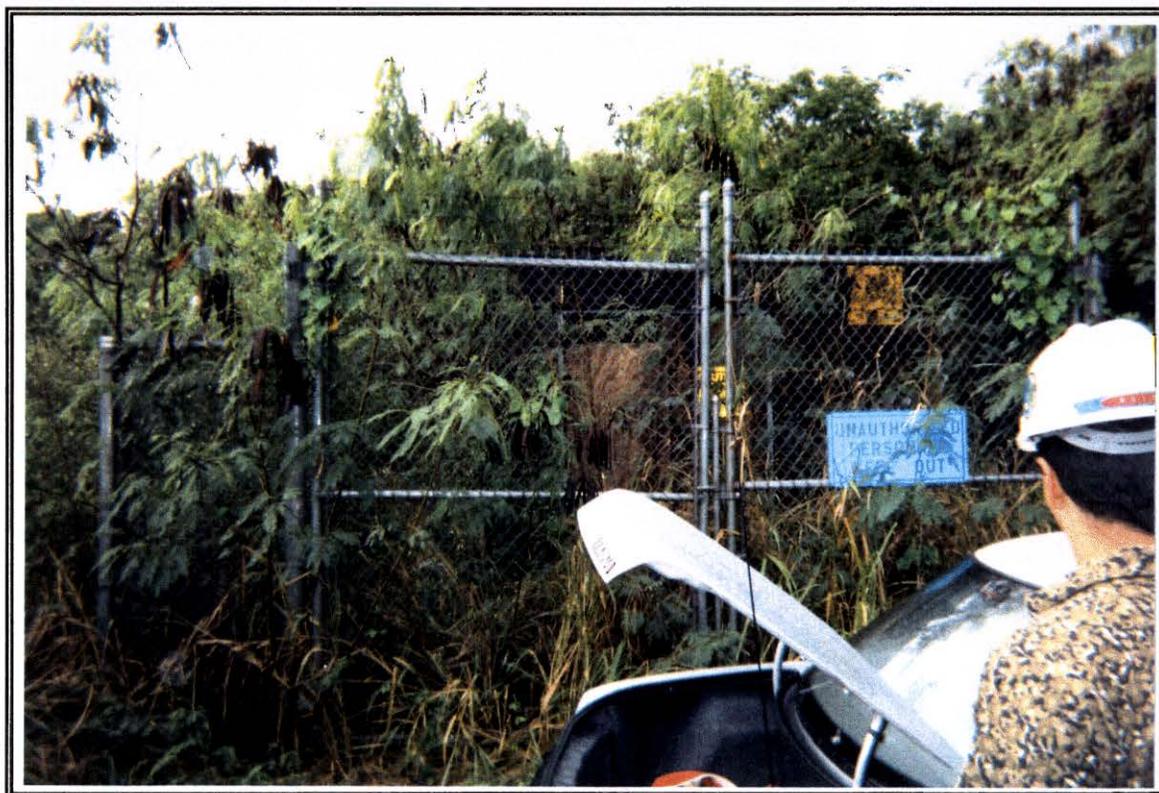
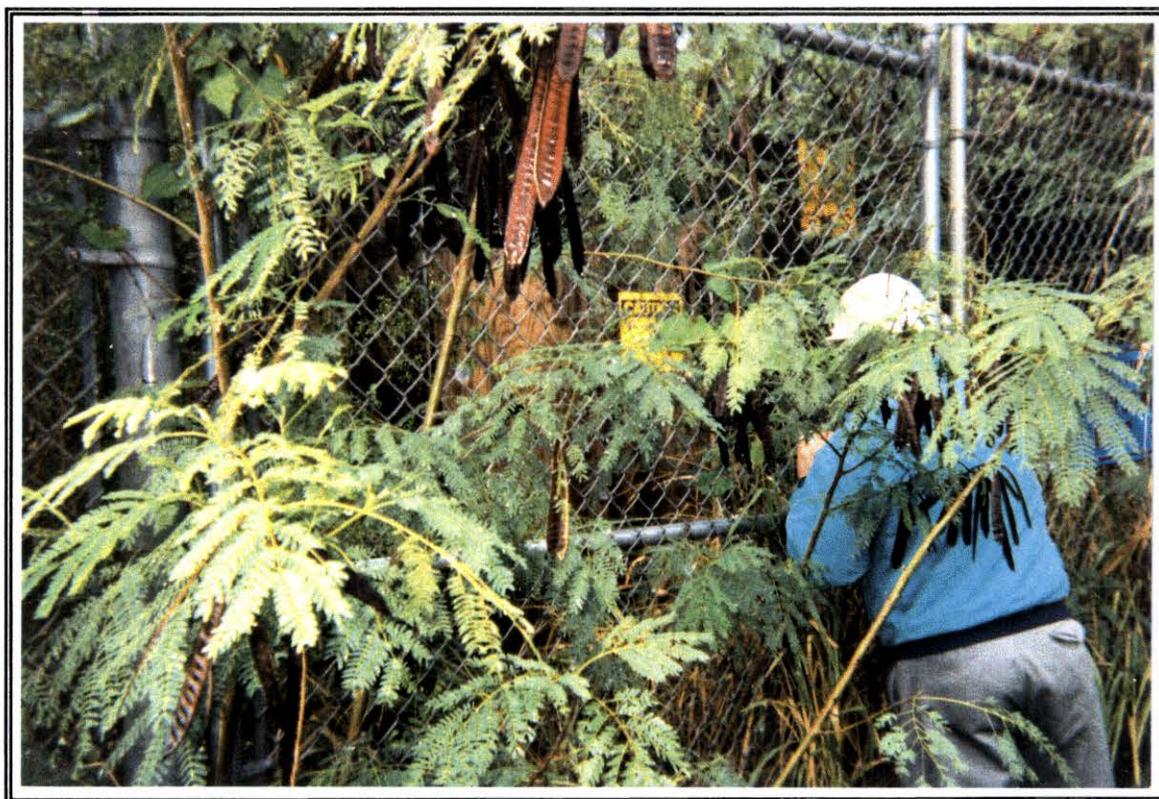
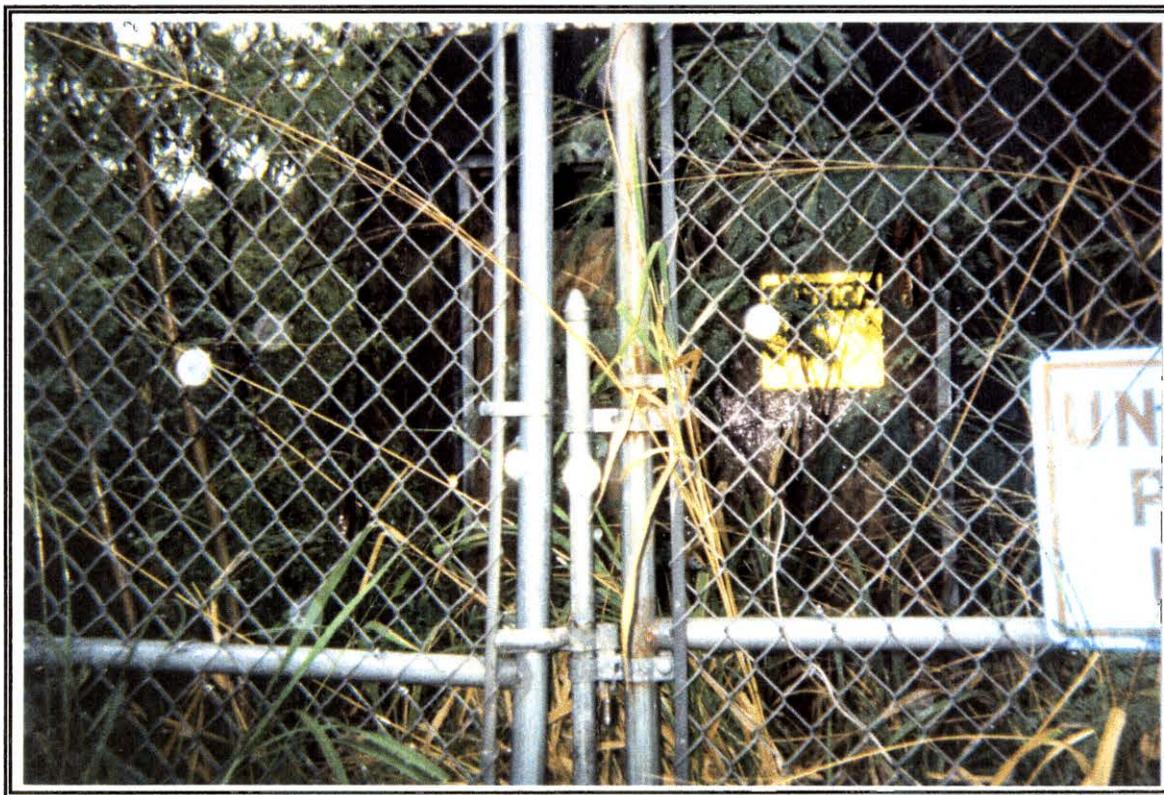
17. Fence - Gate (W)

18. Fence - Gate (NW)

19. Fence - Gate (closeup)

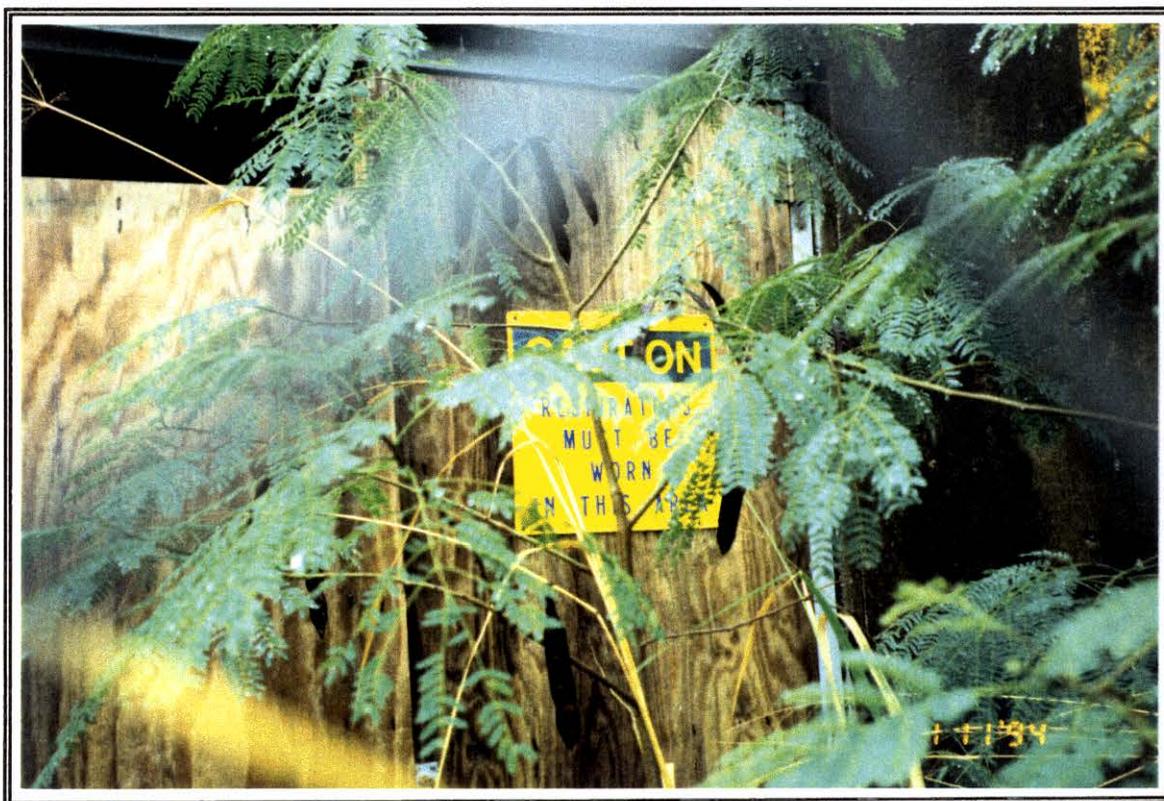
One 5-foot-wide doorway is located on the east side and has two opposing ½-inch-thick plywood doors each connected with two 3½-inch brass gate hinges to the south or north sides of the door frame. Other openings into the building were not readily apparent.

20. Building 121 - Door on east side (W)

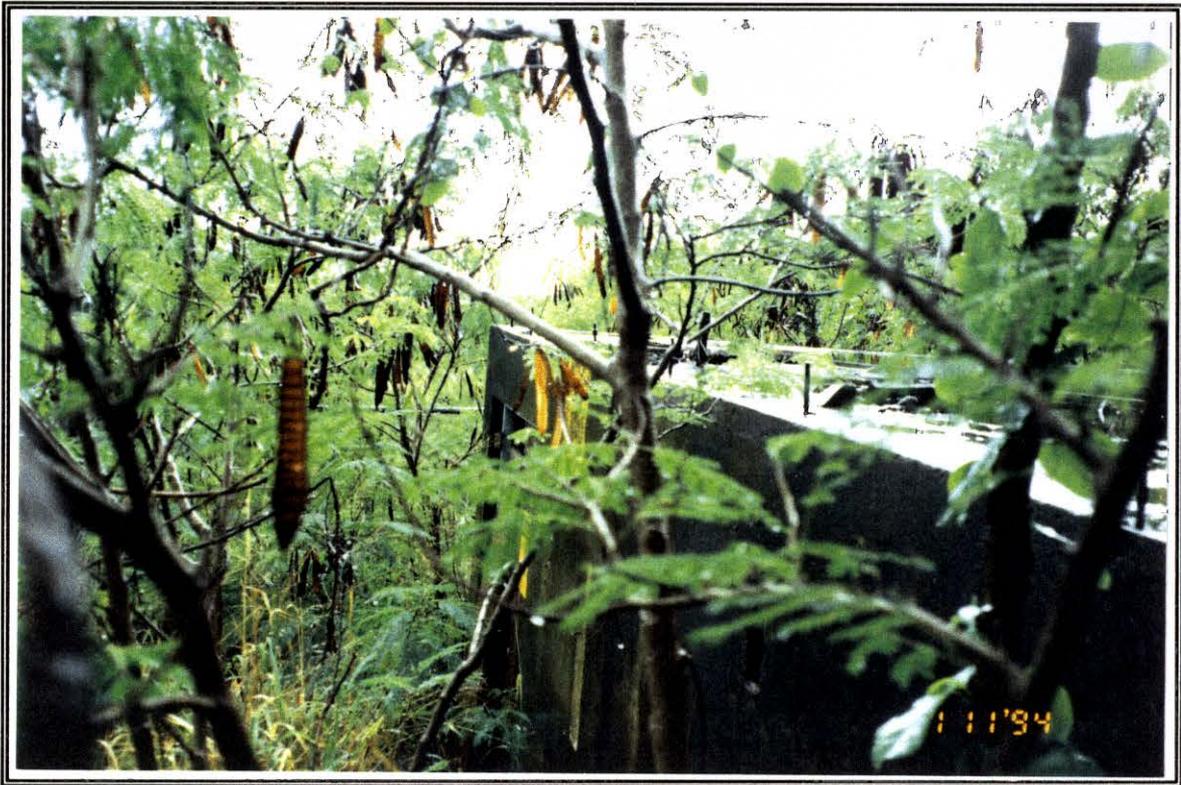
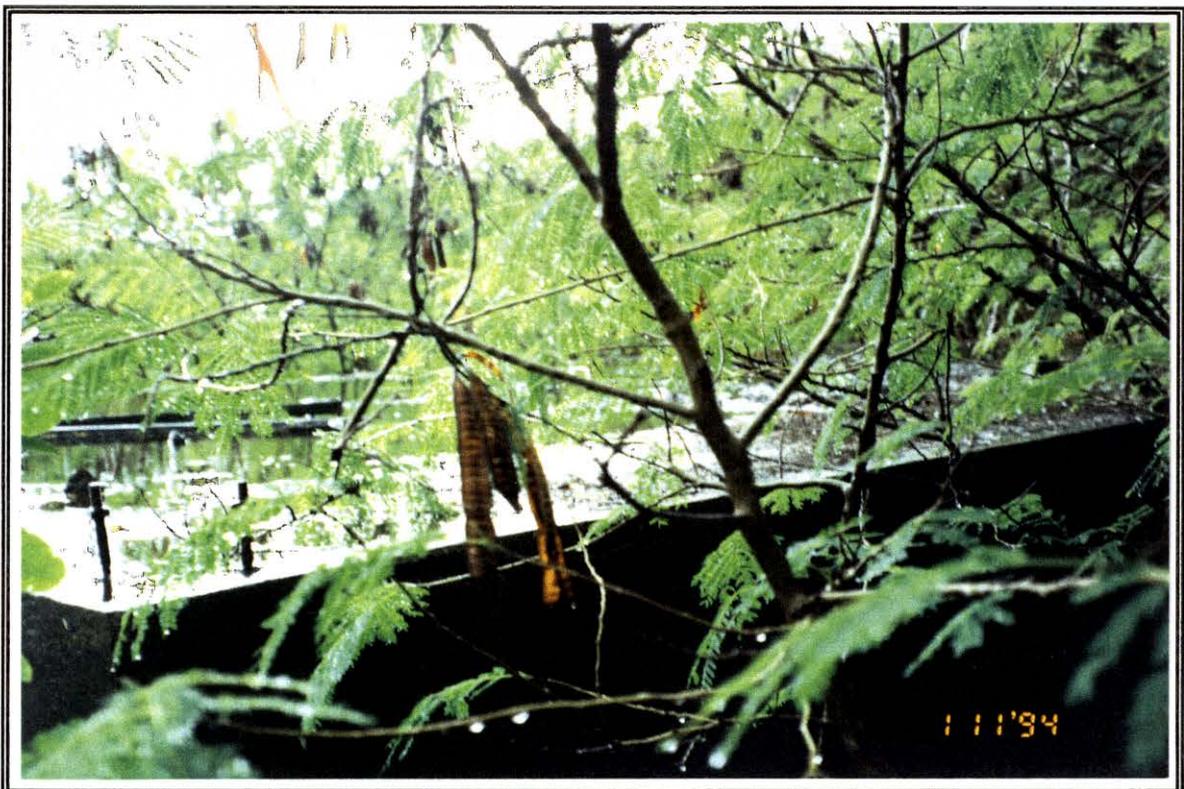
Due to the heavy vegetation and locked gate, much of Building 121 was not observable during the site inspection, including the interior. On the exterior, it is an unpainted, one-story-high, rectangular building of sound, relatively unspalled, pre-cast concrete walls with a flat concrete roof.

21. Building 121 - East side (SW)

22. Building 121 - Roof and north side (SW)
