Phase I Environmental Assessment at Malaria Control Building Building 64

Prepared for
**U.S. Naval Station,
Roosevelt Roads**

March 2000

Prepared by
Baker Environmental, Inc.
Airport Office Park, Bldg. 3
420 Rouser Road
Coraopolis, PA 15108

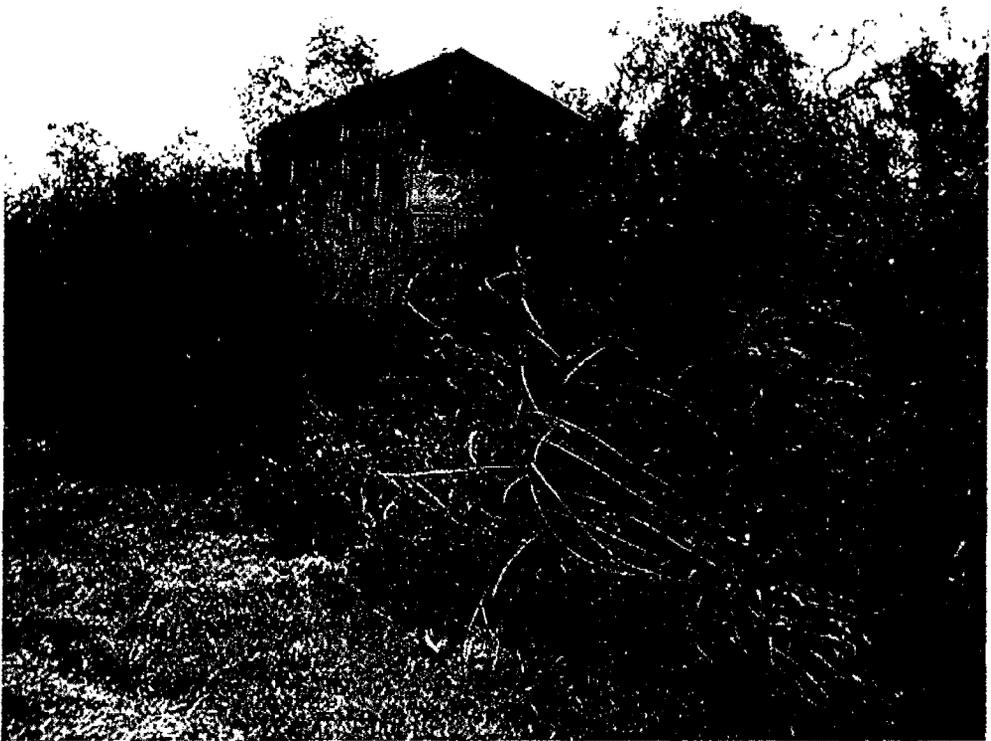
The building is situated in a south to north direction. The building is wood frame construction with corrugated metal siding and roof. The building is constructed on a concrete slab on grade and measures approximately 21 feet by 18 feet. Building 64 was built in 1942 and condemned in 1980. (Photos 1, 2 and 6)

Photo 1: View of Building 64 Looking South

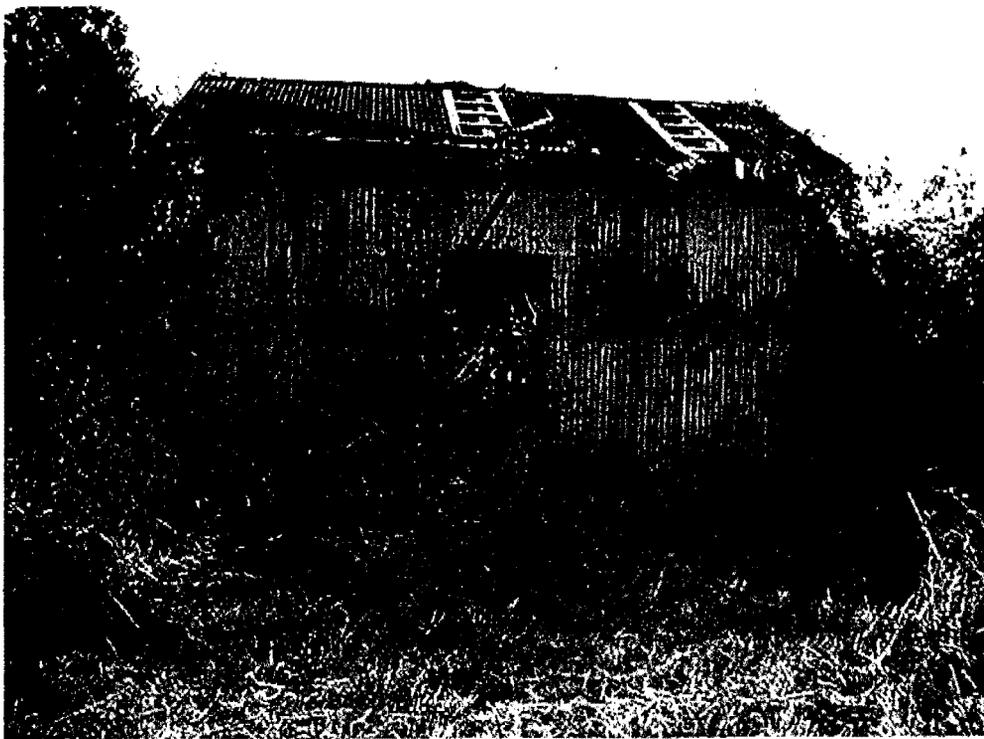
Photo 2: View of Building 64 Looking East

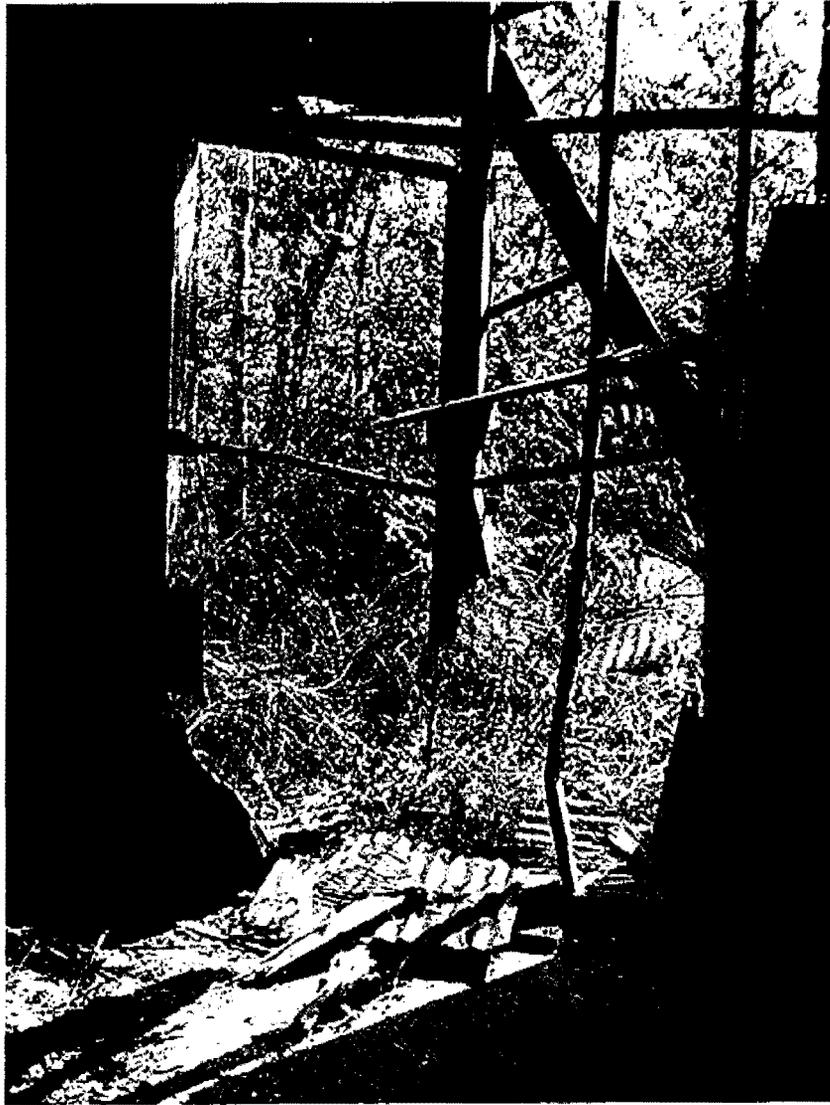
Photo 6: Deteriorated Condition of Eastern Wall
