## **Wastewater Pretreatment Units Evaluation** (WWTP Pretreatments Units, Oil/Water Separators, and Grease Traps)

**U.S. Naval Station Roosevelt Roads  
Puerto Rico**

**Atlantic Division Naval Facilities  
Engineering Command  
Norfolk, VA**

**SEPTEMBER 2002**

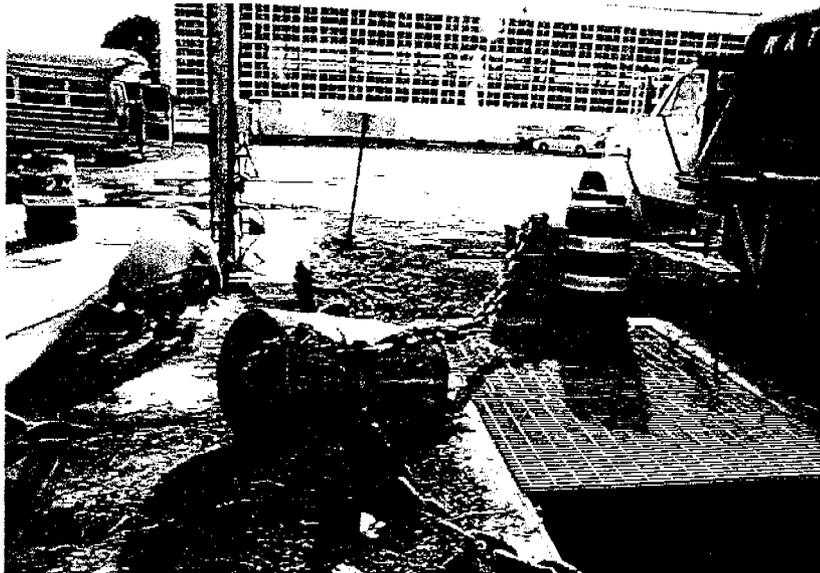
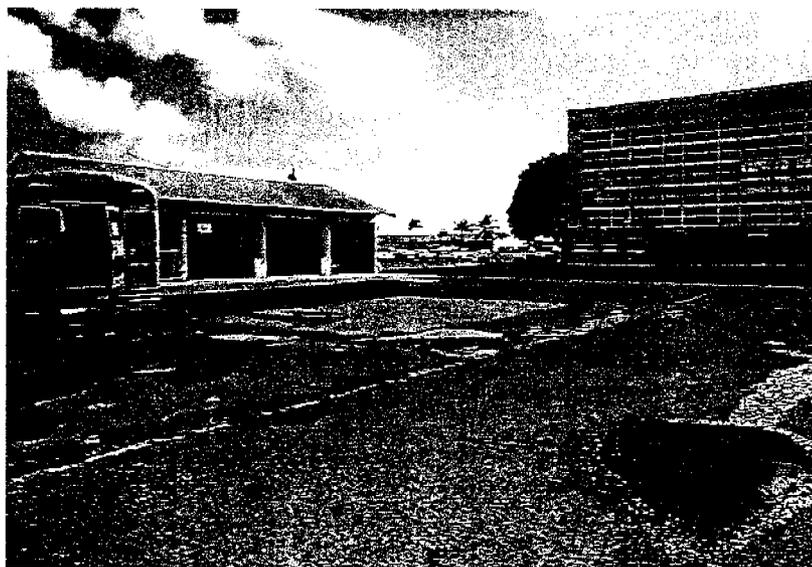
OWS No.: 0031

OWS services the truck wash.
PVC outlet tee cracked.
Some exposed aggregate (<5%).
Small amount of spalling (<5%).
275 Gallons of sludge removed

- **OWS-31** – This OWS has an excessive drainage area. The recommended solution is installation of a flow-limiting-device to limit hydraulic loading on the OWS during a significant rain event.

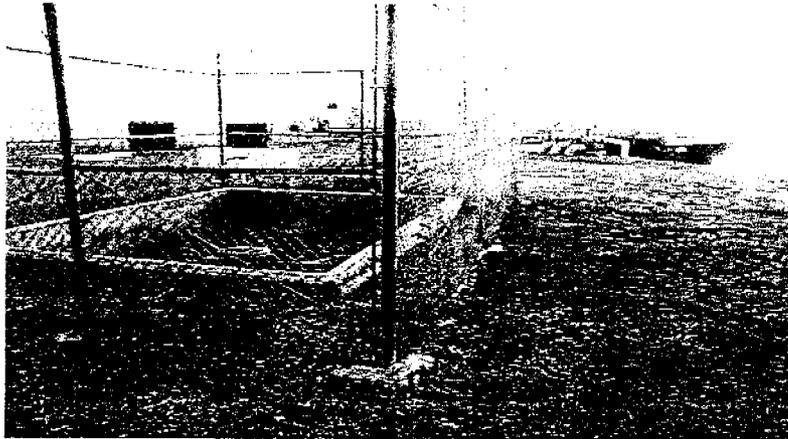
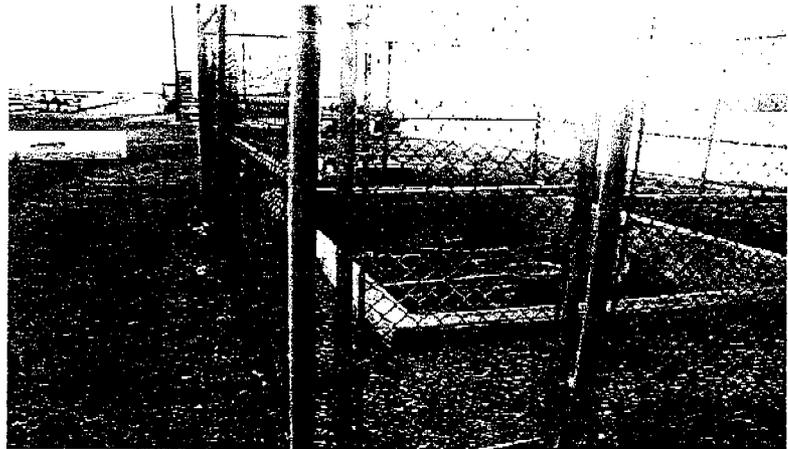
OWS No.: 0266

Inspected condition of concrete containment.
Prefabricated OWS inside concrete containment was not inspected.
Concrete containment dimensions are 14' L x 10' W x 9.3' D.
Recommend installing a Stage 1 sump similar to OWS-0799.
No sludge removed from this OWS

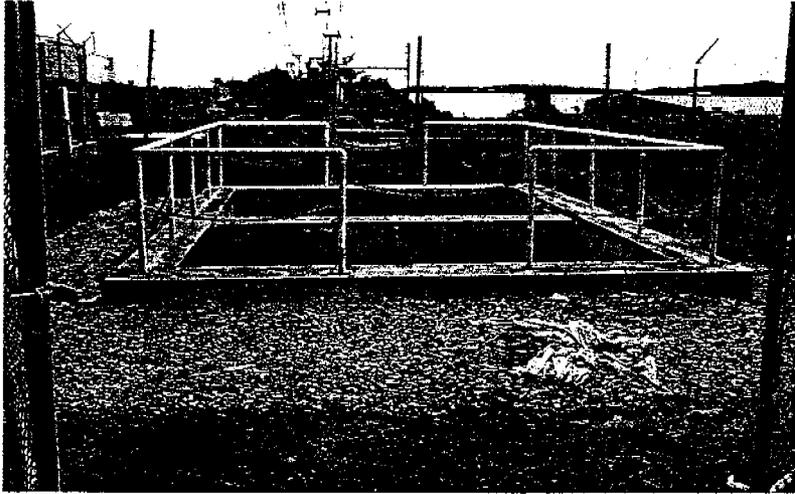
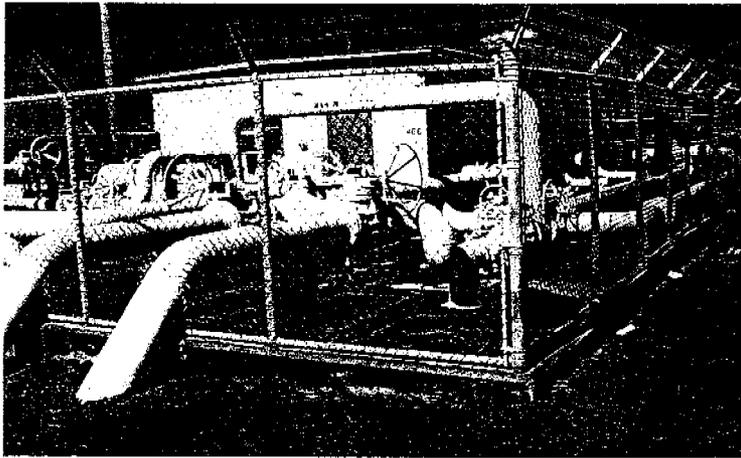
OWS No.: 0466

770 Gallons of sludge removed.
Inclined plate coalescer in very good condition

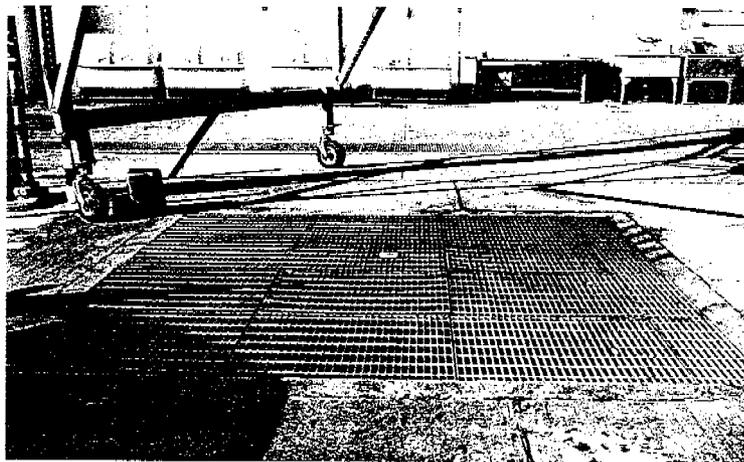
OWS No.: 0860

- **OWS-860** – This OWS had a hole in its side through which groundwater flowed into the OWS. Although this was only occurring in one location, it is quite possible that the concrete has deteriorated at other locations. Structural testing and analysis by a qualified structural engineer is required to determine the extent of damage and how to best repair the OWS.

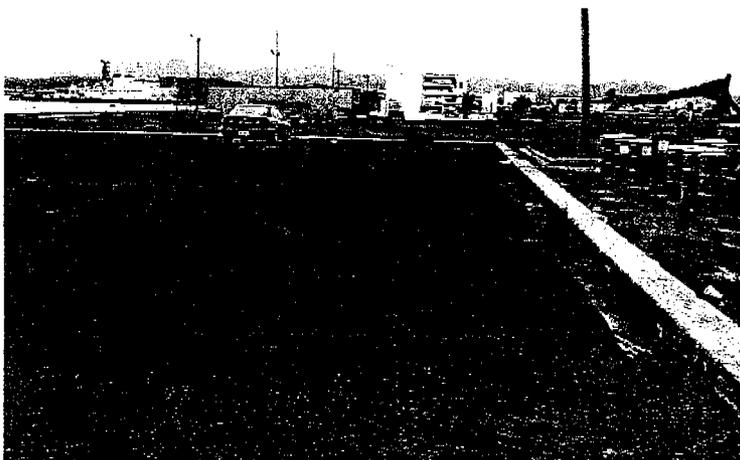
OWS No.: 2311

- **OWS-2311** – This OWS has significant crumbling aggregate and large cracks. The concrete is not easily repairable. Structural testing and analysis by a qualified structural engineer is required to determine the extent of damage and how to best repair the OWS. CH2M HILL recommends this OWS be abandoned since it also has drainage problems and the flow it receives can be easily routed to an adjacent OWS (OWS-2364).

- **OWS-2311** – The recommended solution is abandoning the OWS and routing its flow to an adjacent OWS (OWS-2364). A flow-limiting device would also need to be installed to prevent the OWS-2364 from exceeding its capacity.

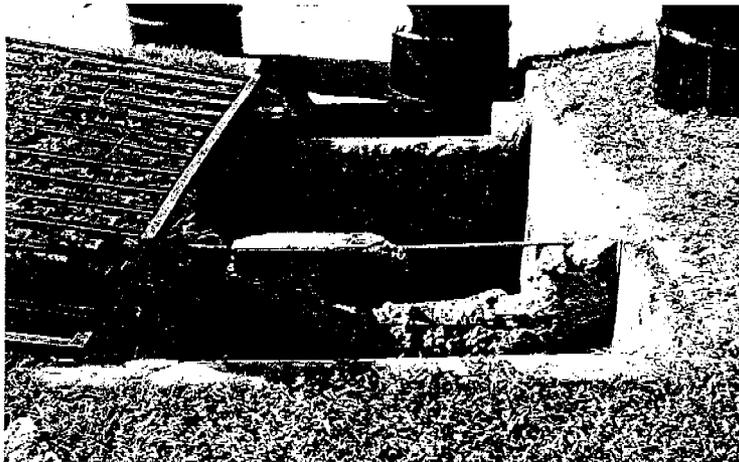
OWS No.: 3152

- **OWS-3152** – although this OWS does not have an excessive drainage area, it only has the capacity to treat approximately 50% of the stormwater generated by the design storm. This OWS is at Sea Bee Camp Bravo. Installation of a flow-limiting device is a possibility and the curb surrounding the washdown area are would prevent flooding of adjacent areas. Installation of a larger OWS is also a possibility and given the poor condition of this OWS, it may be the best alternative.

- **OWS-3152** – This OWS has significant exposed reinforcing steel and crumbling aggregate. Structural testing and analysis by a qualified structural engineer is required to determine the extent of damage and how to best repair the OWS.

- **OWS-3152** – Due to its structural and sizing problems, the recommended solution is installation of a new OWS or abandonment of the OWS.
