Final
Asbestos Inspection Report
for

Naval Activity Puerto Rico
Ceiba, Puerto Rico

Volume 3 of 7

Buildings 646 through 1698

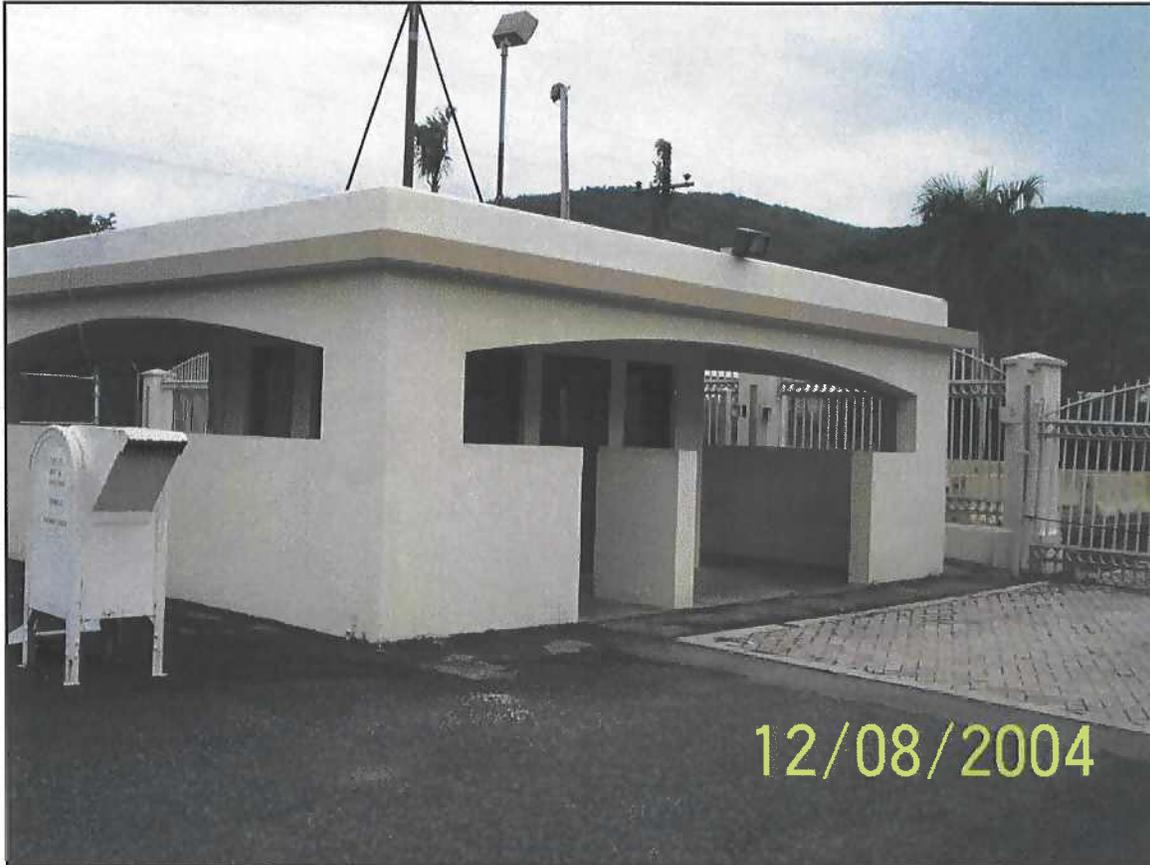
BUILDING 646

Building 646 is identified as “Gatehouse #3” and is approximately 506 square feet in size. Three suspect homogeneous materials were identified and sampled. None of these materials were found to be ACM.

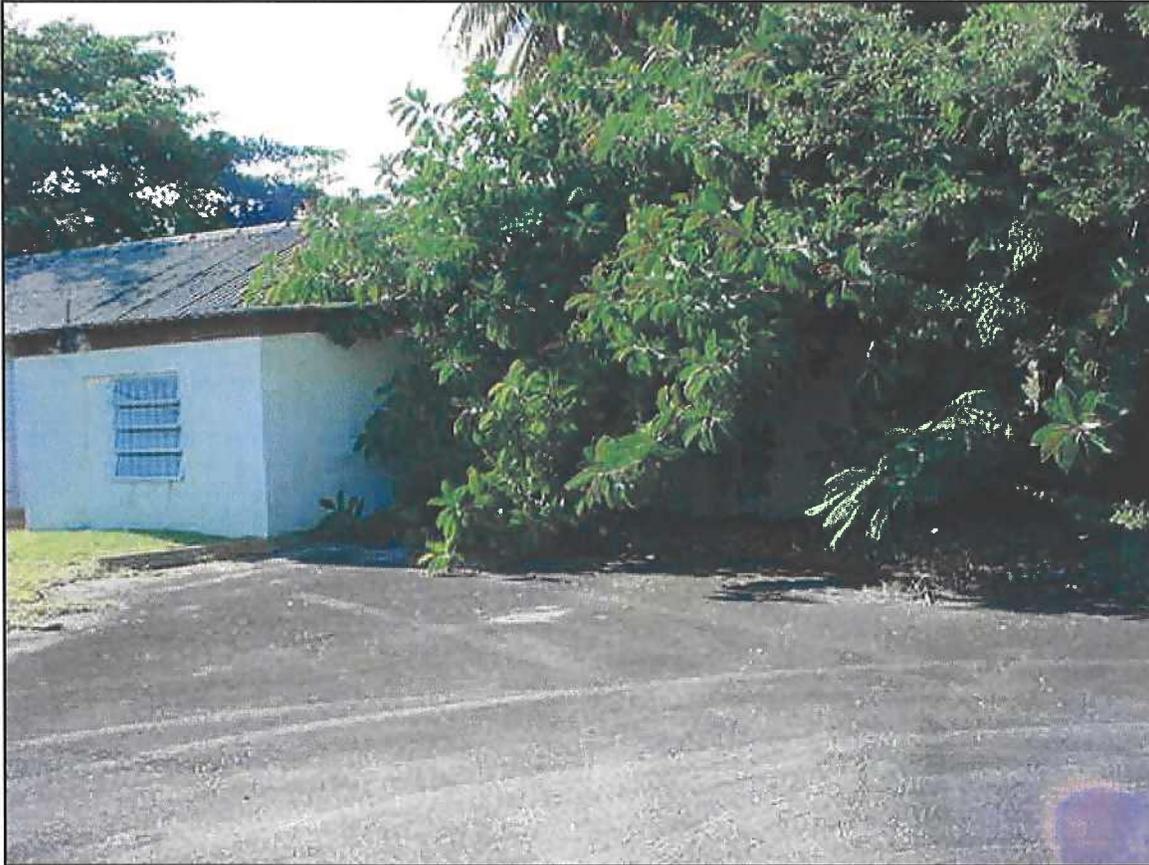
BUILDING 663

Building 663 is identified as “G.E./Contractor Admin” and is approximately 3,056 square feet in size. Ten suspect homogeneous materials were identified and sampled. One material, corrugated cement roof panels (Material #005), was found to be an ACM. No friable, damaged, and accessible ACM was identified.

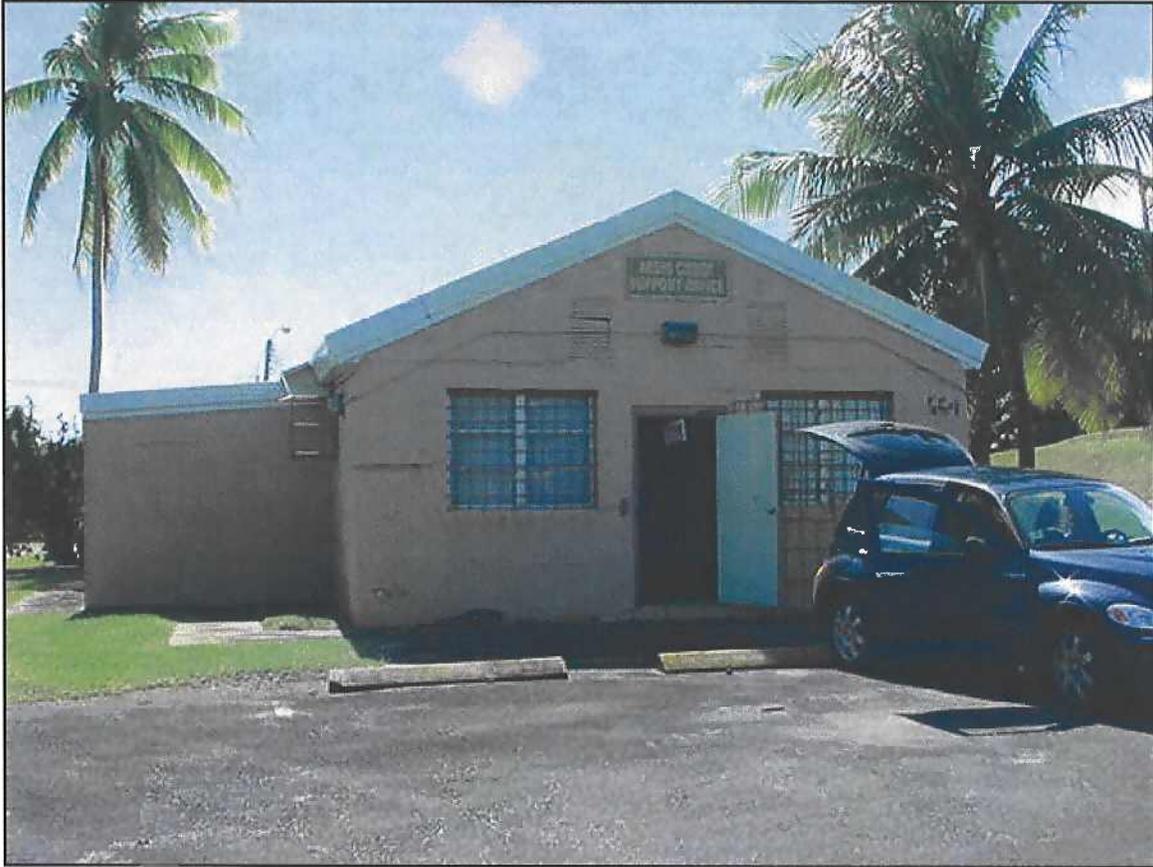
BUILDING 664

Building 664 is identified as “ROC Support Bldg” and is approximately 2,002 square feet in size. Four suspect homogeneous materials were identified and sampled. One material, floor adhesive (Material #002), was found to be an ACM. No friable, damaged, and accessible ACM was identified.

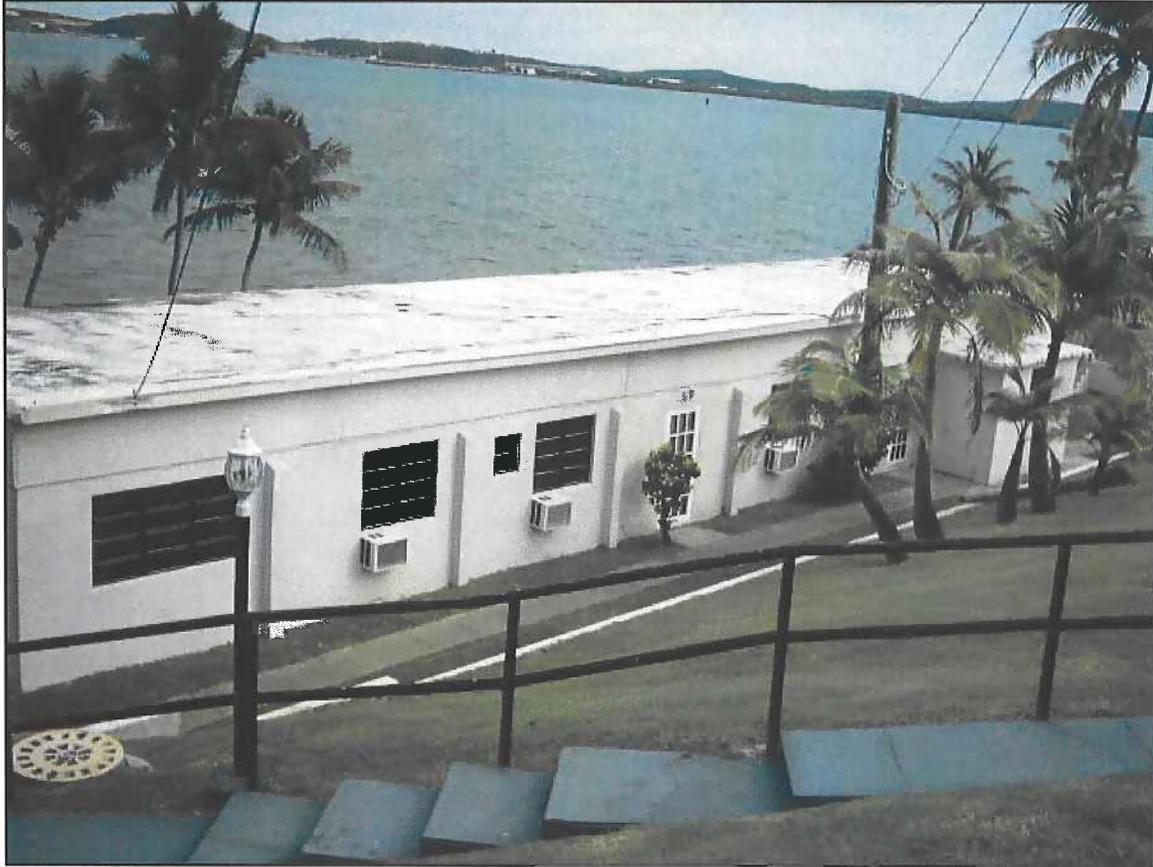
BUILDING 672

Building 672 is identified as “UOPH” and is approximately 2,231 square feet in size. Eight suspect homogeneous materials were identified and sampled. One material, residual black flooring adhesive (Material #001), was found to be an ACM. No friable, damaged, and accessible ACM was identified.

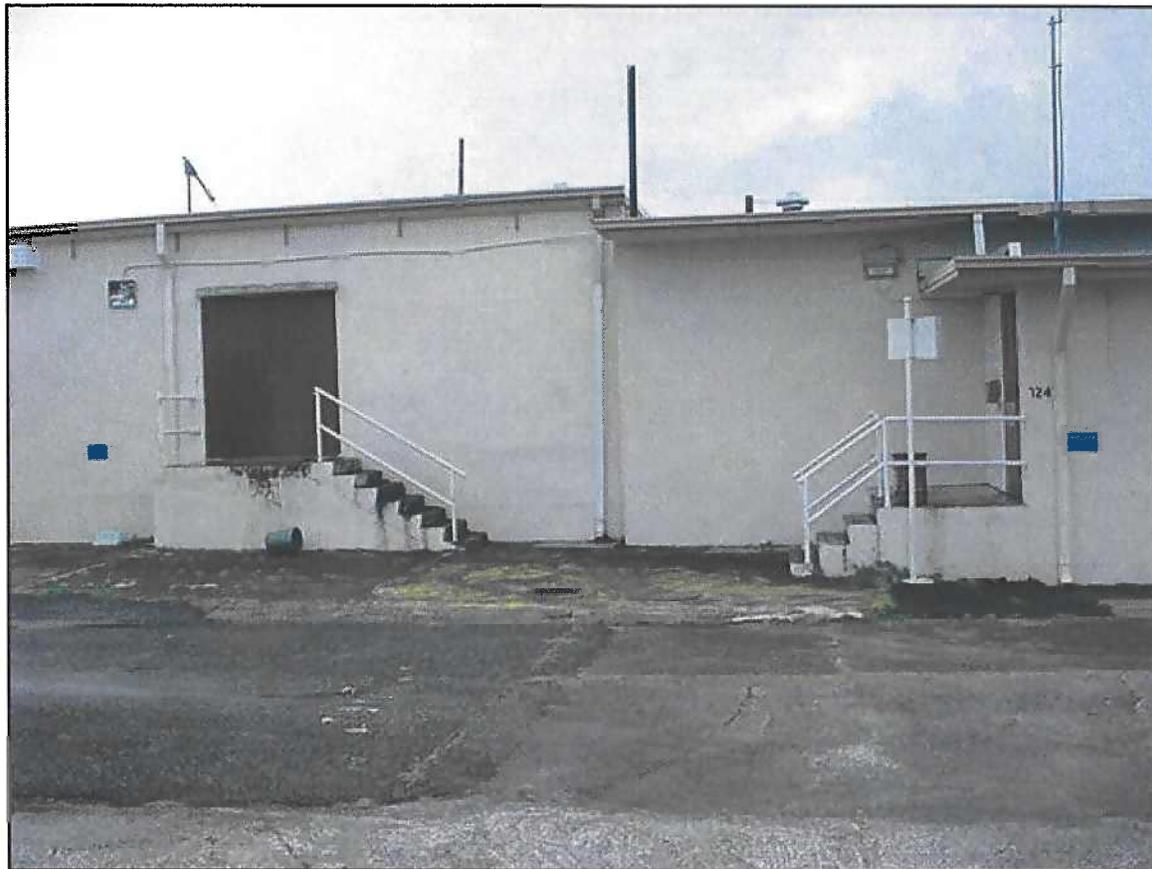
BUILDING 724

Building 724 is identified as “Naval Communications Center” and is approximately 15,030 square feet in size. Twenty eight suspect homogeneous materials were identified and sampled. Five materials were found to be ACM, including: vinyl floor tile (Material #005), floor adhesive (Material #011), exterior stucco (Material #016), interior stucco (Material #022), and wall tile adhesive (Material #026). No friable, damaged, and accessible ACM was identified.

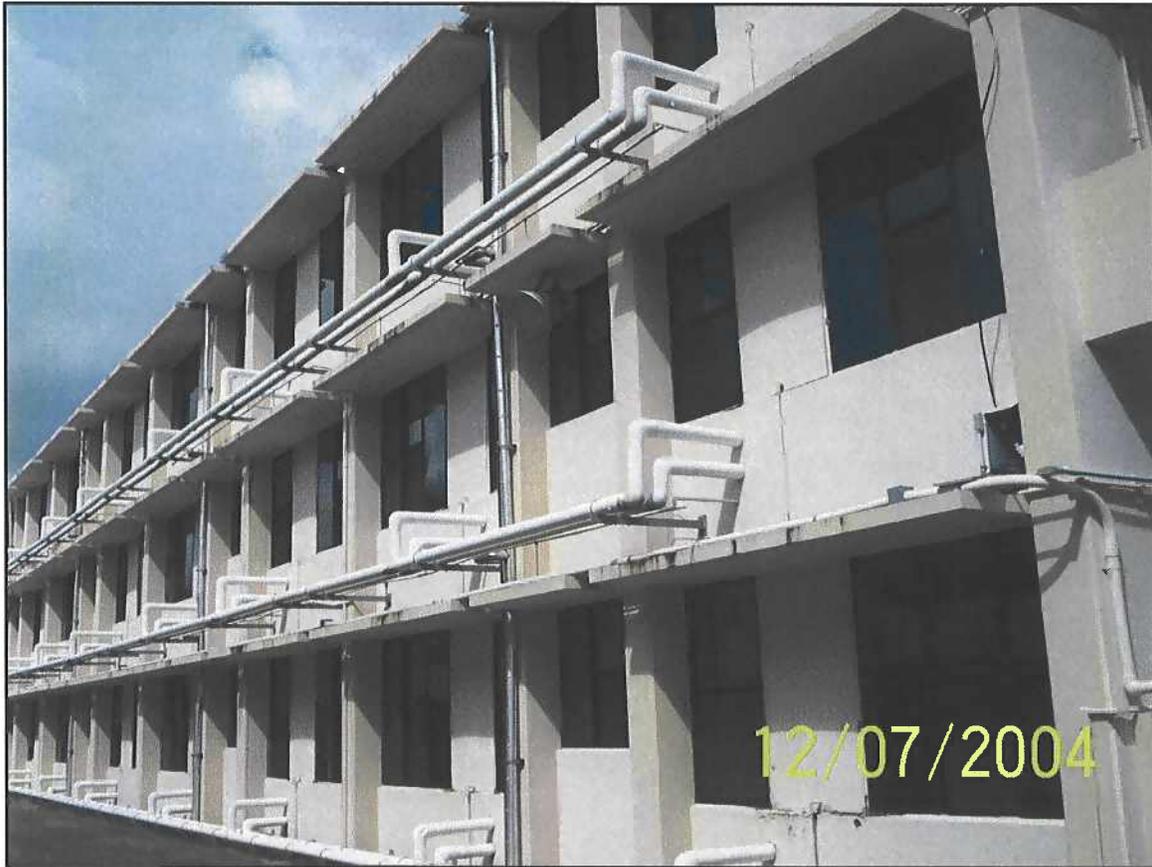
BUILDING 725

Building 725 is identified as “BOQ Tran Pty W3-W-5 & 03/Abv” and is approximately 11,996 square feet in size. Three suspect homogeneous materials were identified and sampled. None of these materials were found to be ACM.

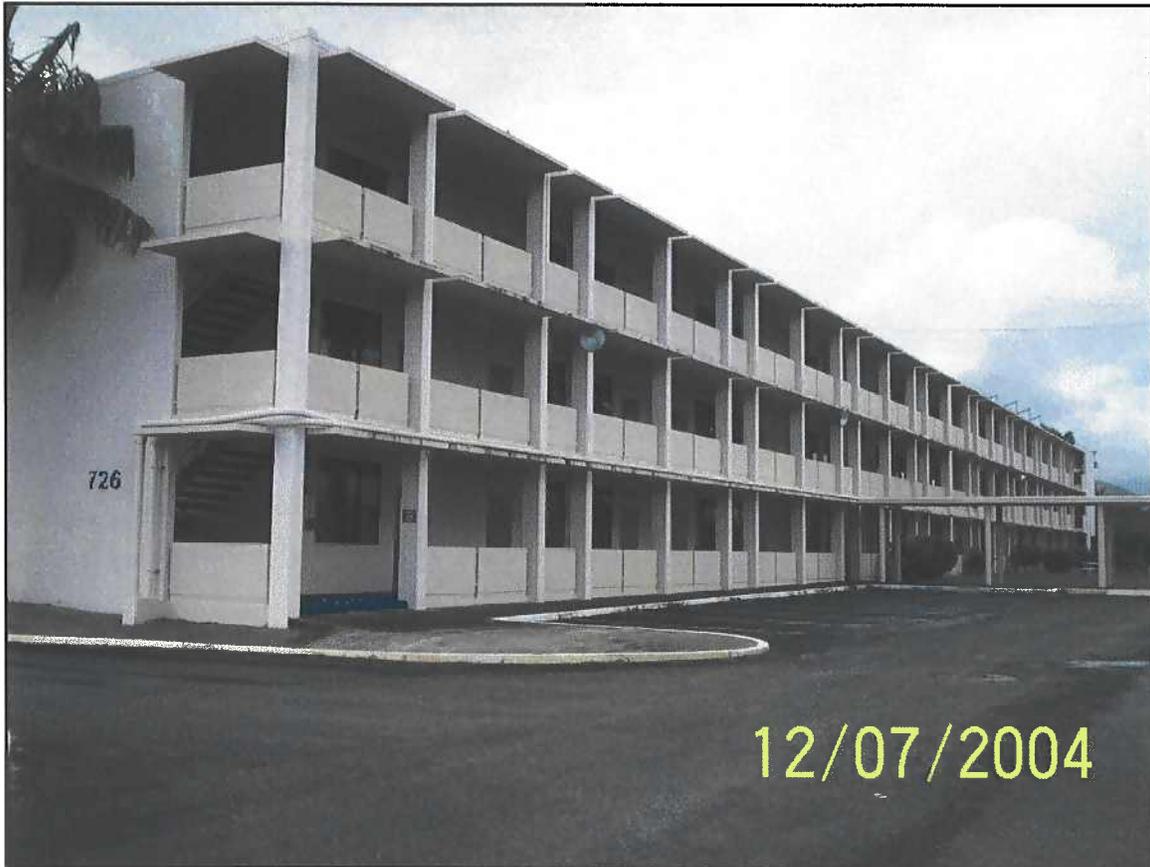
BUILDING 726

Building 726 is identified as “BOQ Tran W3/W5 & 03/Above” and is approximately 21,207 square feet in size. Three suspect homogeneous materials were identified and sampled. None of these materials were found to be ACM.

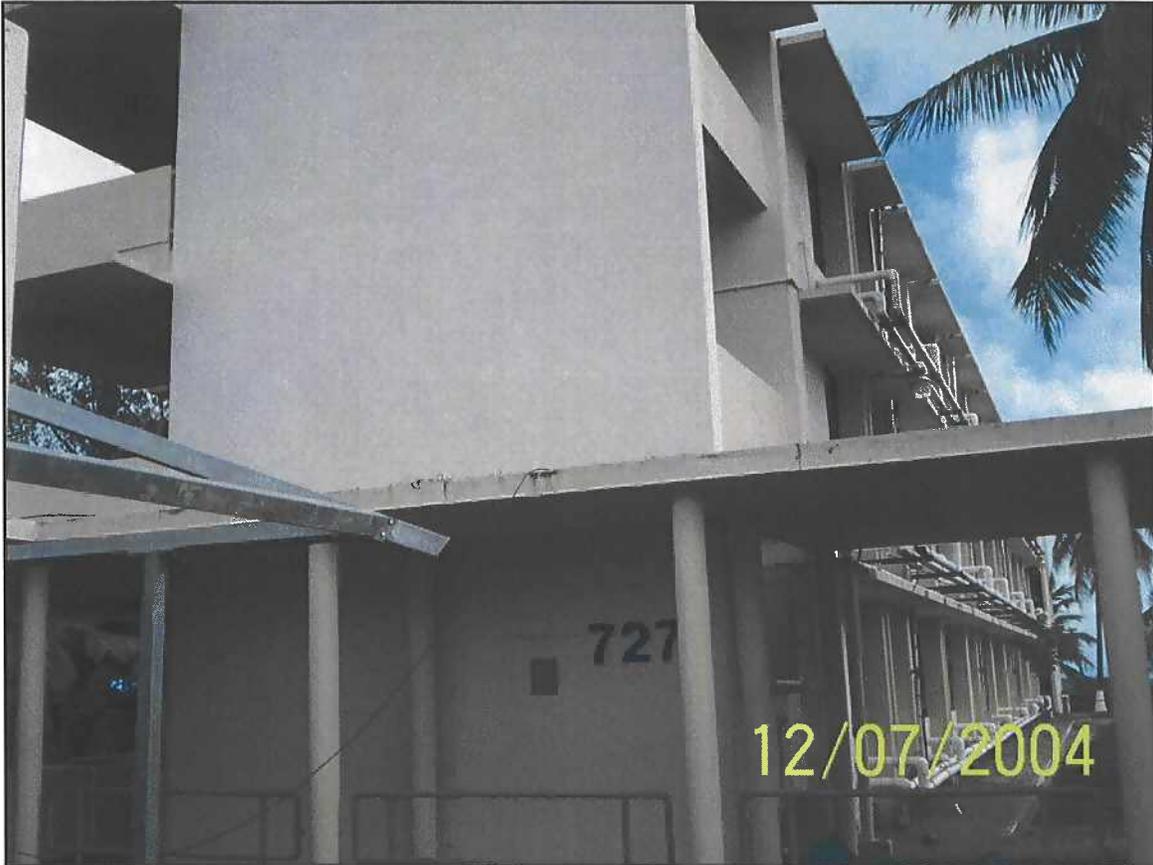
BUILDING 727

Building 727 is identified as “BOQ Tran W3/W5 & 03/Above” and is approximately 11,996 square feet in size. Three suspect homogeneous materials were identified and sampled. None of the materials were found to be ACM.

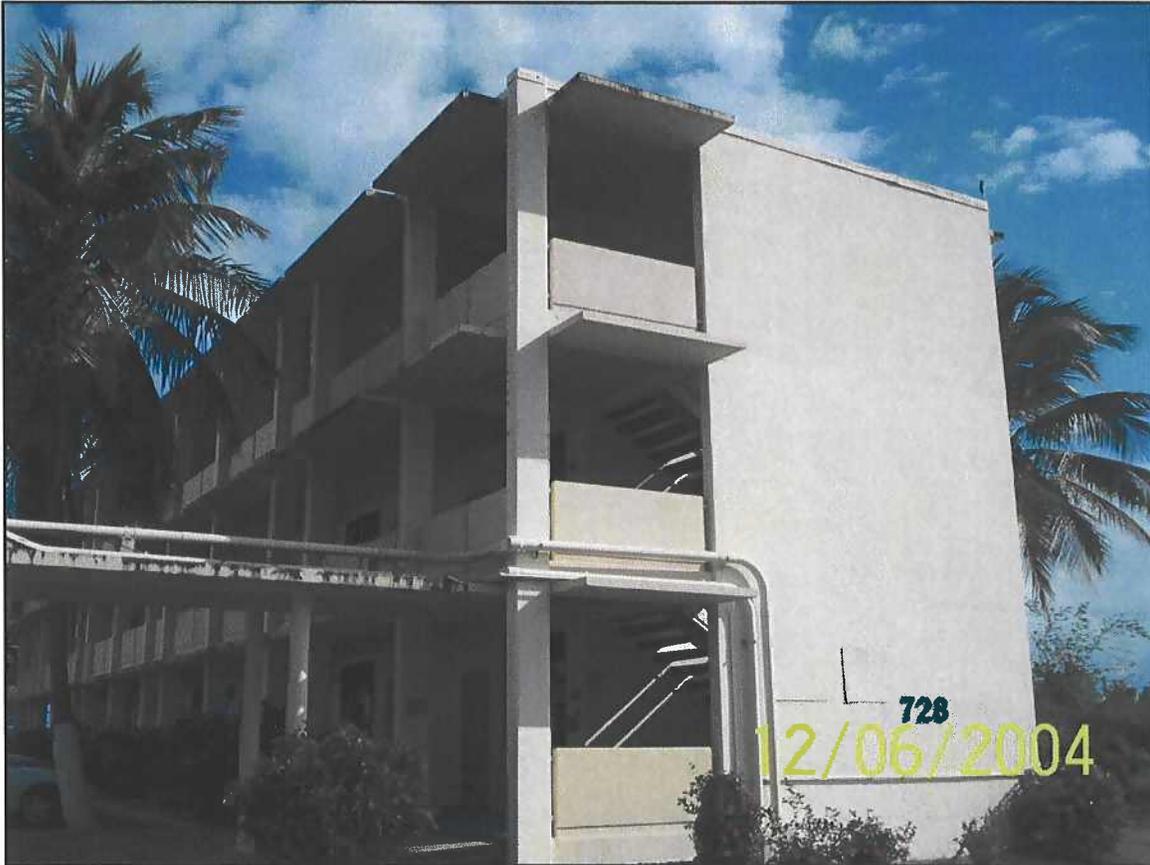
BUILDING 728

Building 728 is identified as “BOQ Trans W3/W5 & 03/Above” and is approximately 11,901 square feet in size. Three suspect homogeneous materials were identified and sampled. None of the materials were found to be ACM.

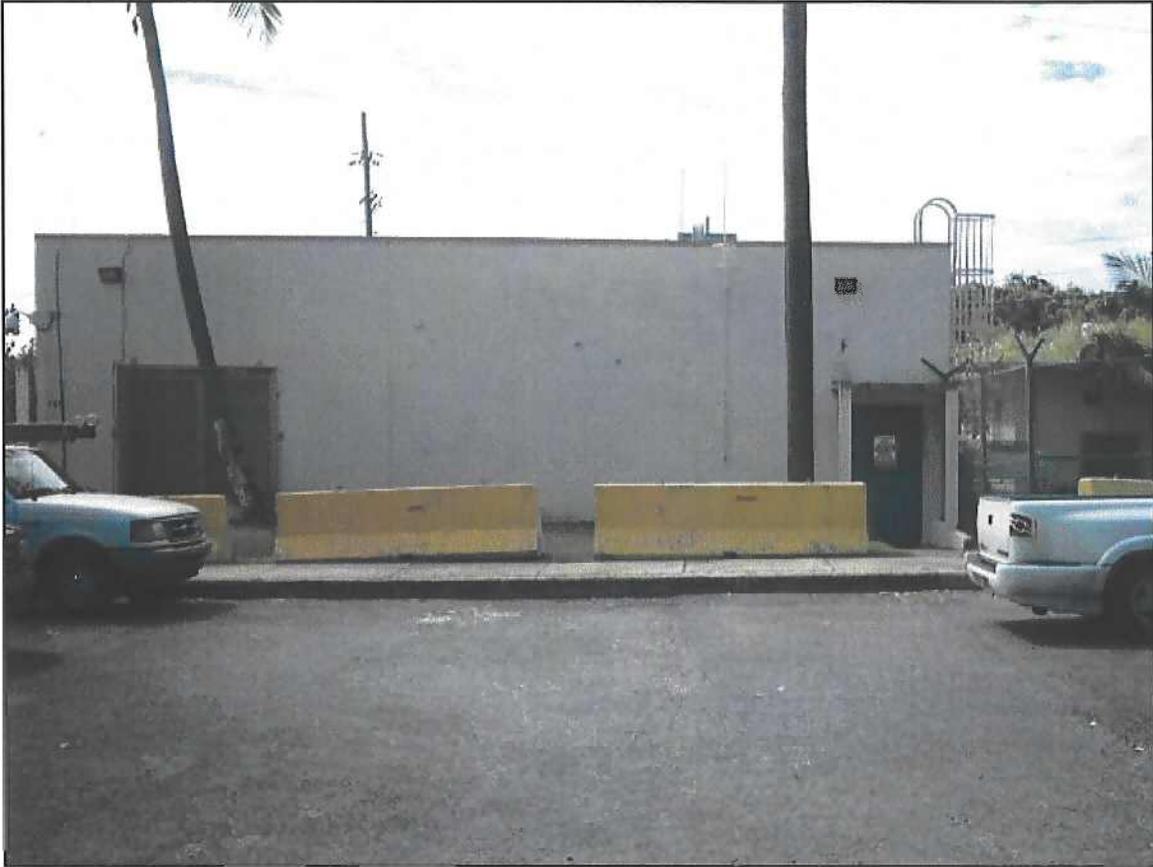
BUILDING 737

Building 737 is identified as “NAVCOMMSTA Building” and is approximately 3,140 square feet in size. Nine suspect homogeneous materials were identified and sampled. Two materials, two types of floor adhesive (Materials #002 and #008), were found to be ACM. No friable, damaged, and accessible ACM was identified.

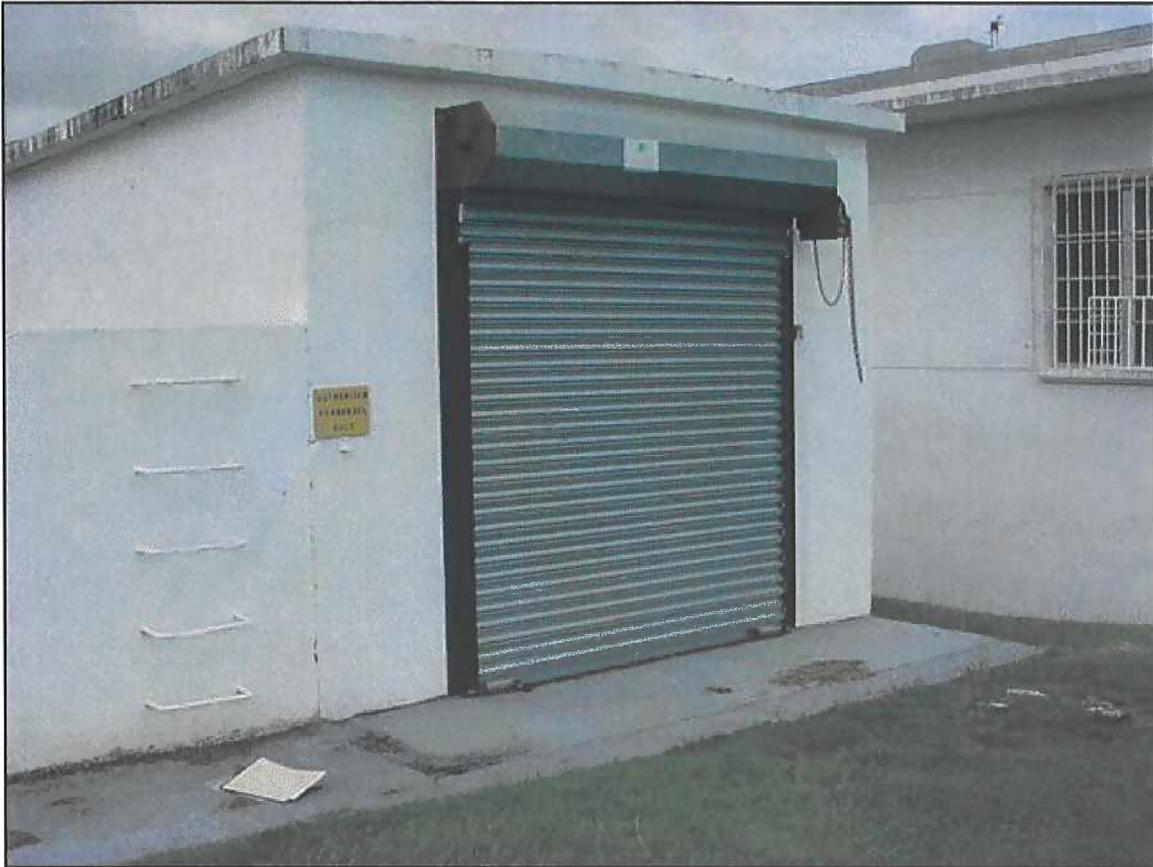
BUILDING 760

Building 760 is identified as “Misc Stge by Bldg. 598” and is approximately 228 square feet in size. No suspect materials were identified. Therefore, no sampling was conducted.

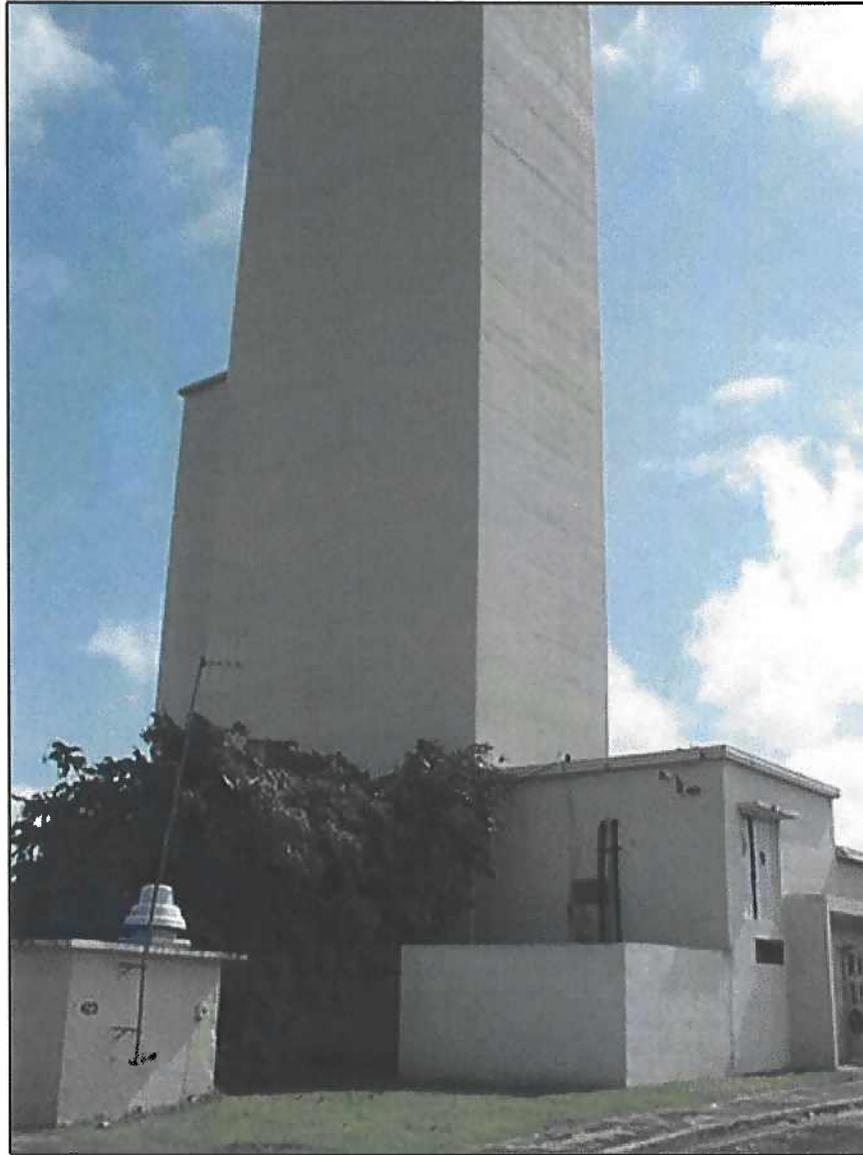
Building 777 is identified as “Survival Equipment Shop” and is approximately 8,715 square feet in size. Eleven suspect homogeneous materials were identified and sampled. Four materials, two types of floor adhesive (Materials #004 and #006), vinyl floor tile (Material #005), and cove base adhesive (Material #007), were found to be ACM. No friable, damaged, and accessible ACM was identified.

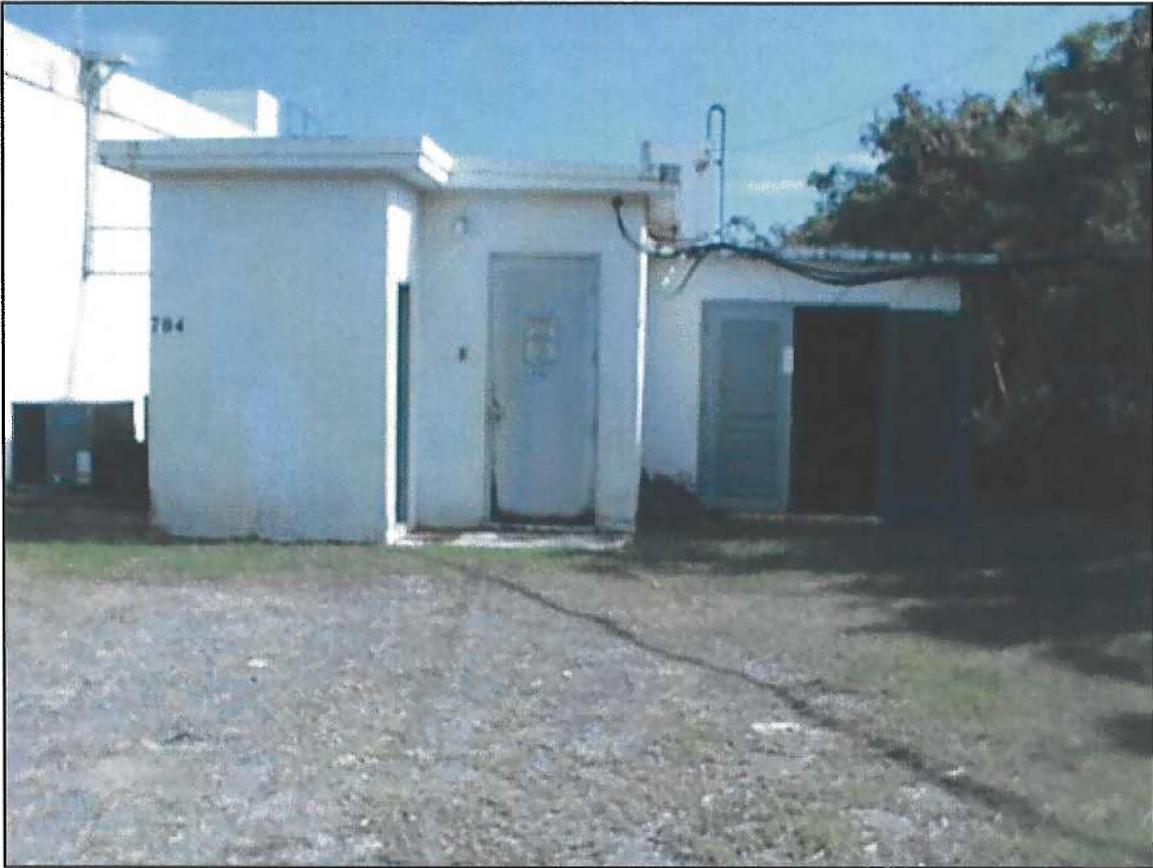
Building 784 is identified as “Tacan Unit/Gen Building” and is approximately 550 square feet in size. Seven suspect homogeneous materials were identified and sampled. Three materials were found to be an ACM, including: vinyl floor tile (Material #001), floor adhesive (Material#002), and cove base adhesive (Material #004). No friable, damaged, and accessible ACM was identified.

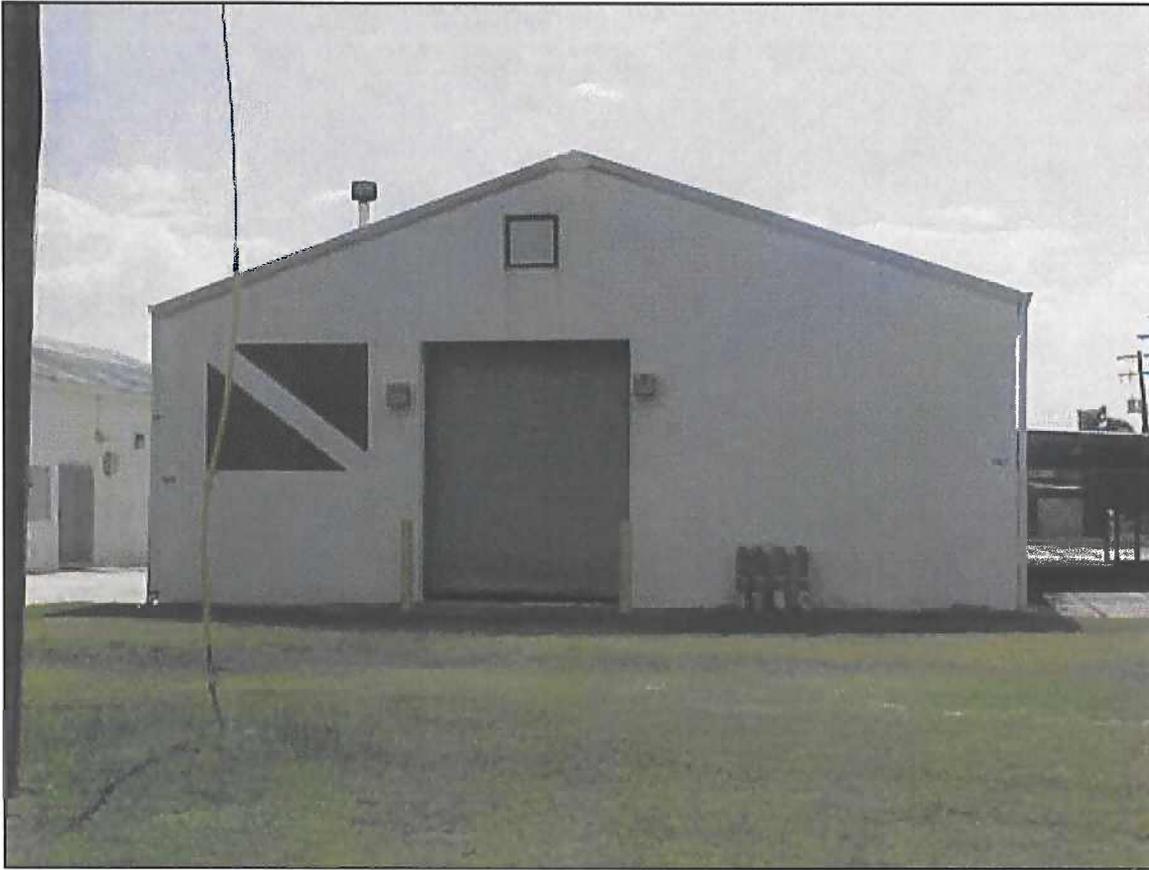
Building 787 is identified as “Nav Spec War Unit 4 Maantshop” and is approximately 4,000 square feet in size. Seven suspect homogeneous materials were identified and sampled. None of the materials were found to be ACM.

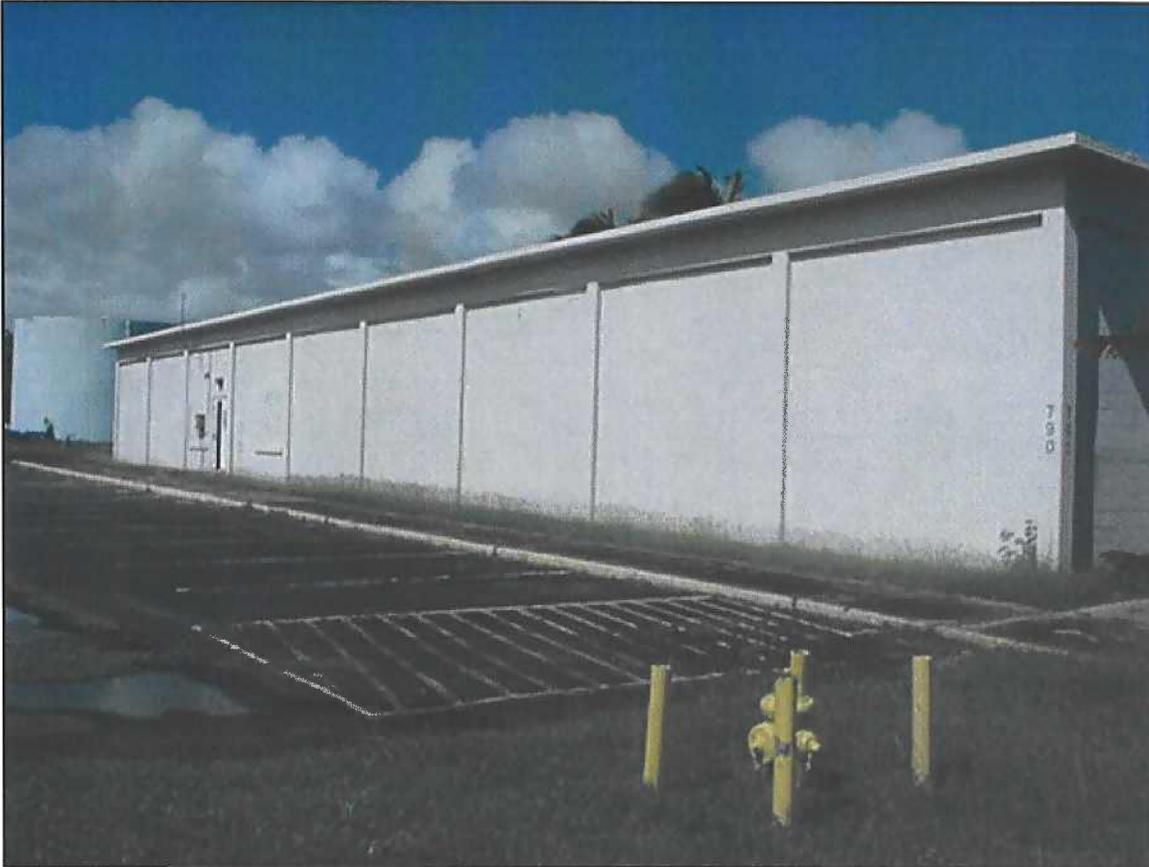
Building 790 is identified as “Photo Lab” and is approximately 6,758 square feet in size. Sixteen suspect homogeneous materials were identified and sampled. Five materials, two types of vinyl floor tile (Materials #001 and #004) and three types of floor adhesive (Materials #002, #009, and #011), were found to be ACM. No friable, damaged, and accessible ACM was identified.

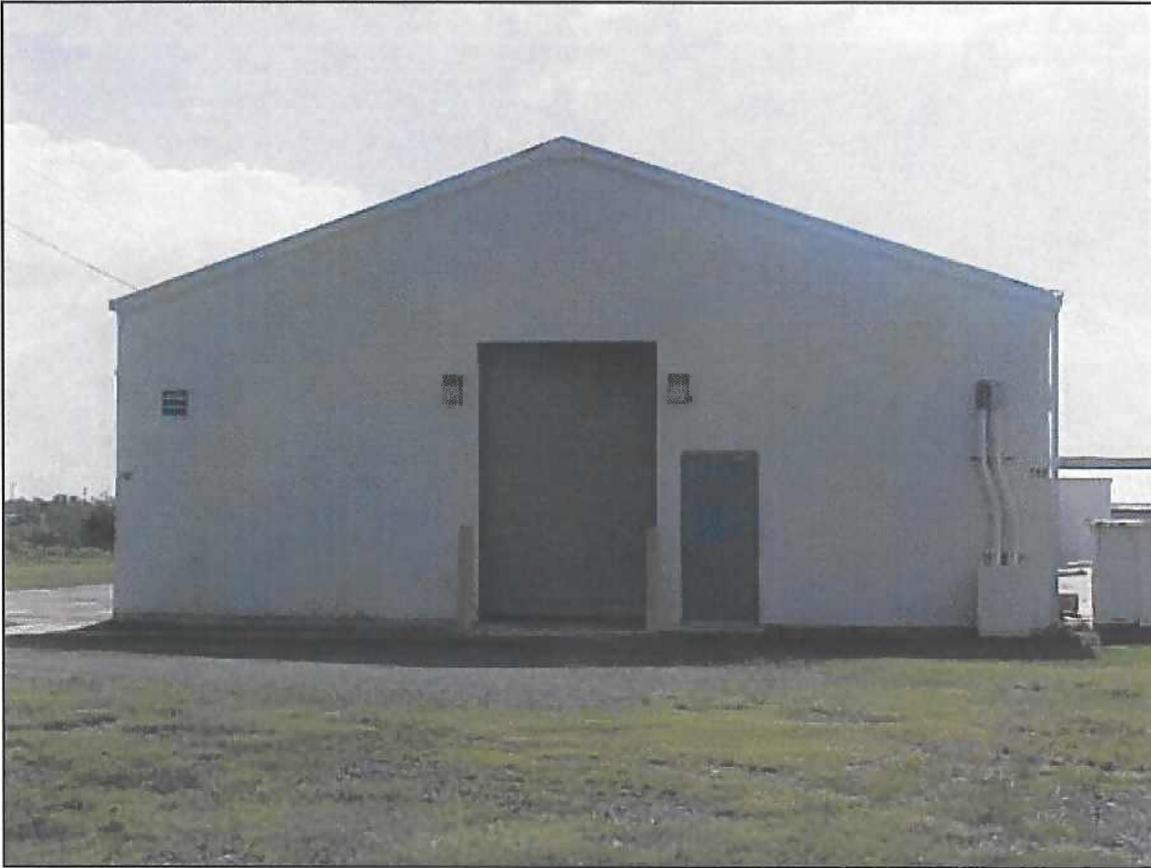
Building 792 identified as “NSWU-4 Veh/Boat Shop Maint” and is approximately 4,000 square feet in size. Six suspect homogeneous materials were identified and sampled. None of the materials were found to be ACM.

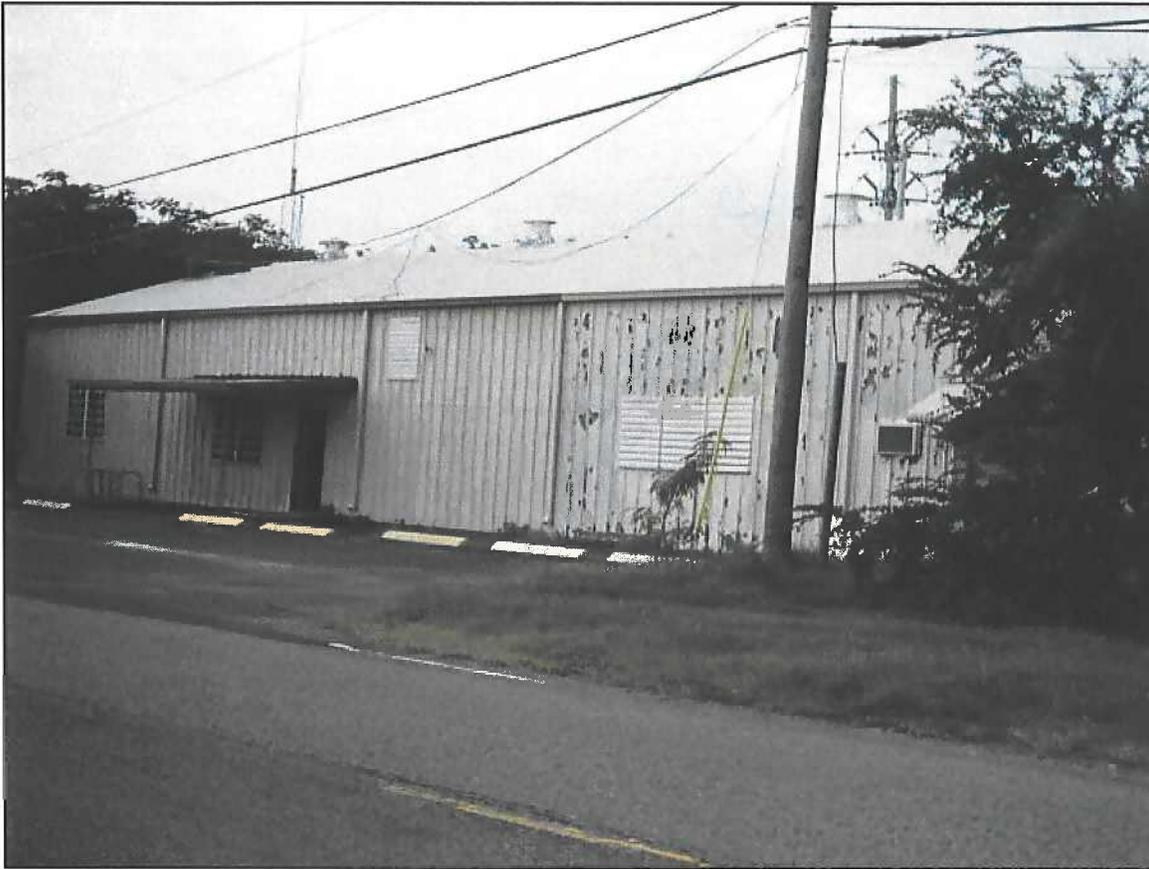
Building 793 is identified as “Self Help / Thrift Shop / Teen C” and is approximately 6,400 square feet in size. Six suspect homogeneous materials were identified and sampled. One material, carpet adhesive (Material #005), was found to be an ACM. No friable, damaged, and accessible ACM was identified.

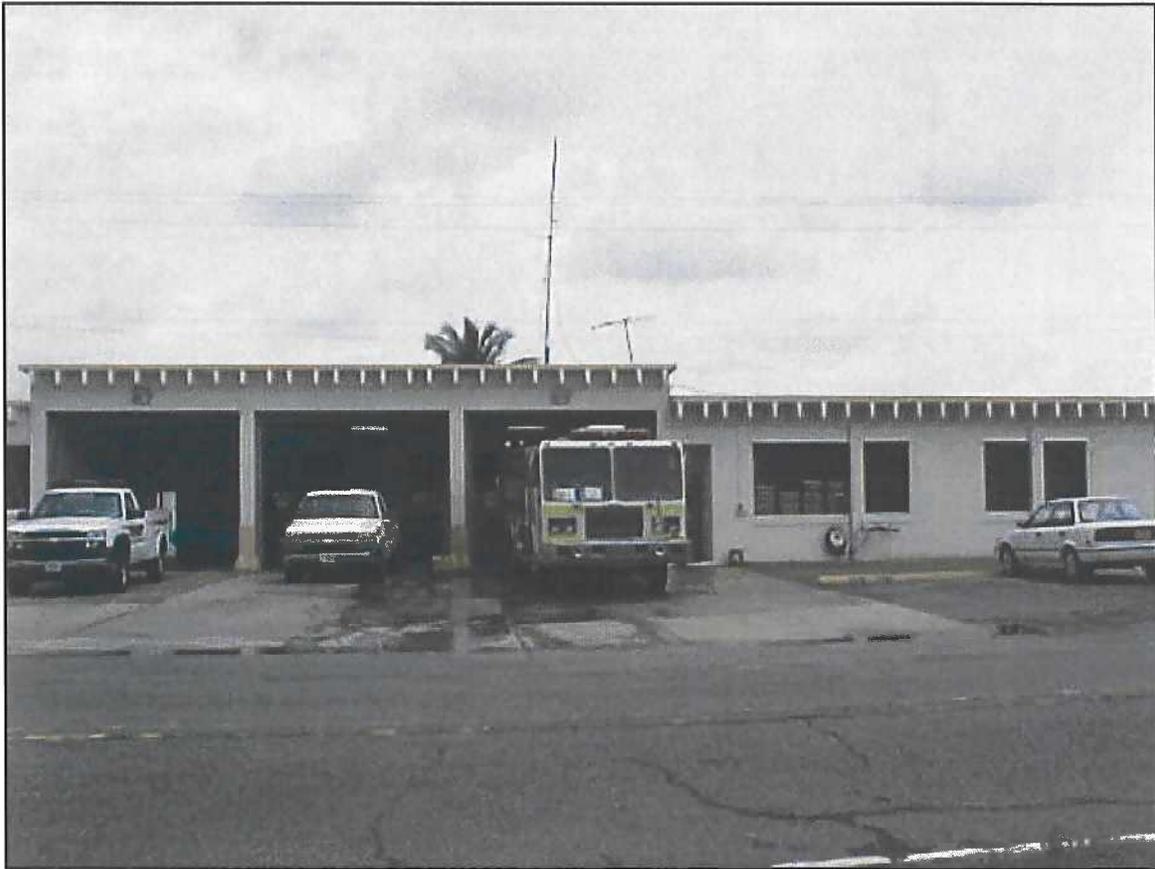
Building 798 is identified as “Structural Fire Station” and is approximately 4,348 square feet in size. 12 suspect homogeneous materials were identified and sampled. Four materials, two types of floor adhesive (Materials #002 and #010), vinyl floor tile (Material #009), and asphaltic roofing material (Material #011), were found to be ACM. No friable, damaged, and accessible ACM was identified.

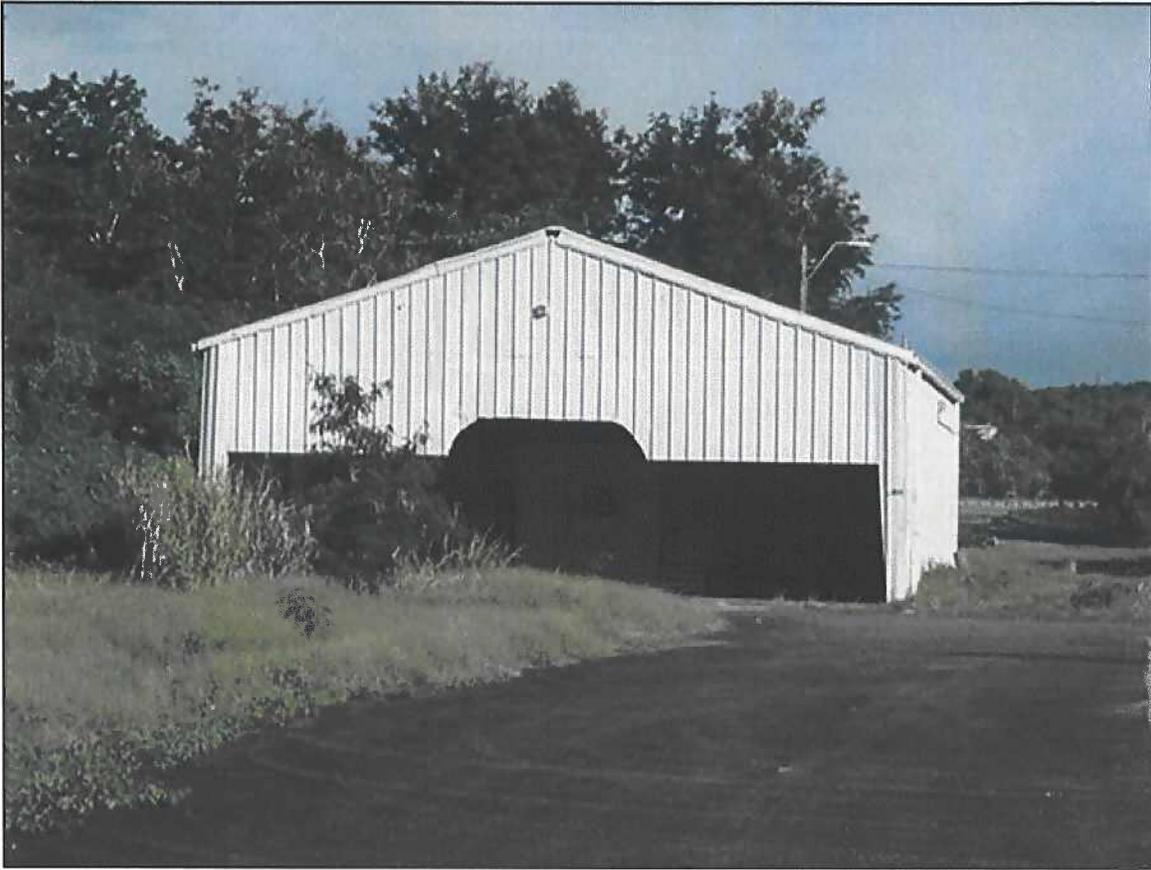
Building 801 is identified as “Flying Club” and is approximately 2,400 square feet in size. Five suspect homogeneous materials were identified and sampled. None of these materials were found to be ACM.

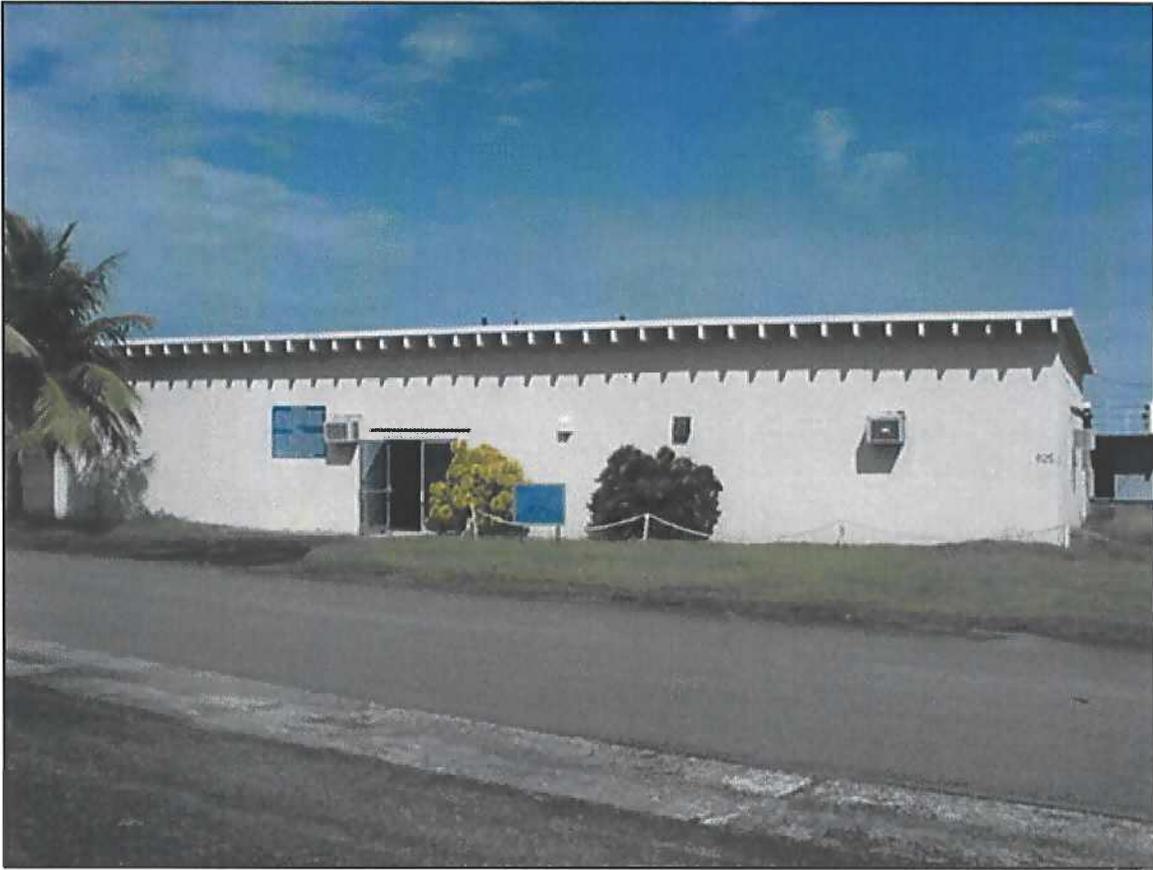
Building 825 is identified as “Q2C Drone Storage” and is approximately 3,200 square feet in size. Six suspect homogeneous materials were identified and sampled. Five materials were found to be ACM, including joint compound associated with wallboard (Material #001), two types of vinyl floor tile (Materials #002 and #004), floor adhesive (Material #003), and cove base adhesive (Material #005). No friable, damaged, and accessible ACM was identified.

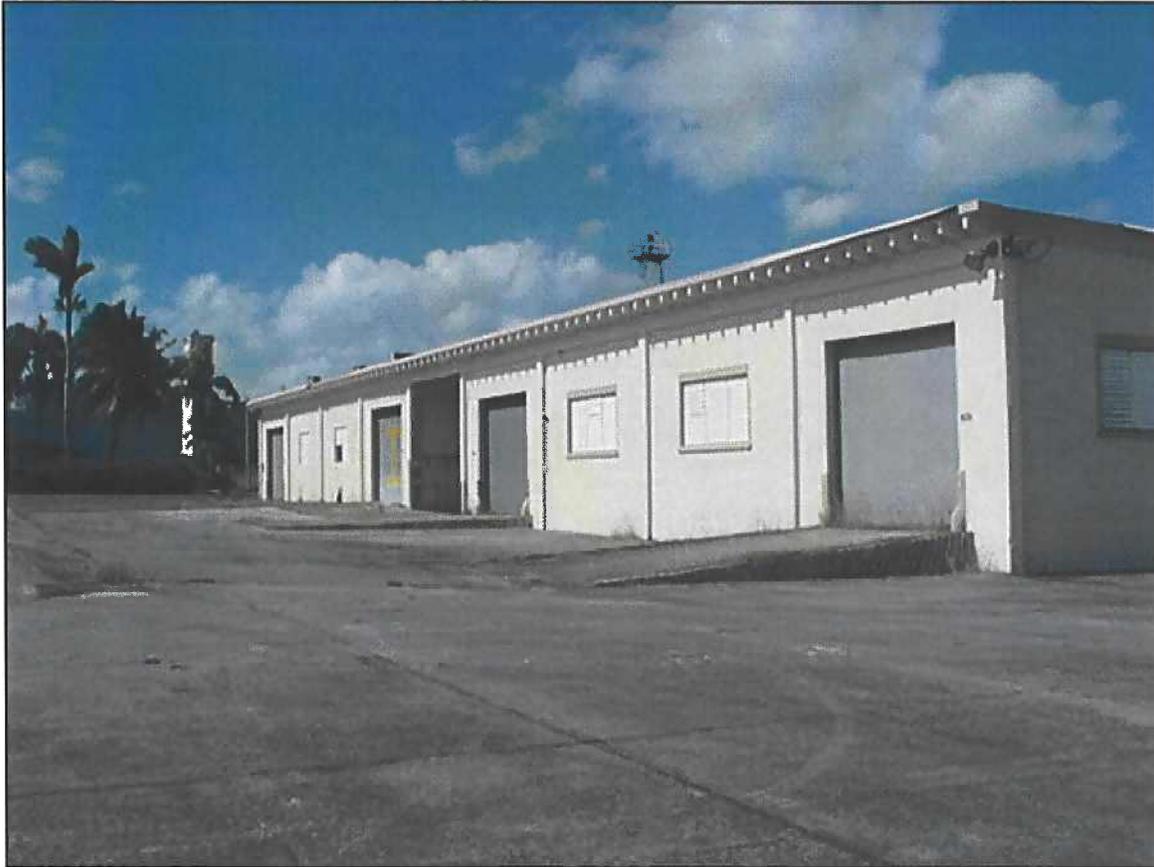
Building 826 is identified as “Ground Support Shop” and is approximately 6,920 square feet in size. Ten suspect homogeneous materials were identified and sampled. Two of these materials, two types of floor adhesive (Materials #003 and #007), were found to be ACM. No friable, damaged, and accessible ACM was identified.
