Final
Asbestos Inspection Report
for

Naval Activity Puerto Rico
Ceiba, Puerto Rico

Volume 3 of 7

Buildings 646 through 1698

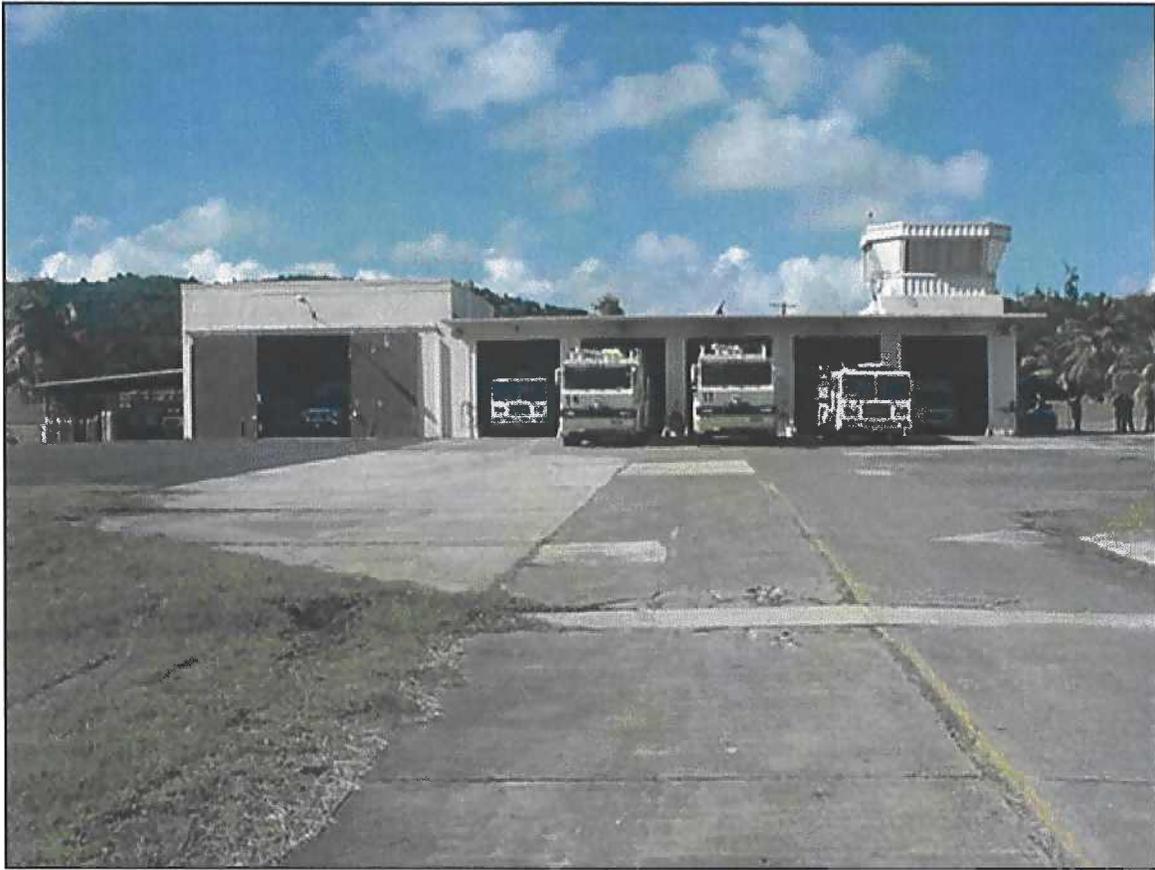
Building 827 is identified as “ACFT Fire Rescue Sta” and is approximately 6,585 square feet in size. Sixteen suspect homogeneous materials were identified and sampled. Three materials, floor adhesive (Material #002) and two types of vinyl floor tile (Materials #011 and #012), were found to be an ACM. No friable, damaged, and accessible ACM was identified.

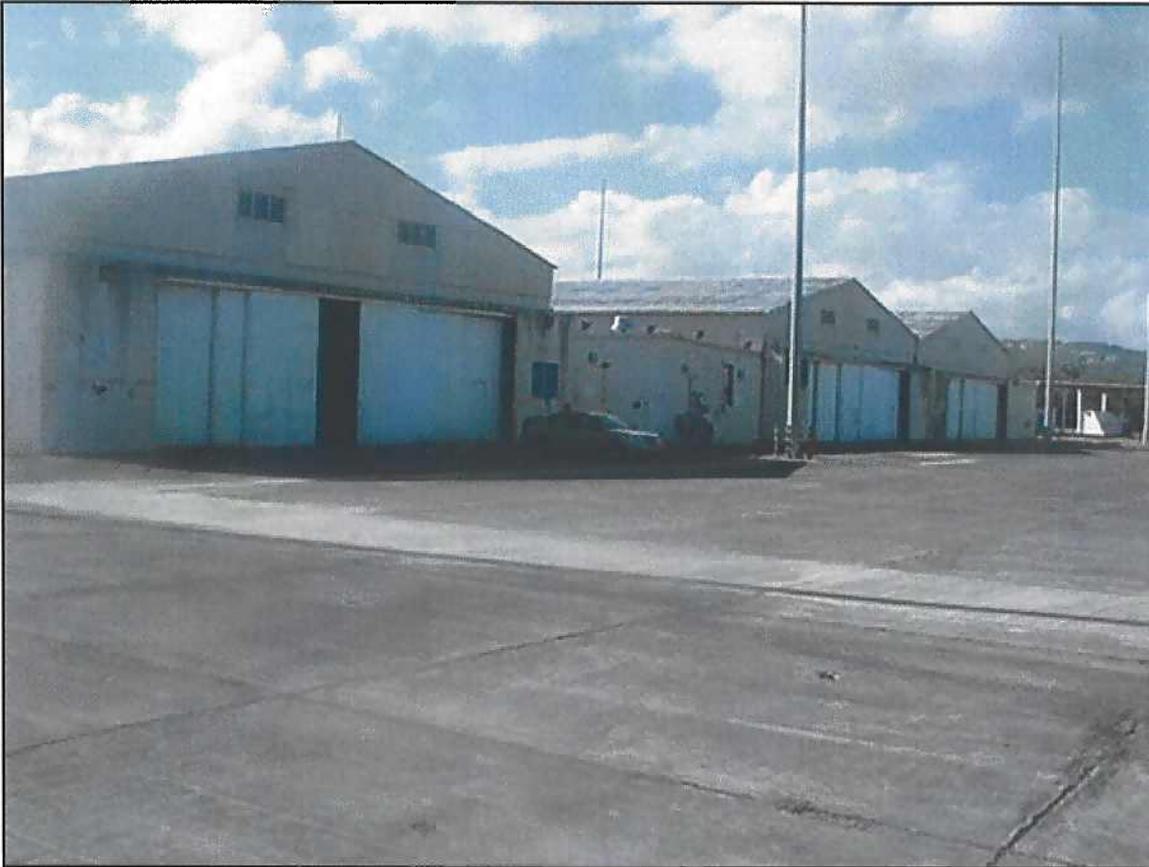
Building 860 is identified as “Drone Support Bldg” and is approximately 29,172 square feet in size. Fifteen suspect homogeneous materials were identified and sampled. Seven materials were found to be ACM, including: two types of floor adhesive (Materials #003 and #007), two types of vinyl floor tile (Materials #005 and #011), ceiling tiles (Material #010), and roofing material (Material #013). No friable, damaged, and accessible ACM was identified.

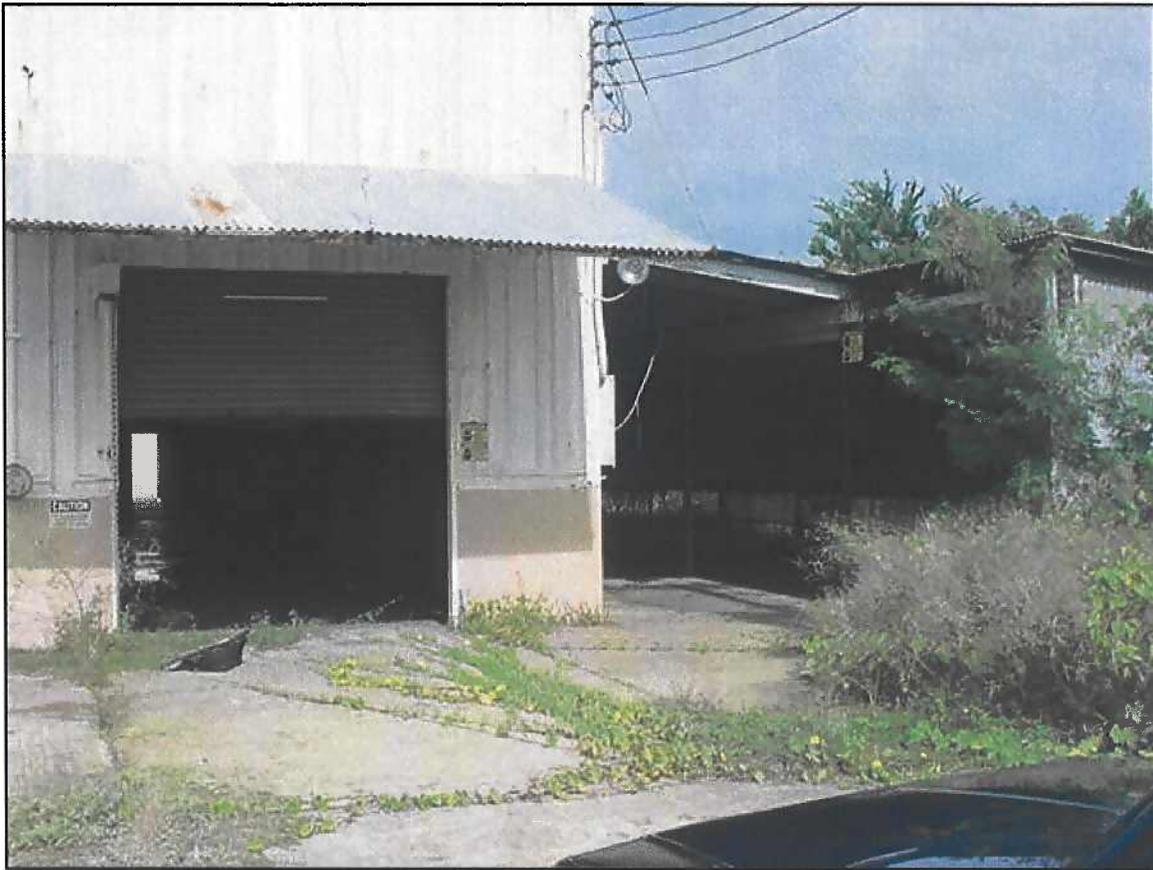
Building 870 is identified as “ASROC Facility” and is approximately 2,499 square feet in size. Three suspect homogeneous materials were identified and sampled. Two materials, two types of asphaltic roofing (Materials #001 and #002), were found to be ACM. No friable, damaged, and accessible ACM was identified.

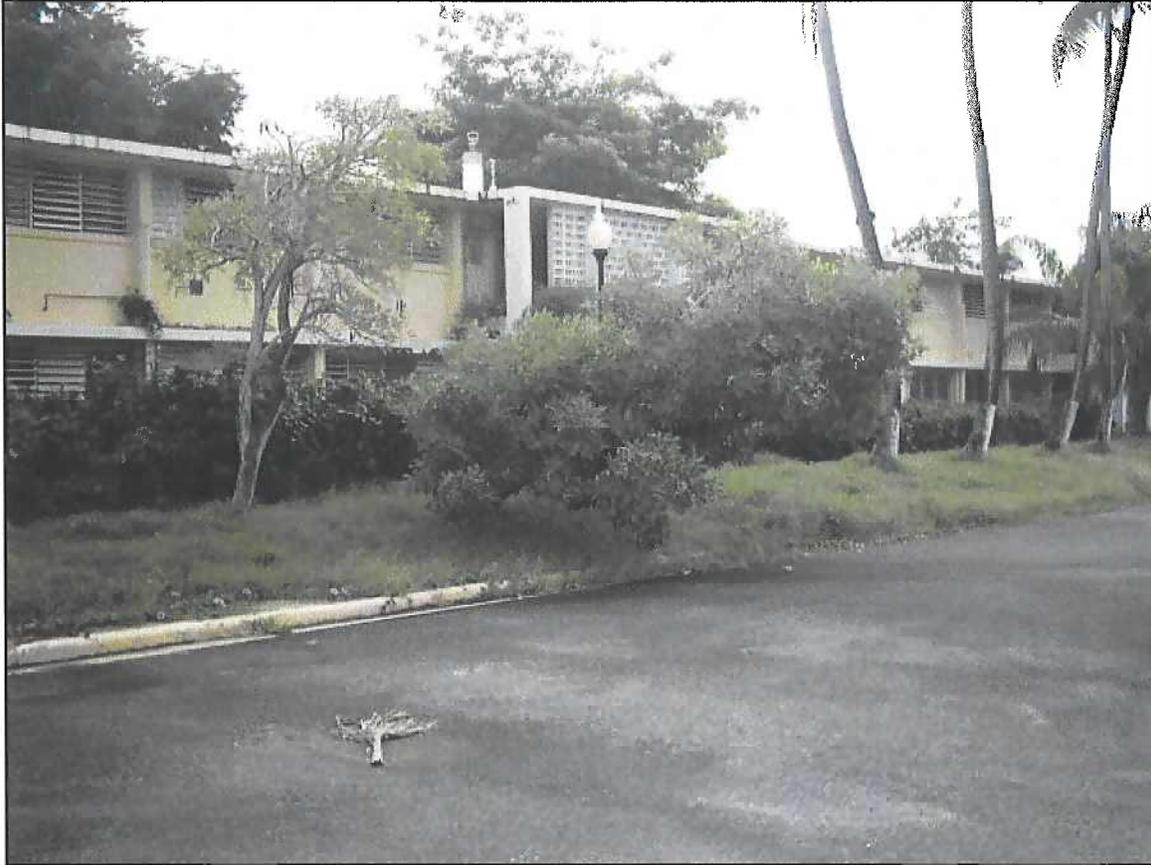
Building 885 is identified as “Personal Property Building” and is approximately 8,168 square feet in size. Ten suspect homogeneous materials were identified and sampled. Eight materials, four types of vinyl floor tile (Materials #002, #004, #006, and #008) and associated adhesives (Materials #003, #005, #007, and #009), were found to be ACM. No friable, damaged, and accessible ACM was identified.

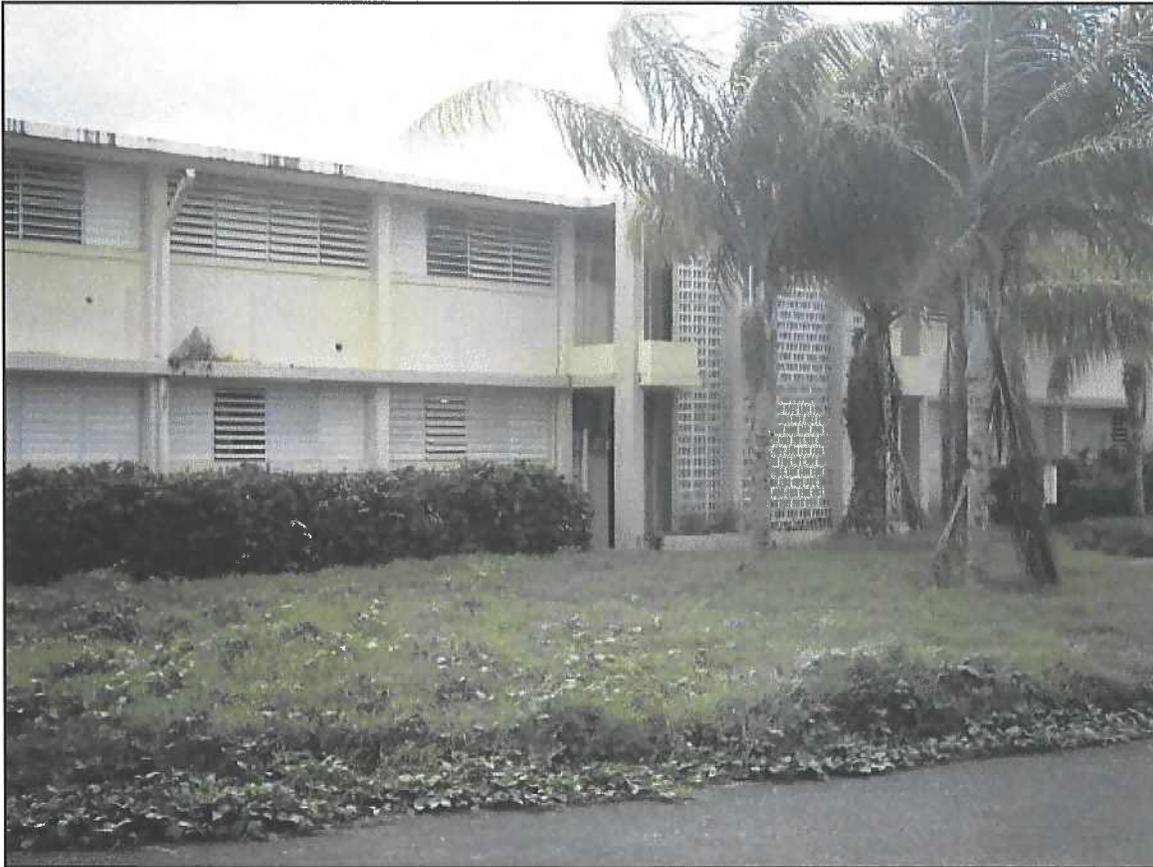
Building 887 is identified as “Navy College” and is approximately 5,096 square feet in size. Thirteen suspect homogeneous materials were identified and sampled. Five of these materials, three types of floor adhesive (Materials #003, #007, and #011) and two types of vinyl floor tile (Materials #004 and #006), were found to be ACM. No friable, damaged, and accessible ACM was identified.

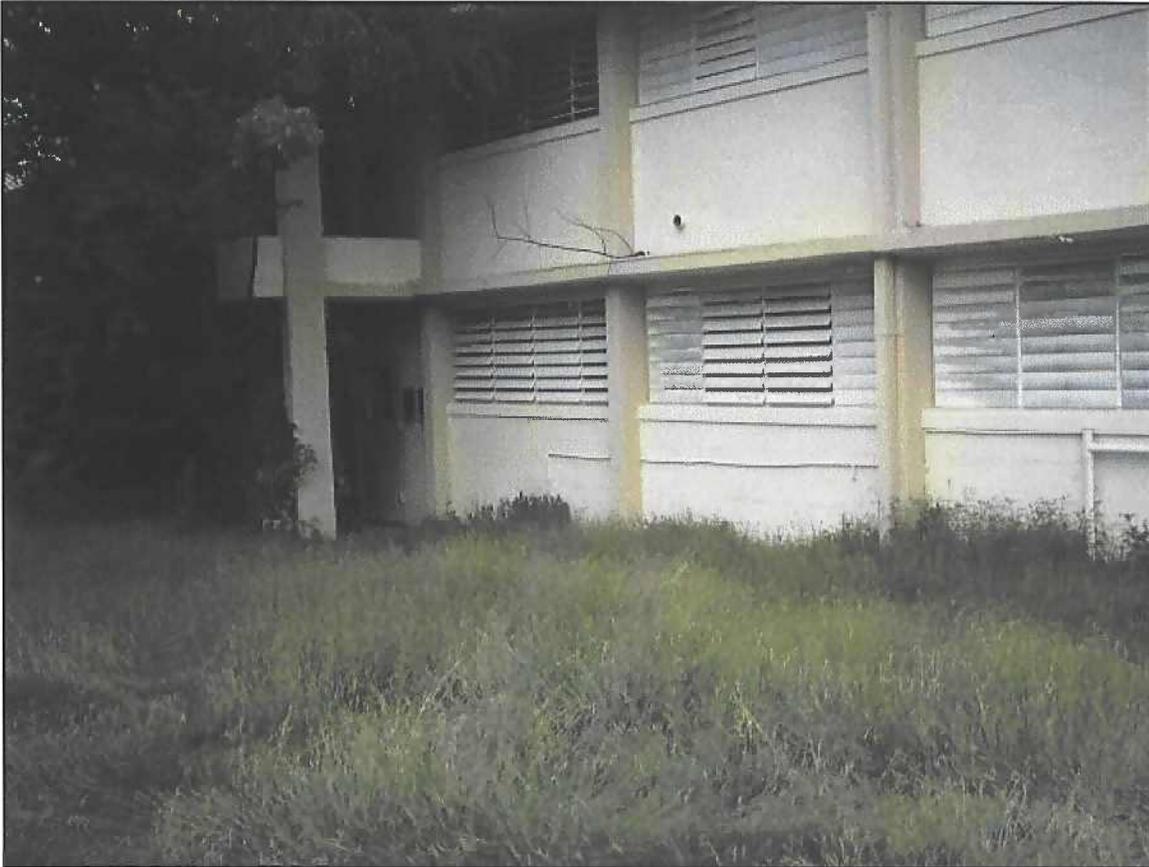
Building 888 is identified as “Medical Clinics (EIP/MDO)” and is approximately 7,918 square feet in size. Thirteen suspect homogeneous materials were identified and sampled. Five of these materials, three types of vinyl floor tile (Materials #008, #010, and #012) and two types of floor adhesive (Material #011 and #013), were found to be ACM. No friable, damaged, and accessible ACM was identified.

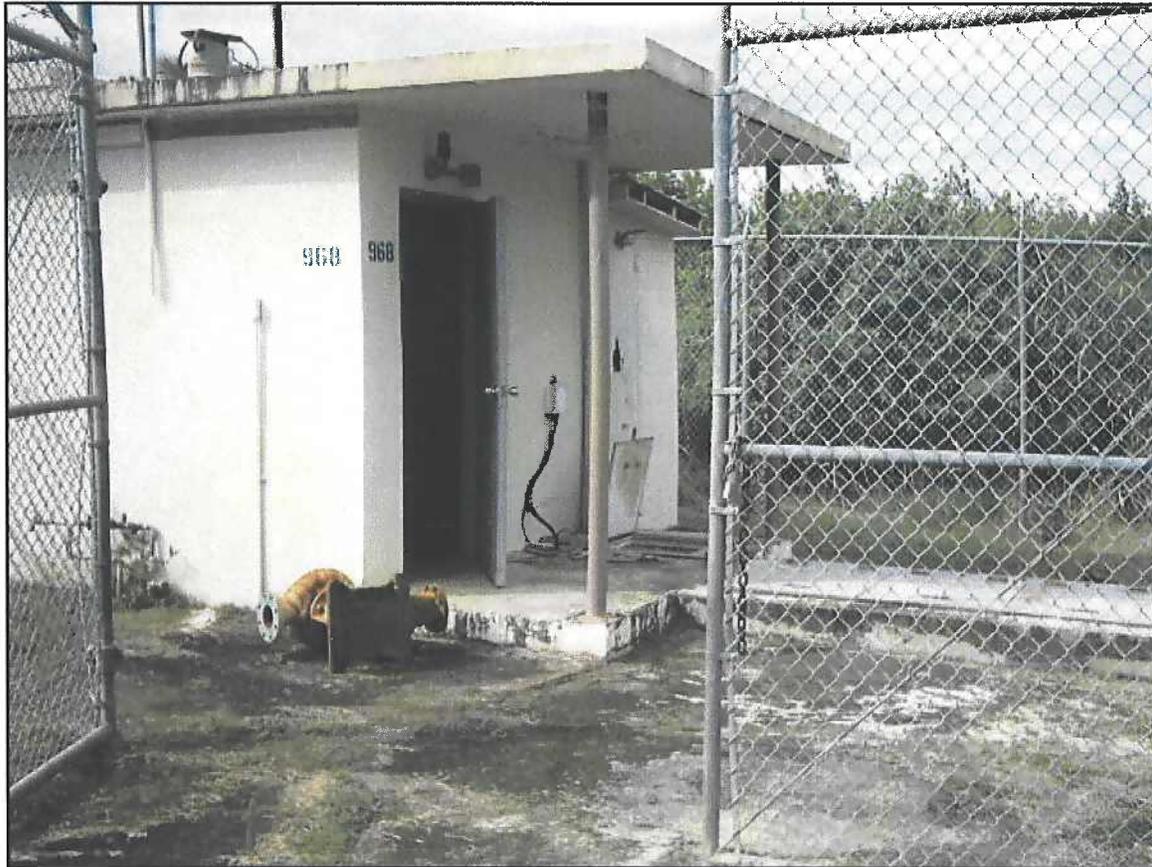
Building 968 is identified as “Sewage Pumping Sta (Capehart)” and is approximately 280 square feet in size. One suspect homogeneous material was identified and sampled. This material, corrugated cement roof panels (Material #001), was found to be ACM. No friable, damaged, and accessible ACM was identified.

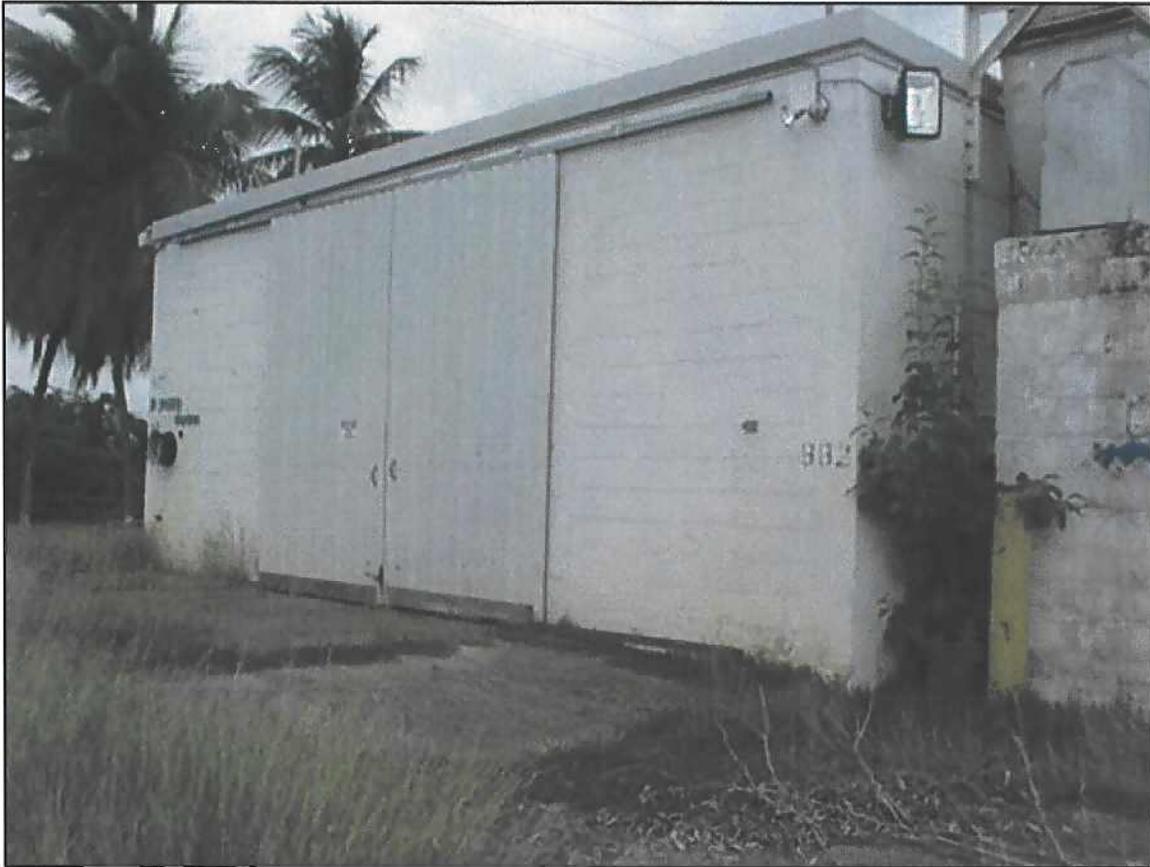
Building 982 is identified as “Battery Shop” and is approximately 2,460 square feet in size. Nine suspect homogeneous materials were identified and sampled. One material, floor adhesive (Material #003), was found to be ACM. No friable, damaged, and accessible ACM was identified.

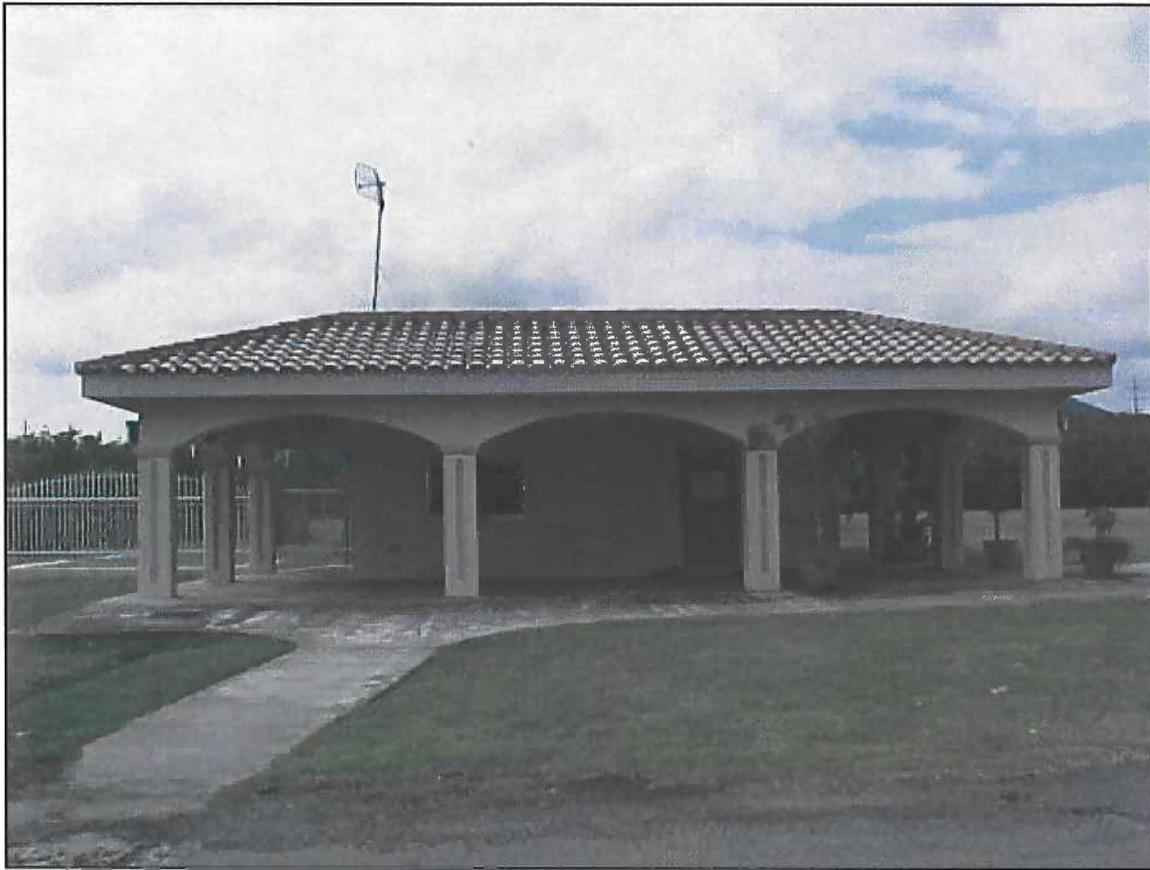
Building 1203 is identified as “Pass Office Gate#1” and is approximately 1,680 square feet in size. Nine suspect homogeneous materials were identified and sampled. One material, vinyl floor tile (Material #008), was found to be an ACM. No friable, damaged, and accessible ACM was identified.

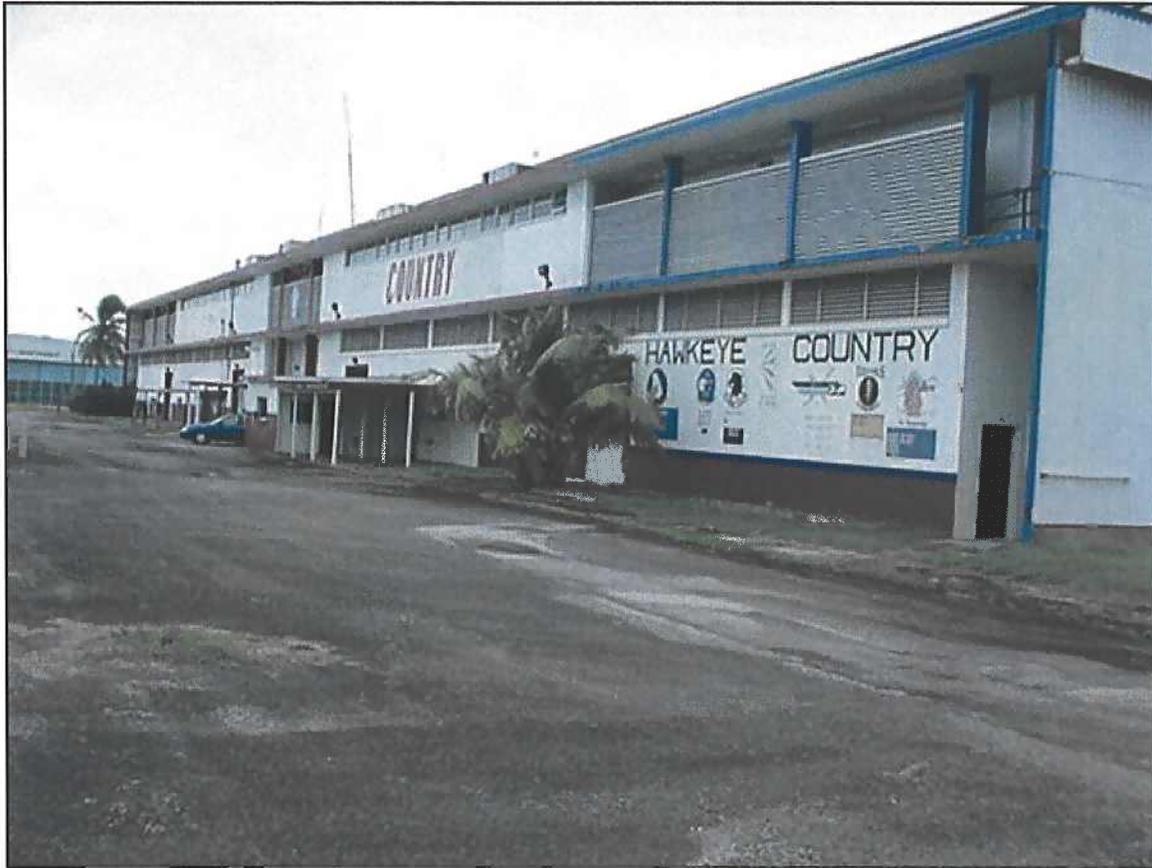
Building 1625 is identified as “Hanger VC-8” and is approximately 44,988 square feet in size. Twenty-eight suspect homogeneous materials were identified and sampled. Ten materials were found to be ACM, including: asphaltic roofing sealant (Material #002), six types of floor adhesive (Materials #004, #008, #012, #022, #024, and #028), and vinyl floor tile (Materials #021, #023, #027). No friable, damaged, and accessible ACM was identified.

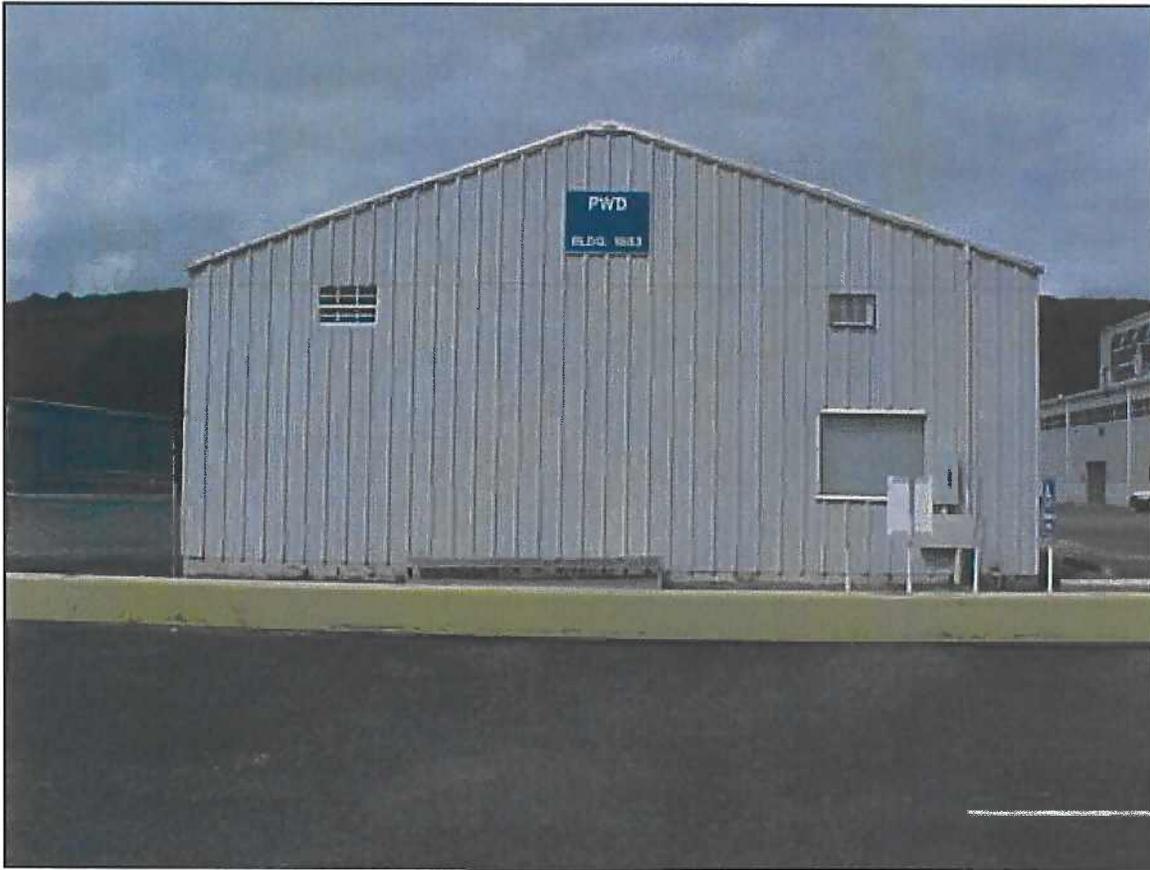
Building 1683 is identified as “PW Maint. Storage” and is approximately 4,000 square feet in size. Nine suspect homogeneous materials were identified and sampled. One material, floor adhesive (Material #007), was found to be an ACM. No friable, damaged, and accessible ACM was identified.

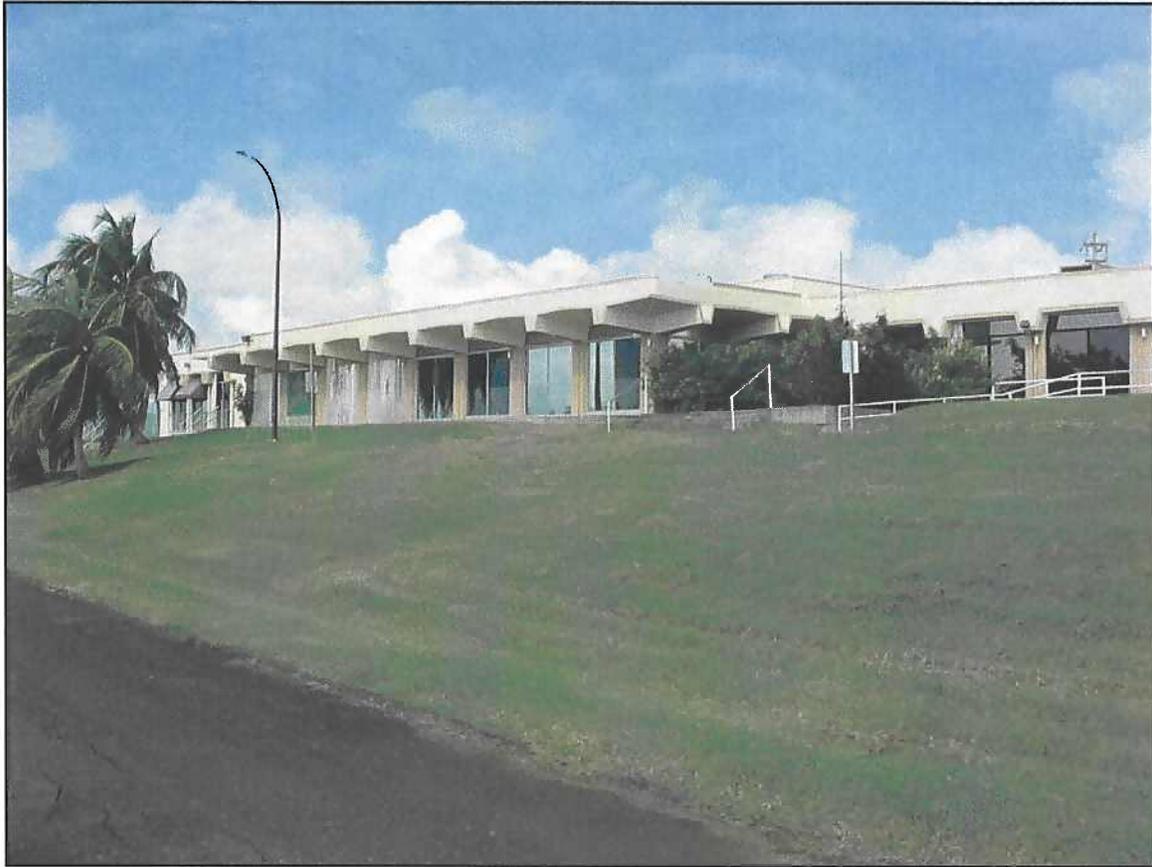
Building 1684 is identified as “Harbor Lights/Crossroads” and is approximately 13,350 square feet in size. Eleven suspect homogeneous materials were identified and sampled. Three materials, cove base adhesive (Material #005), vinyl floor tile (Material #008), and floor adhesive (Material #009), were found to be ACM. No friable, damaged, and accessible ACM was identified.

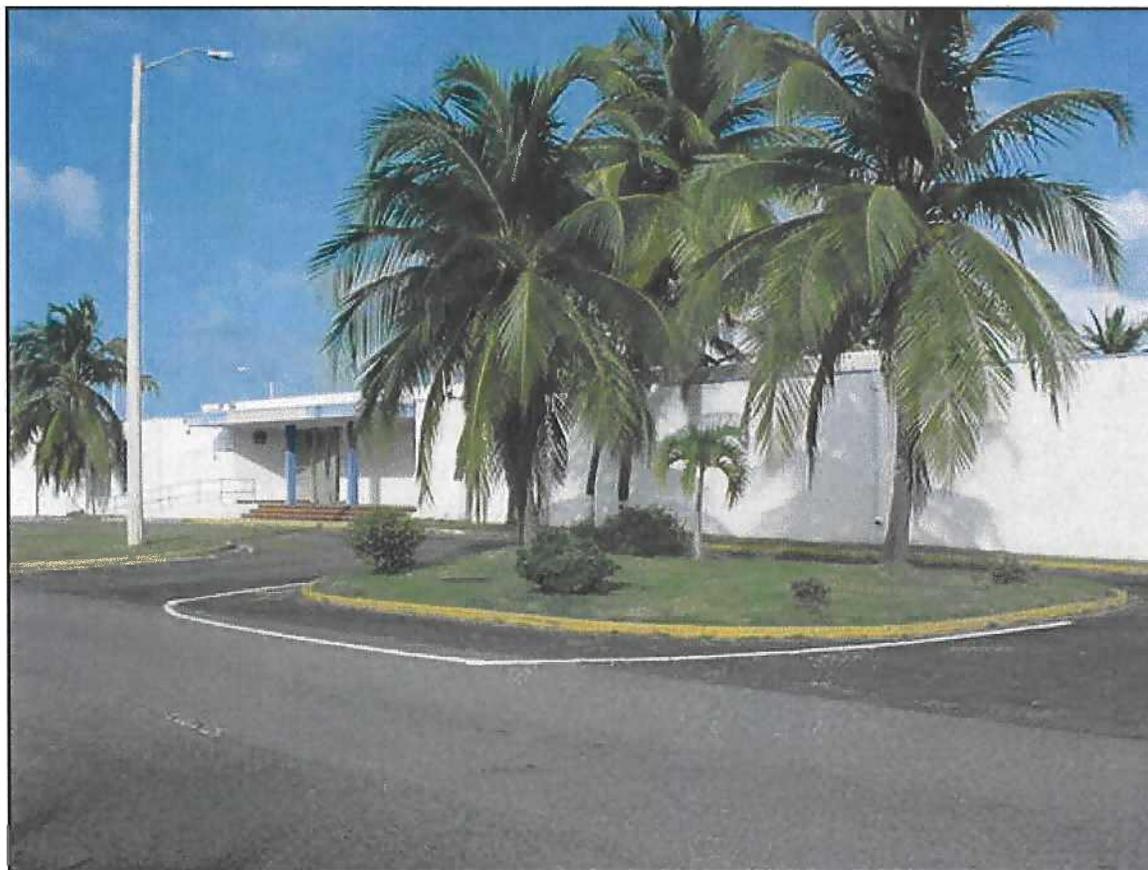
Building 1685 is identified as “US Comsolant Admin/Customs” and is approximately 9,094 square feet in size. Twenty six suspect homogeneous materials were identified and sampled. Nine materials, three types of vinyl floor tile (Materials #003, #012, and #017), five types of floor adhesive (Materials #004, #010, #013, #016, and #018), and ceiling plaster (Material #026), were found to be ACM. No friable, damaged, and accessible ACM was identified.

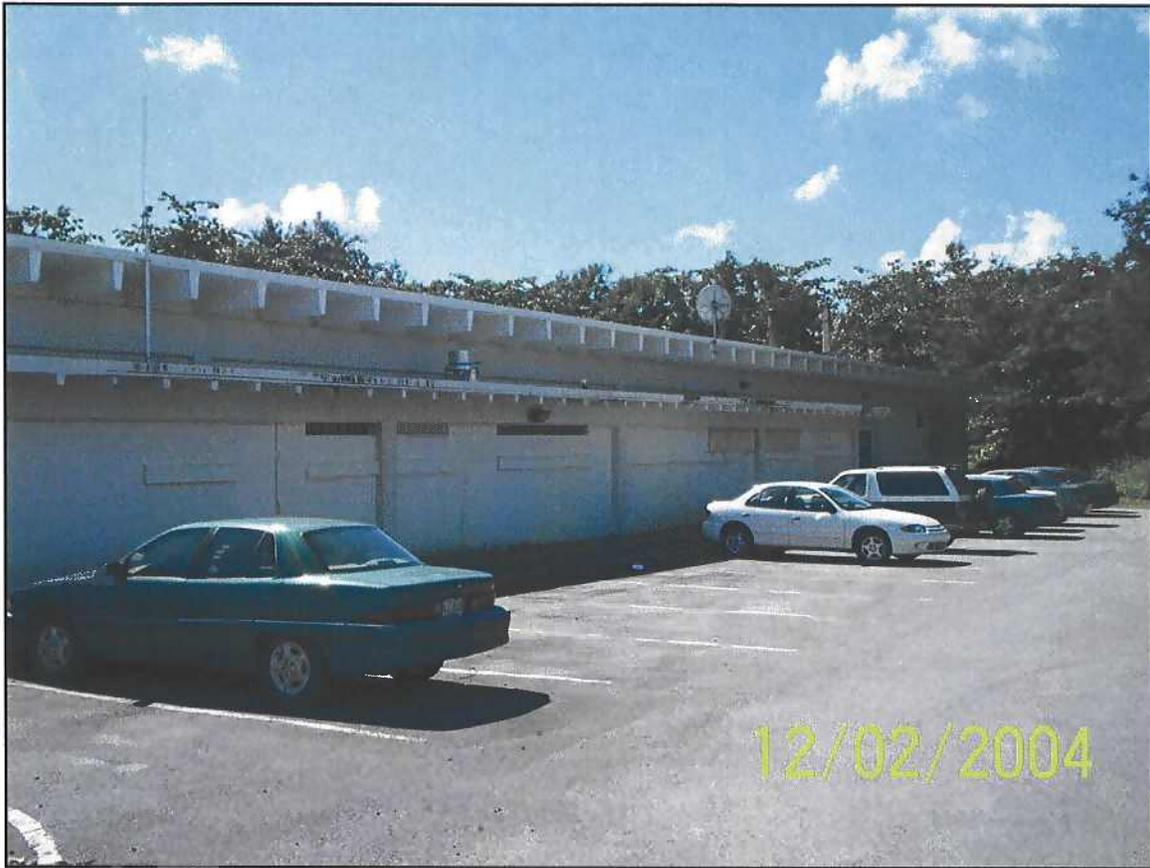
Building 1686 is identified as “F.B.I. Office” and is approximately 15,890 square feet in size. Seventeen suspect homogeneous materials were identified and sampled. Seven materials were found to be ACM, including: vinyl floor tile and associated mastic (Material #006), thermal pipe and fitting insulation (Material #008), thermal fitting insulation (Material #013), two types of thermal pipe insulation (Materials #014 and #016), sheet gasket (Material #015), and tank insulation (Material #017). A portion of Material #008 is friable, damaged, and accessible ACM.

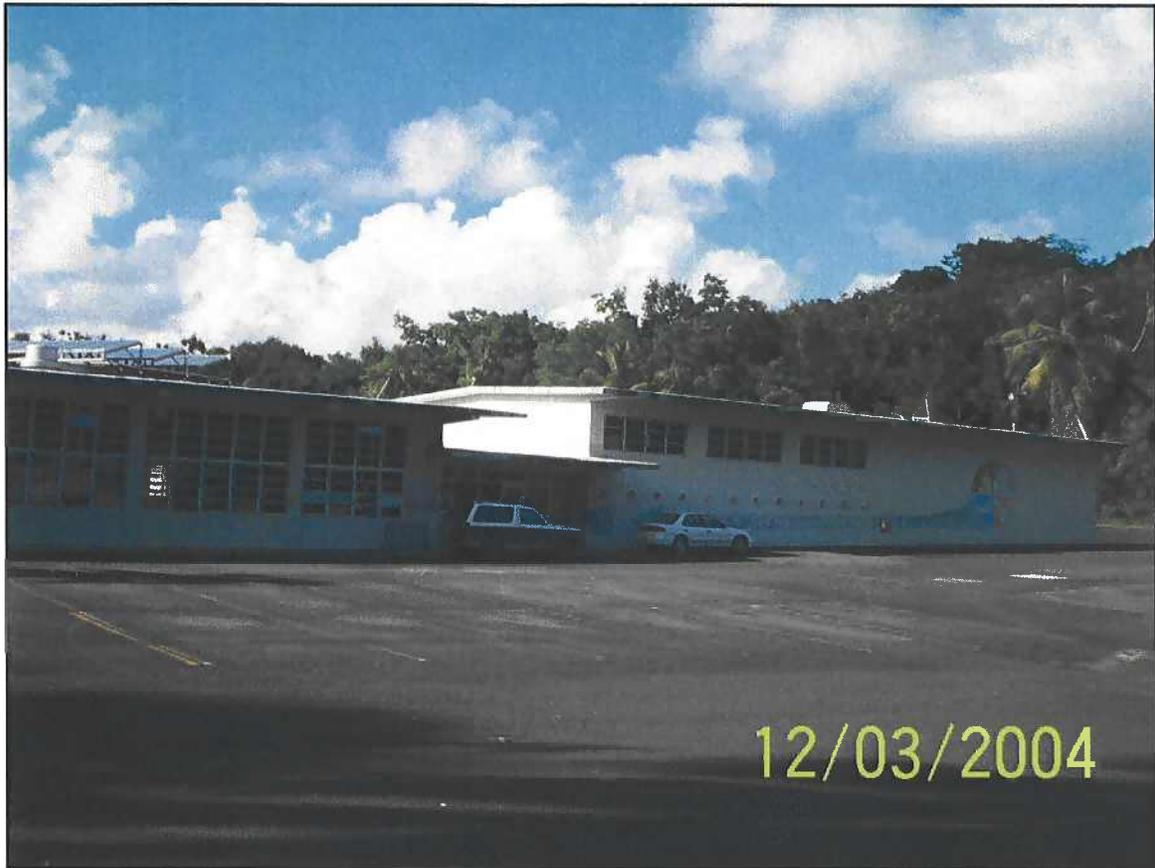
Building 1687 is identified as “Gymnasium/Fitness Center” and is approximately 19,760 square feet in size. Sixteen suspect homogeneous materials were identified and sampled. Six materials, five types of vinyl floor tile (Materials #001, #005, #006, #010, and #011) and caulking (Material #016), were found to be ACM. No friable, damaged, and accessible ACM was identified.

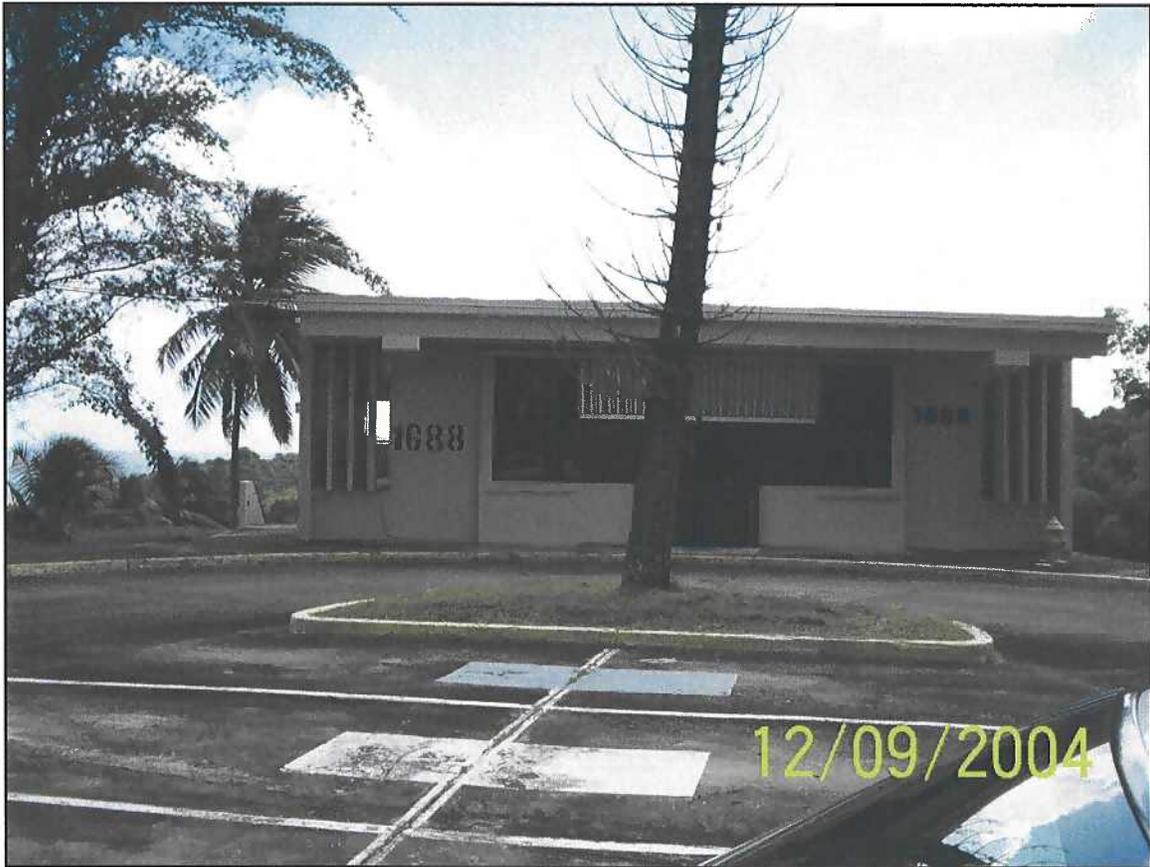
Building 1688 is identified as “BOQ Trans W1/W2 and 01/02” and is approximately 49,685 square feet in size. Thirteen suspect homogeneous materials were identified and sampled. One material, black asphaltic roofing (Material #001), was found to be an ACM. No friable, damaged, and accessible ACM was identified.
