Final  
**Asbestos Inspection Report**  
for

Naval Activity Puerto Rico  
Ceiba, Puerto Rico

Volume 5 of 7

Buildings 2004 through 2339

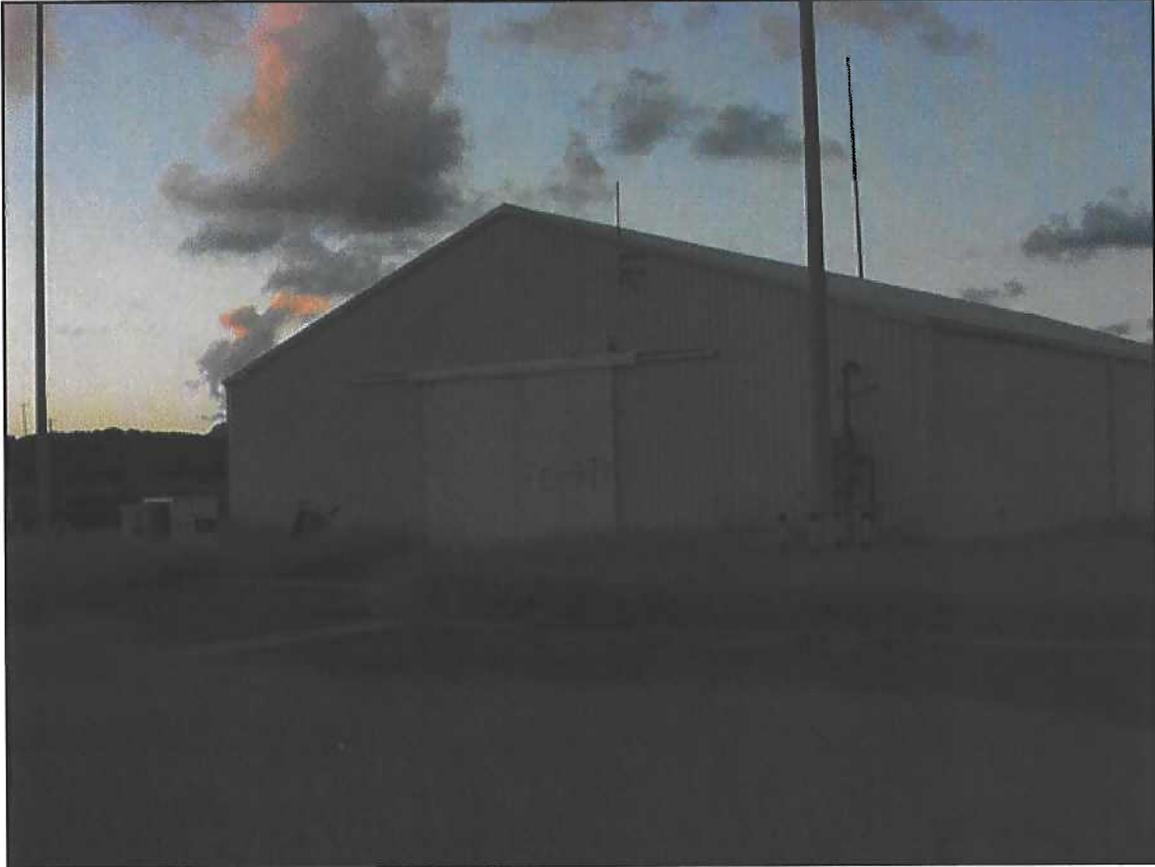
## BUILDING 2004

Building 2004 is identified as “Drone Bal/Stor. Fac-Cabras” and is approximately 6,000 square feet in size. Four suspect homogeneous materials were identified and sampled. None of the materials were found to be ACM.

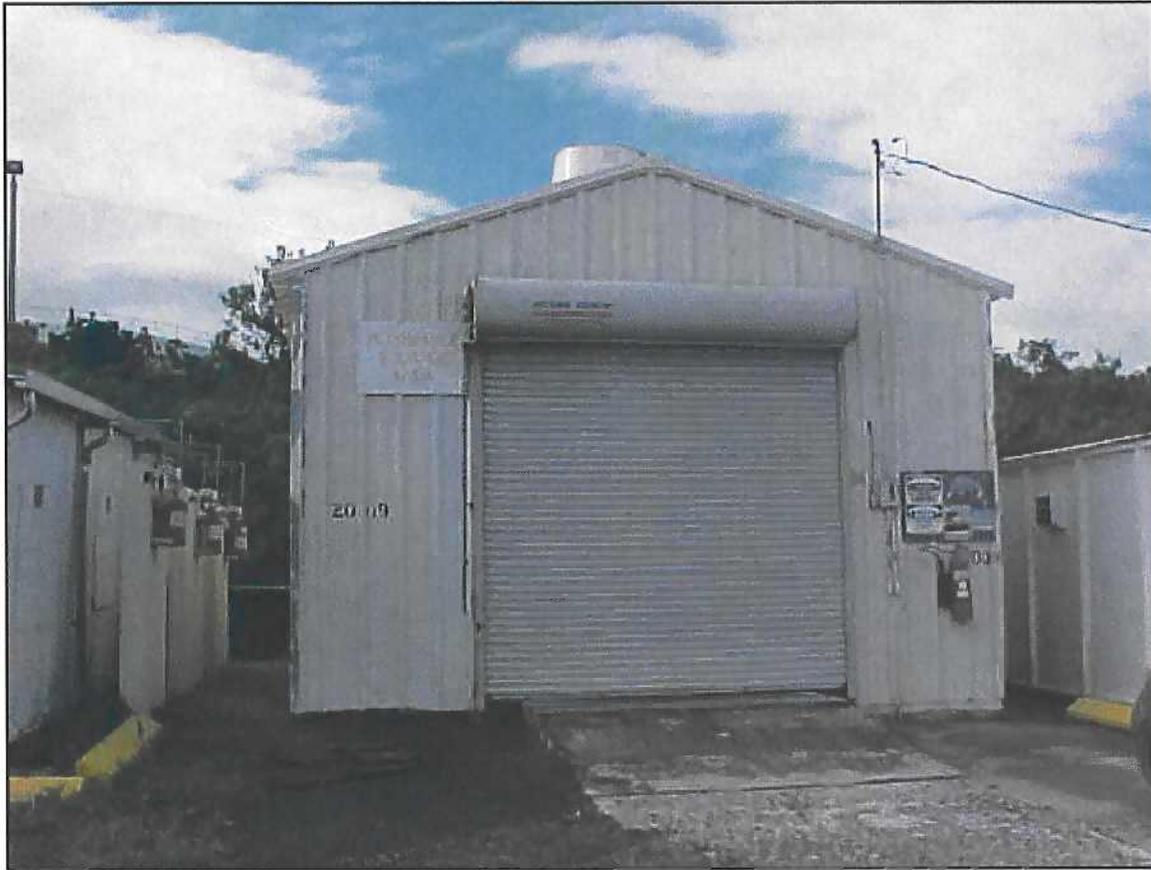
## BUILDING 2009

Building 2009 is identified as “DRMO Flammable Storage” and is approximately 400 square feet in size. No suspect materials were identified. Therefore, no sampling was conducted.

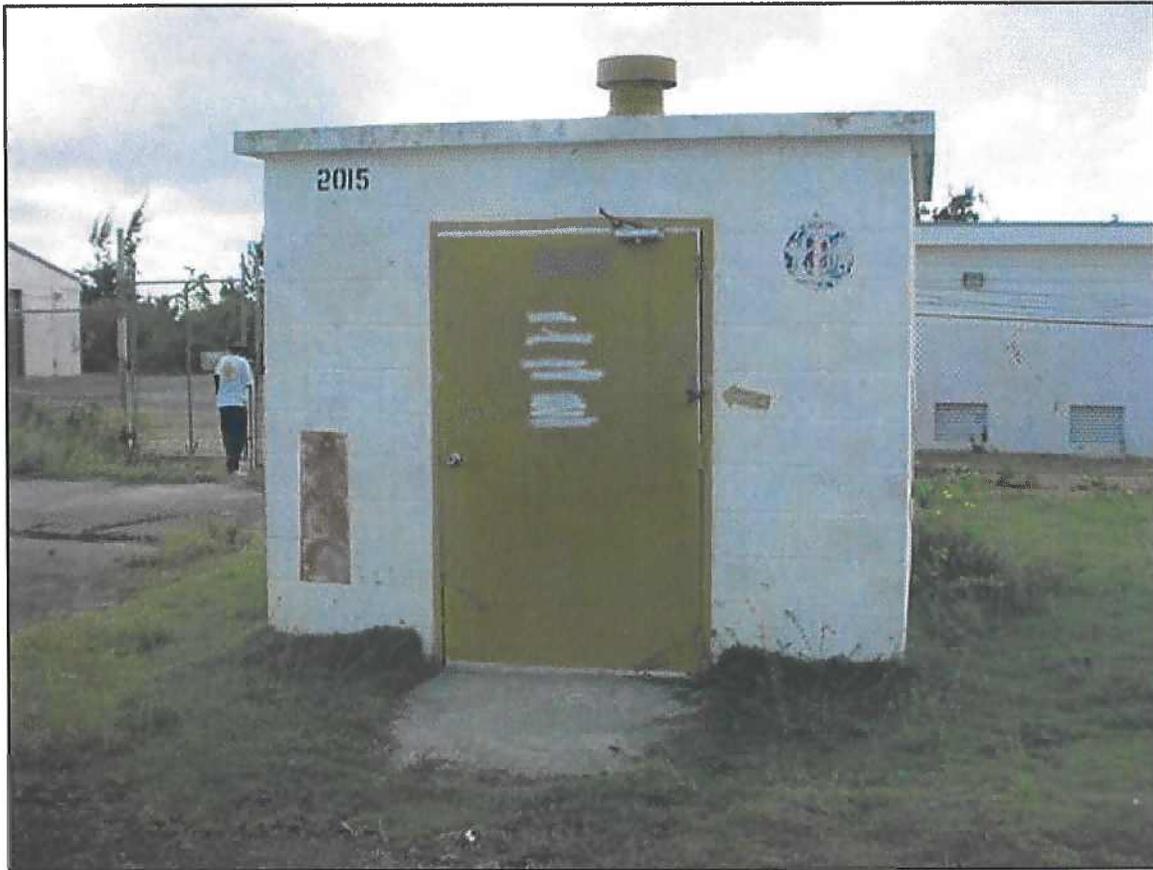
## BUILDING 2015

Building 2015 is identified as “Torpedo Paint Shop” and is approximately 100 square feet in size. No suspect materials were identified. Therefore, no sampling was conducted.

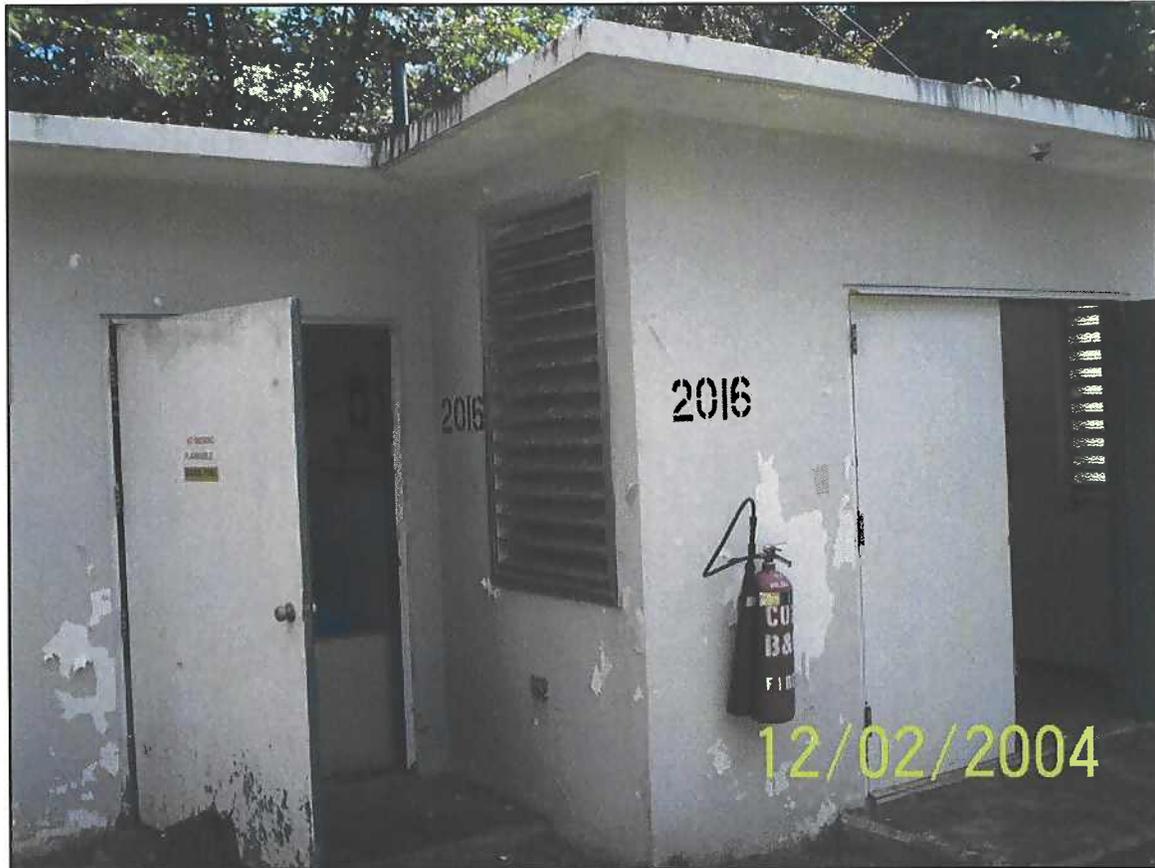
## BUILDING 2016

Building 2016 is identified as “Genr Cen Alarm LS 542” and is approximately 290 square feet in size. Two suspect homogeneous materials were identified and sampled. One material, black sheet gasket (Material #002), was found to be an ACM. No friable, damaged, and accessible ACM was identified.

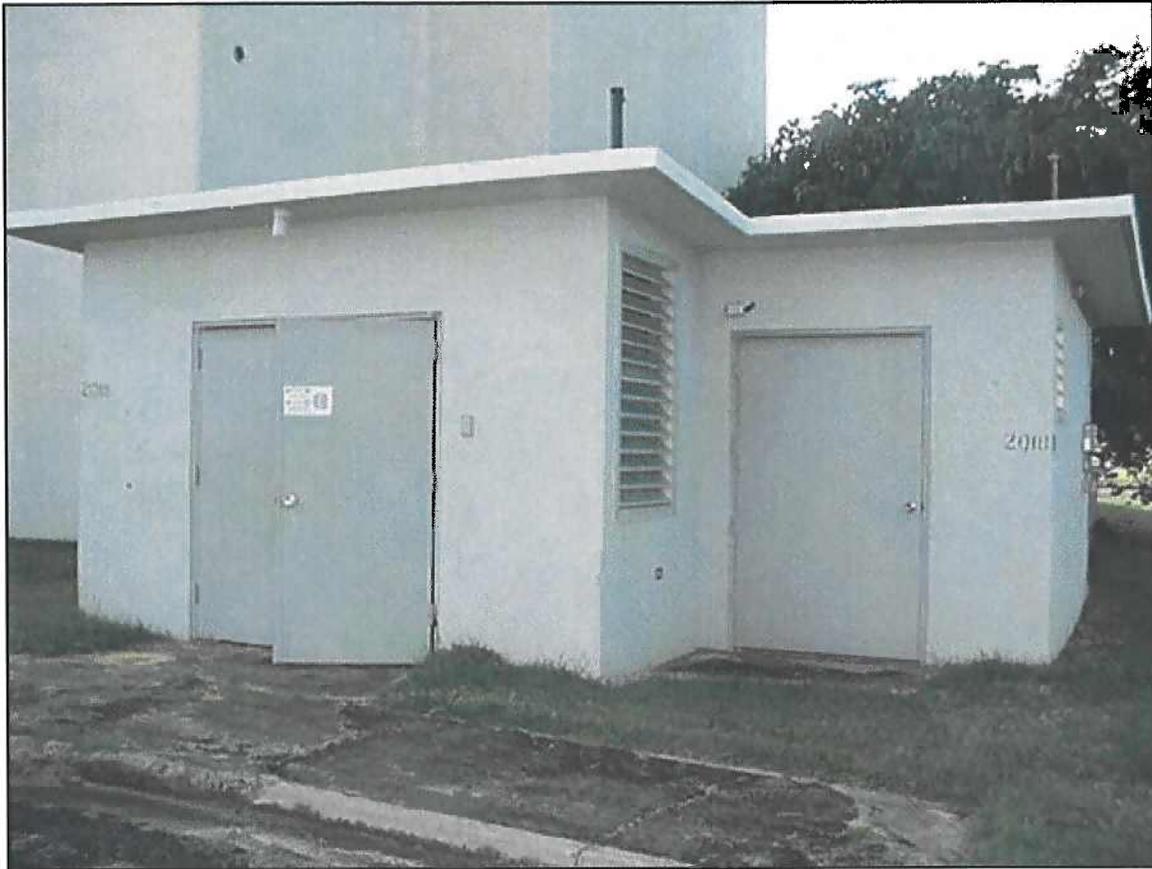
## BUILDING 2018

Building 2018 is identified as “Generator House by LS 423” and is approximately 320 square feet in size. One suspect homogeneous material was identified and sampled. The material is not ACM.

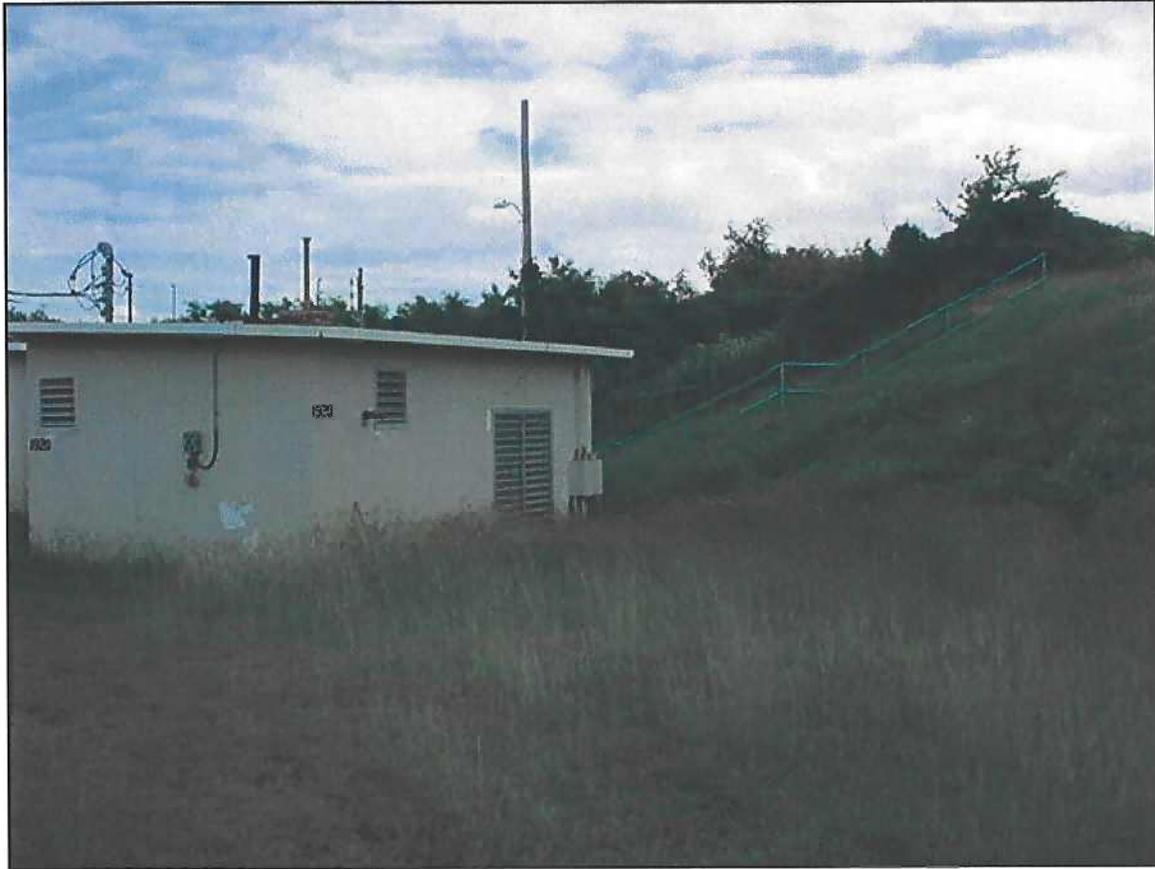
## BUILDING 2019

Building 2019 is identified as “Generator House by LS 1758” and is approximately 333 square feet in size. Three suspect homogeneous materials were identified and sampled. None of the materials were found to be ACM.

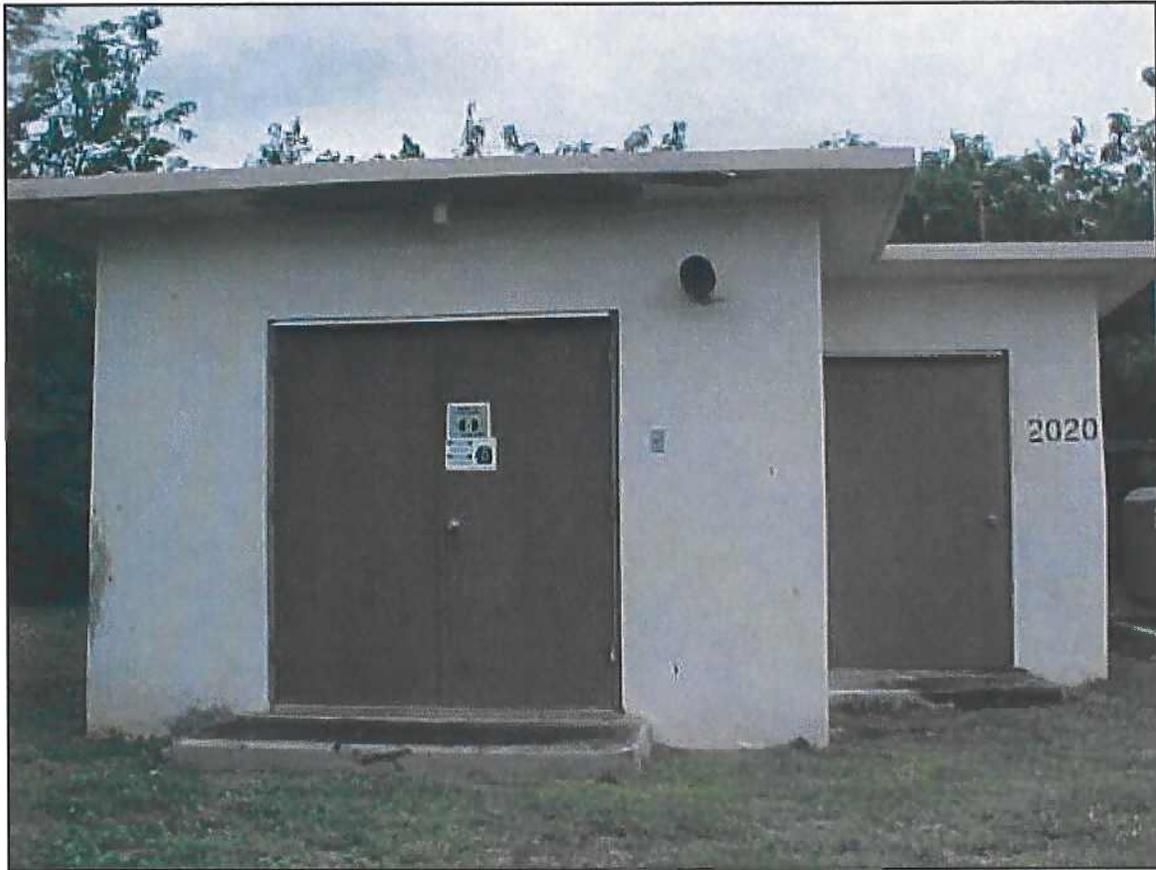
## BUILDING 2020

Building 2020 is identified as “Gen Hse/LS Cent by B2033” and is approximately 268 square feet in size. No suspect materials were identified. Therefore, no sampling was conducted.

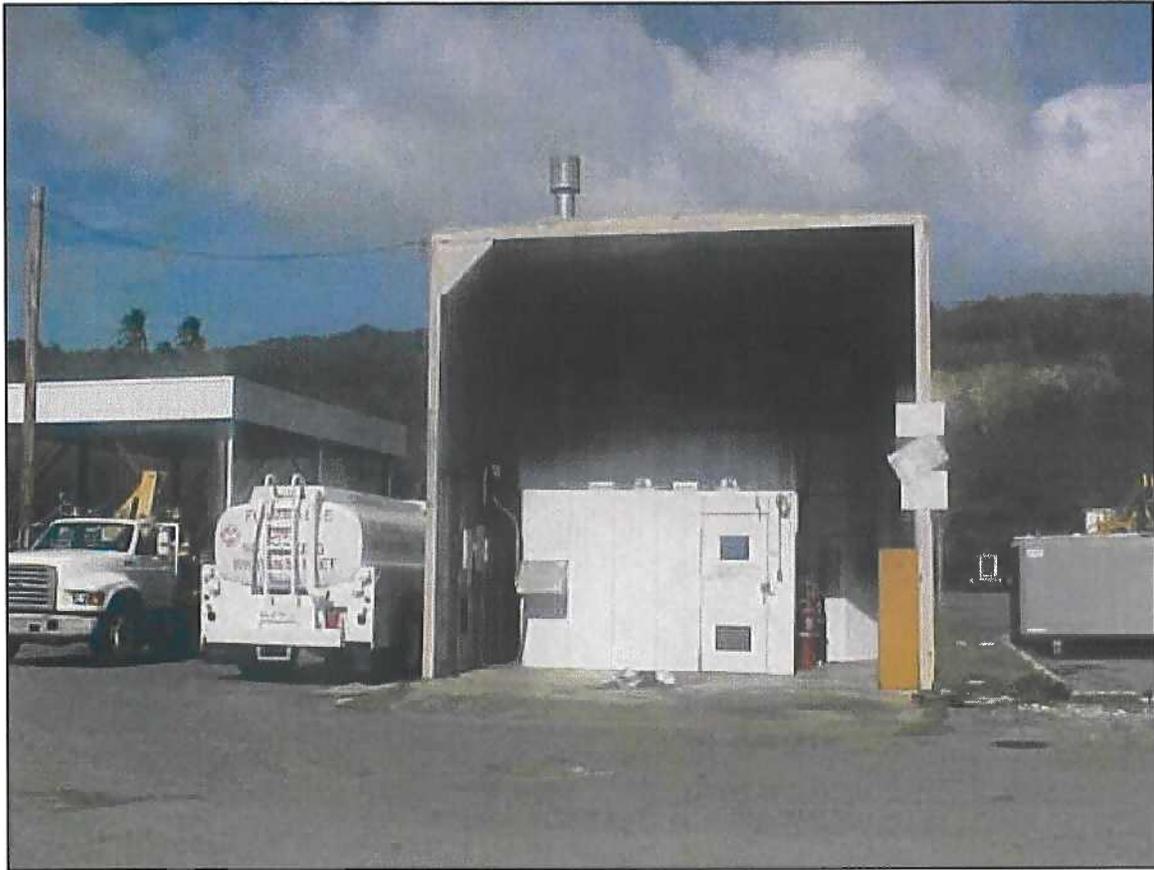
## BUILDING 2022

Building 2022 is identified as “Vehicle Paint Booth” and is approximately 1,380 square feet in size. No suspect materials were identified. Therefore, no sampling was conducted.

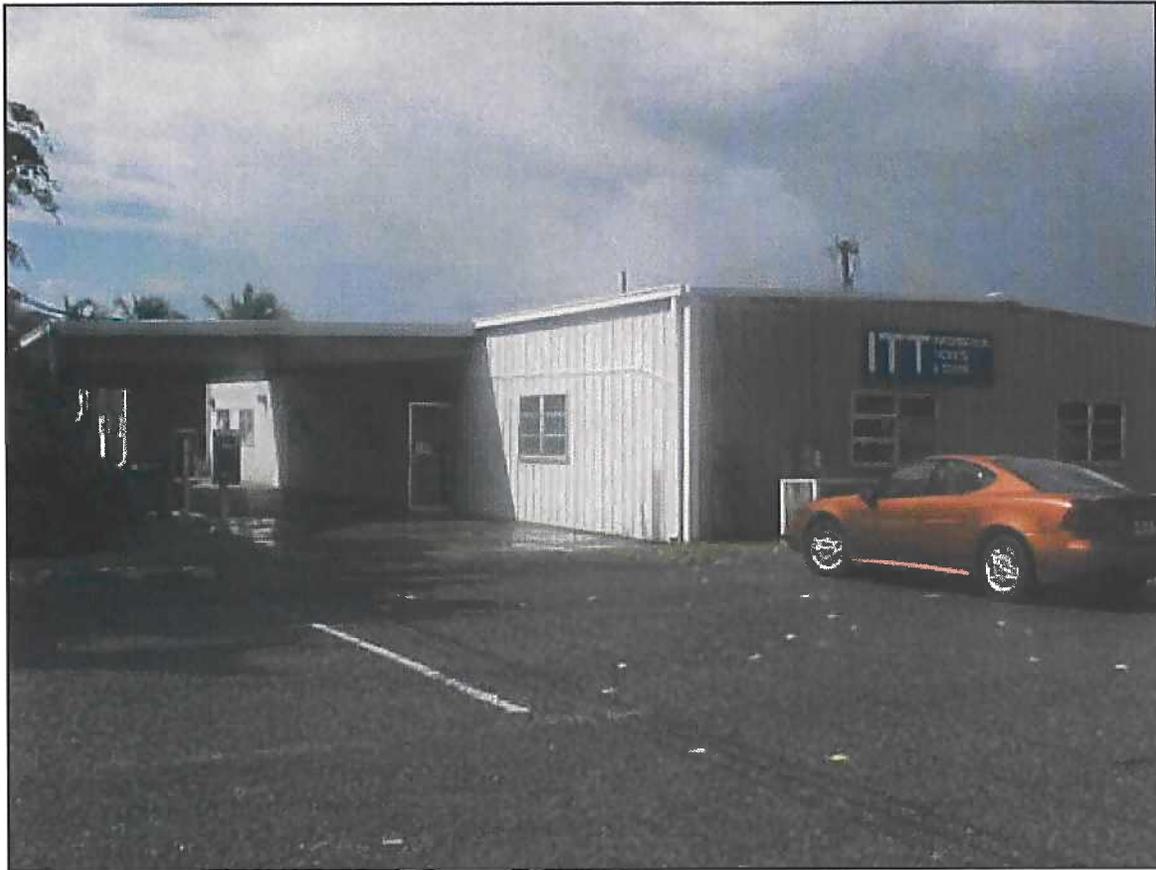
## BUILDING 2024

Building 2024 is identified as “Liberty Center/ITT Travel” and is approximately 4,000 square feet in size. Nine suspect homogeneous materials were identified and sampled. None of the materials were found to be ACM.

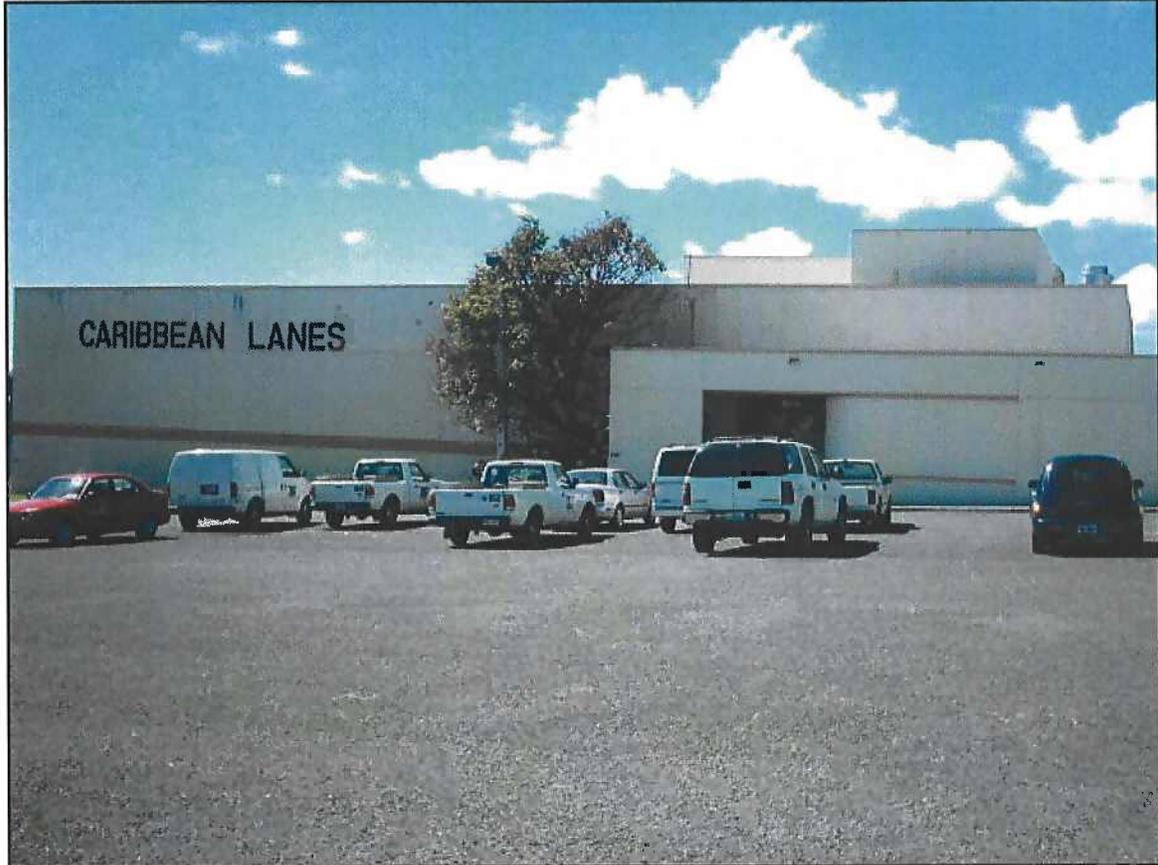
## BUILDING 2035

Building 2035 is identified as “Caribbean Lanes” and is approximately 23,690 square feet in size. Fifteen suspect homogeneous materials were identified and sampled. None of these materials were found to be ACM.

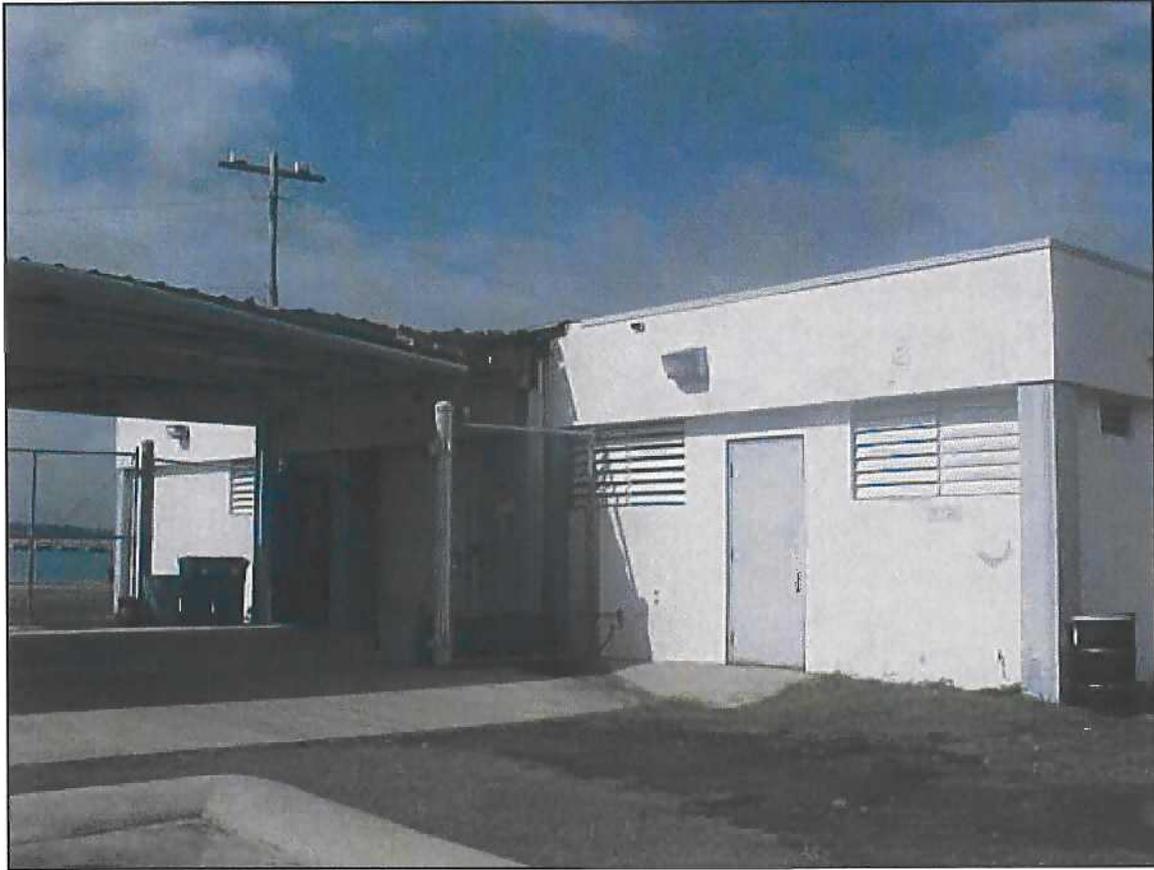
## BUILDING 2036

Building 2036 is identified as “Shore Support Building” and is approximately 1,525 square feet in size. Five suspect homogeneous materials were identified and sampled. None of the materials were found to be ACM.

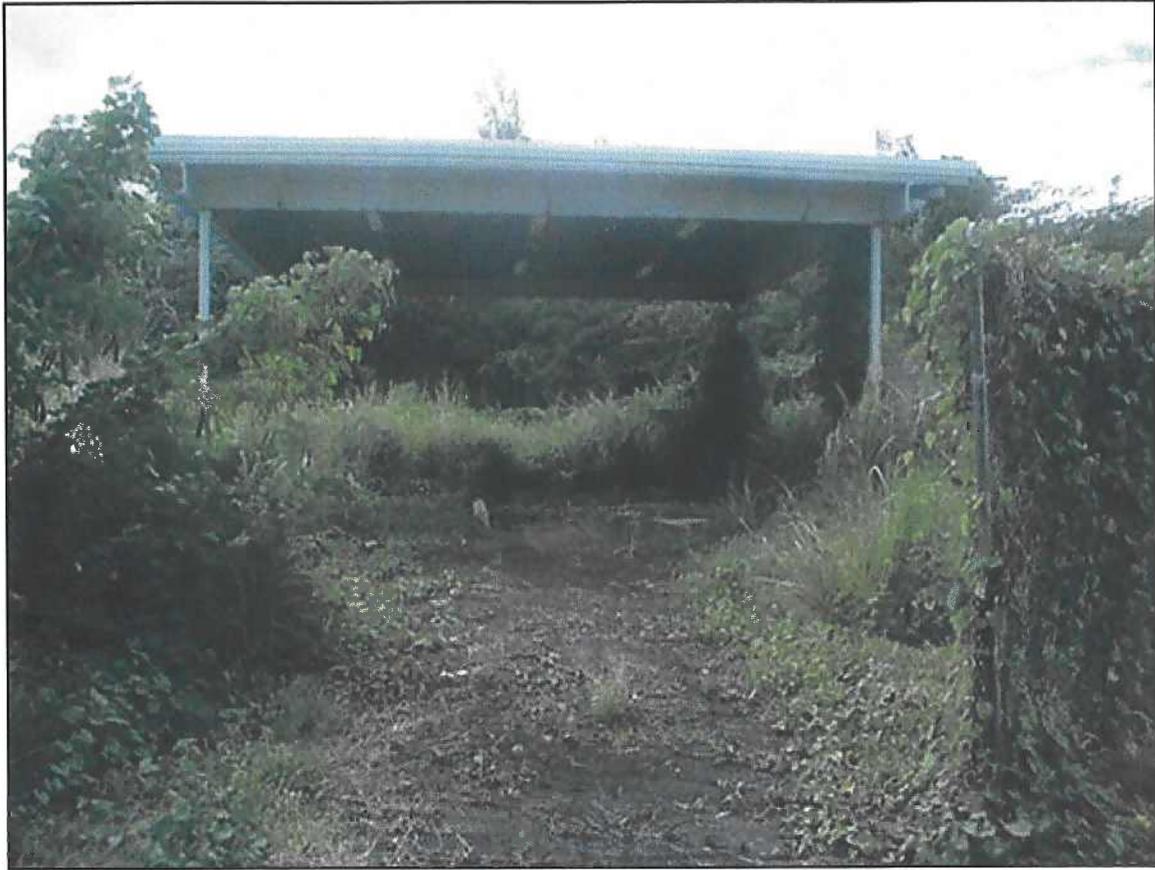
## **BUILDING 2057**

Building 2057 is identified as “Missile Test Assy Shed” and is approximately 784 square feet in size. No suspect materials were identified. Therefore, no sampling was conducted.

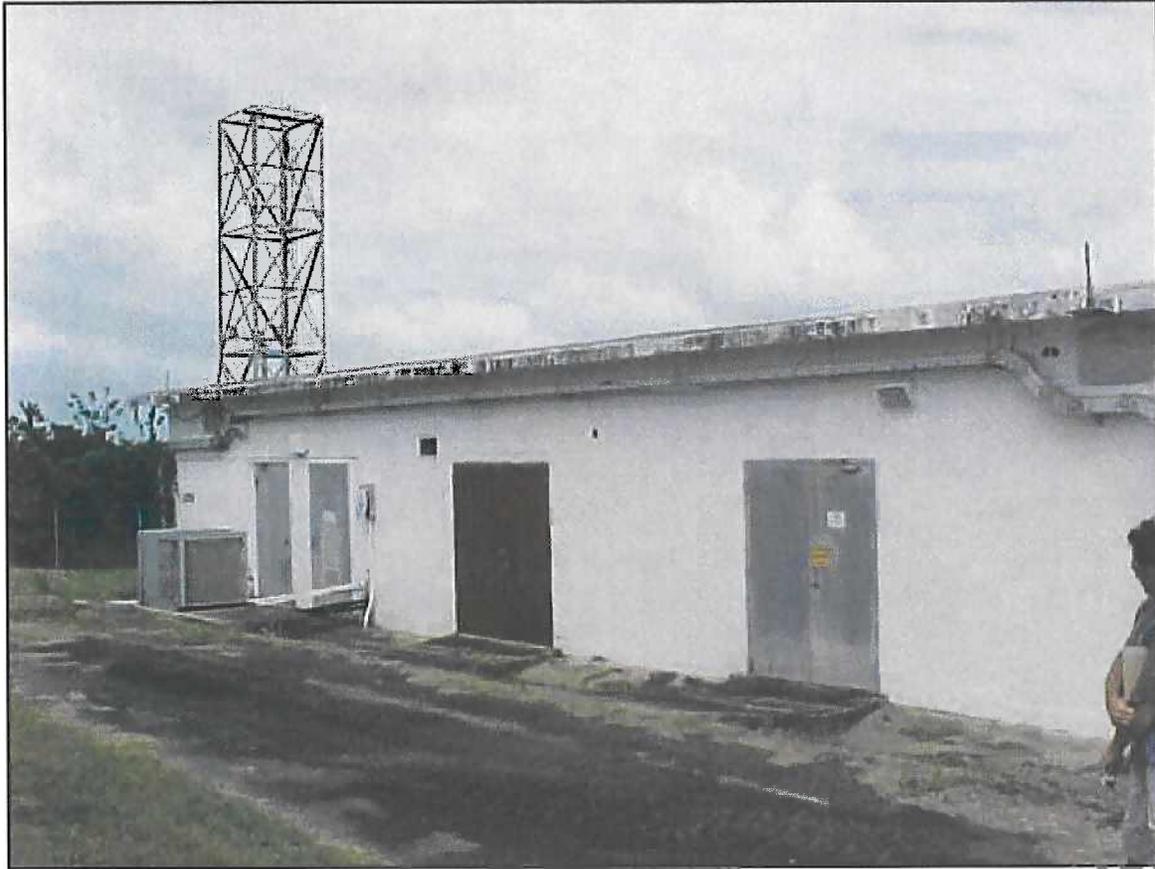
## BUILDING 2059

Building 2059 is identified as “Communication Bldg By B1729 ” and is approximately 1,560 square feet in size. Three suspect homogeneous materials were identified and sampled. One material, vinyl floor tile (Material #001), was found to be an ACM. No friable, damaged, and accessible ACM were identified.

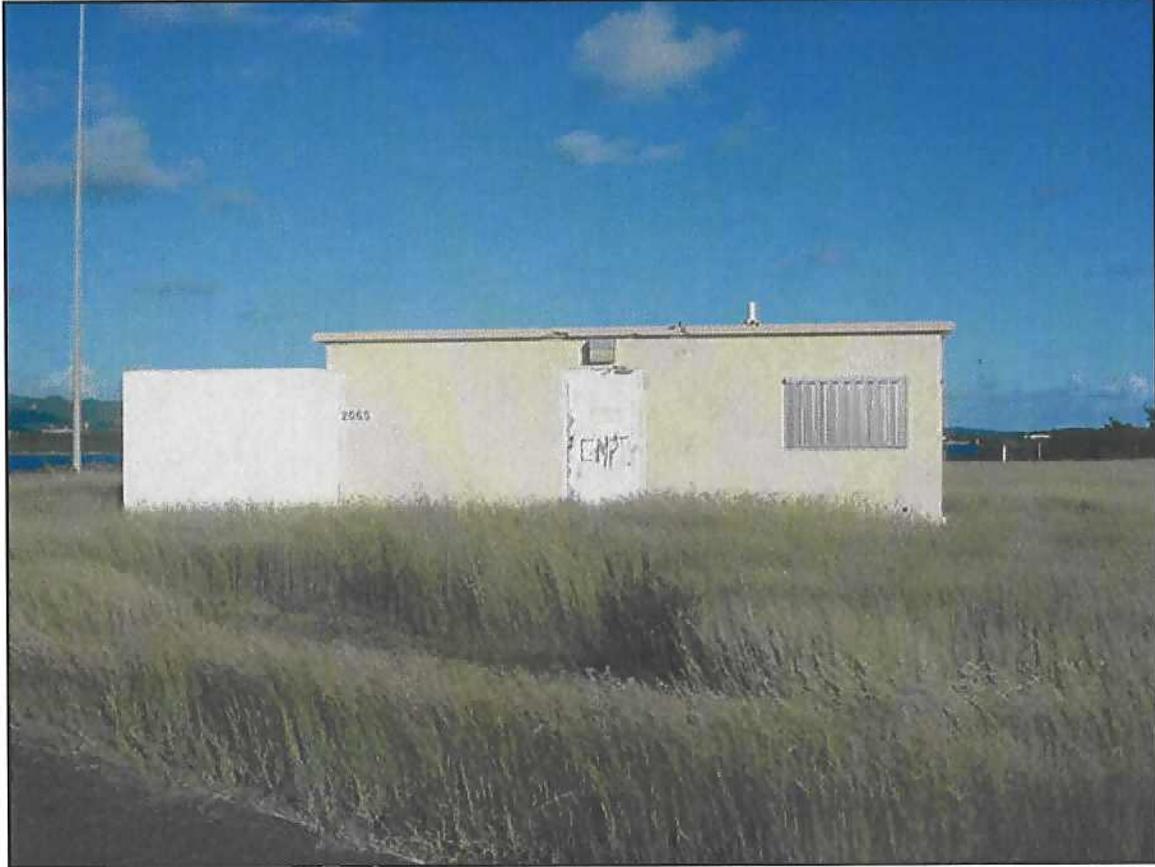
## BUILDING 2065

Building 2065 is identified as “Cabras Range Ops Facility” and is approximately 351 square feet in size. Seven suspect homogeneous materials were identified and sampled. Two materials, vinyl floor tile (Material #001) and floor adhesive (Material #002), were found to be ACM. No friable, damaged, and accessible ACM was identified.

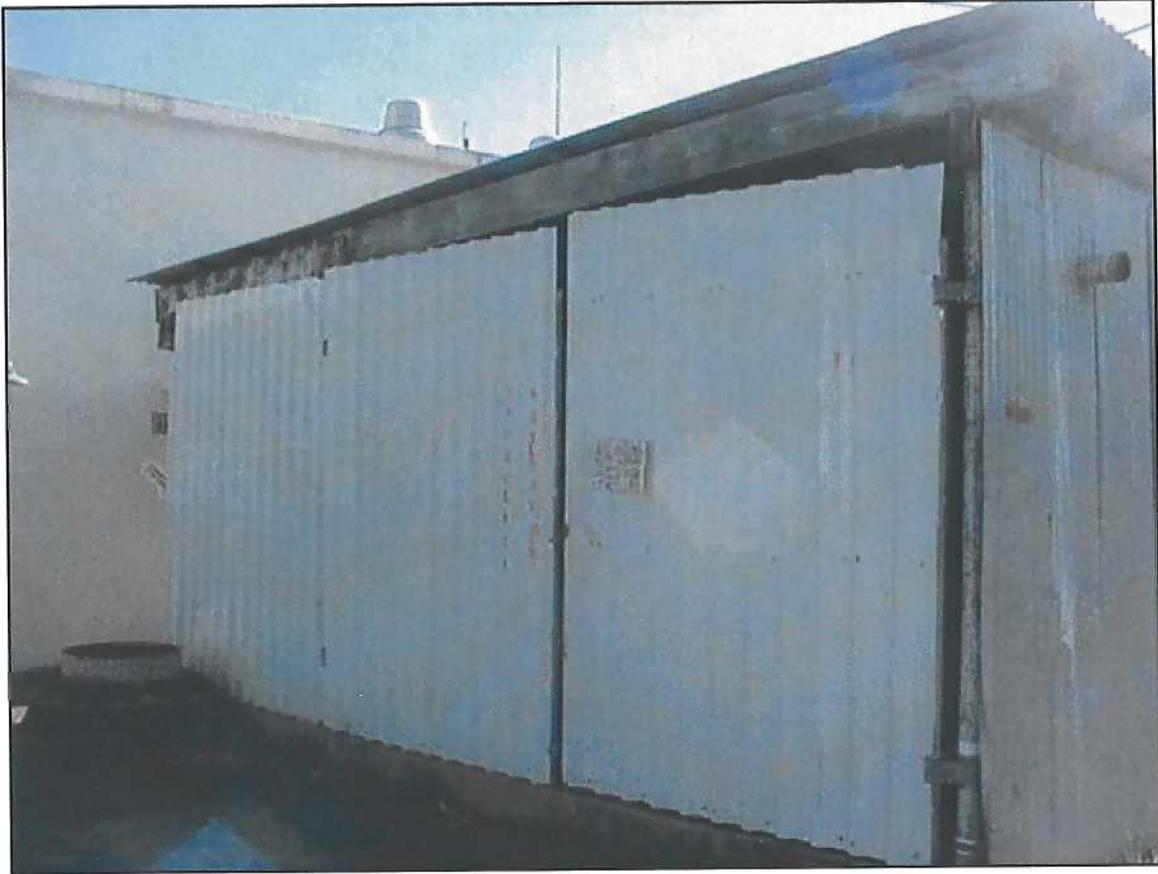
## BUILDING 2079

Building 2079 is identified as “Standby Gen Plt by Bldg 860” and is approximately 420 square feet in size. No suspect materials were identified. Therefore, no sampling was conducted.

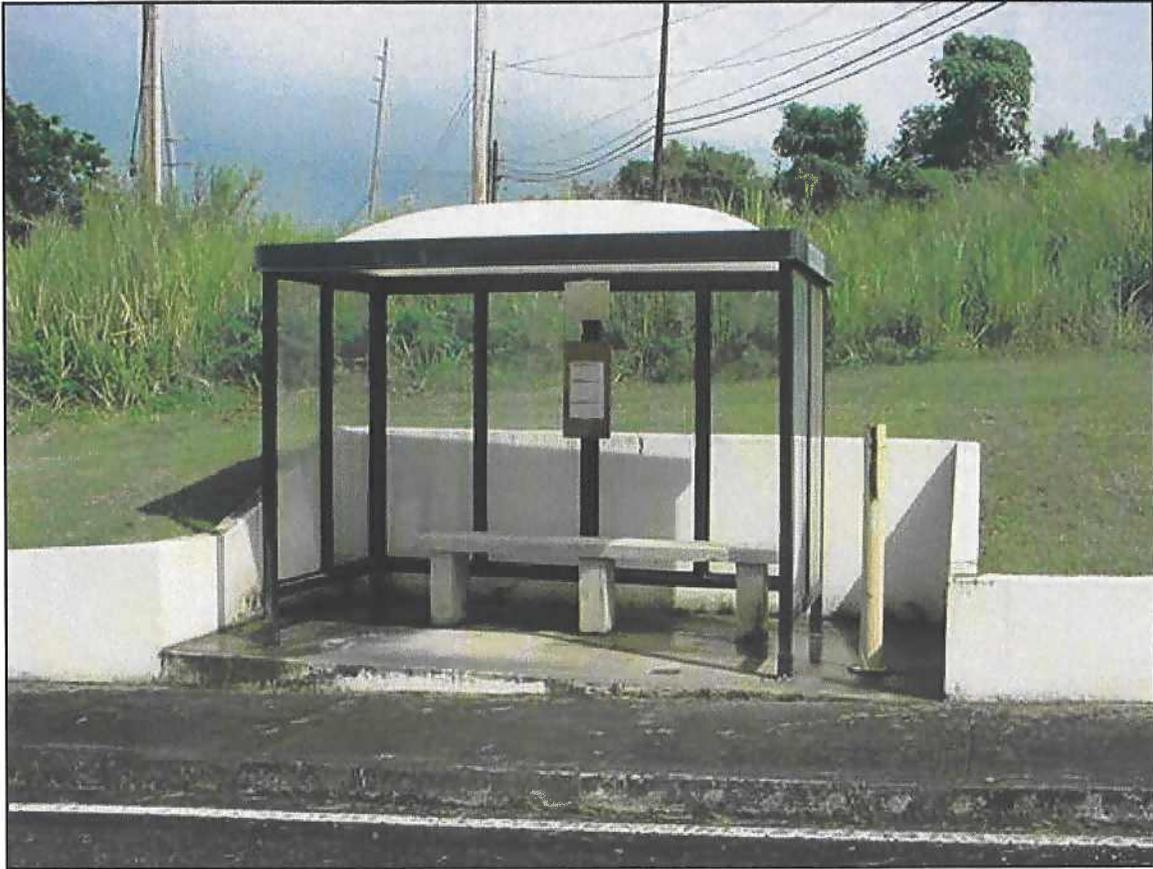
## BUILDING 2206

Building 2206 is identified as “Bus Shltr N. Delicias” and is approximately 70 square feet in size. No suspect materials were identified. Therefore, no sampling was conducted.

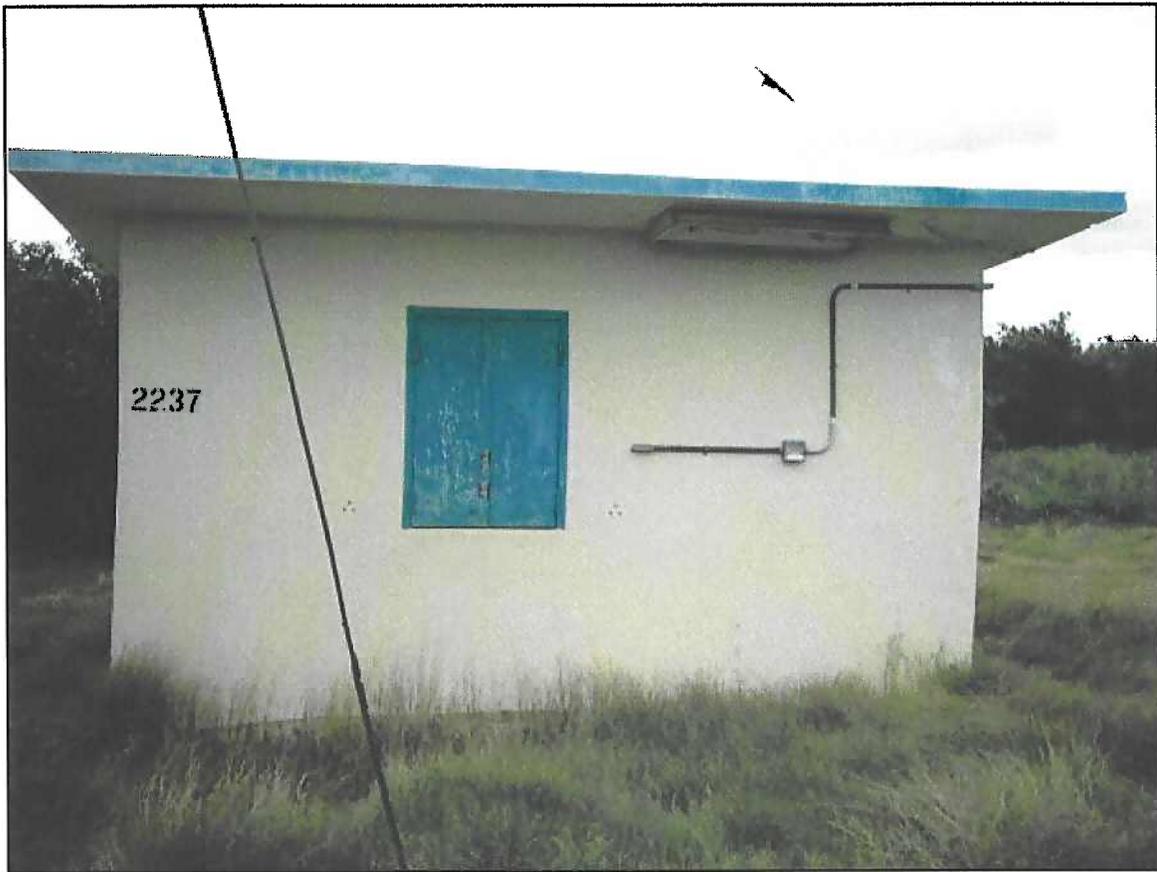
## BUILDING 2237

Building 2237 is identified as “Concess Stgecom Bch Ballfl” and is approximately 144 square feet in size. No suspect materials were identified. Therefore, no sampling was conducted.

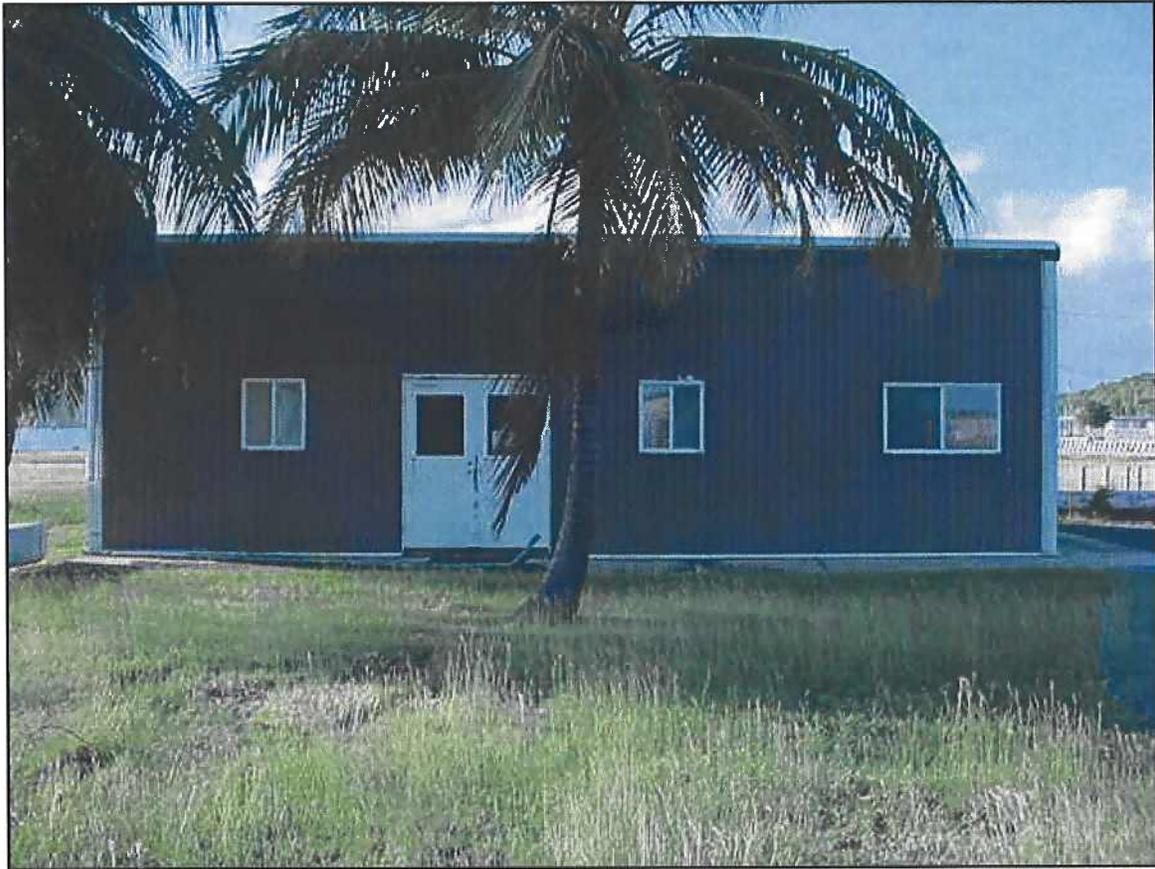
## BUILDING 2242

Building 2242 is identified as “Vacant” and is approximately 1,600 square feet in size. Eight suspect homogeneous materials were identified and sampled. Three materials, two types of vinyl floor tile (Materials #005 and #006) and floor adhesive (Material #007), were found to be an ACM. No friable, damaged, and accessible ACM was identified.

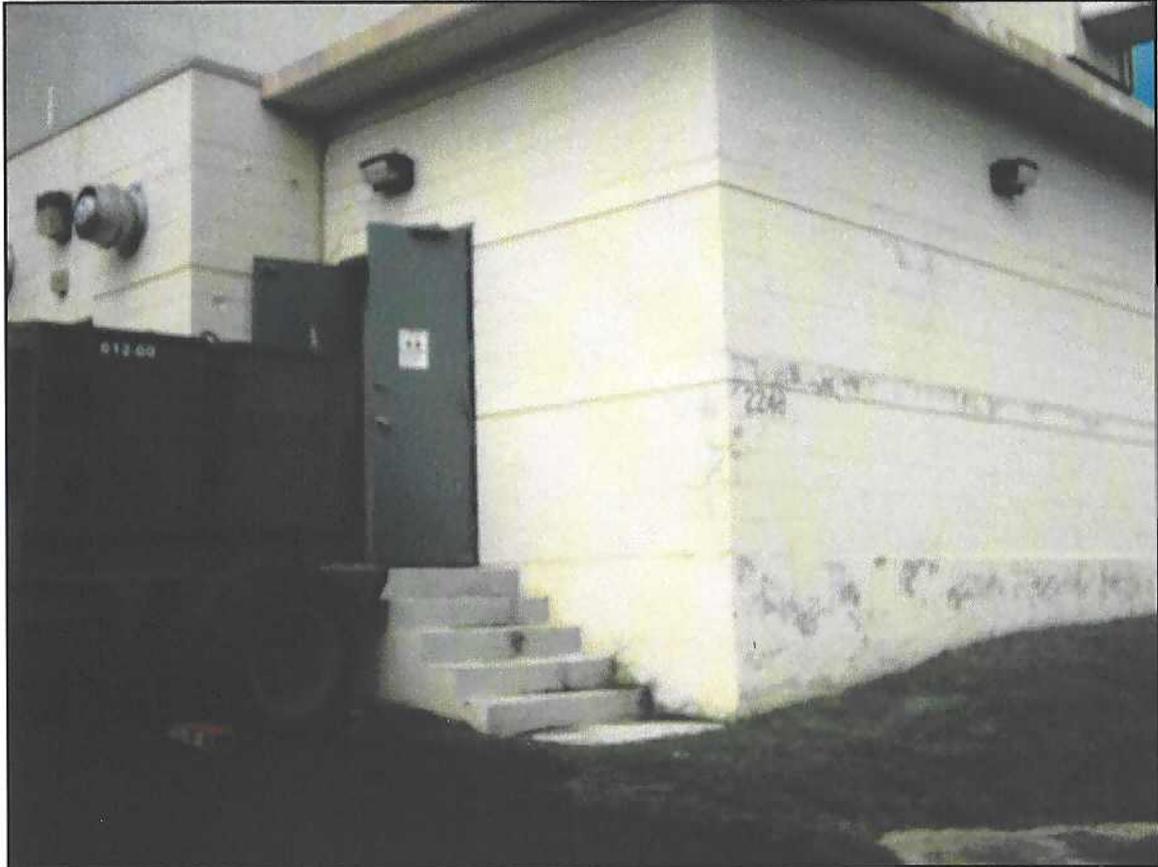
## BUILDING 2248

Building 2248 is identified as “UPS Shltr for B# 386” and is approximately 364 square feet in size. Five suspect homogeneous materials were identified and sampled. Two materials, vinyl floor tile (Material #001) and its associated adhesive (Material #002), were found to be ACM. No friable, damaged, and accessible ACM was identified.

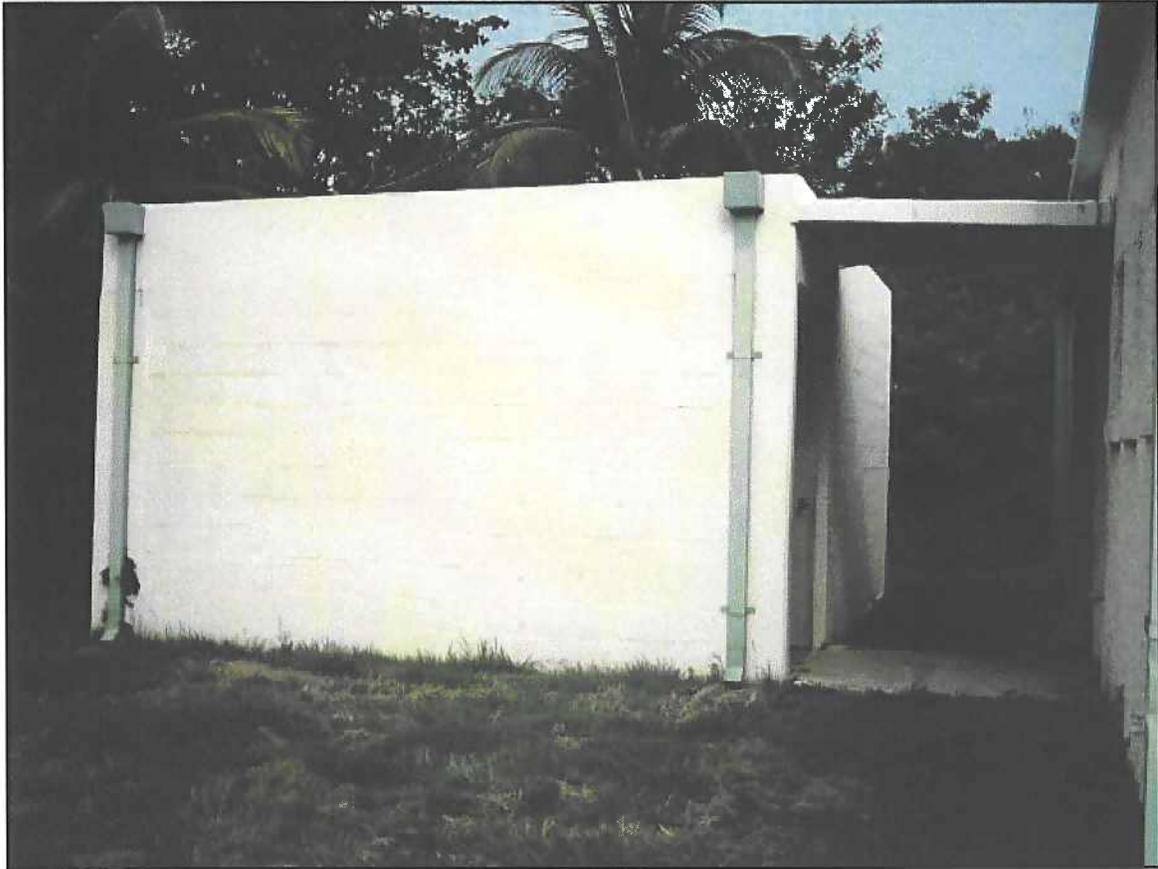
## BUILDING 2251

Building 2251 is identified as “Addtln Stge B1811” and is approximately 336 square feet in size. No suspect materials were identified. Therefore, no sampling was conducted.

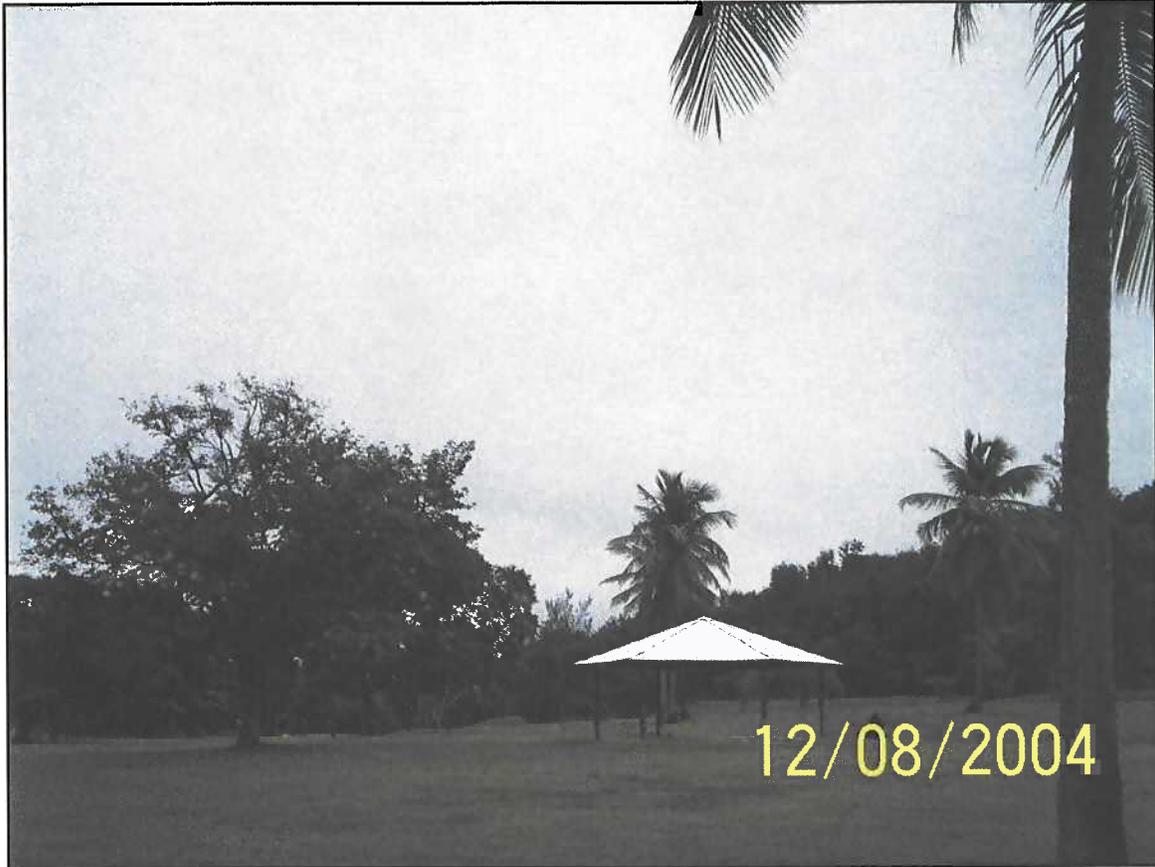
**BUILDING 2253**

Building 2253 is identified as “Recreation Pavilion” and is approximately 471 square feet in size. No suspect materials were identified. Therefore, no sampling was conducted.
