Final  
**Asbestos Inspection Report**  
for

Naval Activity Puerto Rico  
Ceiba, Puerto Rico

Volume 5 of 7

Buildings 2004 through 2339

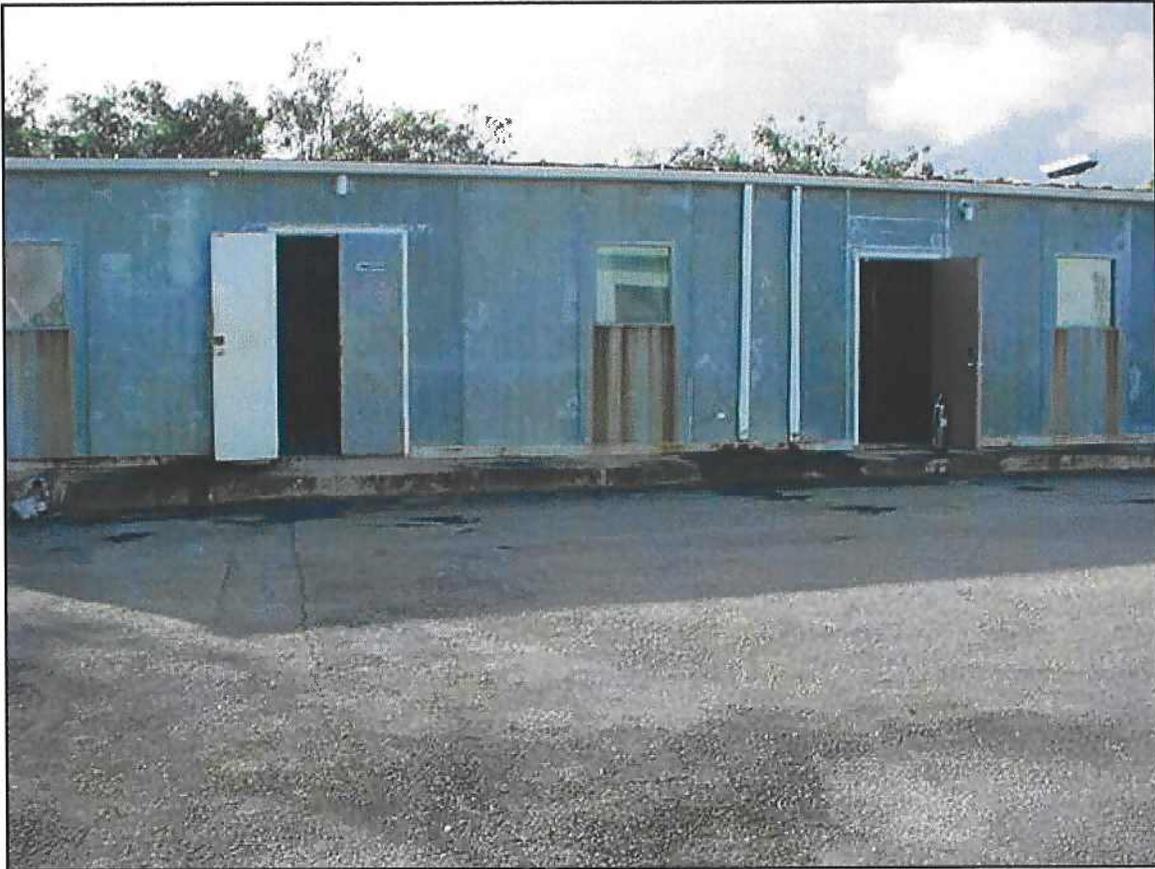
## BUILDING 2256

Building 2256 is identified as “Media Ctr Annex to B-296” and is approximately 1,092 square feet in size. Seven suspect homogeneous materials were identified and sampled. One material, black roofing tar (Material #001), was found to be ACM. No friable, damaged, and accessible ACM was identified.

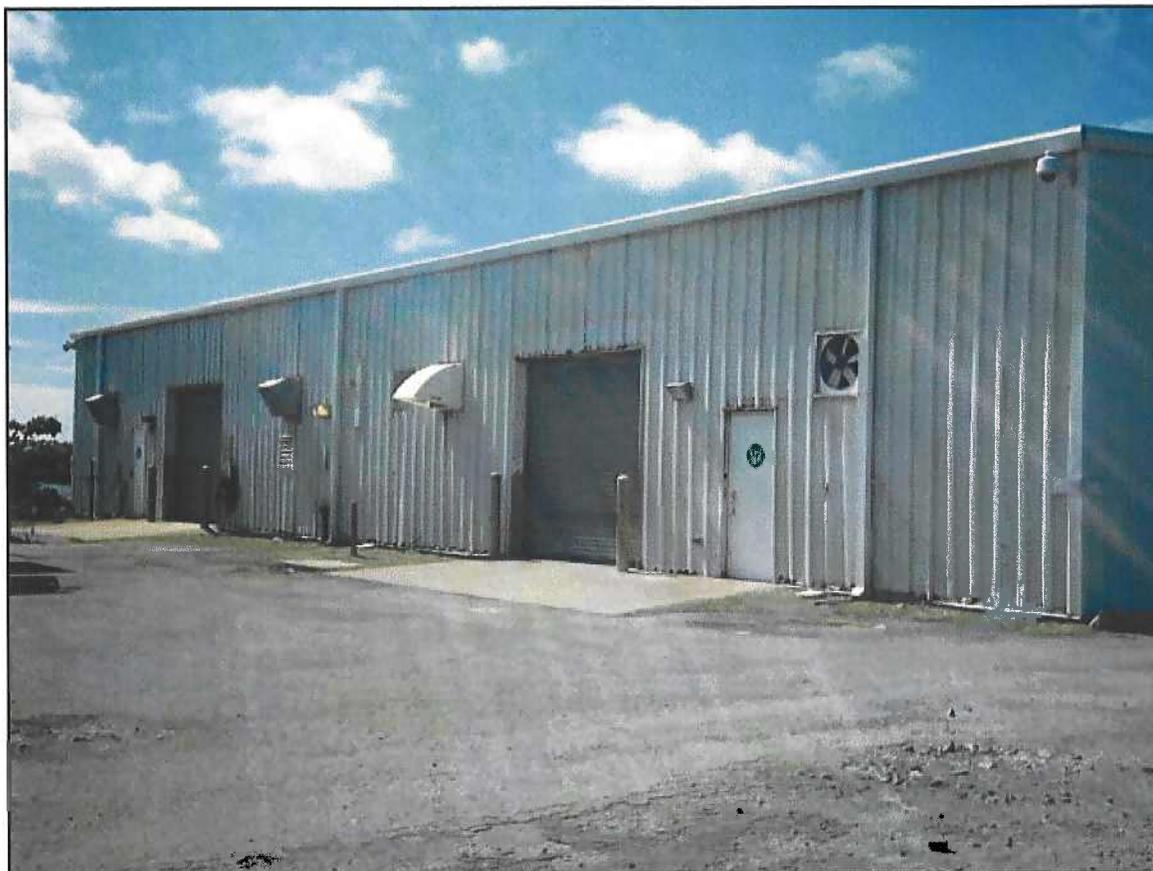
## BUILDING 2262

Building 2262 is identified as “U S Customs Building” and is approximately 6,000 square feet in size. Five suspect homogeneous materials were identified and sampled. None of these materials were found to be ACM.

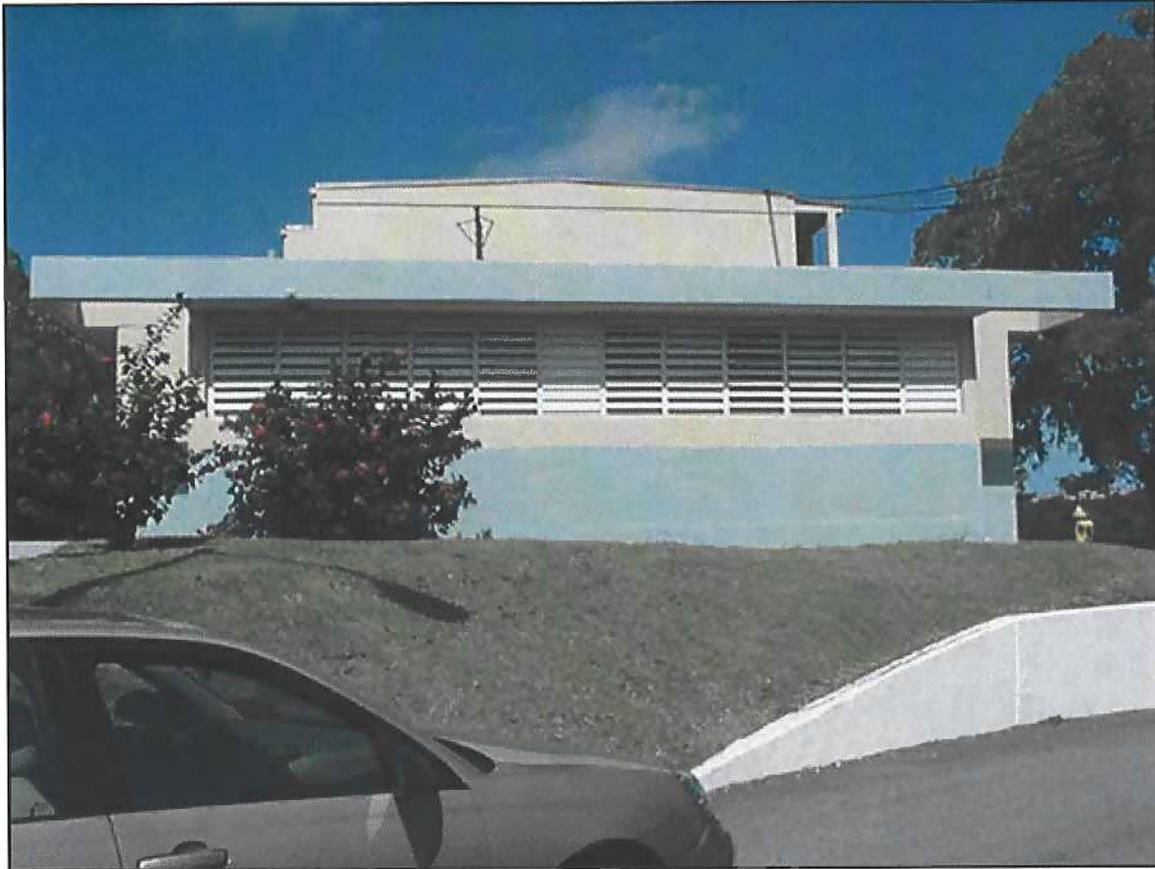
## BUILDING 2263

Building 2263 is identified as “Laundromat at UEPH by B#1710” and is approximately 1,369 square feet in size. Two suspect homogeneous materials were identified and sampled. Neither was found to be an ACM.

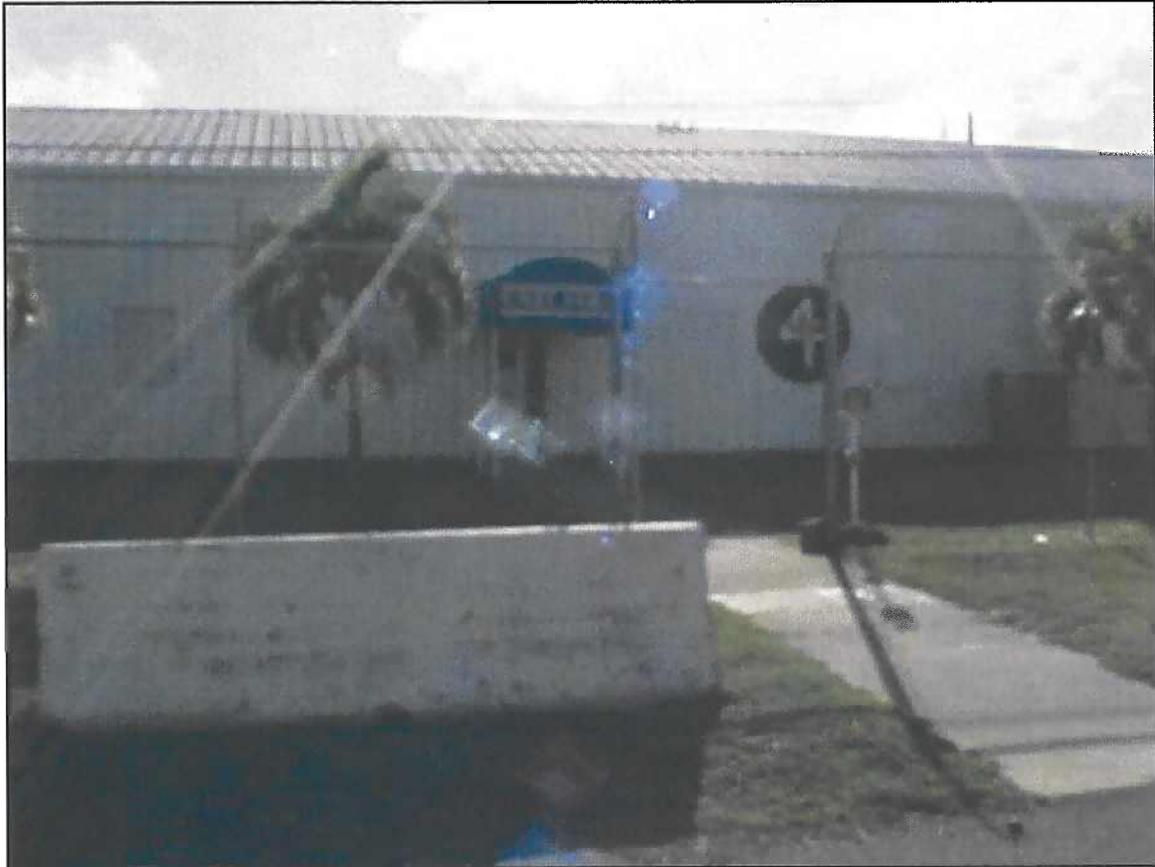
Building 2276 is identified as “UDT Admin/Armory Bldg” and is approximately 4,312 square feet in size. Eight suspect homogeneous materials were identified and sampled. None of the materials were found to be ACM.

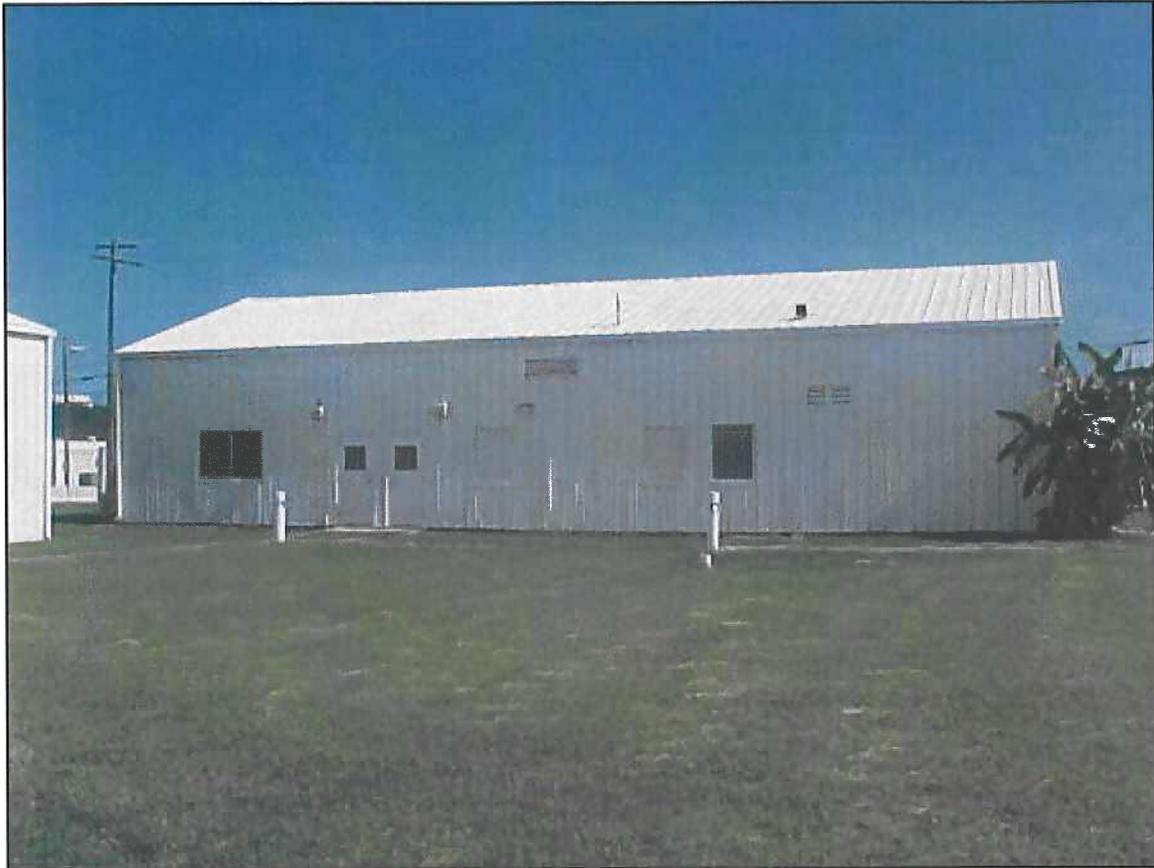
Building 2277 is identified as “Weight Room/Lounge UDT” and is approximately 3,000 square feet in size. Seven suspect homogeneous materials were identified and sampled. One material, floor adhesive (Material #004), was found to be an ACM. No friable, damaged, and accessible ACM were identified.

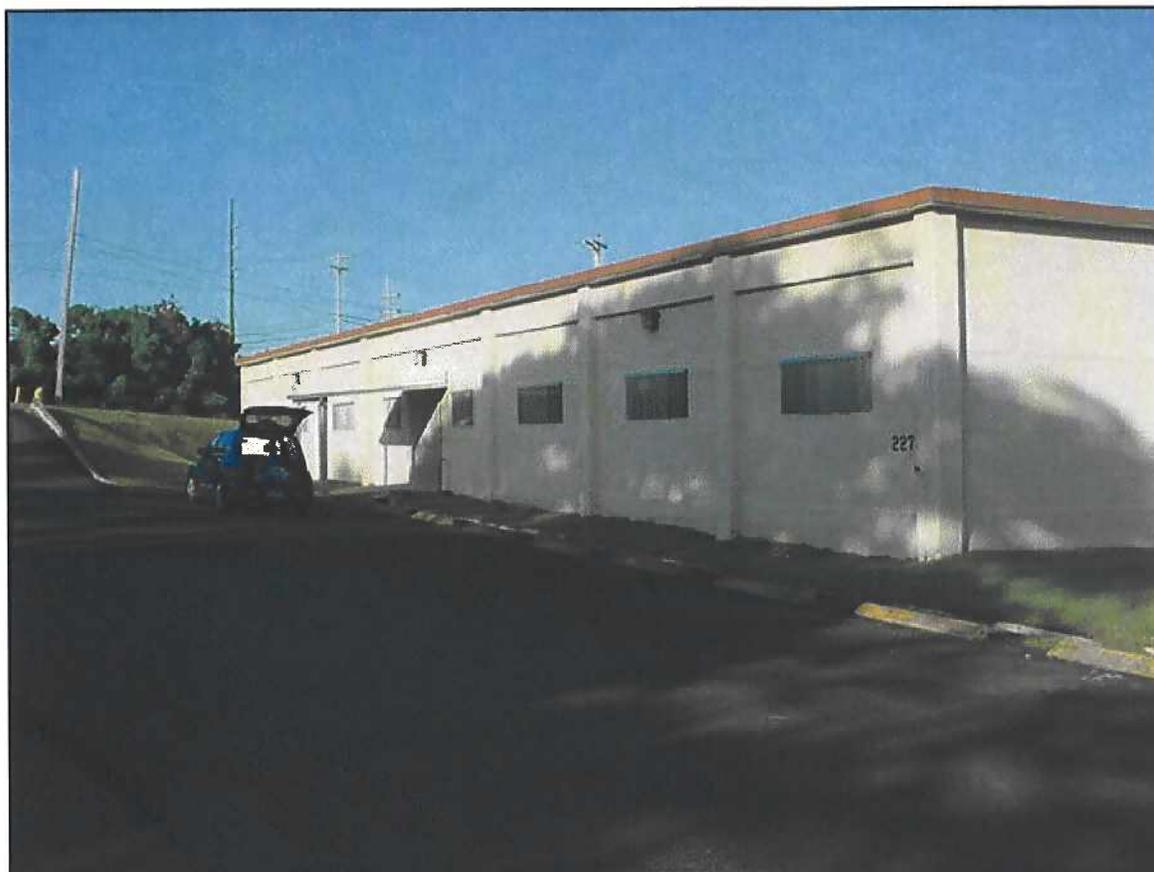
Building 2278 is identified as “AFWTF (Office Annex) B#386” and is approximately 4,960 square feet in size. Six suspect homogeneous materials were identified, and five were sampled. One material, floor adhesive (Material #002), was found to be ACM. The asphaltic roofing material (Material #006) could not be sampled safely, and was therefore assumed to be ACM. No friable, damaged, and accessible ACM was identified.

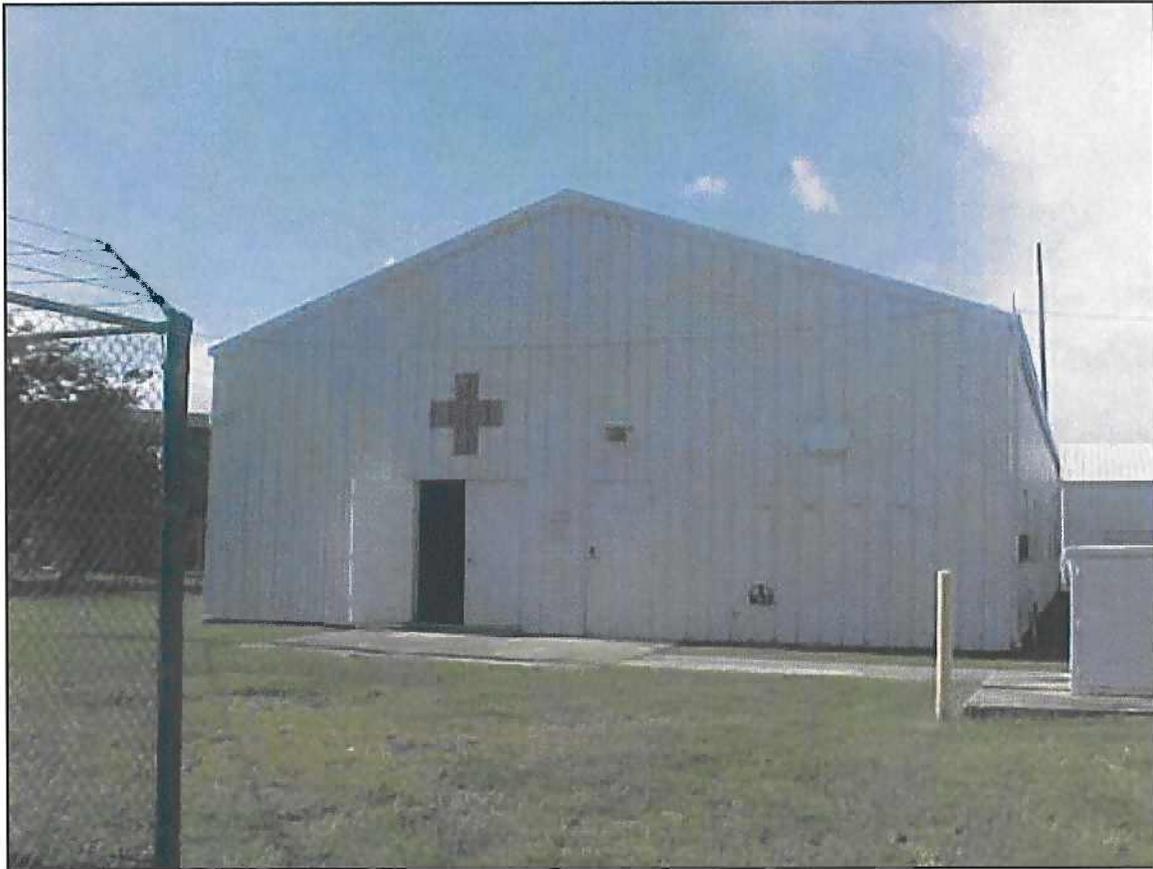
Building 2281 is identified as “UDT Isolation/Medical Bldg” and is approximately 4,000 square feet in size. Nine suspect homogeneous materials were identified and sampled. None of these materials were found to be ACM.

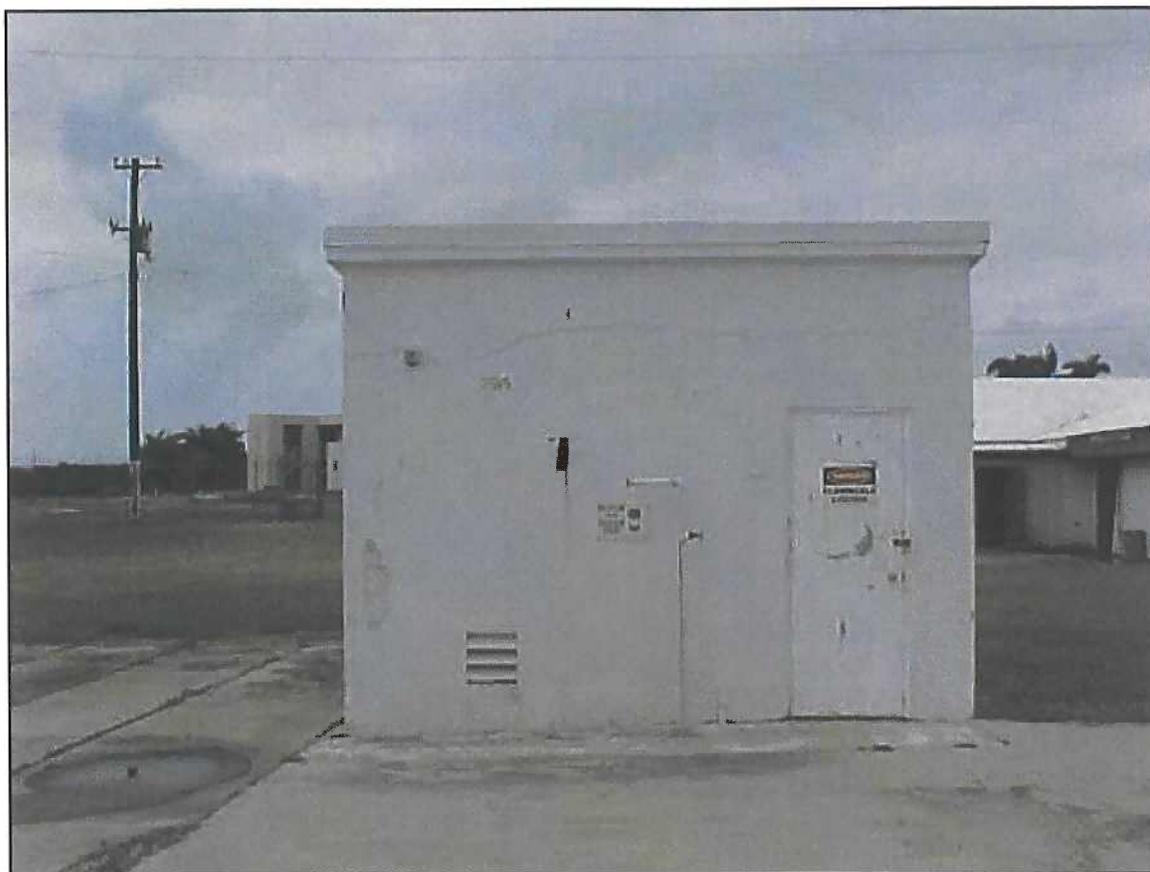
Building 2283 is identified as “Fuel Gas Stge at UDT” and is approximately 196 square feet in size. No suspect materials were identified. Therefore, no sampling was conducted.

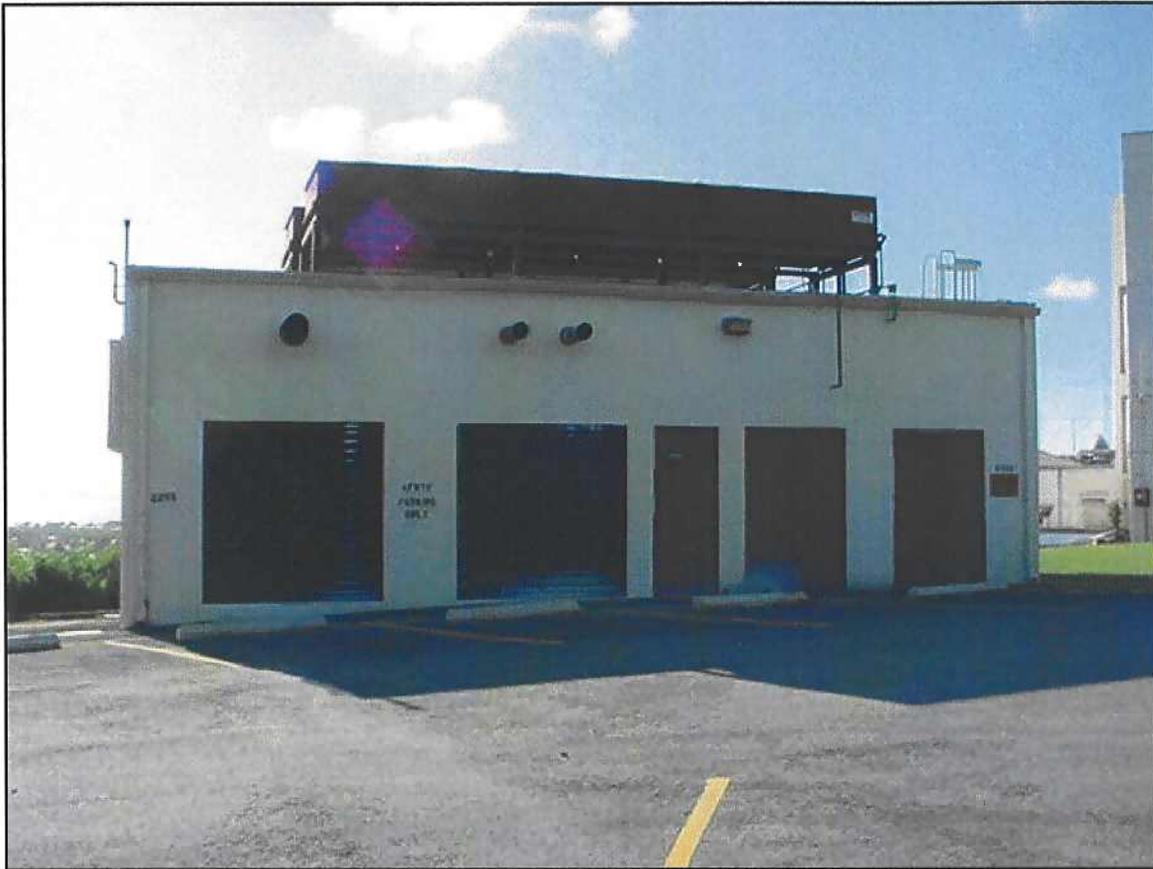
Building 2293 is identified as “ROC. Utility Building” and is approximately 1,260 square feet in size. Two suspect homogeneous materials were identified and sampled. Neither material was found to be ACM.

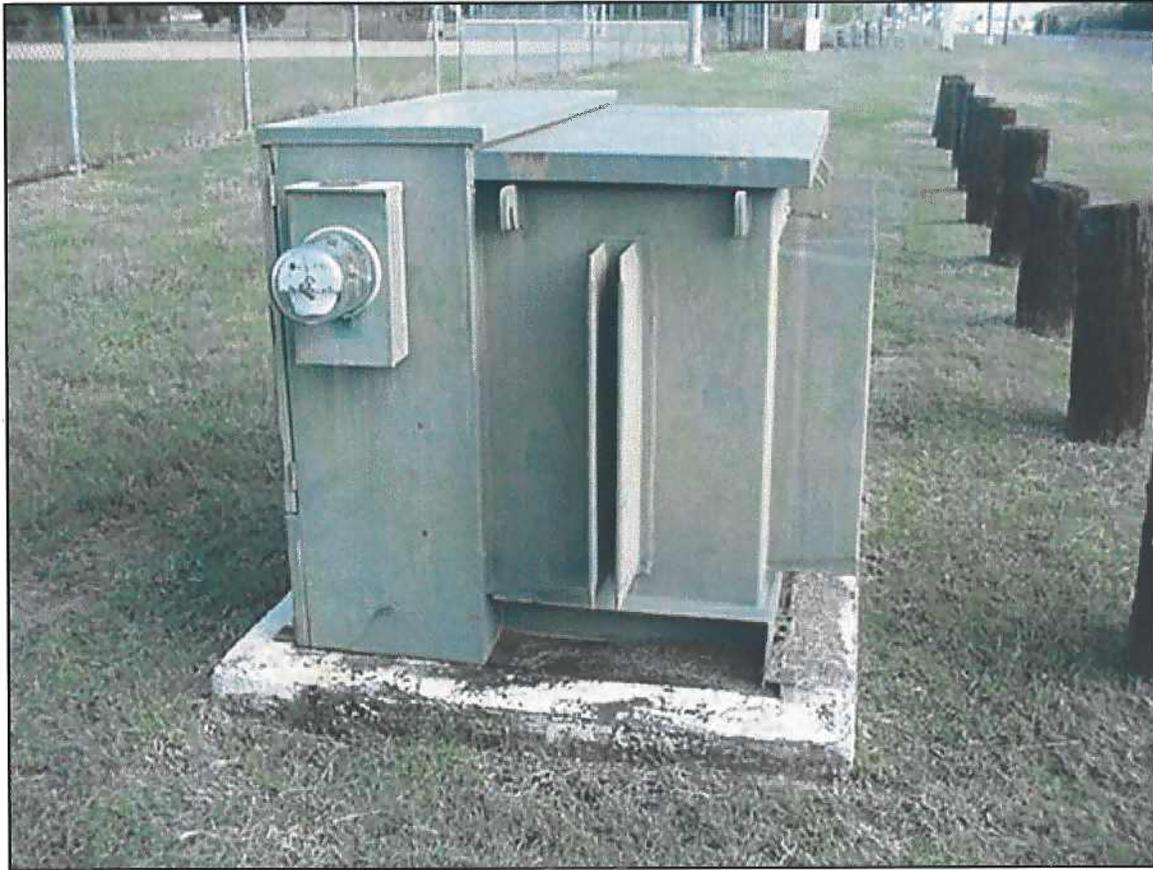
Building 2294 is identified as “SUB-STATION/Fleet Recre Park” and is approximately 12 square feet in size. No suspect materials were identified. Therefore, no sampling was conducted.

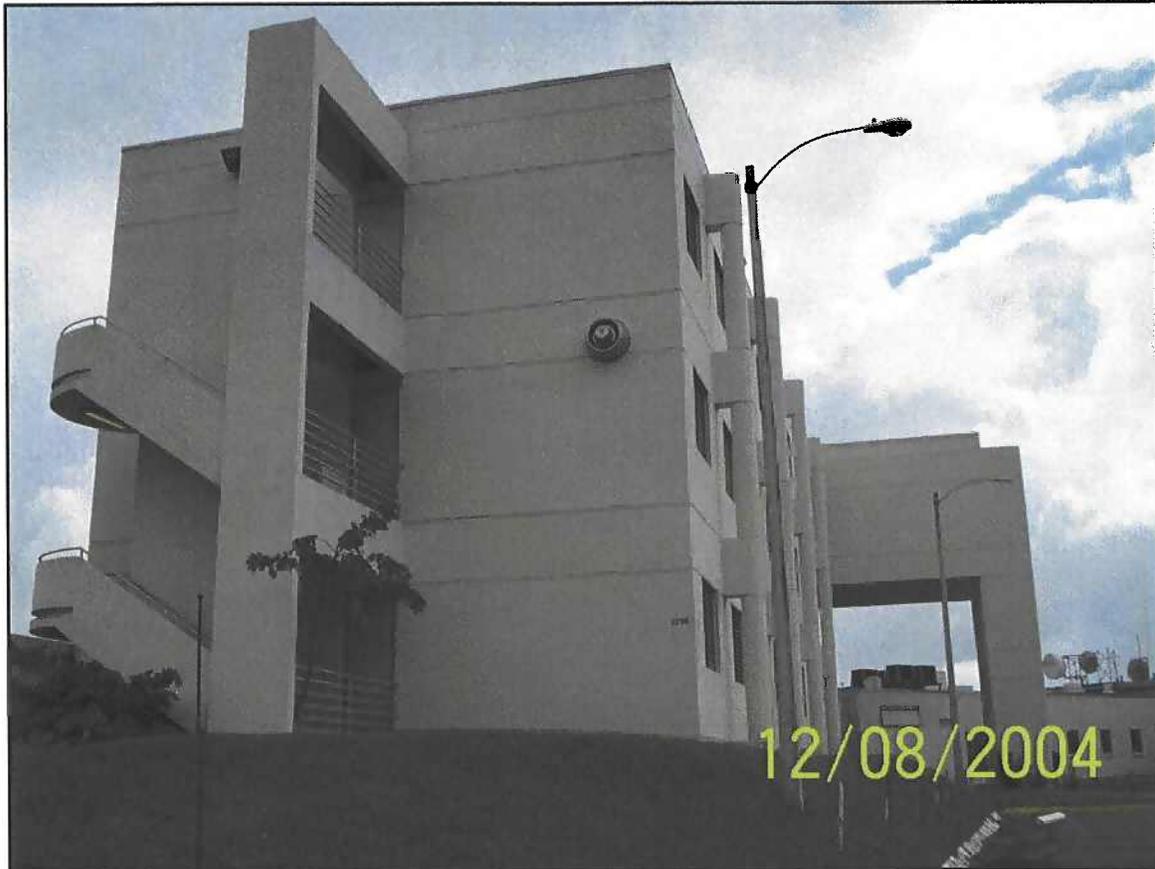
Building 2296 is identified as “Administrative Building AFWTF” and is approximately 22,011 square feet in size. Thirteen suspect homogeneous materials were identified and sampled. One material, cementitious blocks (Material #013), was found to be an ACM. No friable, damaged, and accessible ACM was identified.

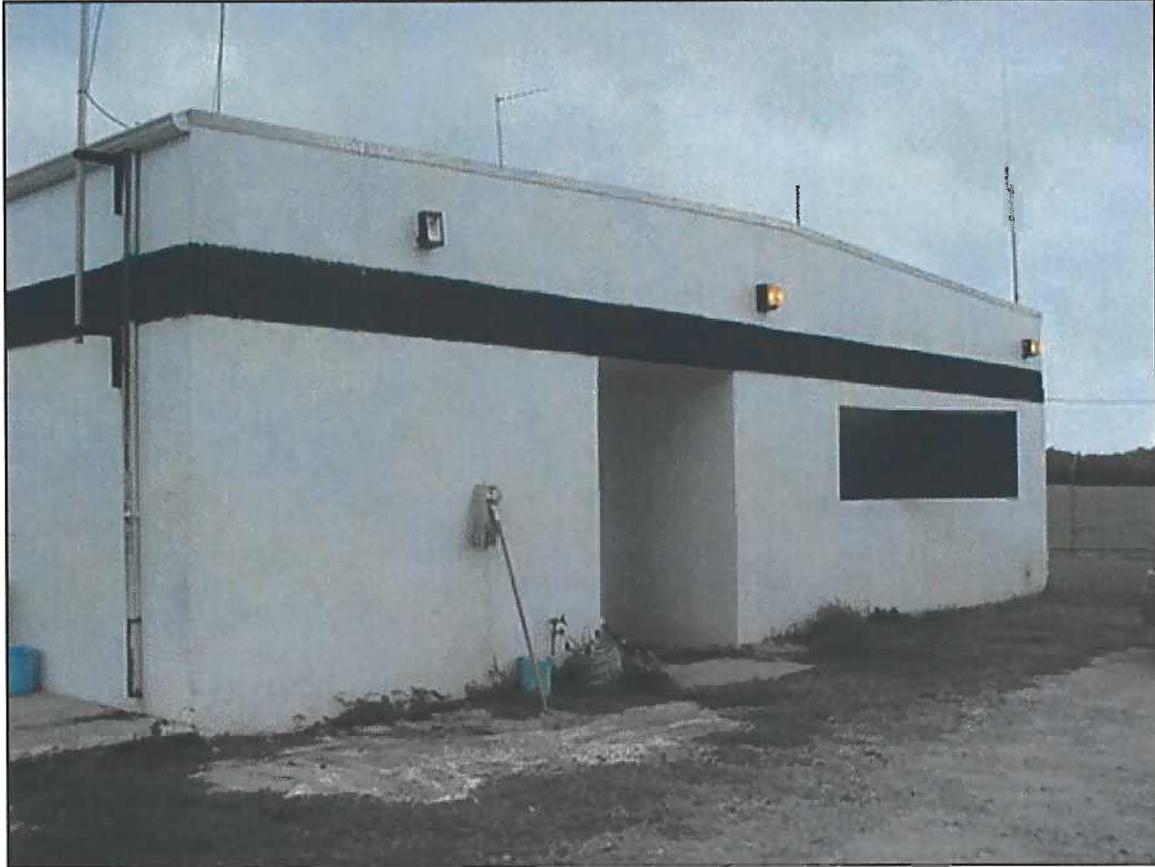
Building 2302 is identified as “Airfield Alarm Control Ctr” and is approximately 1,200 square feet in size. Six suspect homogeneous materials were identified and sampled. None of the materials were found to be ACM.

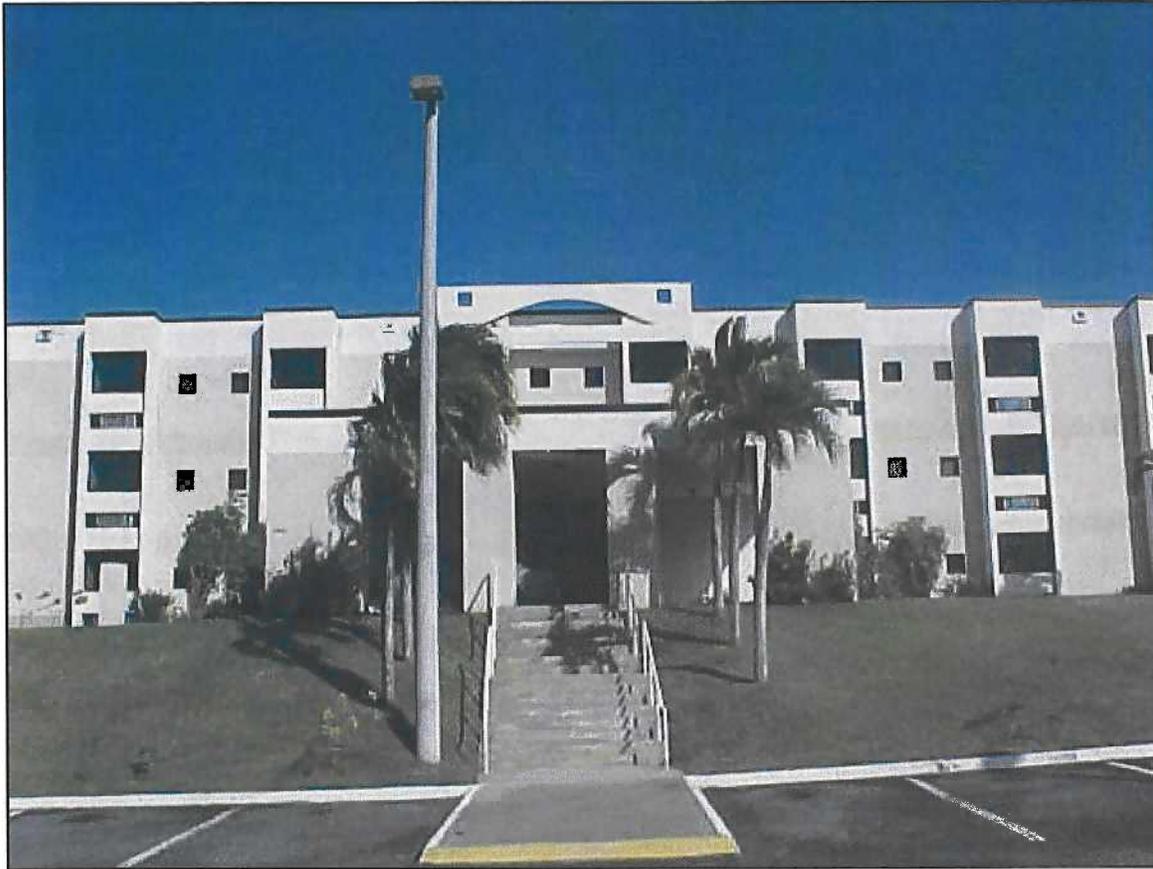
Building 2303 is identified as “Navy Lodge” and is approximately 73,751 square feet in size. Seven suspect homogeneous materials were identified and sampled. None of the materials were found to be ACM.

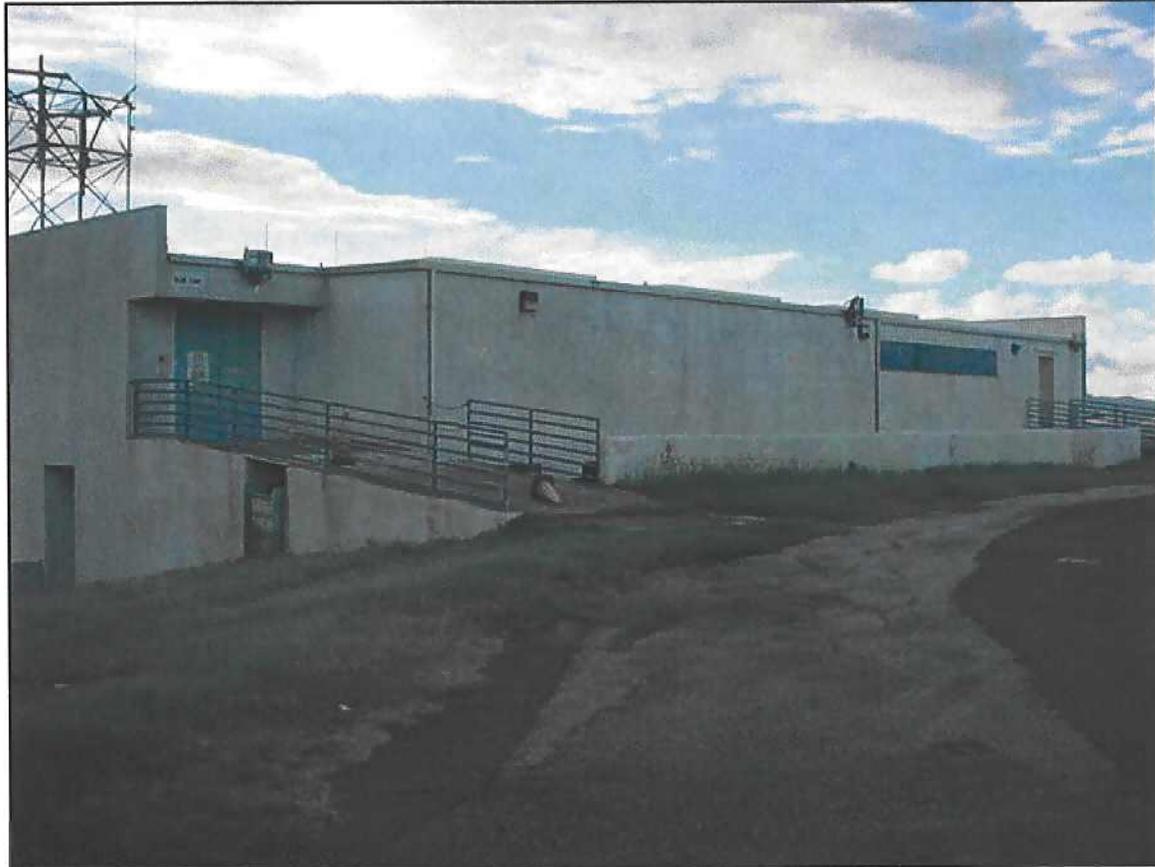
Building 2304 is identified as “Telemetry Bldg” and is approximately 9,222 square feet in size. Sixteen suspect homogeneous materials were identified and sampled. None of the materials were found to be ACM.

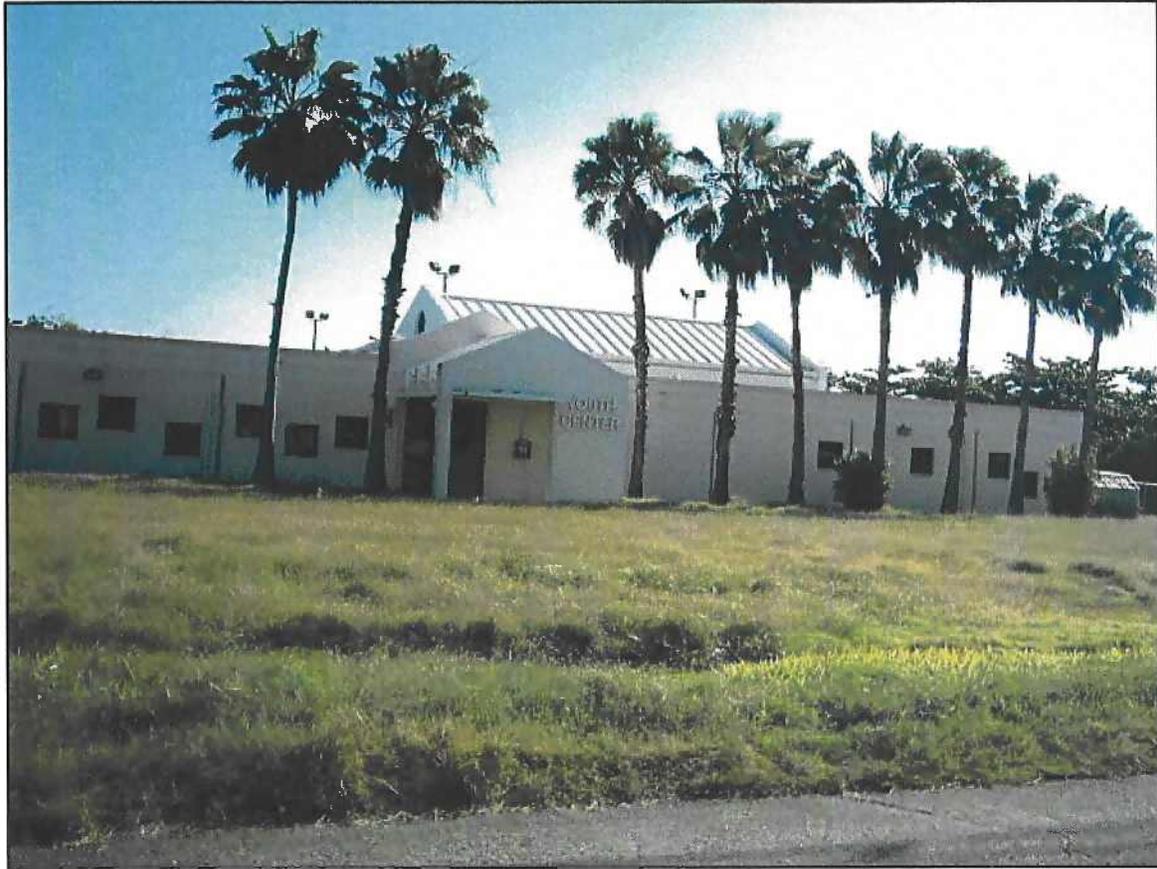
Building 2305 is identified as “Youth Center” and is approximately 7,165 square feet in size. Nine suspect homogeneous materials were identified and sampled. None of these materials were found to be ACM.

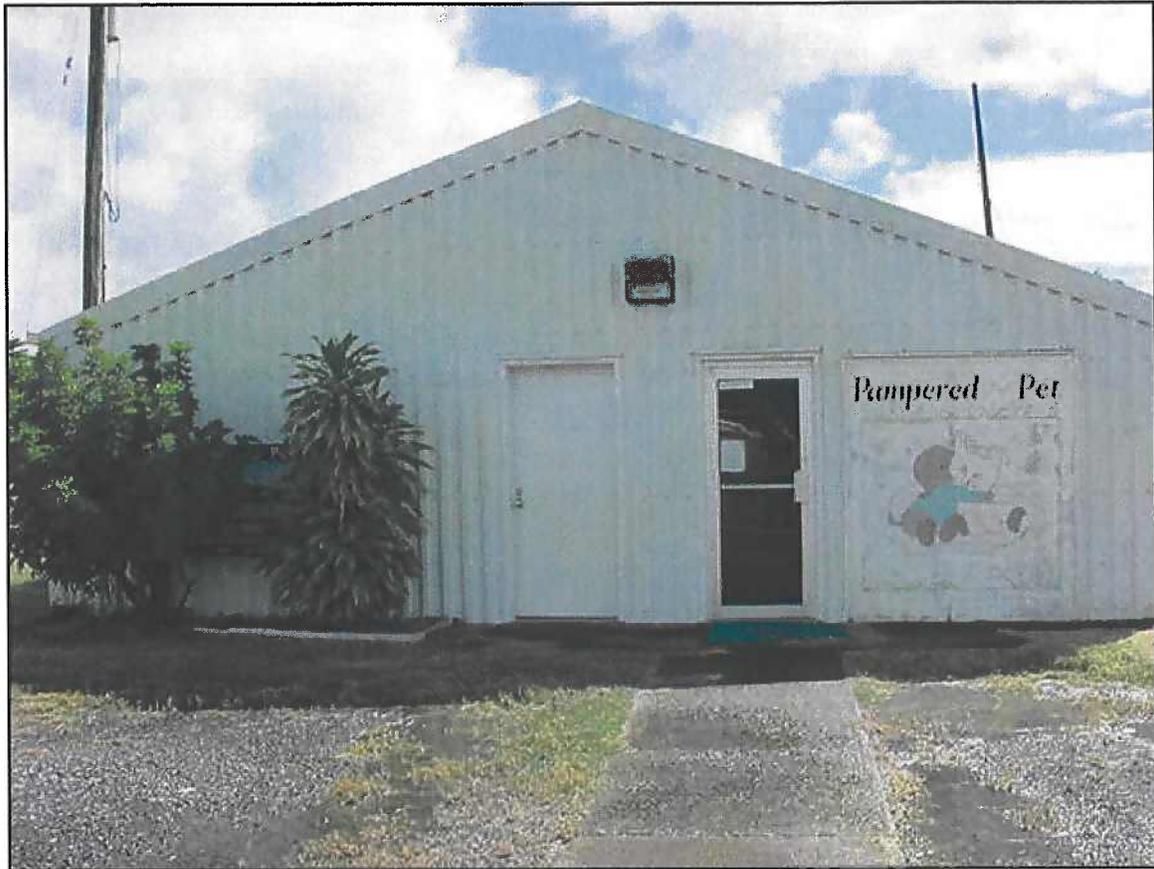
Building 2306 is identified as “Pampered Pet” and is approximately 3,189 square feet in size. Six suspect homogeneous materials were identified and sampled. None of the materials were found to be ACM.

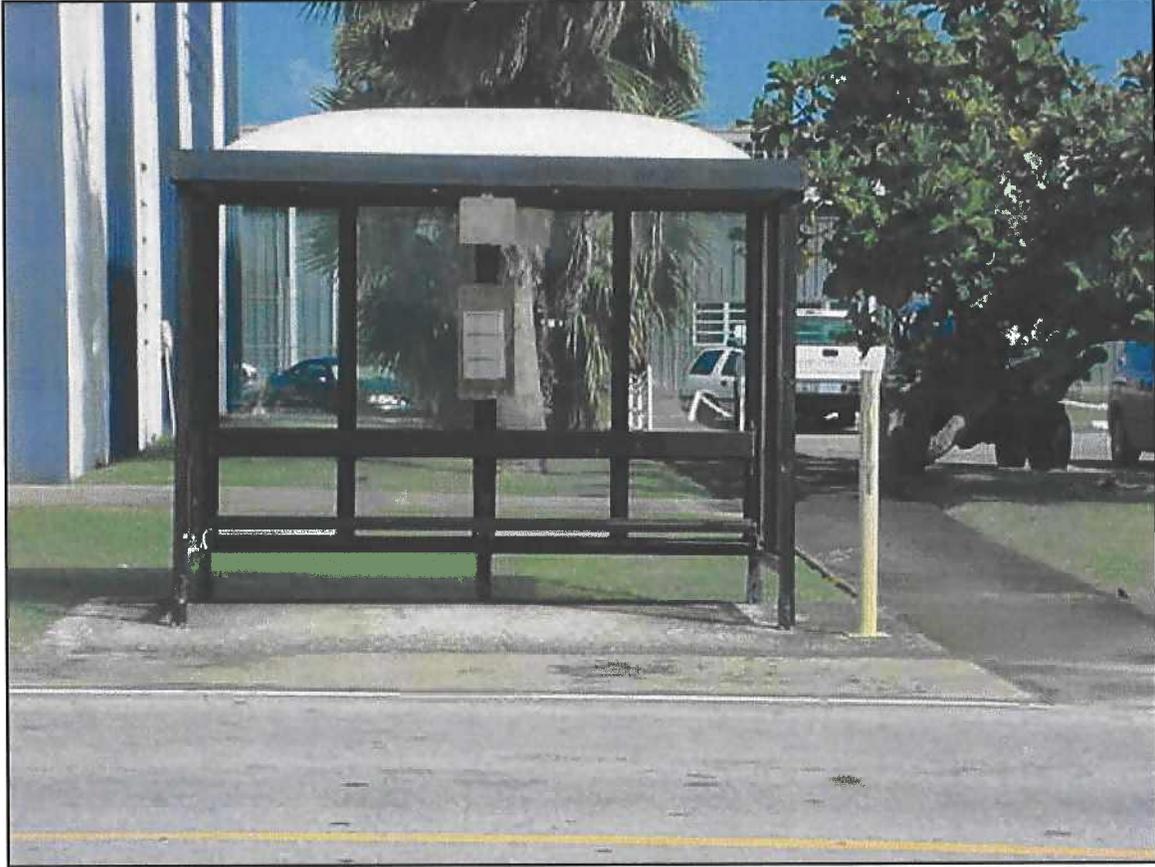
Building 2308 is identified as “Bus Shelter by B#1205” and is approximately 50 square feet in size. No suspect materials were identified. Therefore, no sampling was conducted.

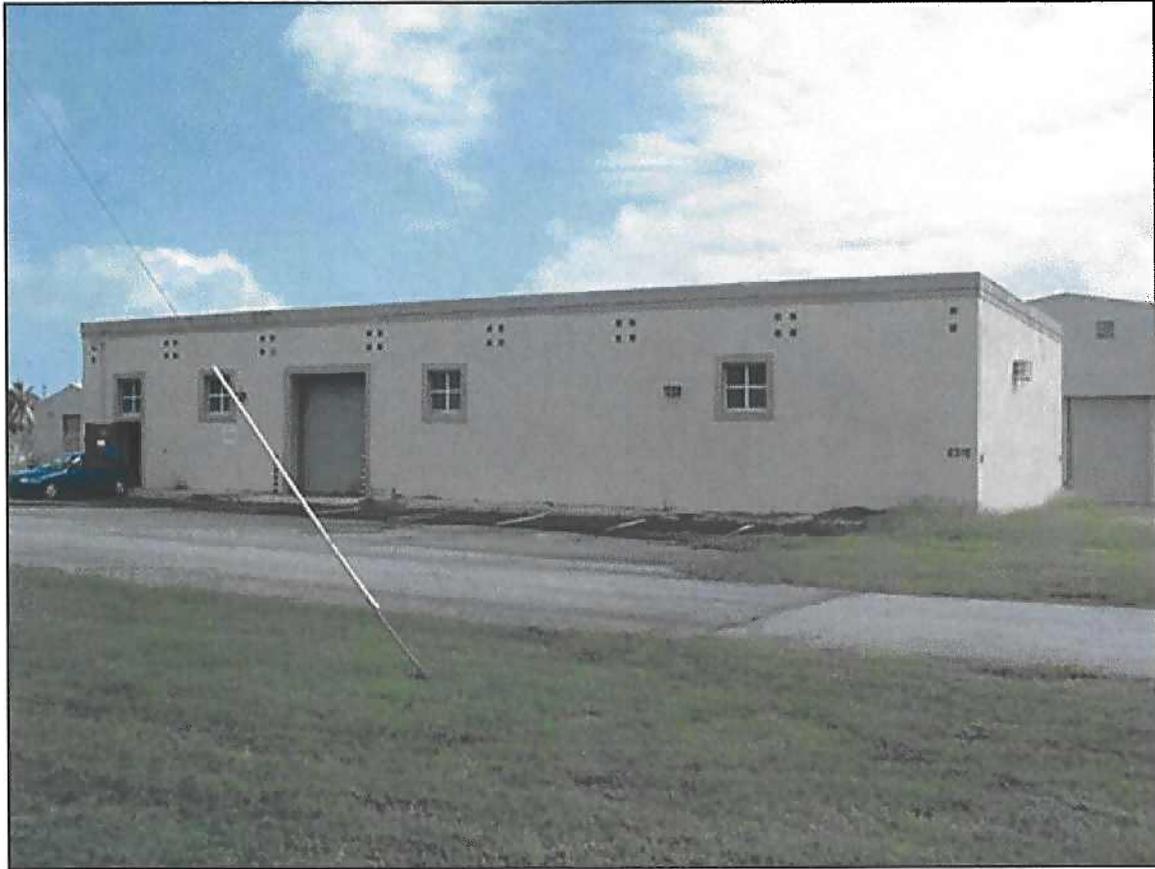
Building 2315 is identified as “Aviation Support Div. (ASD)” and is approximately 4,800 square feet in size. No suspect materials were identified. Therefore, no sampling was conducted.

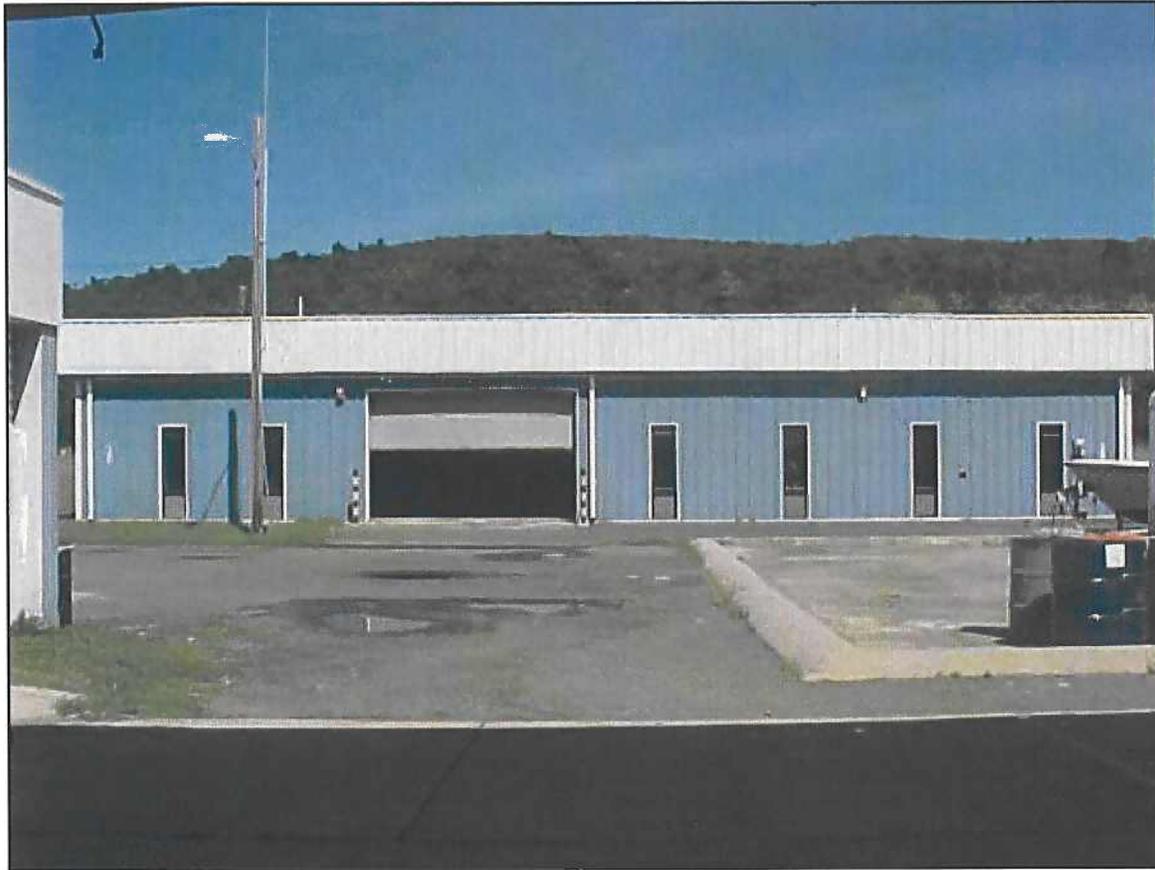
Building 2328 is identified as “Stge Bldg/Wtrfront by B2036” and is approximately 2,400 square feet in size. Four suspect homogeneous materials were identified and sampled. None of these materials were found to be ACM.

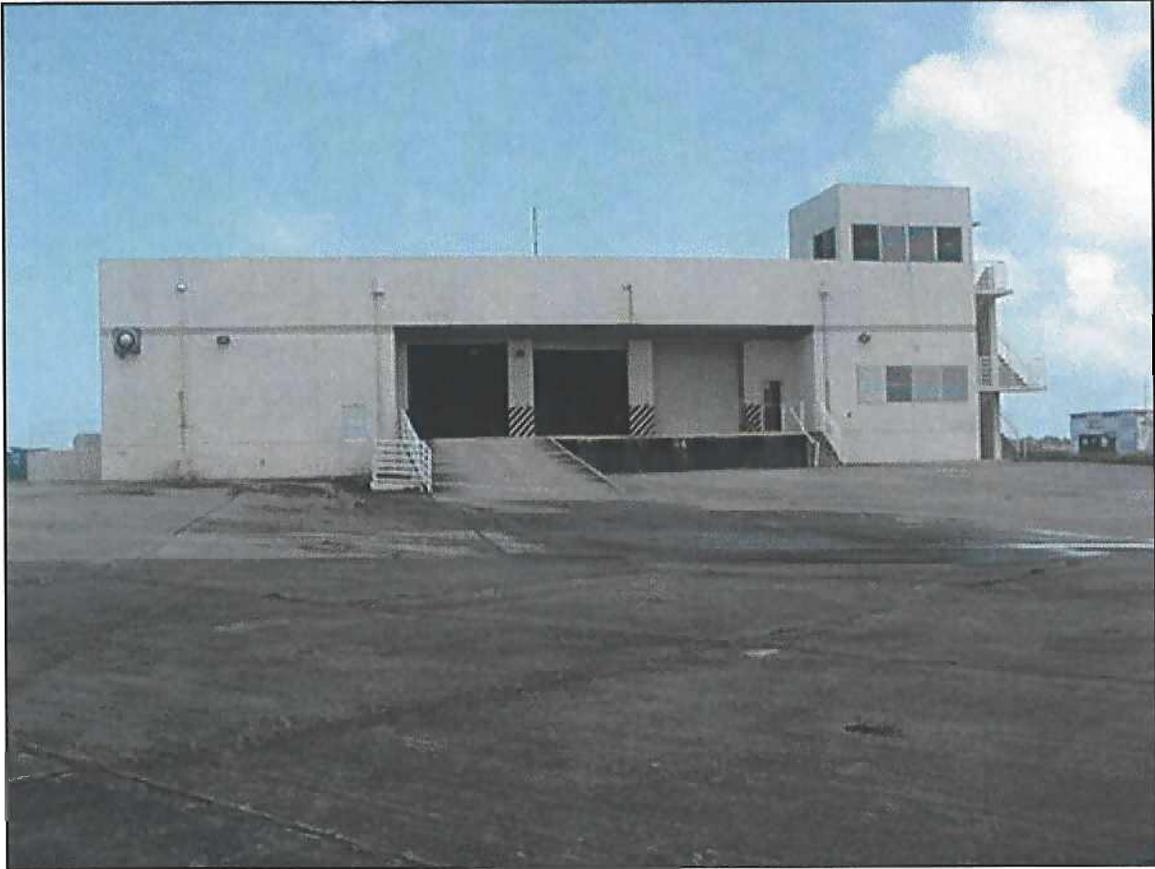
Building 2333 is identified as “Air Cargo Terminal” and is approximately 7,596 square feet in size. Ten suspect homogeneous materials were identified and sampled. No materials were found to be ACM.

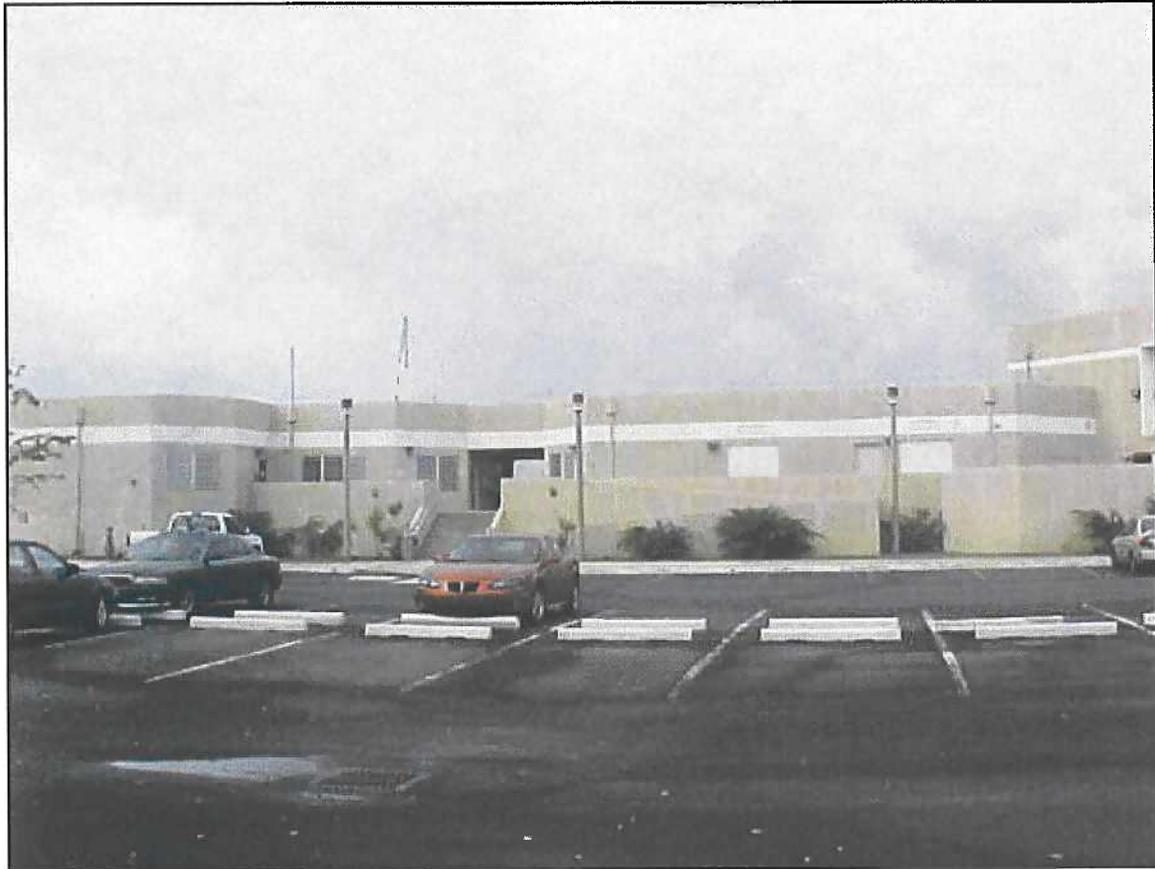
Building 2334 is identified as “Boathouse/Marina” and is approximately 8,450 square feet in size. Eight suspect homogeneous materials were identified and sampled. None of these materials were found to be ACM.
