Final  
**Asbestos Inspection Report**  
for

Naval Activity Puerto Rico  
Ceiba, Puerto Rico

Volume 5 of 7

Buildings 2004 through 2339

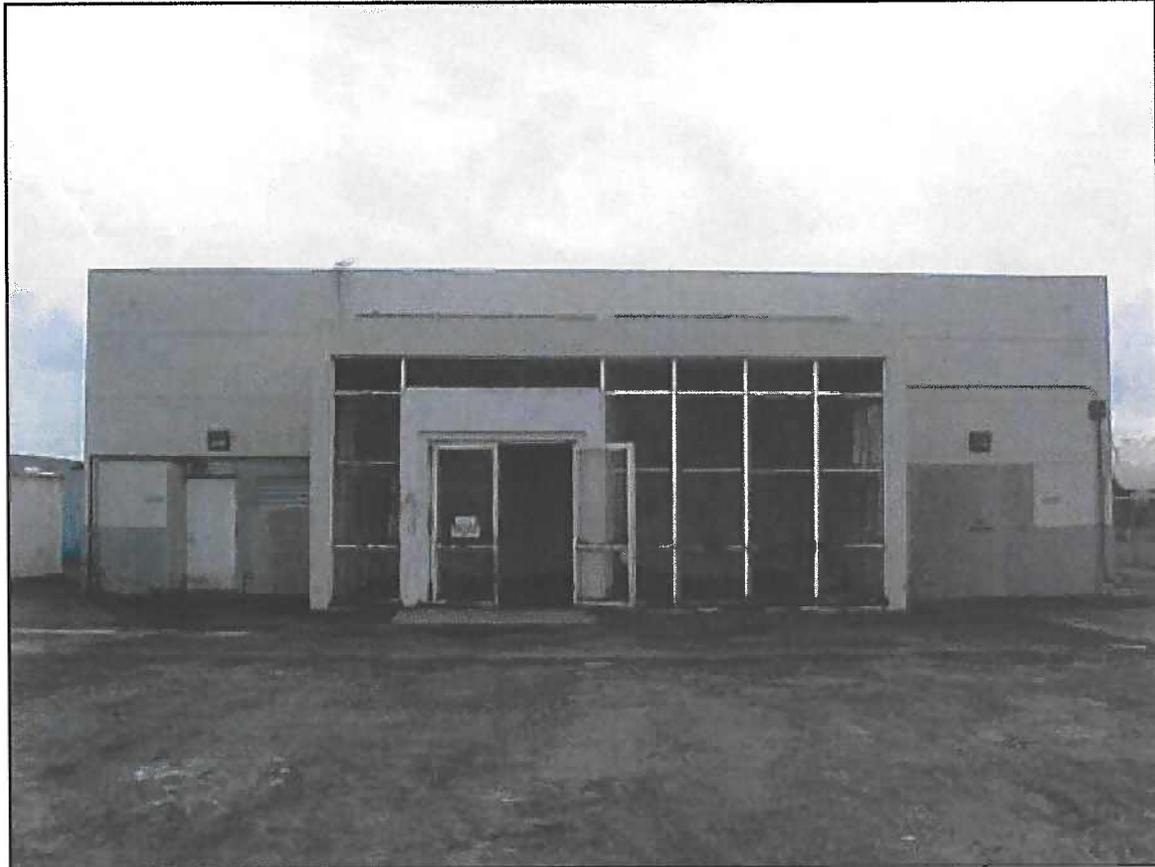
Building 2335 is identified as “Haz/Flamm Stge” and is approximately 5,427 square feet in size. Two suspect homogeneous materials were identified and sampled. Neither of the materials was found to be ACM.

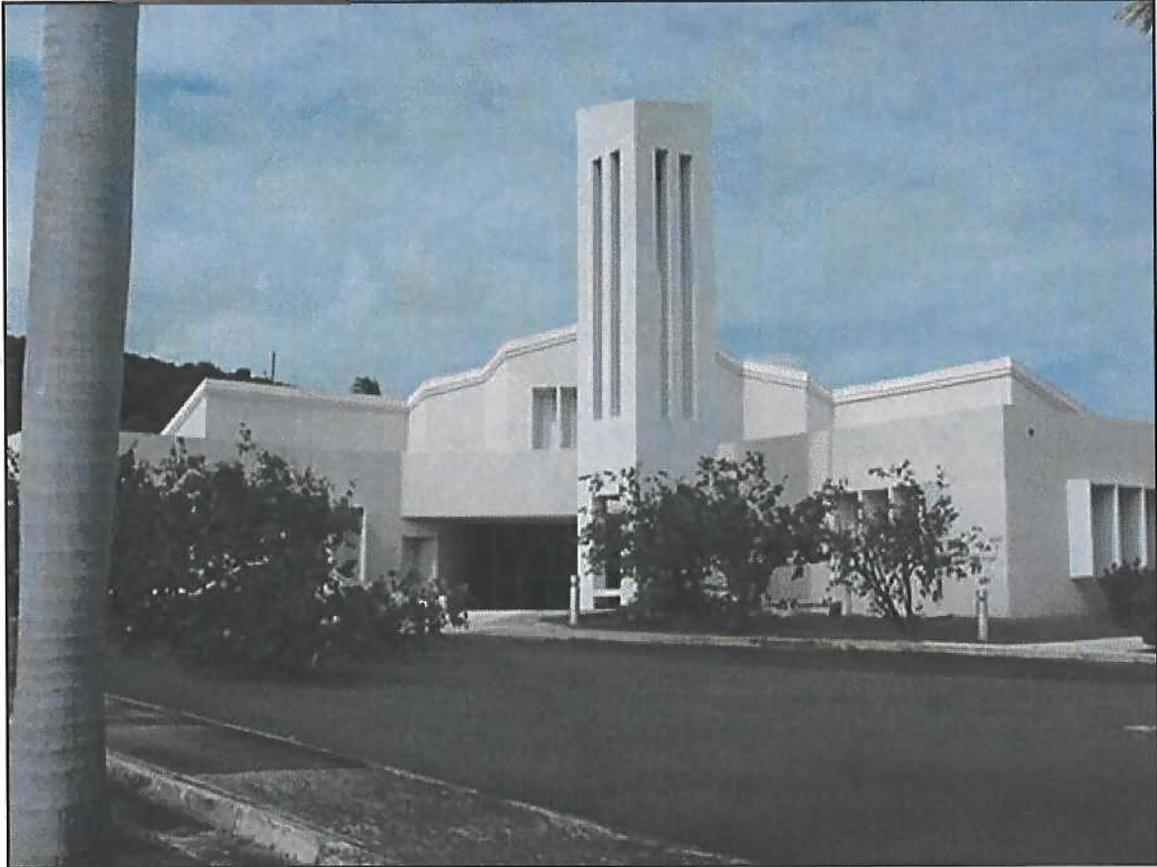
Building 2337 is identified as “Chapel” and is approximately 11,856 square feet in size. Eleven suspect homogeneous materials were identified and sampled. None of the materials were found to be an ACM.

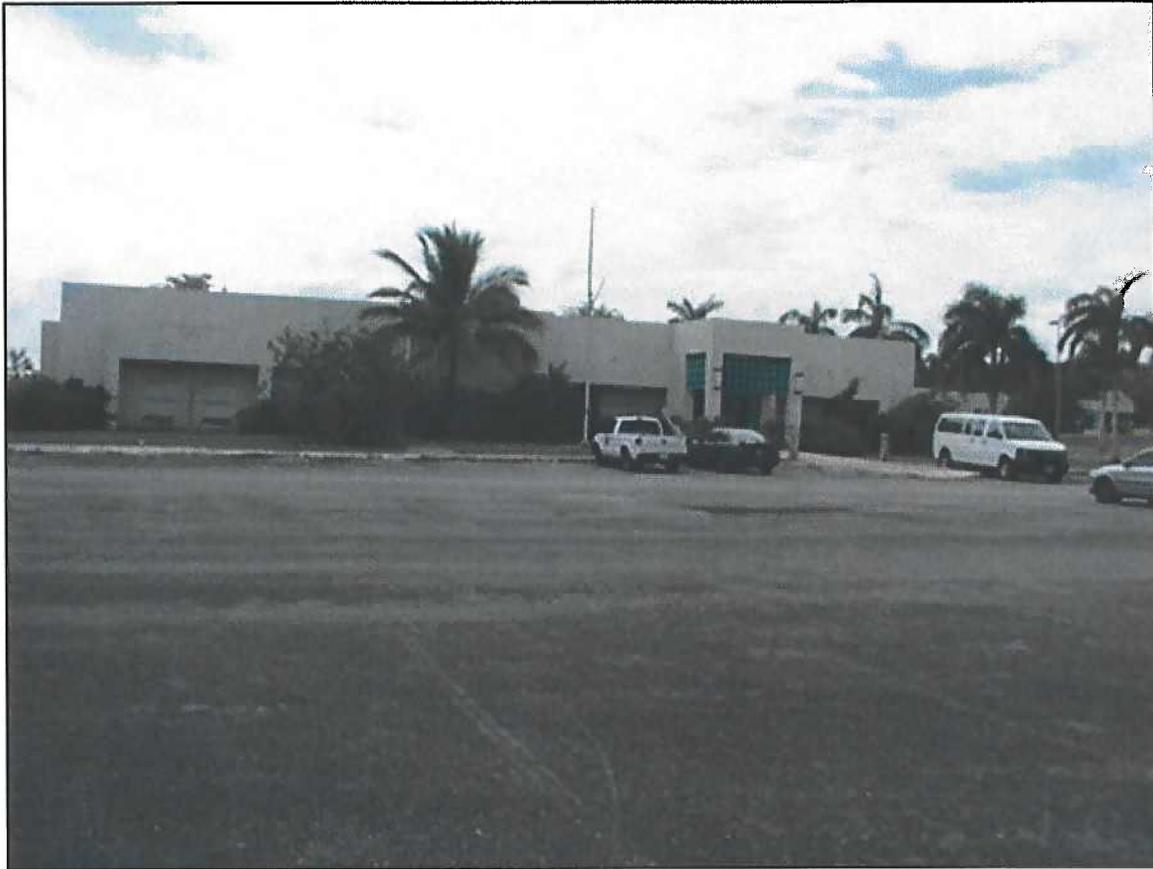
Building 2338 is identified as “Dental Clinic/NILSO” and is approximately 14,719 square feet in size. Eleven suspect homogeneous materials were identified and sampled. None of the materials were found to be ACM.

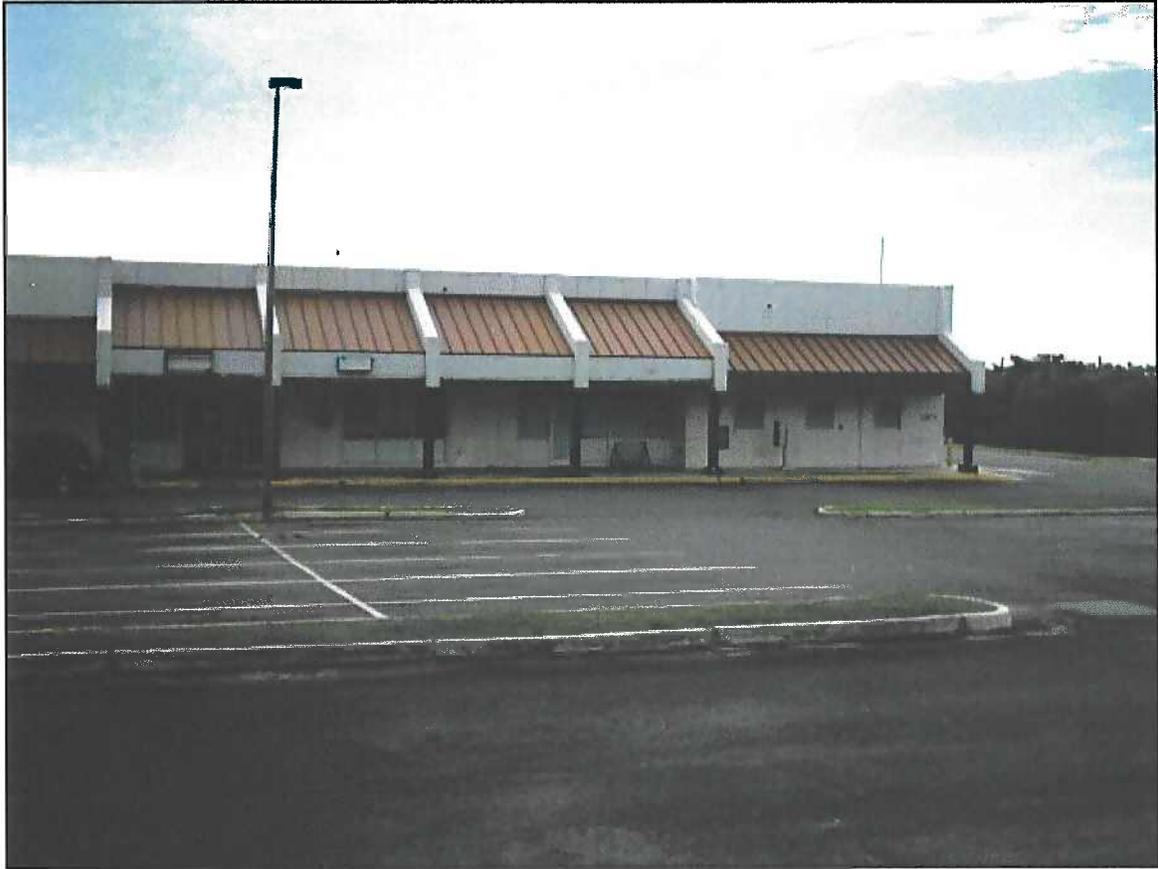
Building 2339 is identified as “Service Sta / Mini-Mart” and is approximately 15,927 square feet in size. Twelve suspect homogeneous materials were identified and sampled. None of these materials were found to be ACM.
