# AERIAL PHOTOGRAPHIC ANALYSIS INDIAN HEAD NAVAL SURFACE WARFARE CENTER

## Charles County, Maryland

TS-PIC-9803362S  
February 1998

This report presents the results of an aerial photographic analysis conducted with historical aerial photographs of the Indian Head Naval Surface Warfare Center located in Charles County, Maryland. Seven dates of black-and-white and color photographs (1956, 1961, 1963, 1967, 1972, 1982, and 1987) were used to analyze the site. Environmentally significant hazardous waste-related features and conditions were identified. The purpose of this report is to provide remote sensing support to field investigations in U.S. Environmental Protection Agency (EPA) Region 3 under the Comprehensive Environmental Response, Compensation, and Liability Act (CERCLA).

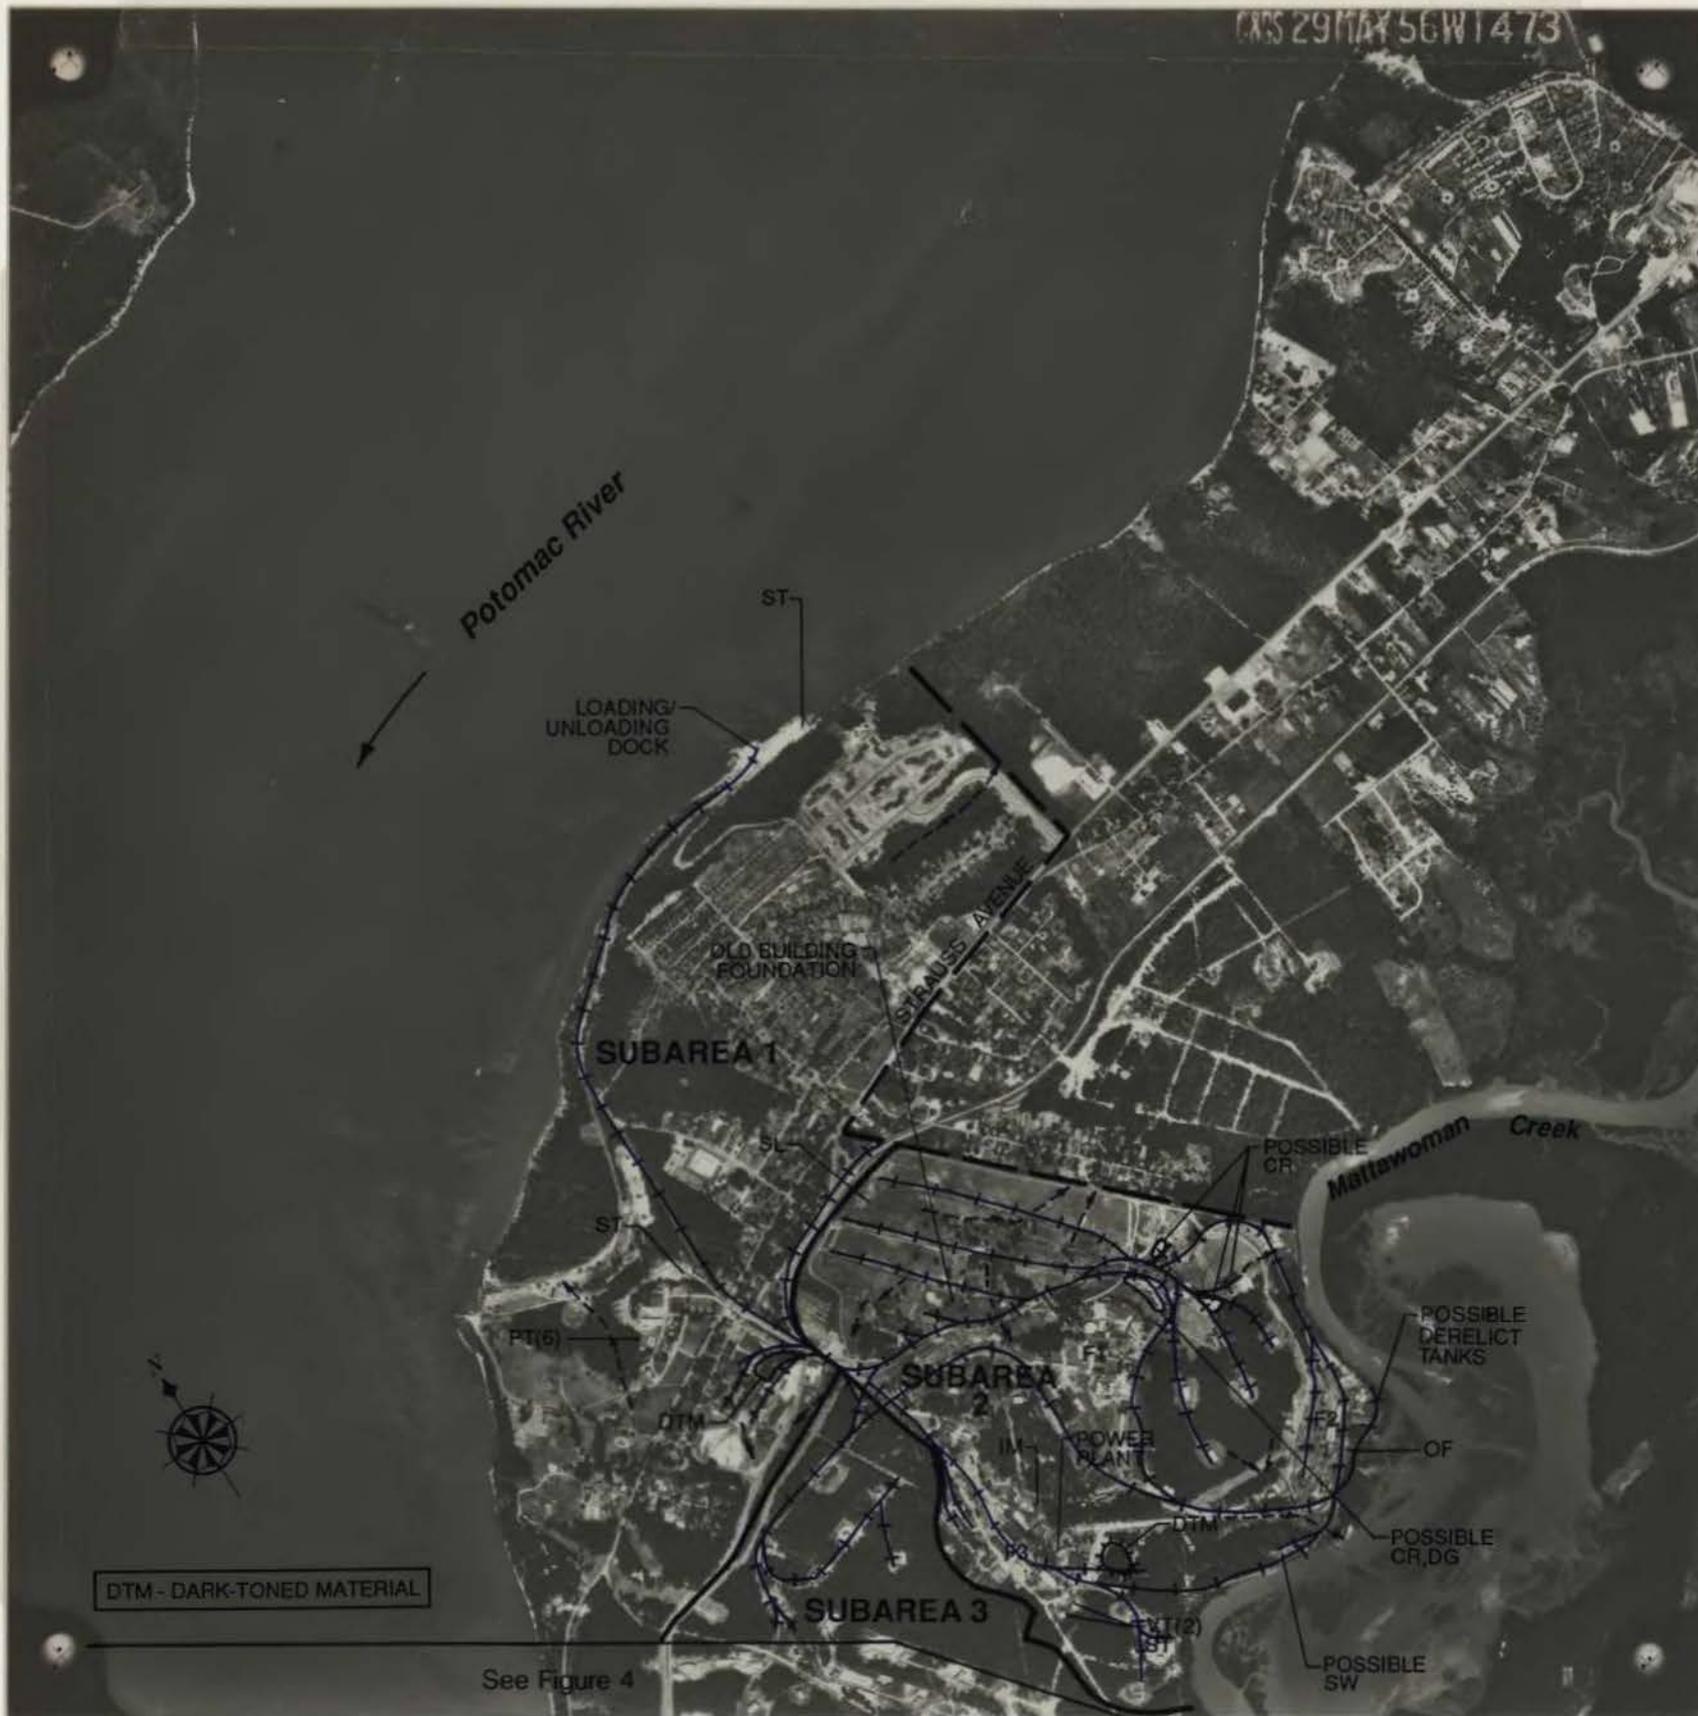
CRS 29 MAY 56 W 1473

This northernmost subarea consists primarily of residential units and institutional buildings such as schools and office buildings. Staining (ST) is visible at a loading/unloading dock on the Potomac River shoreline. To the south, six horizontal high pressure tanks (PT) and a small stain are noted. To the southeast is a large area of dark-toned material (DTM) (probably coal). Adjacent roads and an industrial facility lot (not annotated) have apparently been covered with this material.

Northeast of Facility 1 (F1), large accumulations of possible crates (CR) are visible adjacent to several buildings. Further to the southeast, at Facility 2 (F2), are possible derelict tanks and an outfall (OF). To the south is a deposit of possible solid waste (SW). At Facility 3 (F3) is a power plant with a deposit of dark-toned material (probably coal). A small impoundment (IM) is visible nearby. Stains are present within two large storage tank containments.

This portion of Subarea 3 consists of several storage bunkers (not annotated).

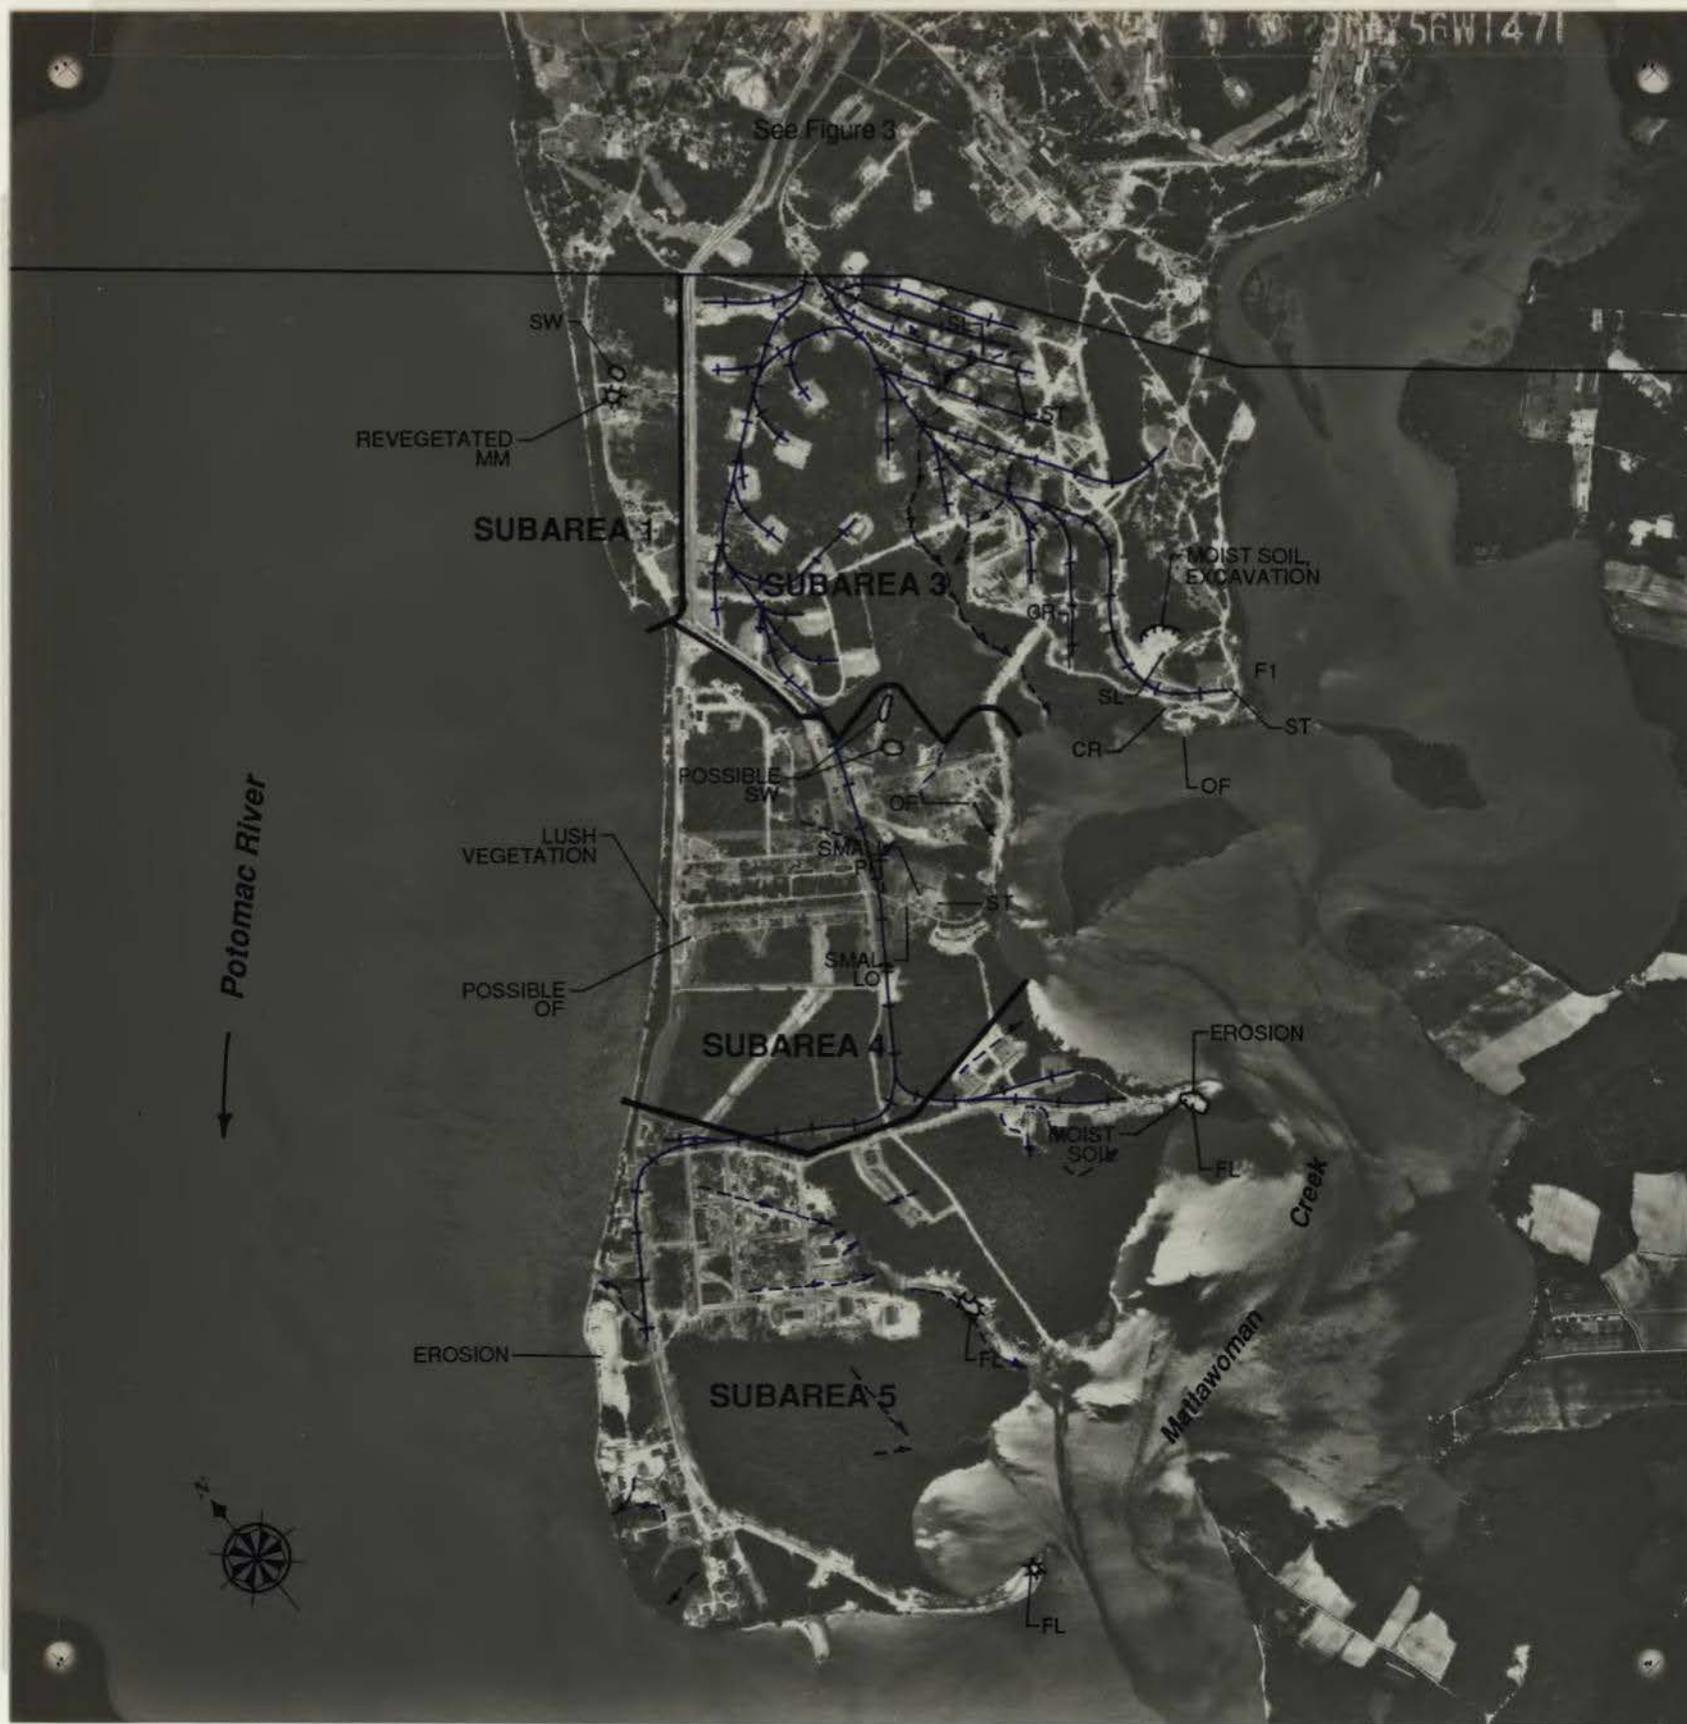
This portion of the subarea is composed primarily of storage units (not annotated) and one processing facility (F1). Staining and standing liquid are noted in the northern portion of this subarea. In the southern portion is a large excavation with moist soil. One outfall, an accumulation of crates, and staining are associated with the nearby facility (F1).

Within the western portion of this subarea, a possible outfall from an adjacent building is indicated by a small area of lush vegetative growth. Two deposits of possible solid waste are visible to the northeast. An outfall is visible on the eastern shoreline. To the south, staining and a small pit are visible within a small lot.

Three accumulations of fill (FL) are visible in this subarea as well as erosion.

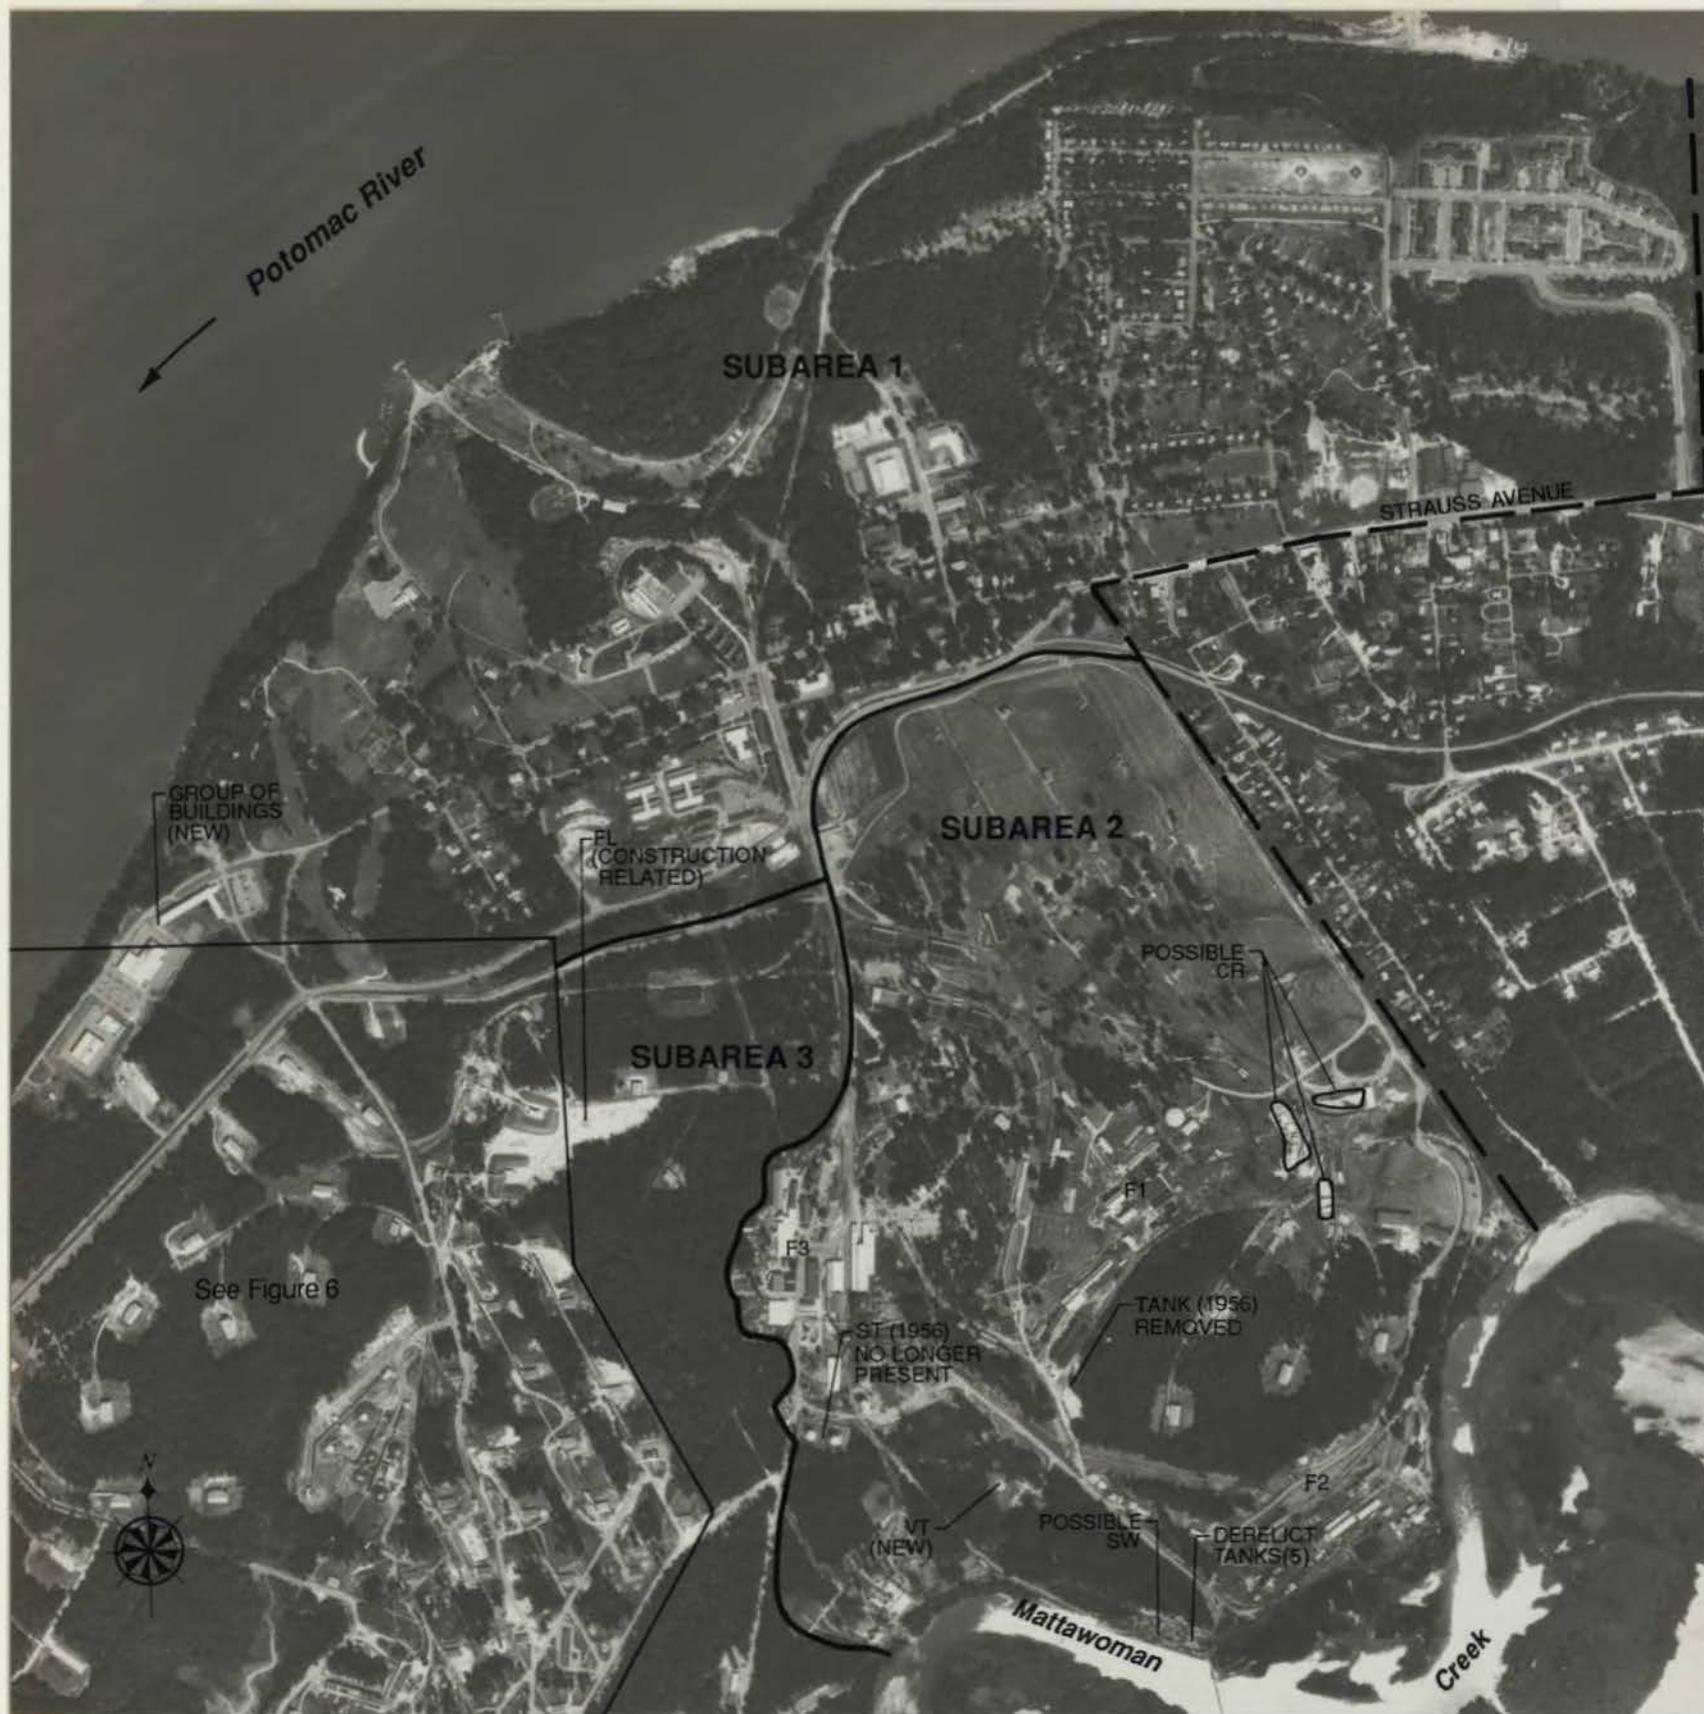
Since 1956 there has been a change in the location of possible crates northeast of Facility 1 (F1) which may indicate usage and replacement of the possible crates. Southwest of Facility 2 (F2) are five derelict tanks and possible solid waste in an open storage area. A large storage tank seen in 1956 has been removed. To the southwest is a new vertical tank (VT).

Construction-related fill is observed in this subarea.

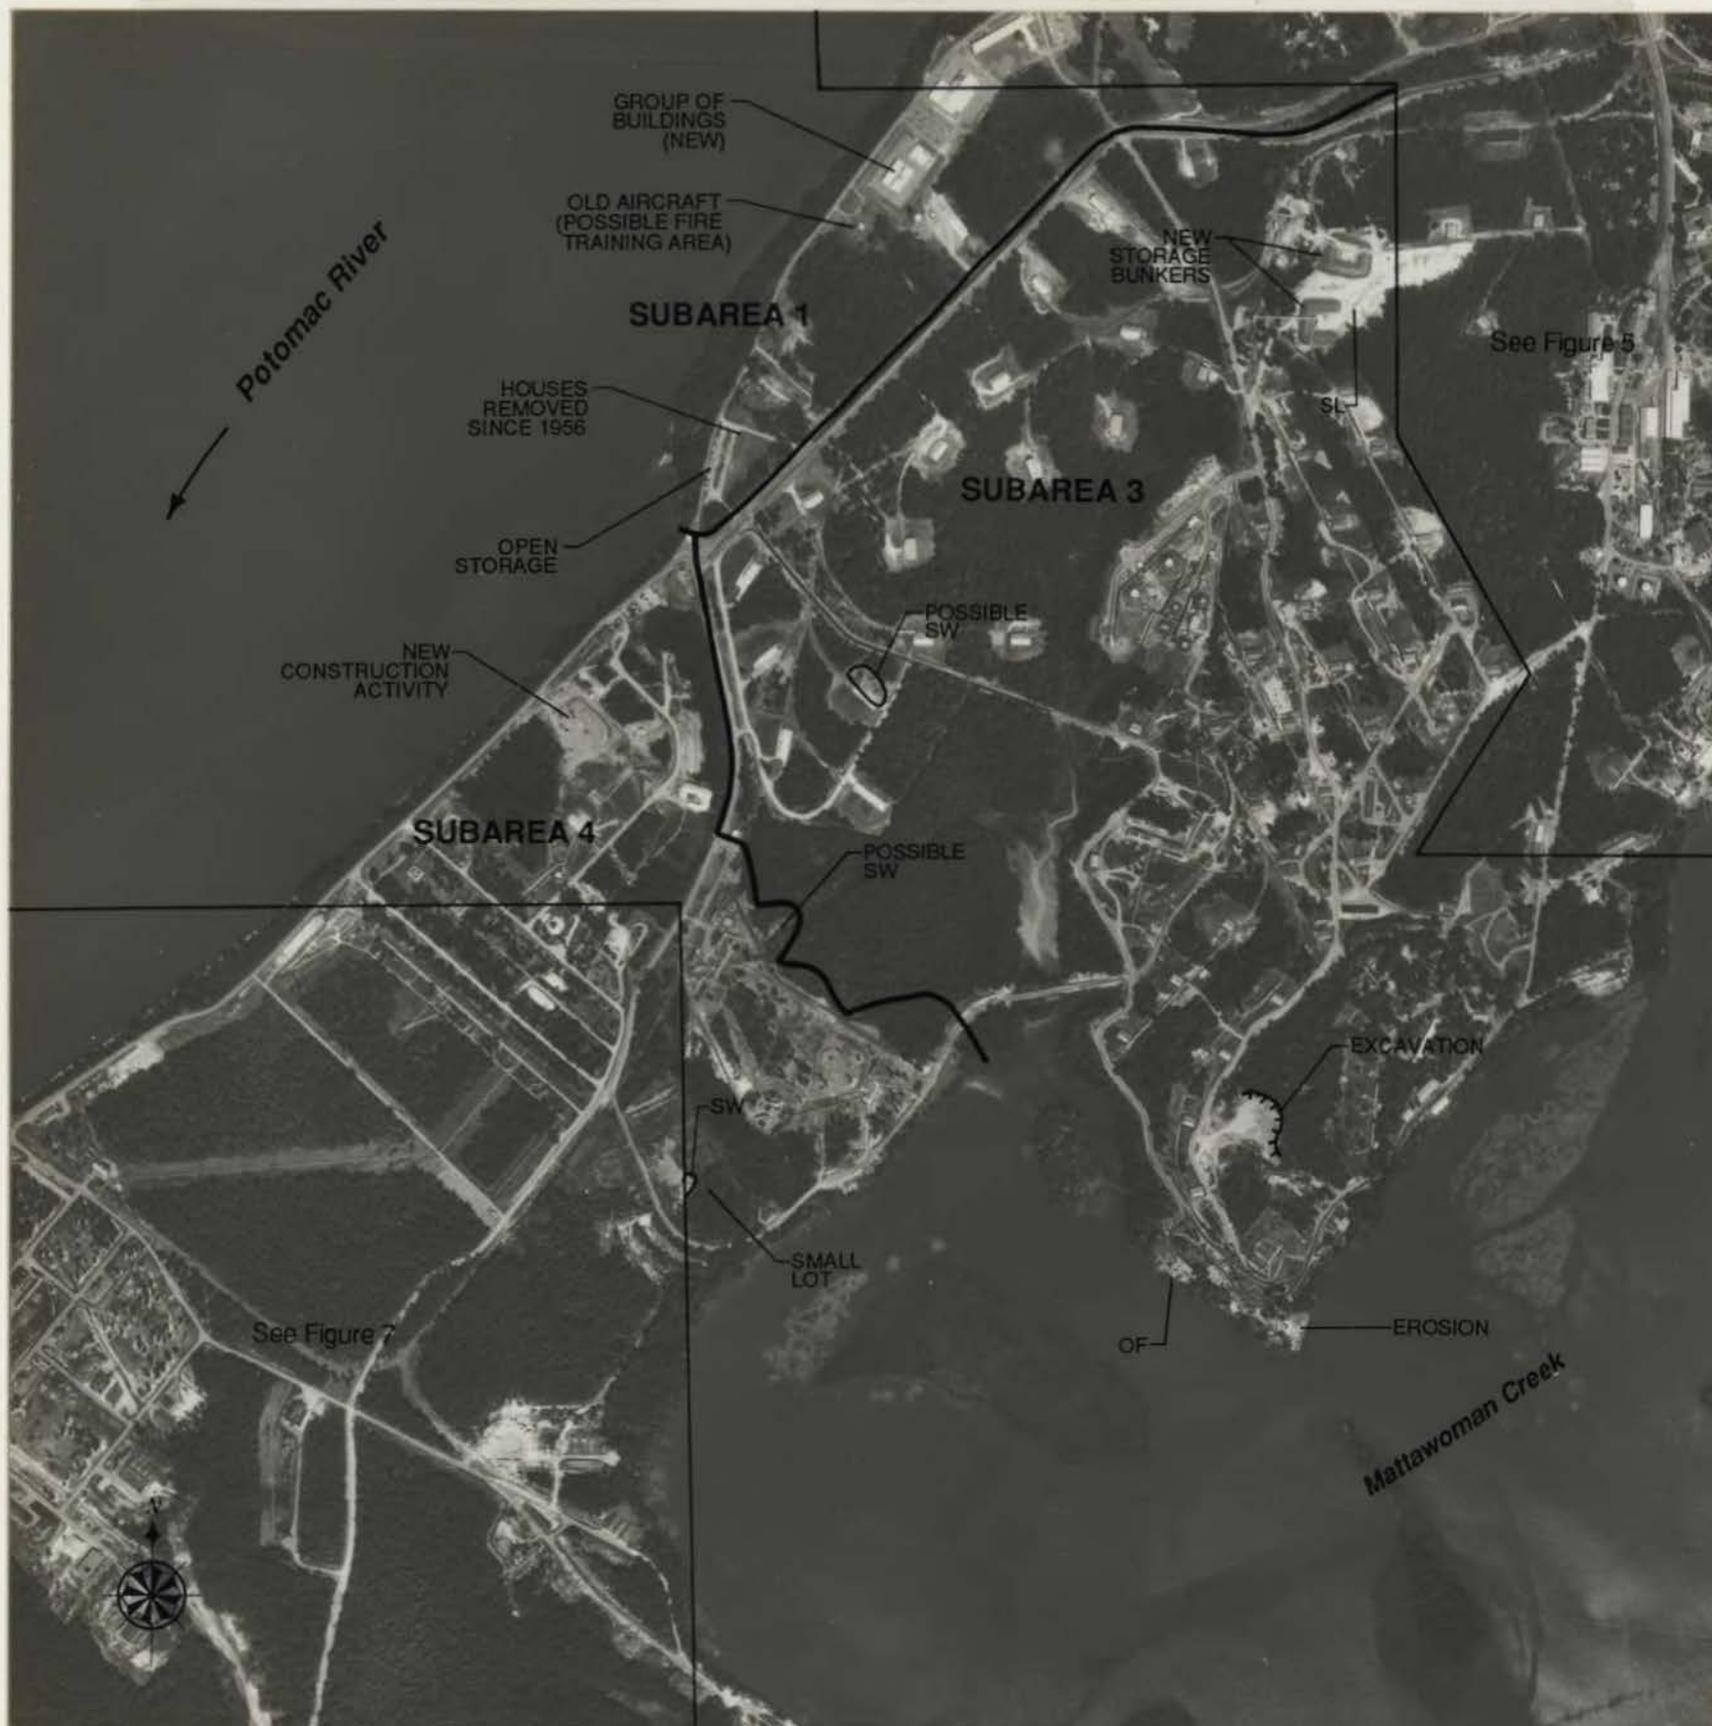
A new group of buildings (also partially visible in Figure 5) is visible in the western portion of Subarea 1. To the south is an old aircraft in an open field. Presence of old aircraft in these conditions may indicate a possible fire training area. Further to the south a small group of houses has been removed since 1956.

New storage bunkers and standing liquid are visible in the northern portion of this subarea. To the southwest, possible solid waste is observed at a storage bunker (not annotated). Photographic tones at the large excavation to the southeast have changed since 1956 indicating continued use of extracted materials. Further to the south, surface erosion is visible.

Possible solid waste is visible at the northern end of Subarea 4. To the south is the small lot where a small pit and staining was observed in 1956. In 1961 a deposit of mounded solid waste is visible. New construction activity is present to the northwest.

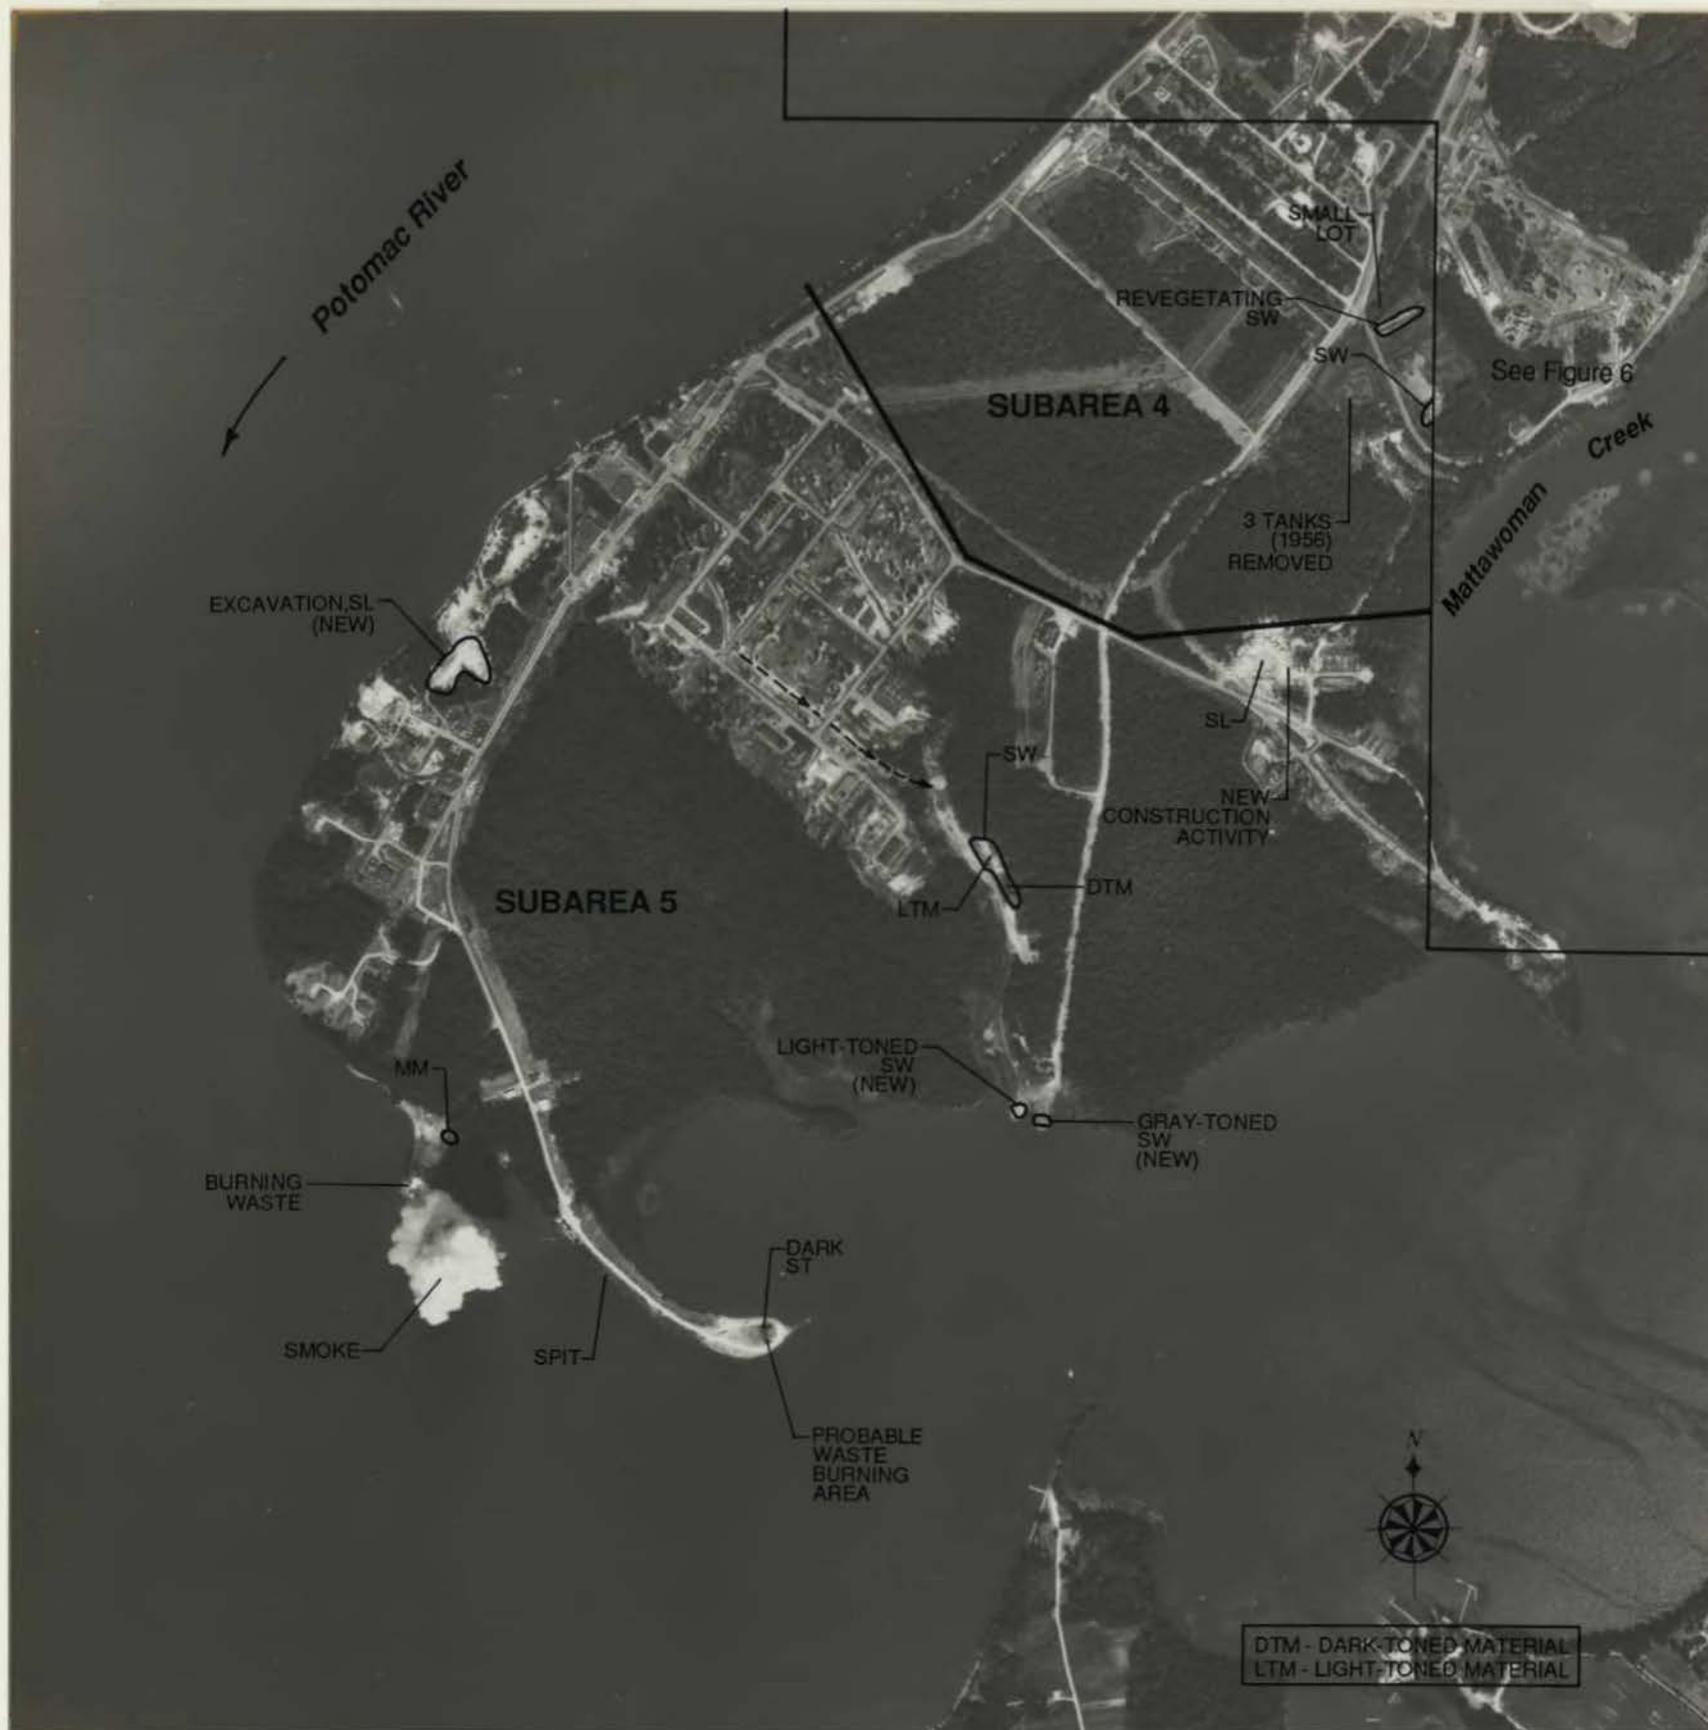
A new excavation with standing liquid is visible on the western shoreline. Further to the south there is burning waste and mounded material. To the east at the end of a spit is a probable waste burning area where dark stains are visible. A large deposit of light- and dark-toned solid waste is visible in the center of the subarea. Solid waste is also visible to the south at the end of an access road.

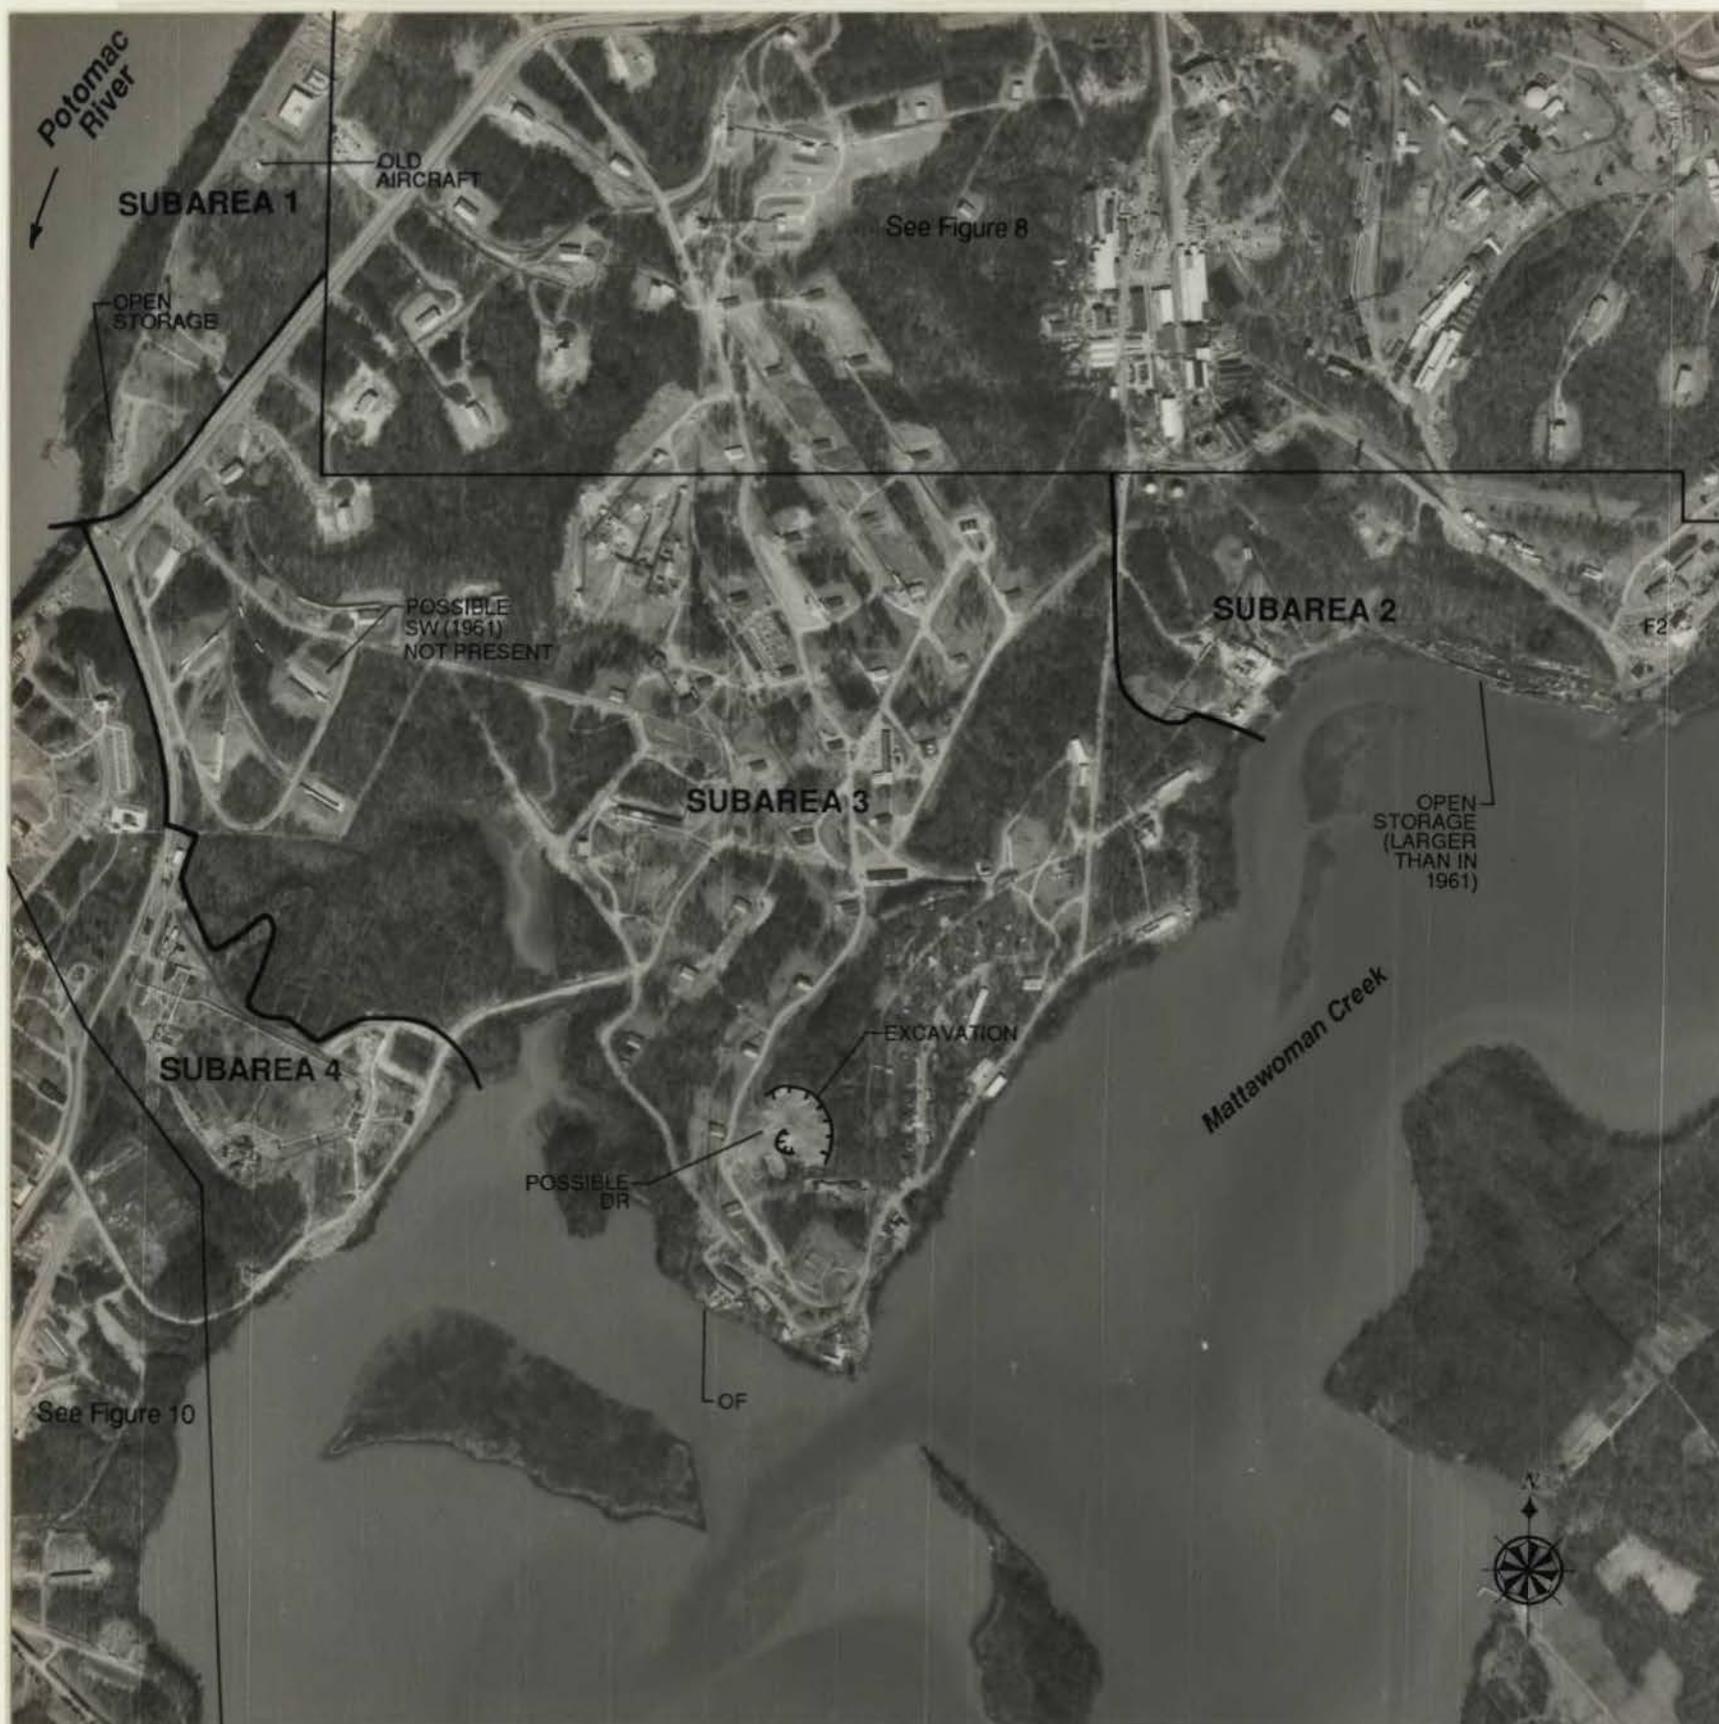
The storage of possible crates is visible east of Facility 1 (F1). Drainageways that flow west from one of the possible crate storage areas are visible in this photograph; however, no staining is observed.

Possible solid waste seen in 1961 near a storage bunker is not present in this photograph. To the southeast the excavation seen in 1961 is larger in extent and a small number of possible drums (DR) are noted.

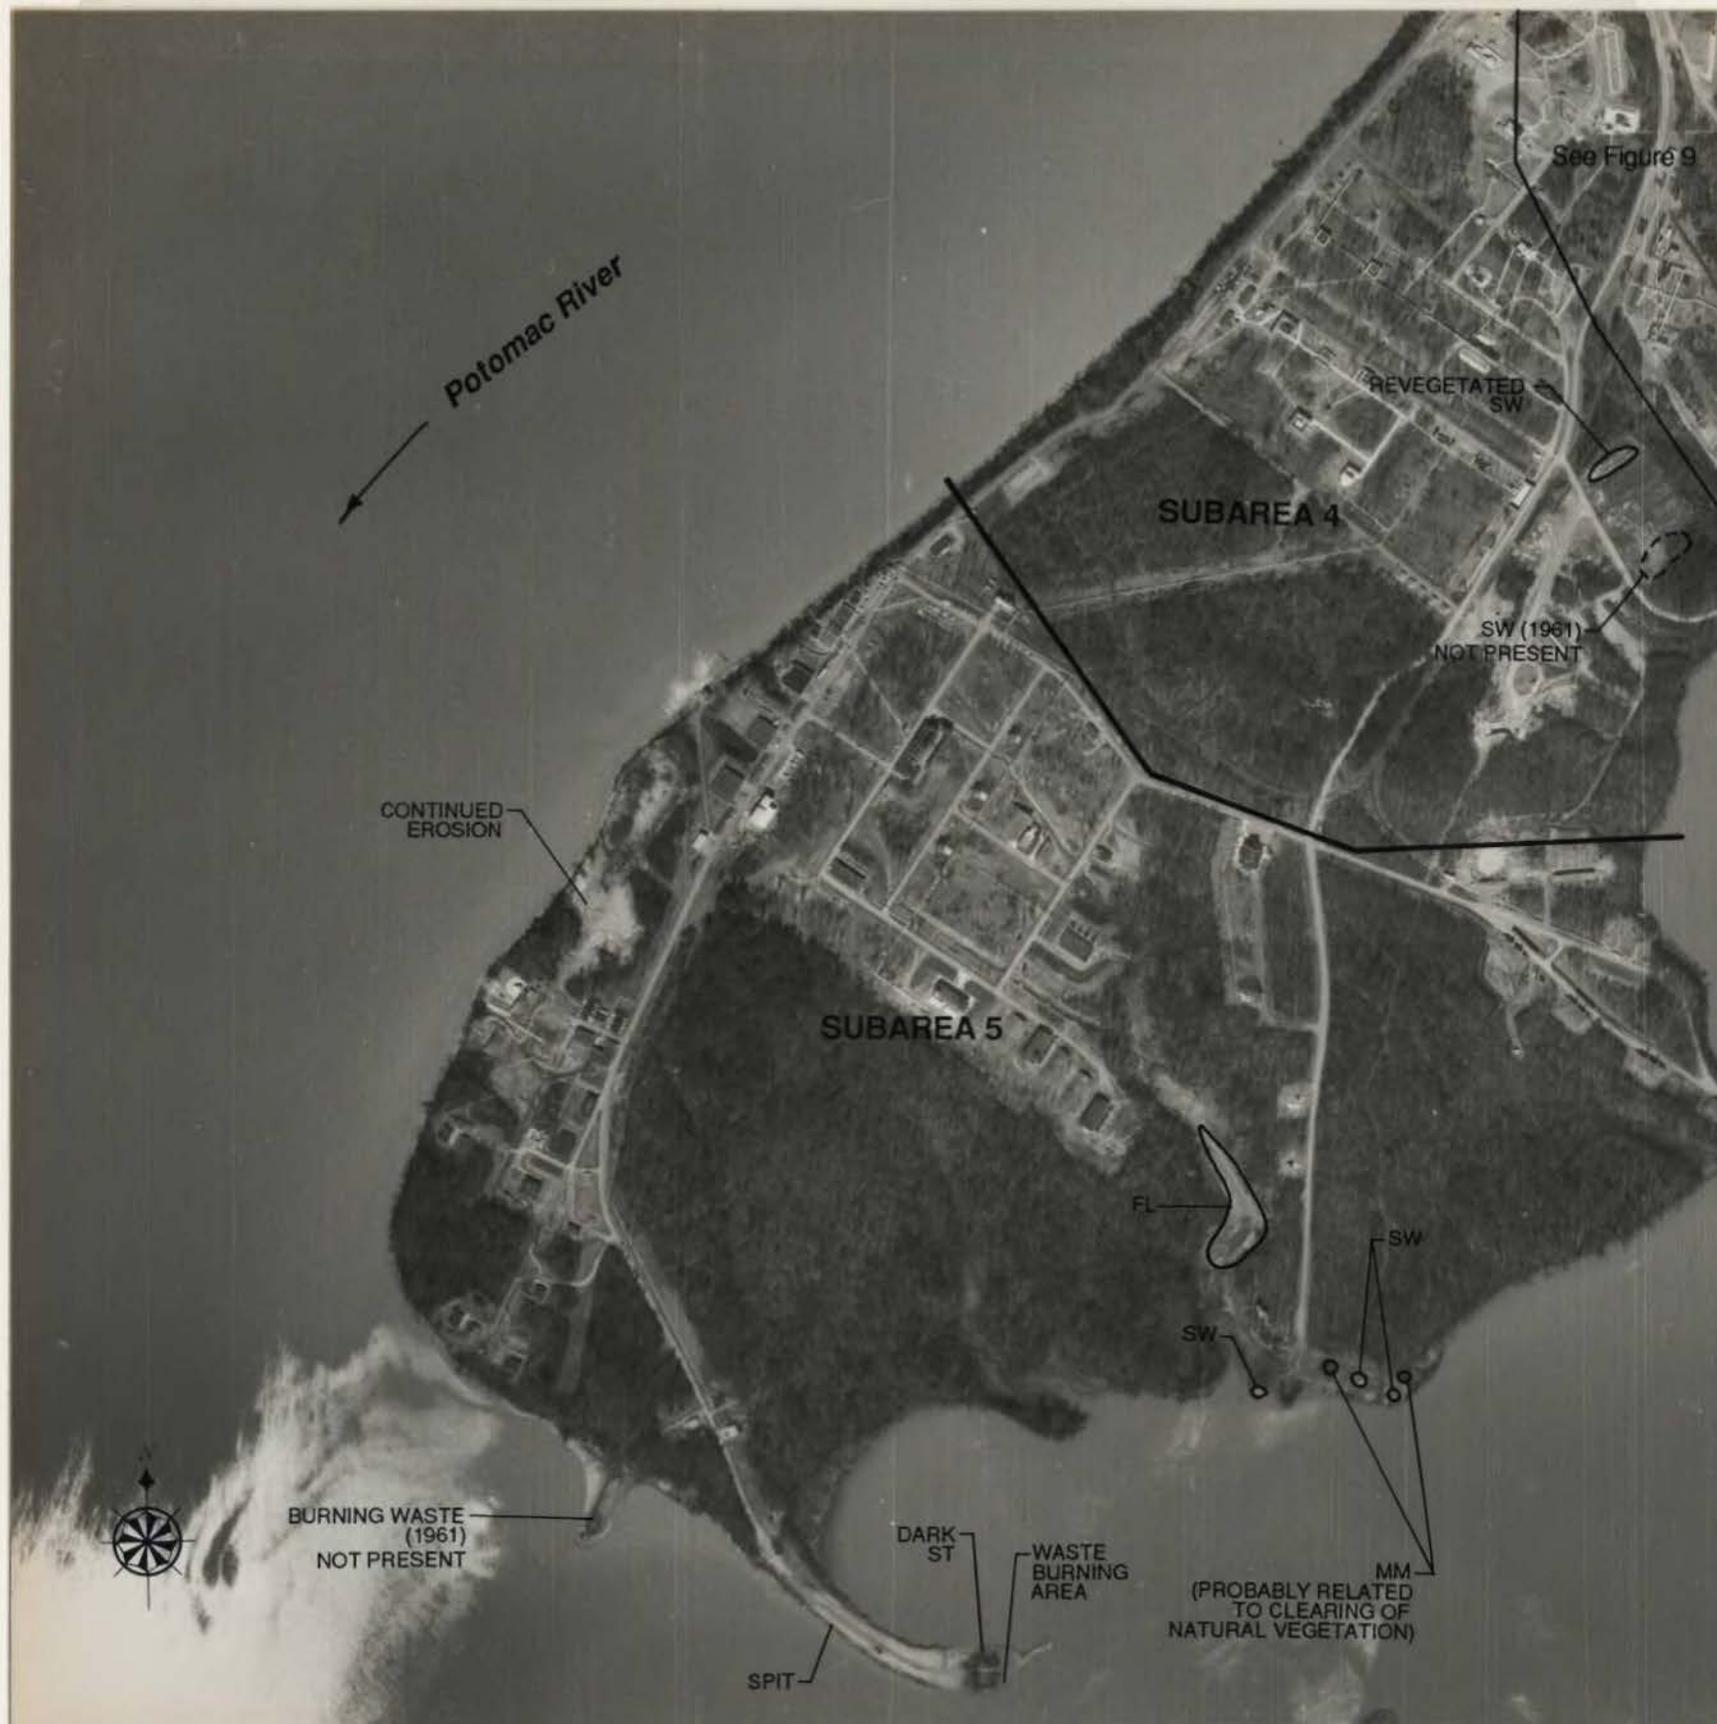
Erosion of fill continues along the riverbank in the western portion of the subarea. To the east, fill has been placed in an area where light- and dark-toned solid waste was observed in 1961. Five mounds of material are visible to the south. Two of the mounds consist of natural vegetation cleared from the surrounding land. Three mounds are deposits of solid waste. The extent of dark stains at the end of the long spit has increased since 1961. The area is definitely being used for burning of waste. No evidence of waste burning seen in 1961 is visible on the small peninsula of land to the west.
