# AERIAL PHOTOGRAPHIC ANALYSIS INDIAN HEAD NAVAL SURFACE WARFARE CENTER

## Charles County, Maryland

TS-PIC-9803362S  
February 1998

This report presents the results of an aerial photographic analysis conducted with historical aerial photographs of the Indian Head Naval Surface Warfare Center located in Charles County, Maryland. Seven dates of black-and-white and color photographs (1956, 1961, 1963, 1967, 1972, 1982, and 1987) were used to analyze the site. Environmentally significant hazardous waste-related features and conditions were identified. The purpose of this report is to provide remote sensing support to field investigations in U.S. Environmental Protection Agency (EPA) Region 3 under the Comprehensive Environmental Response, Compensation, and Liability Act (CERCLA).

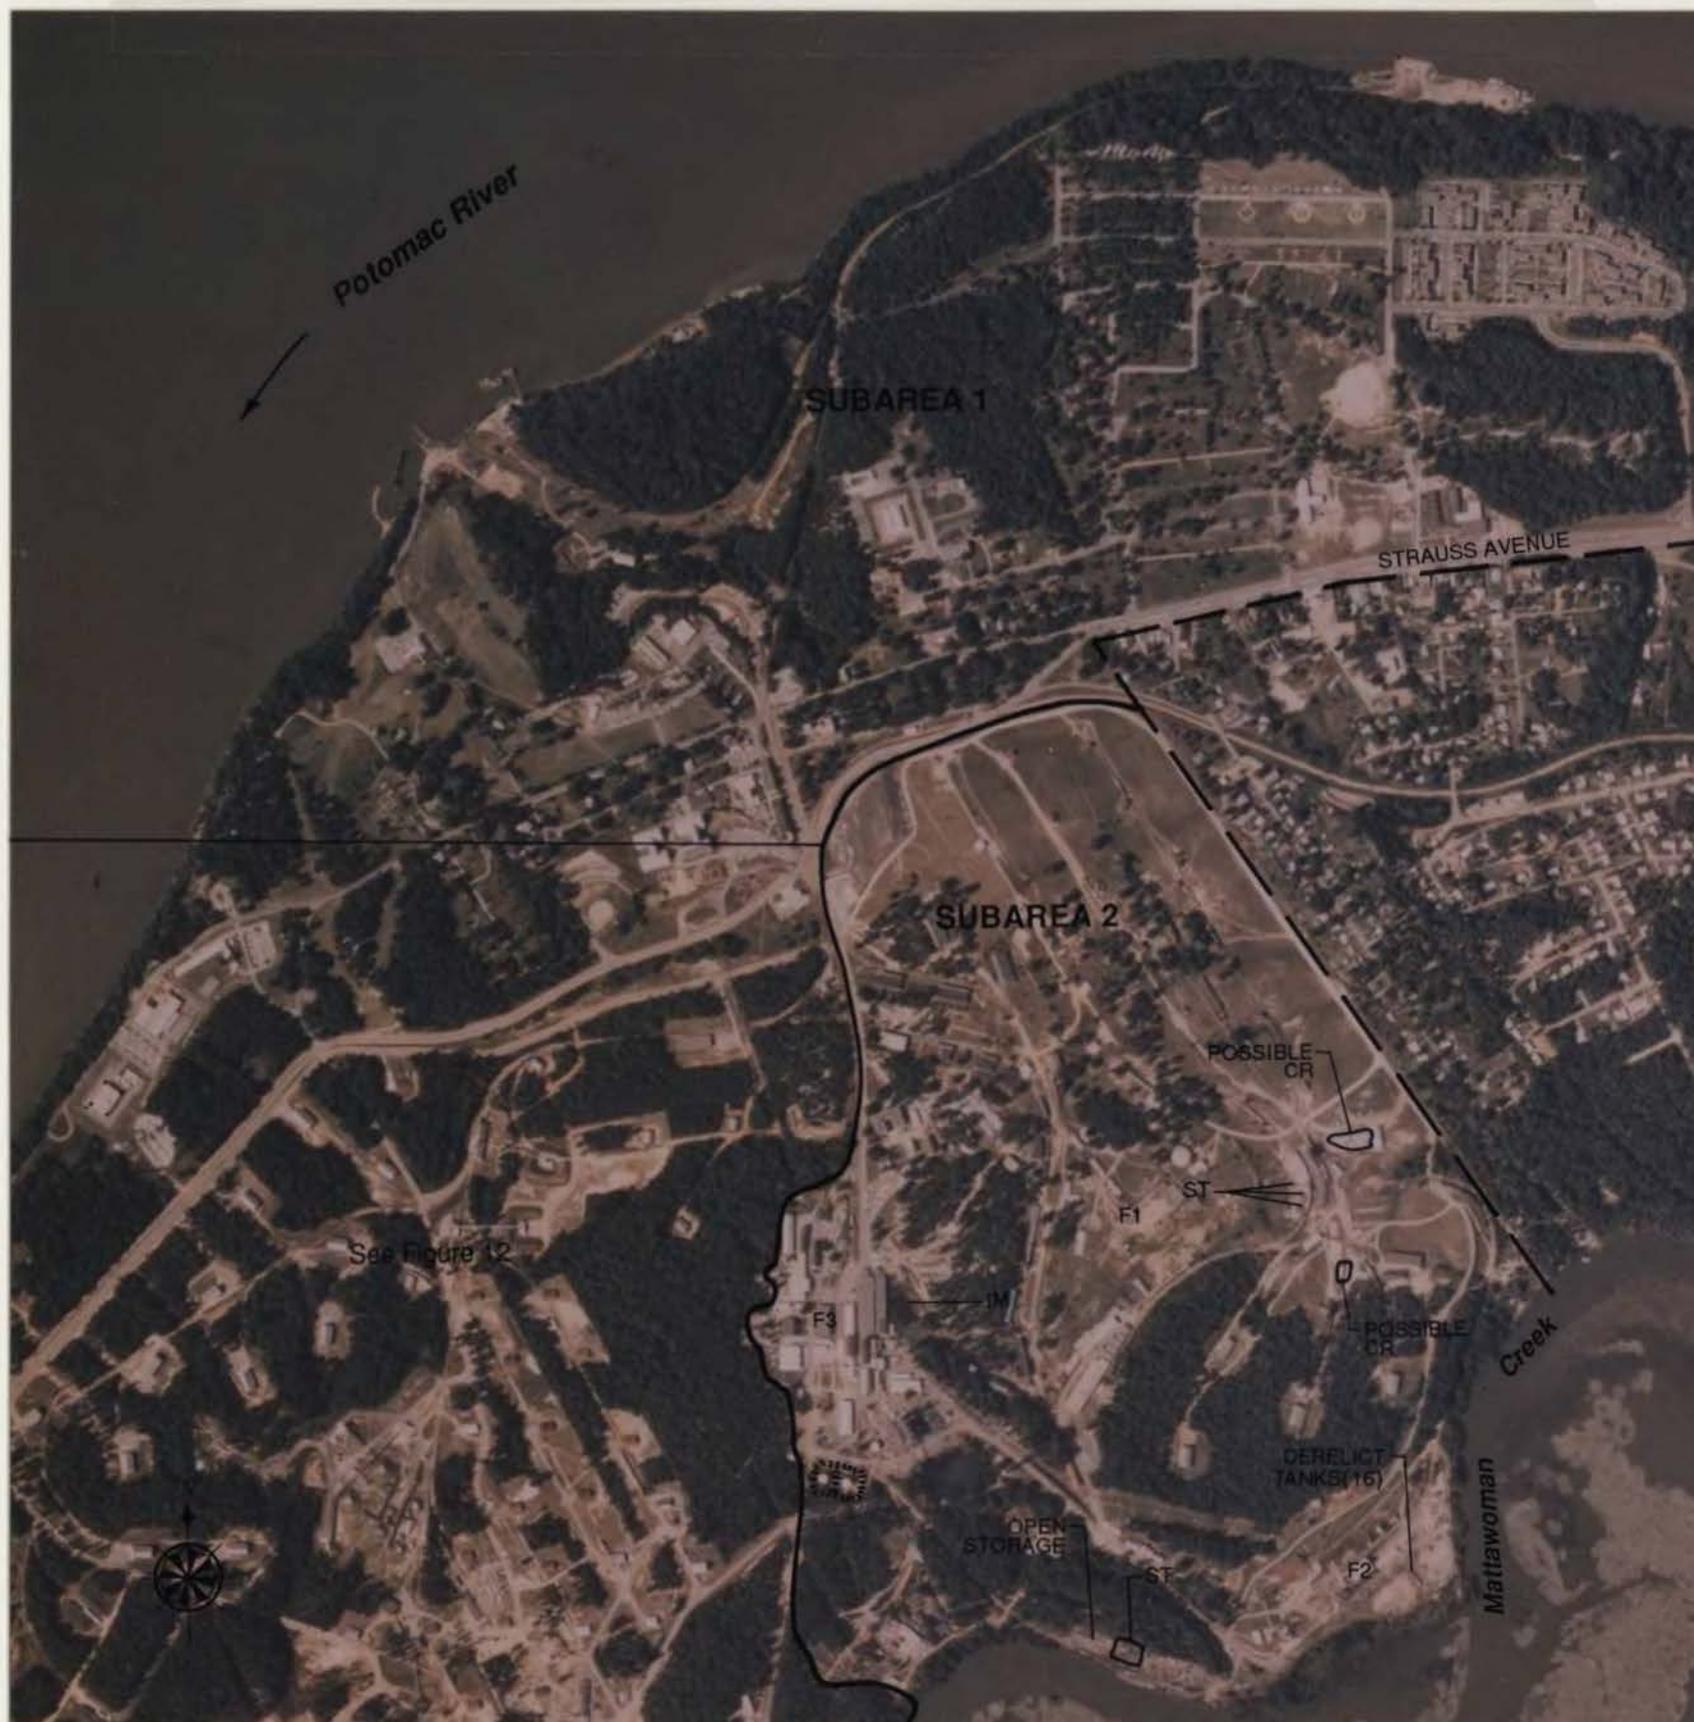
Possible crates are visible east of Facility 1 (F1). Three stains are present where one set of possible crates was observed in 1963. A large stain is visible at the open storage west of Facility 2 (F2). Sixteen derelict tanks are visible near Facility 2 (F2).

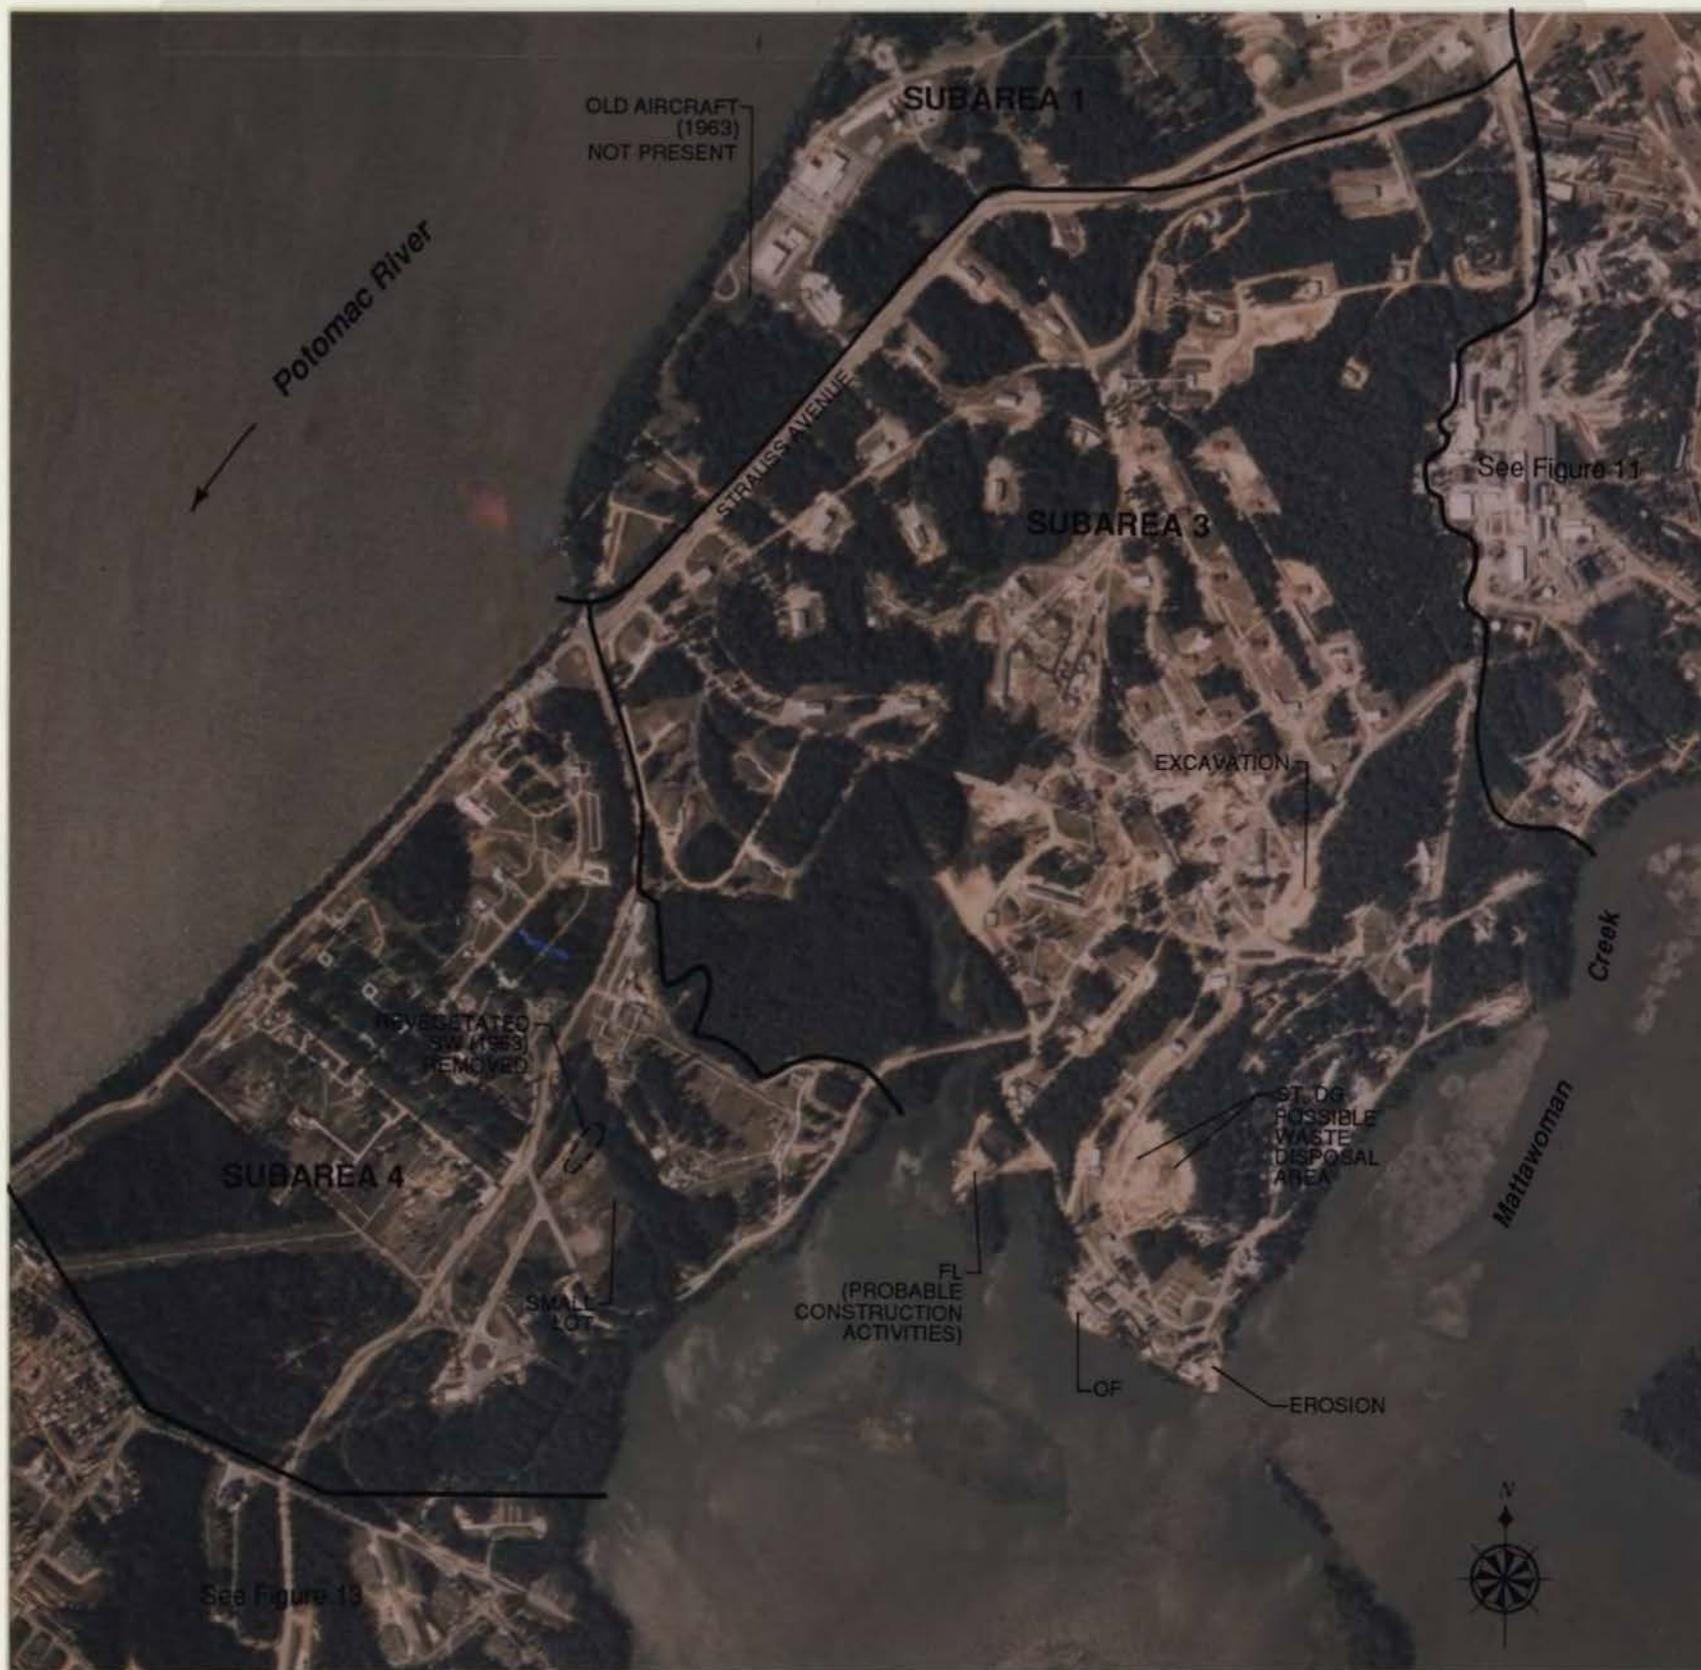
Figure 12. Indian Head NSWC, Main Peninsula, September 15, 1967. Approximate scale 1:12,000.

A small excavation is observed in the eastern portion of the subarea. In the southern portion, the excavation seen in 1963 is larger in extent and two stains and disturbed ground (DG) are noted. The area is possibly being used for waste disposal. To the west is a new area of fill that is probably related to construction activities.

The revegetated solid waste seen in 1963 in the small lot in the eastern portion of the subarea has been removed.

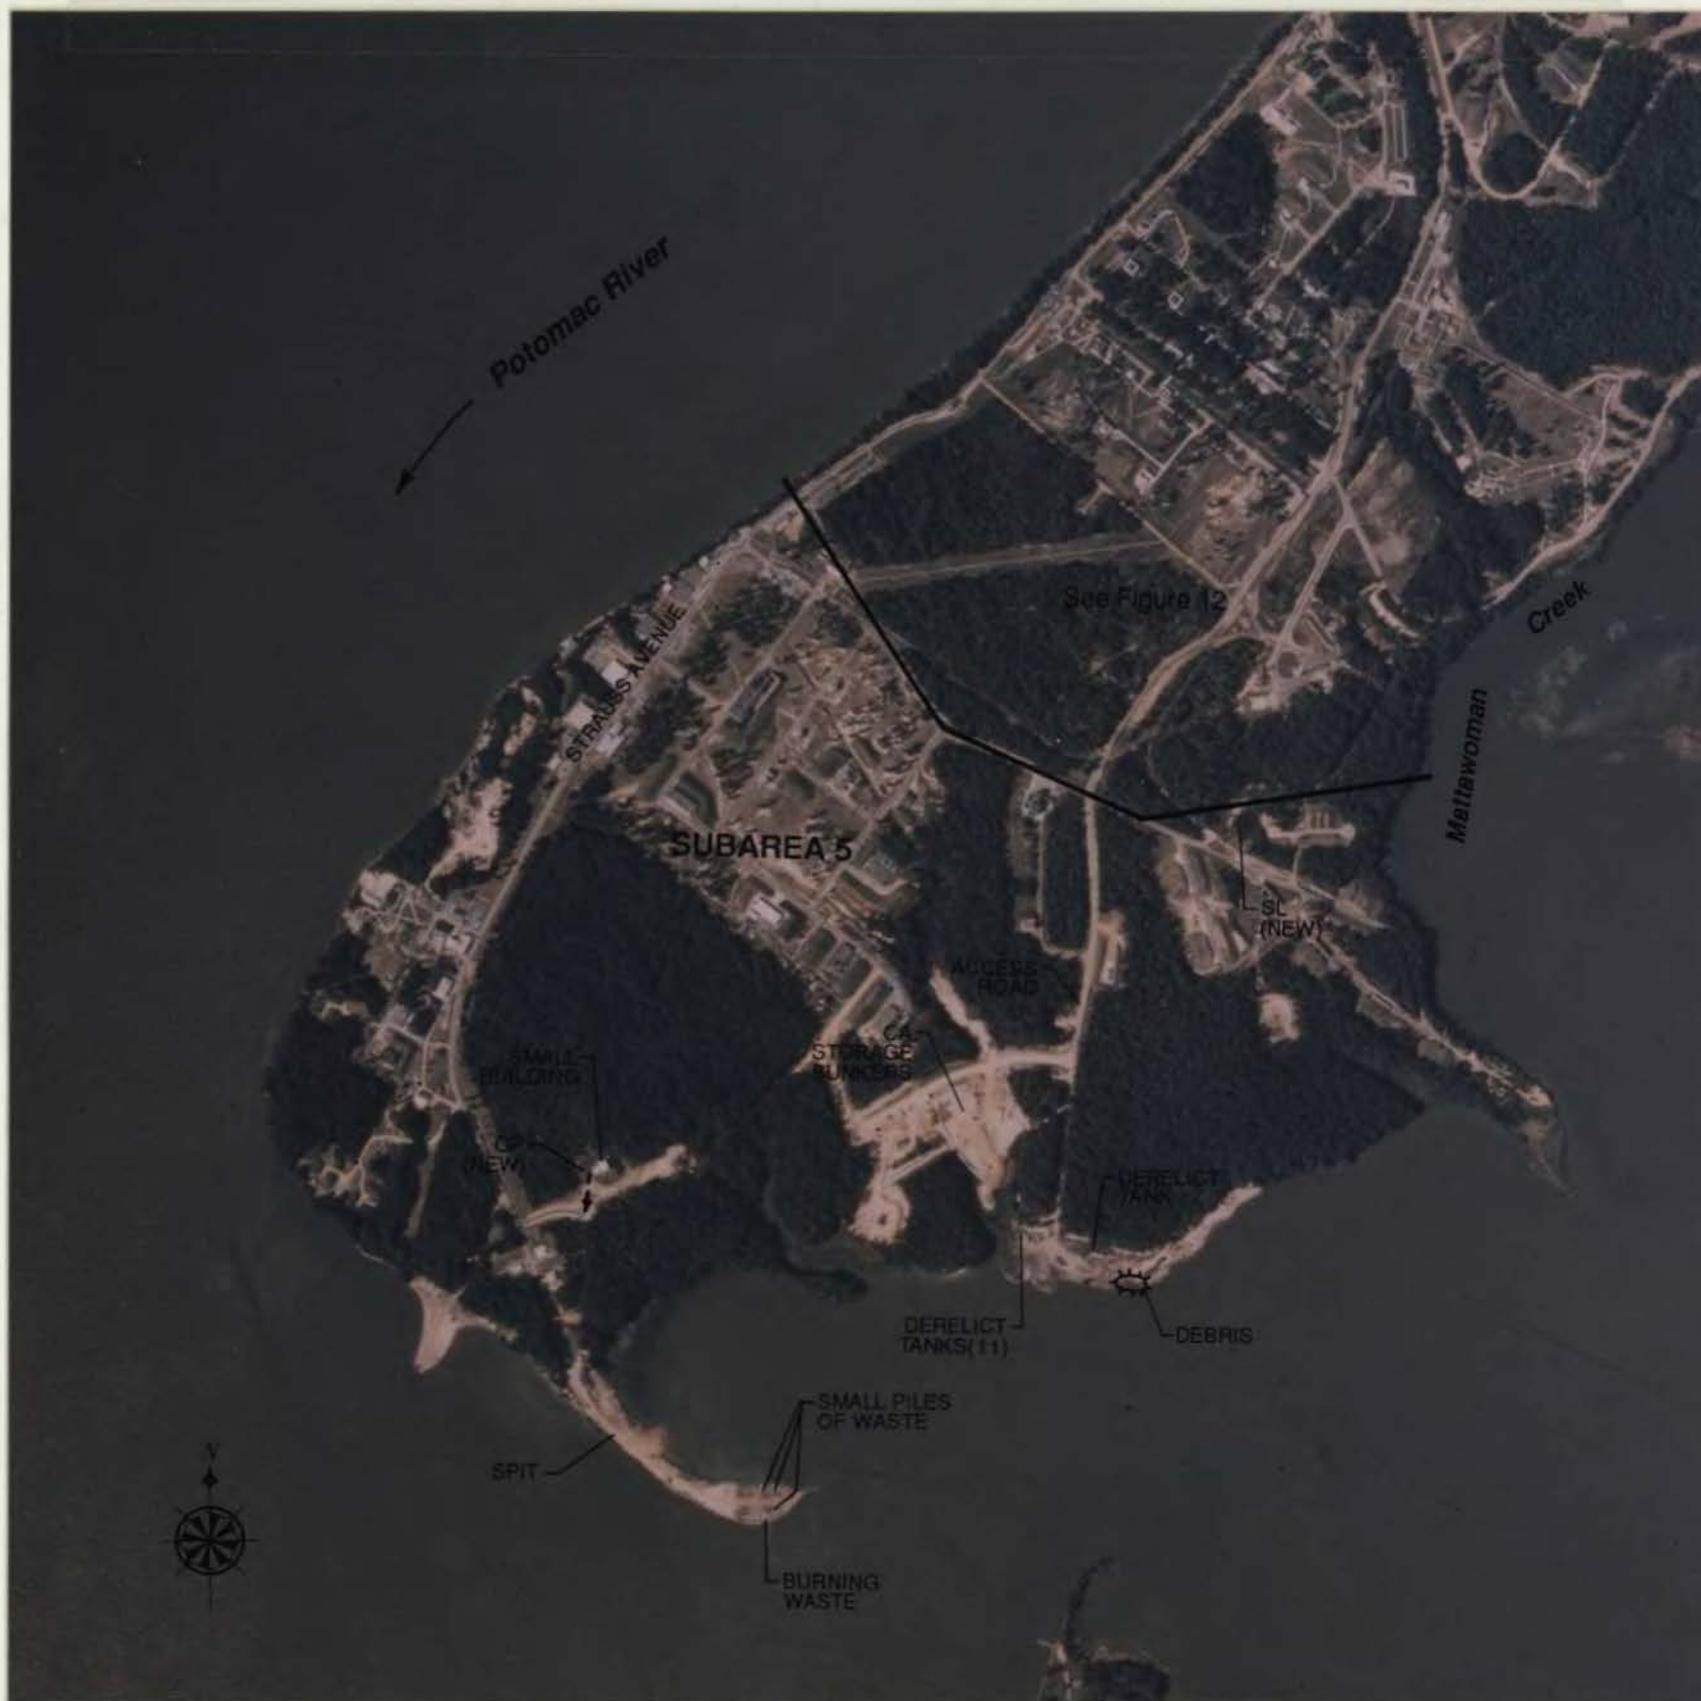
In the center of the subarea a large cleared area (CA) and new storage bunkers have been constructed. To the southeast at the end of the access road are eleven derelict tanks, another larger derelict tank, and mounded debris. Three small piles of waste and a pile of burning waste are visible at the end of the spit. To the northwest is an outfall adjacent to a small building. It flows south into a cleared area.

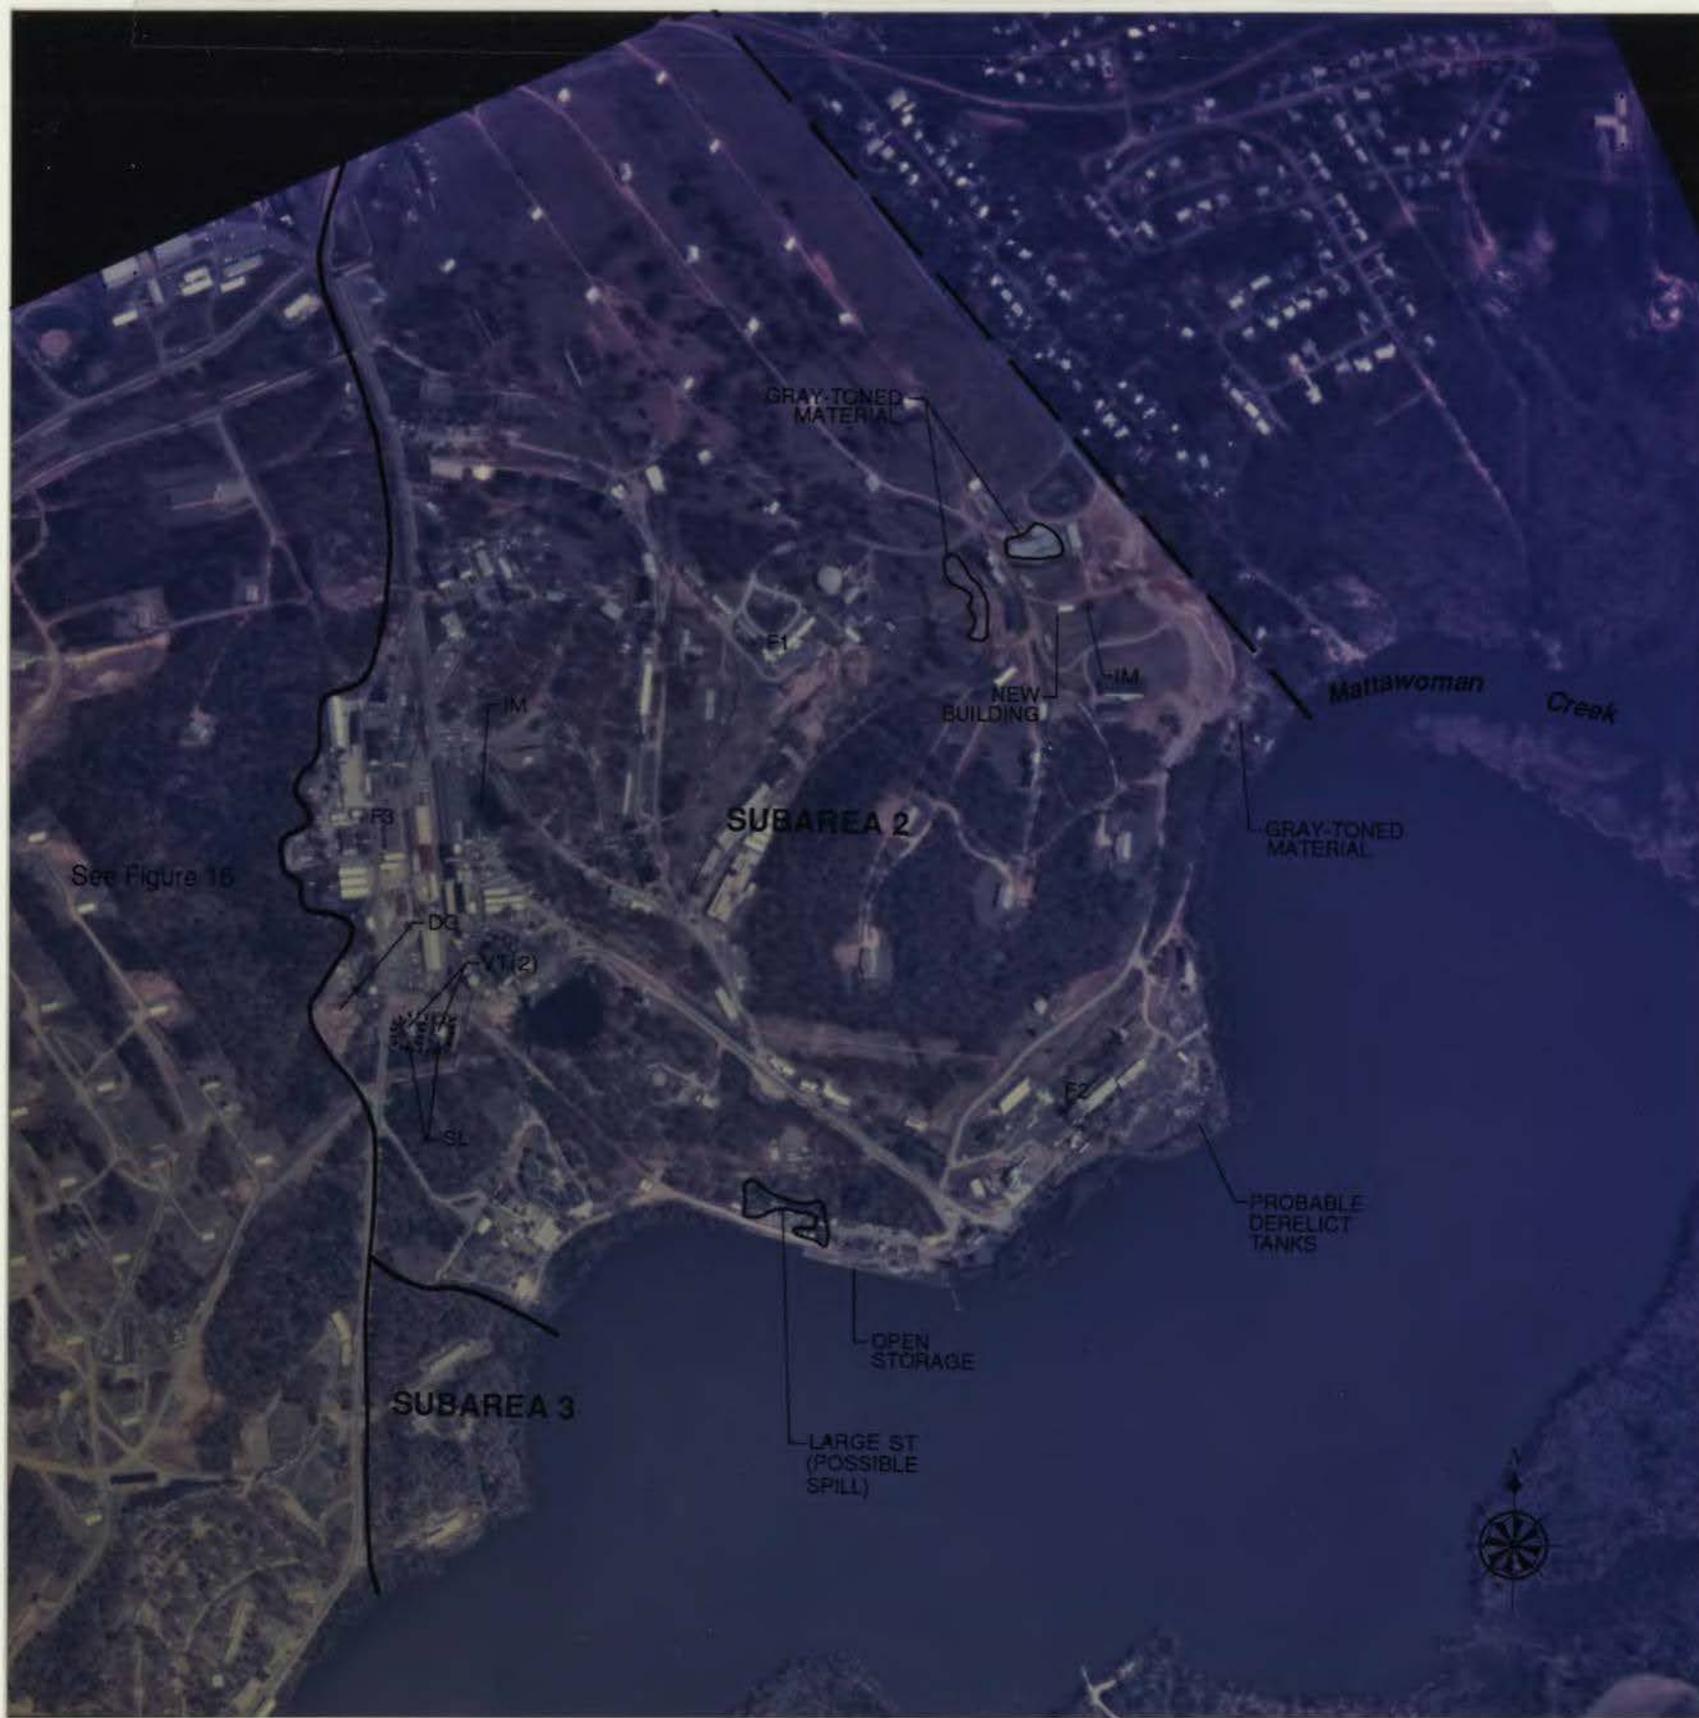
The possible crates seen in earlier photographs are actually accumulations of gray-toned material. This positive identification was possible due to improved photographic resolution in the 1972 photograph. To the south is a new small building. Liquid originates from this building and flows east where it is retained in a small, apparently unlined impoundment (IM). Gray-toned material that has been spread onto the ground is located to the southeast. Several probable derelict tanks are noted adjacent to Facility 2 (F2). West of this facility at the open storage area a large dark-toned stain is visible. The stain may be the result of a spill because it is also present on the top of an embankment that is adjacent to the storage area. South of Facility 3 (F3) is an area of disturbed ground. Nearby, standing liquid is present within the containments of two large storage tanks.

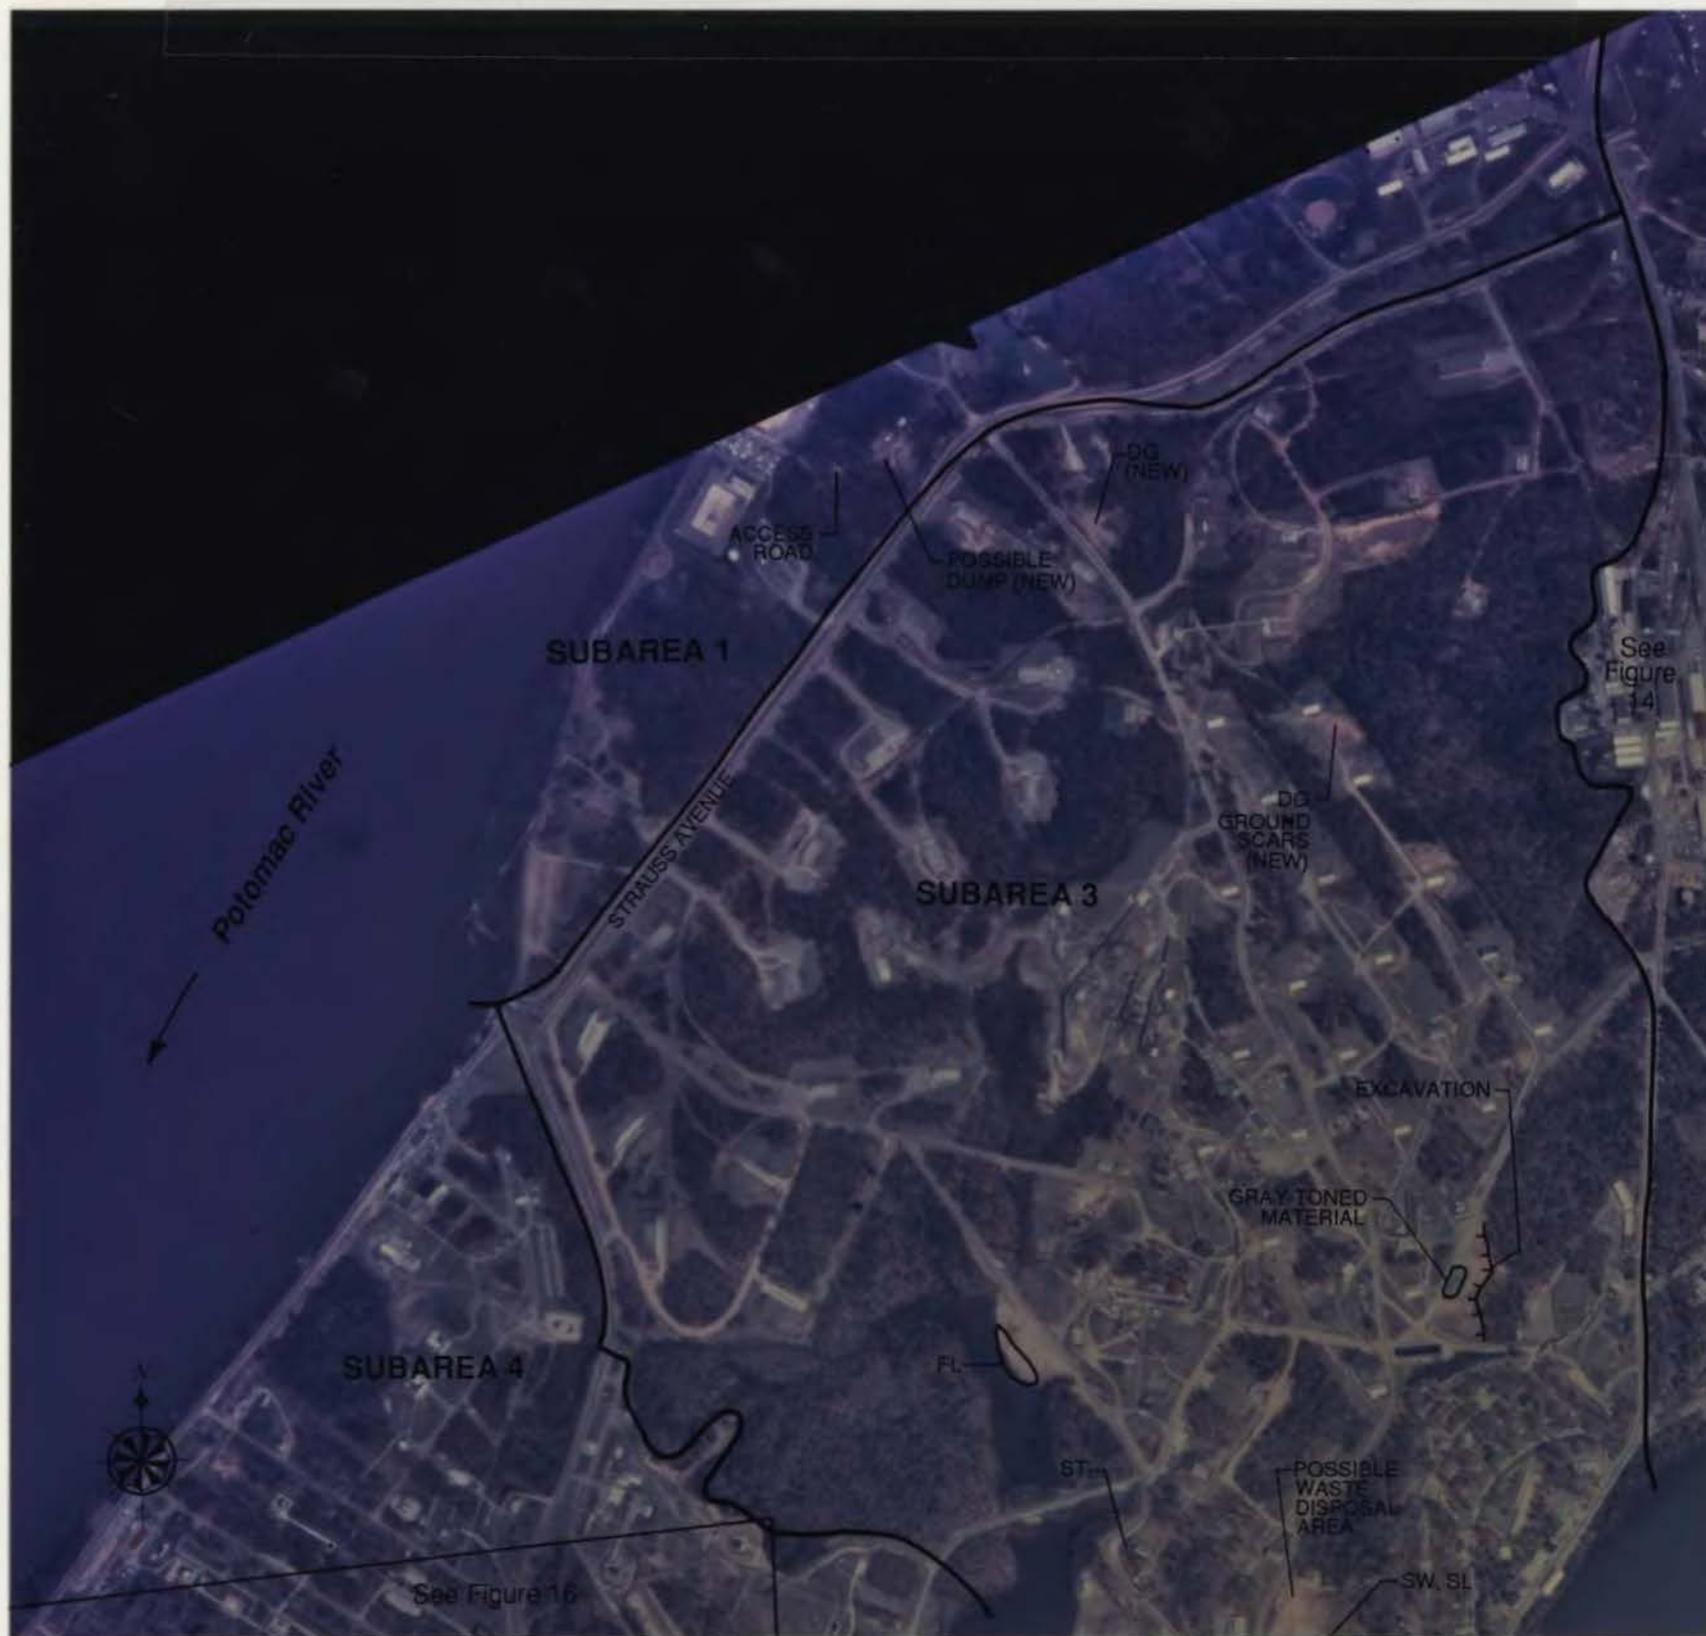
A new possible dump is observed in this portion of the subarea. A small access road leads from a nearby building complex to the possible dump.

Two areas of disturbed ground are observed in the northern portion of this subarea. To the south the excavation seen in 1967 is larger and contains gray-toned mounded material. Further to the south, solid waste and standing liquid are visible at the excavation that was identified as a possible waste disposal area in 1967.

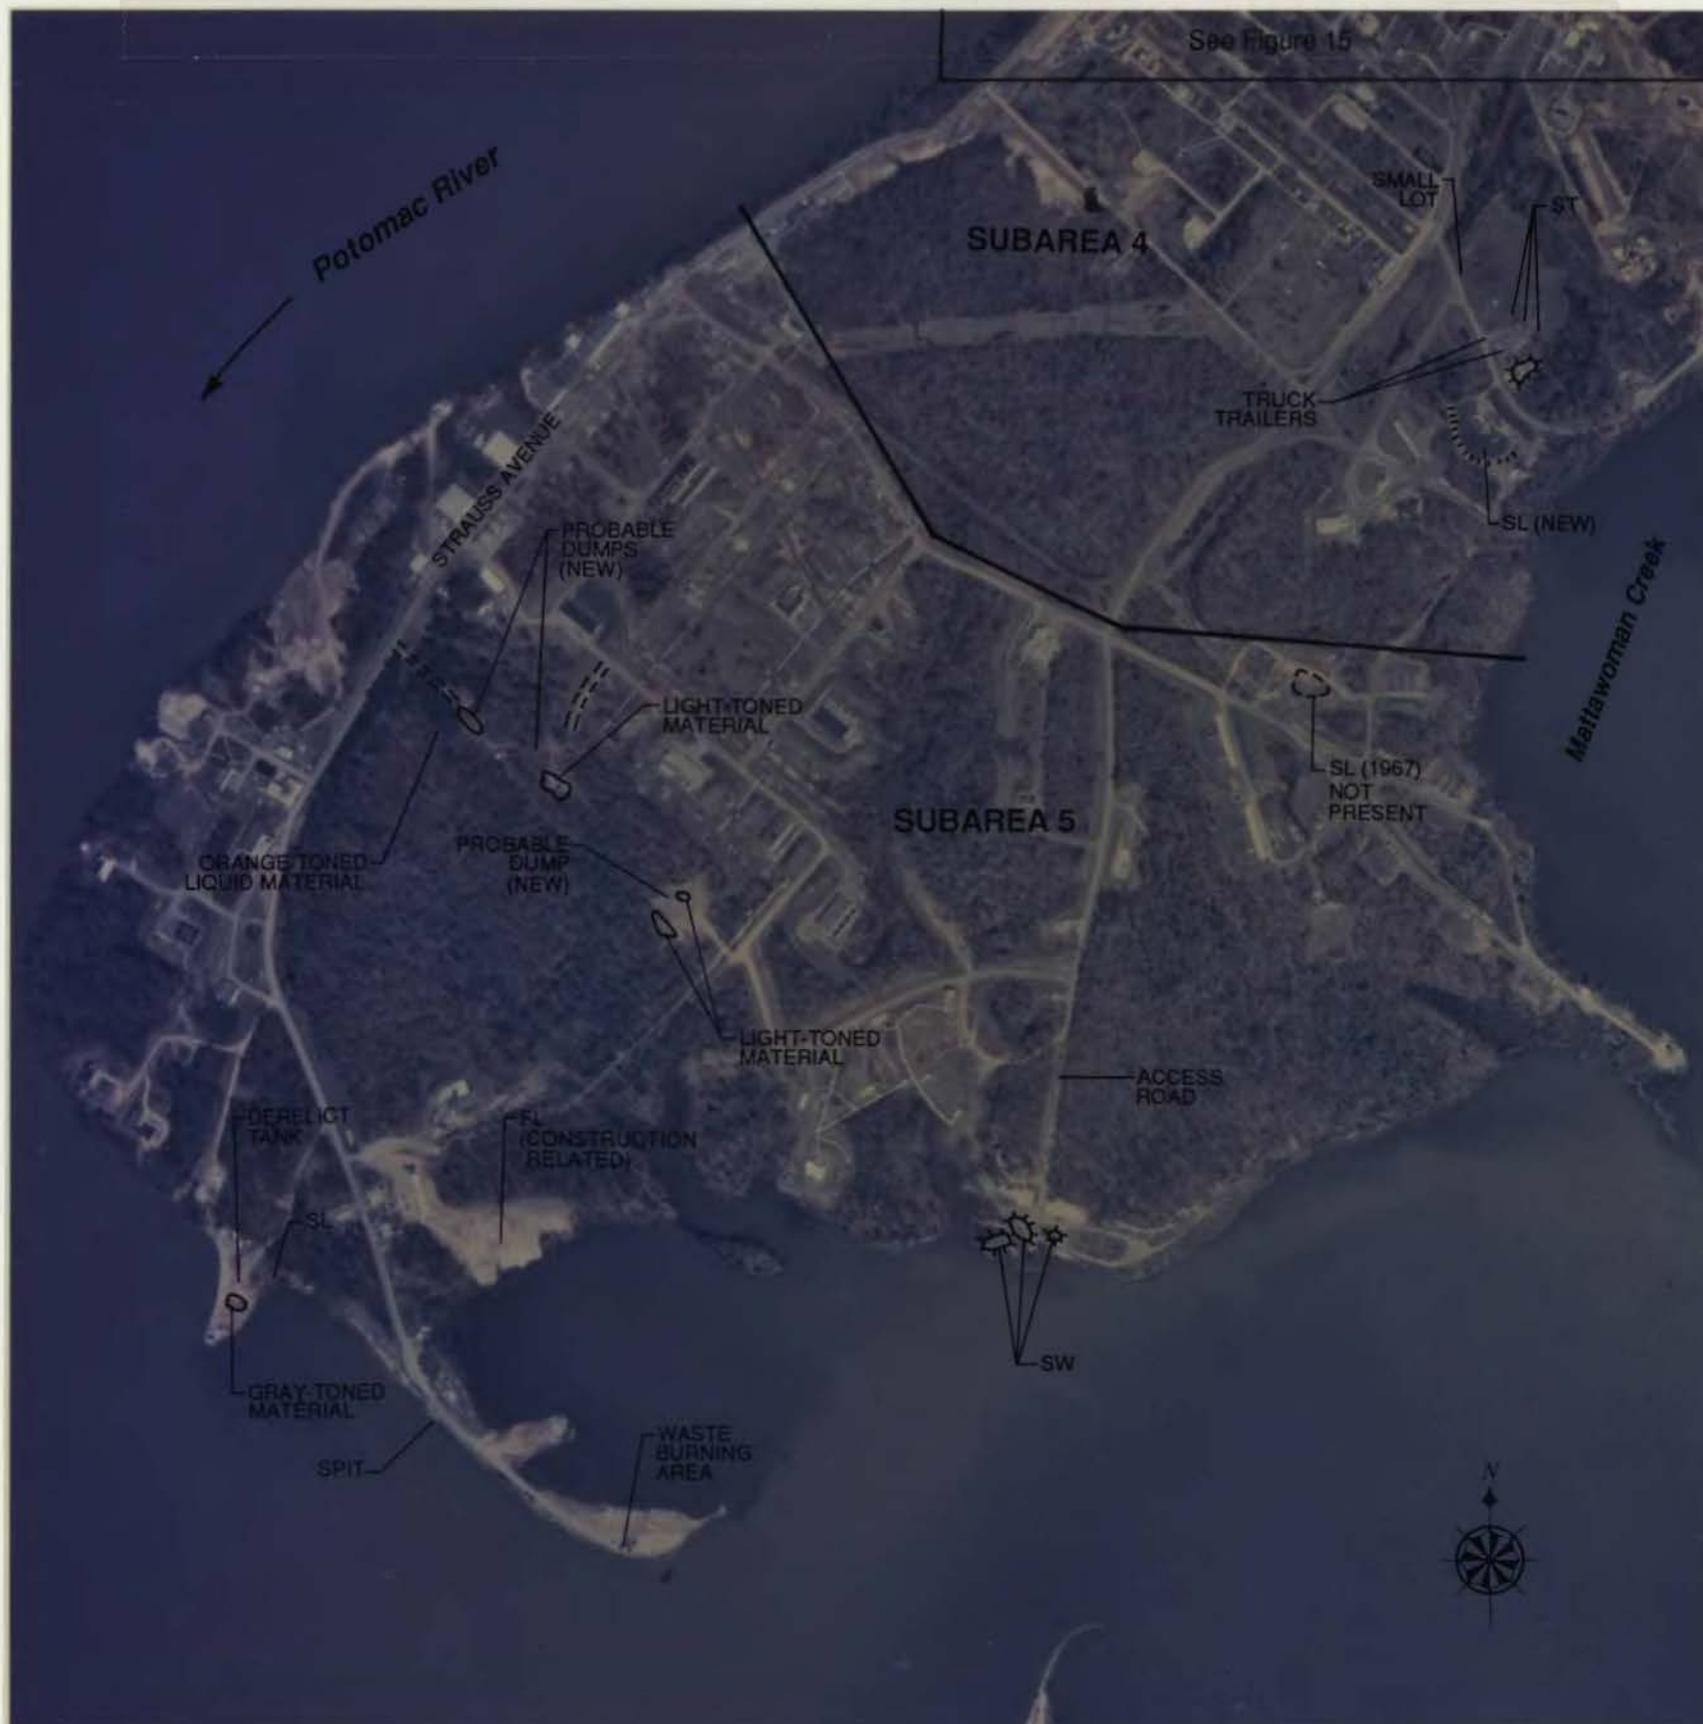
A new area of standing liquid is observed in the eastern portion of this subarea. At the small lot to the north, photographic tones and patterns of soil and waste material have changed since 1967 indicating continuing disposal activity. Three stains, two truck trailers, and mounded material are visible.

Standing liquid seen in the eastern portion of the subarea in 1967 is no longer present. Several new significant features are visible in the western portion of the subarea. Three new probable dump sites are visible. Orange-toned liquid material is existent at one probable dump and light-toned solid material is visible at the other two probable dumps. To the south is a deposit of gray-toned material, a derelict tank, and standing liquid. The waste burning area at the end of the spit appears to be active. To the east at the end of the access road are three mounds of solid waste.

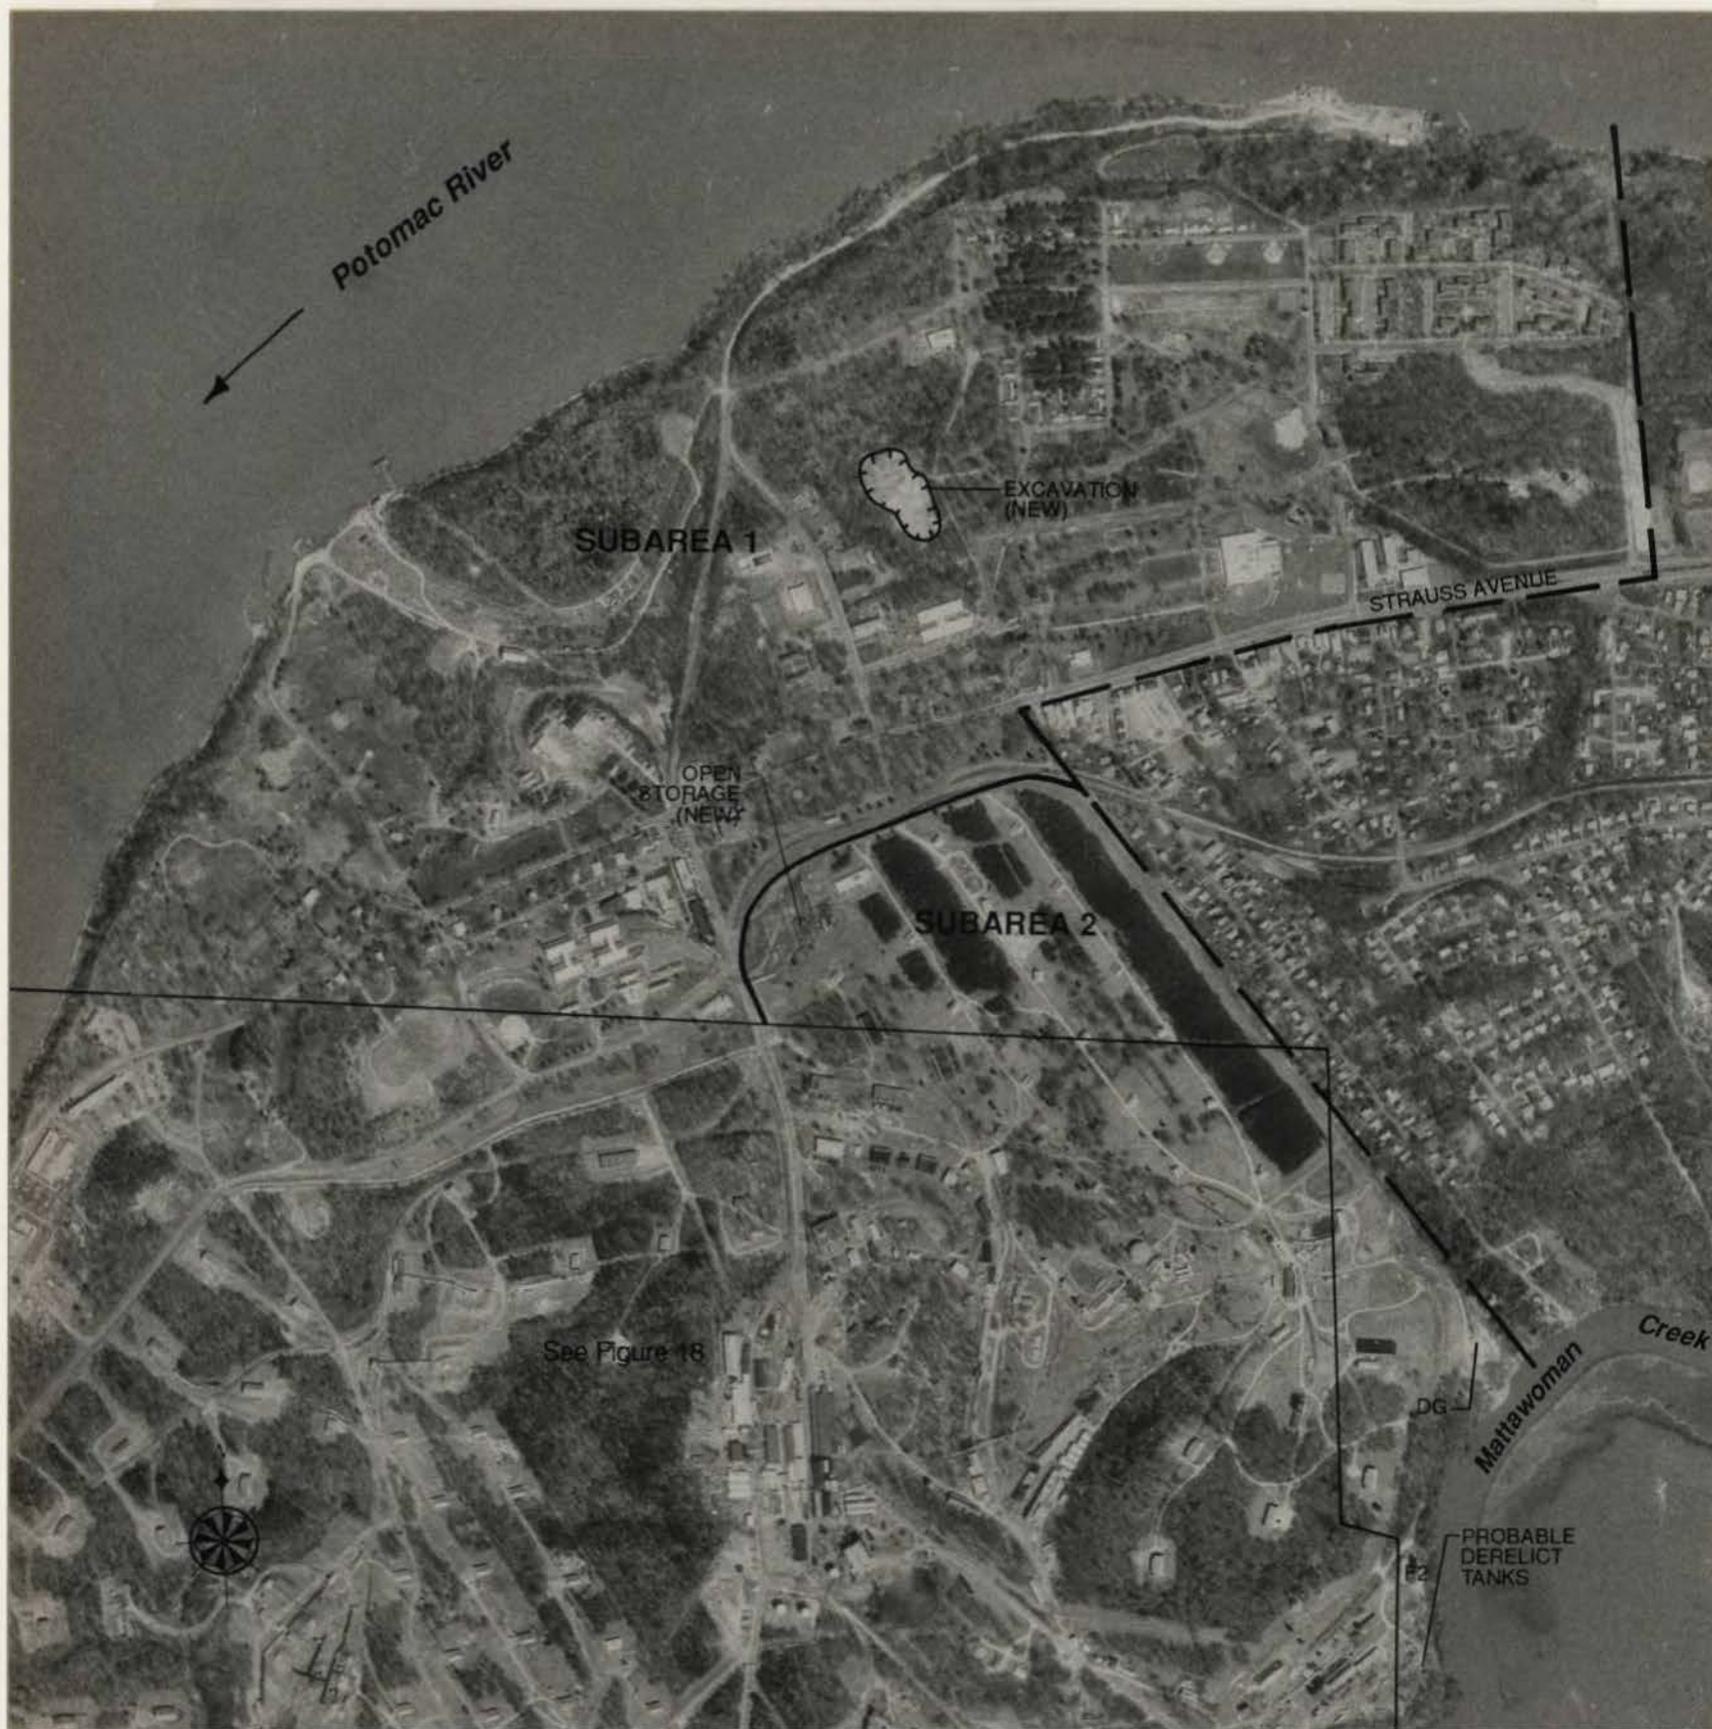
A new open storage area is visible in Subarea 2. Probable derelict tanks are again visible at Facility 2 (F2).
