# AERIAL PHOTOGRAPHIC ANALYSIS INDIAN HEAD NAVAL SURFACE WARFARE CENTER

## Charles County, Maryland

TS-PIC-9803362S  
February 1998

This report presents the results of an aerial photographic analysis conducted with historical aerial photographs of the Indian Head Naval Surface Warfare Center located in Charles County, Maryland. Seven dates of black-and-white and color photographs (1956, 1961, 1963, 1967, 1972, 1982, and 1987) were used to analyze the site. Environmentally significant hazardous waste-related features and conditions were identified. The purpose of this report is to provide remote sensing support to field investigations in U.S. Environmental Protection Agency (EPA) Region 3 under the Comprehensive Environmental Response, Compensation, and Liability Act (CERCLA).

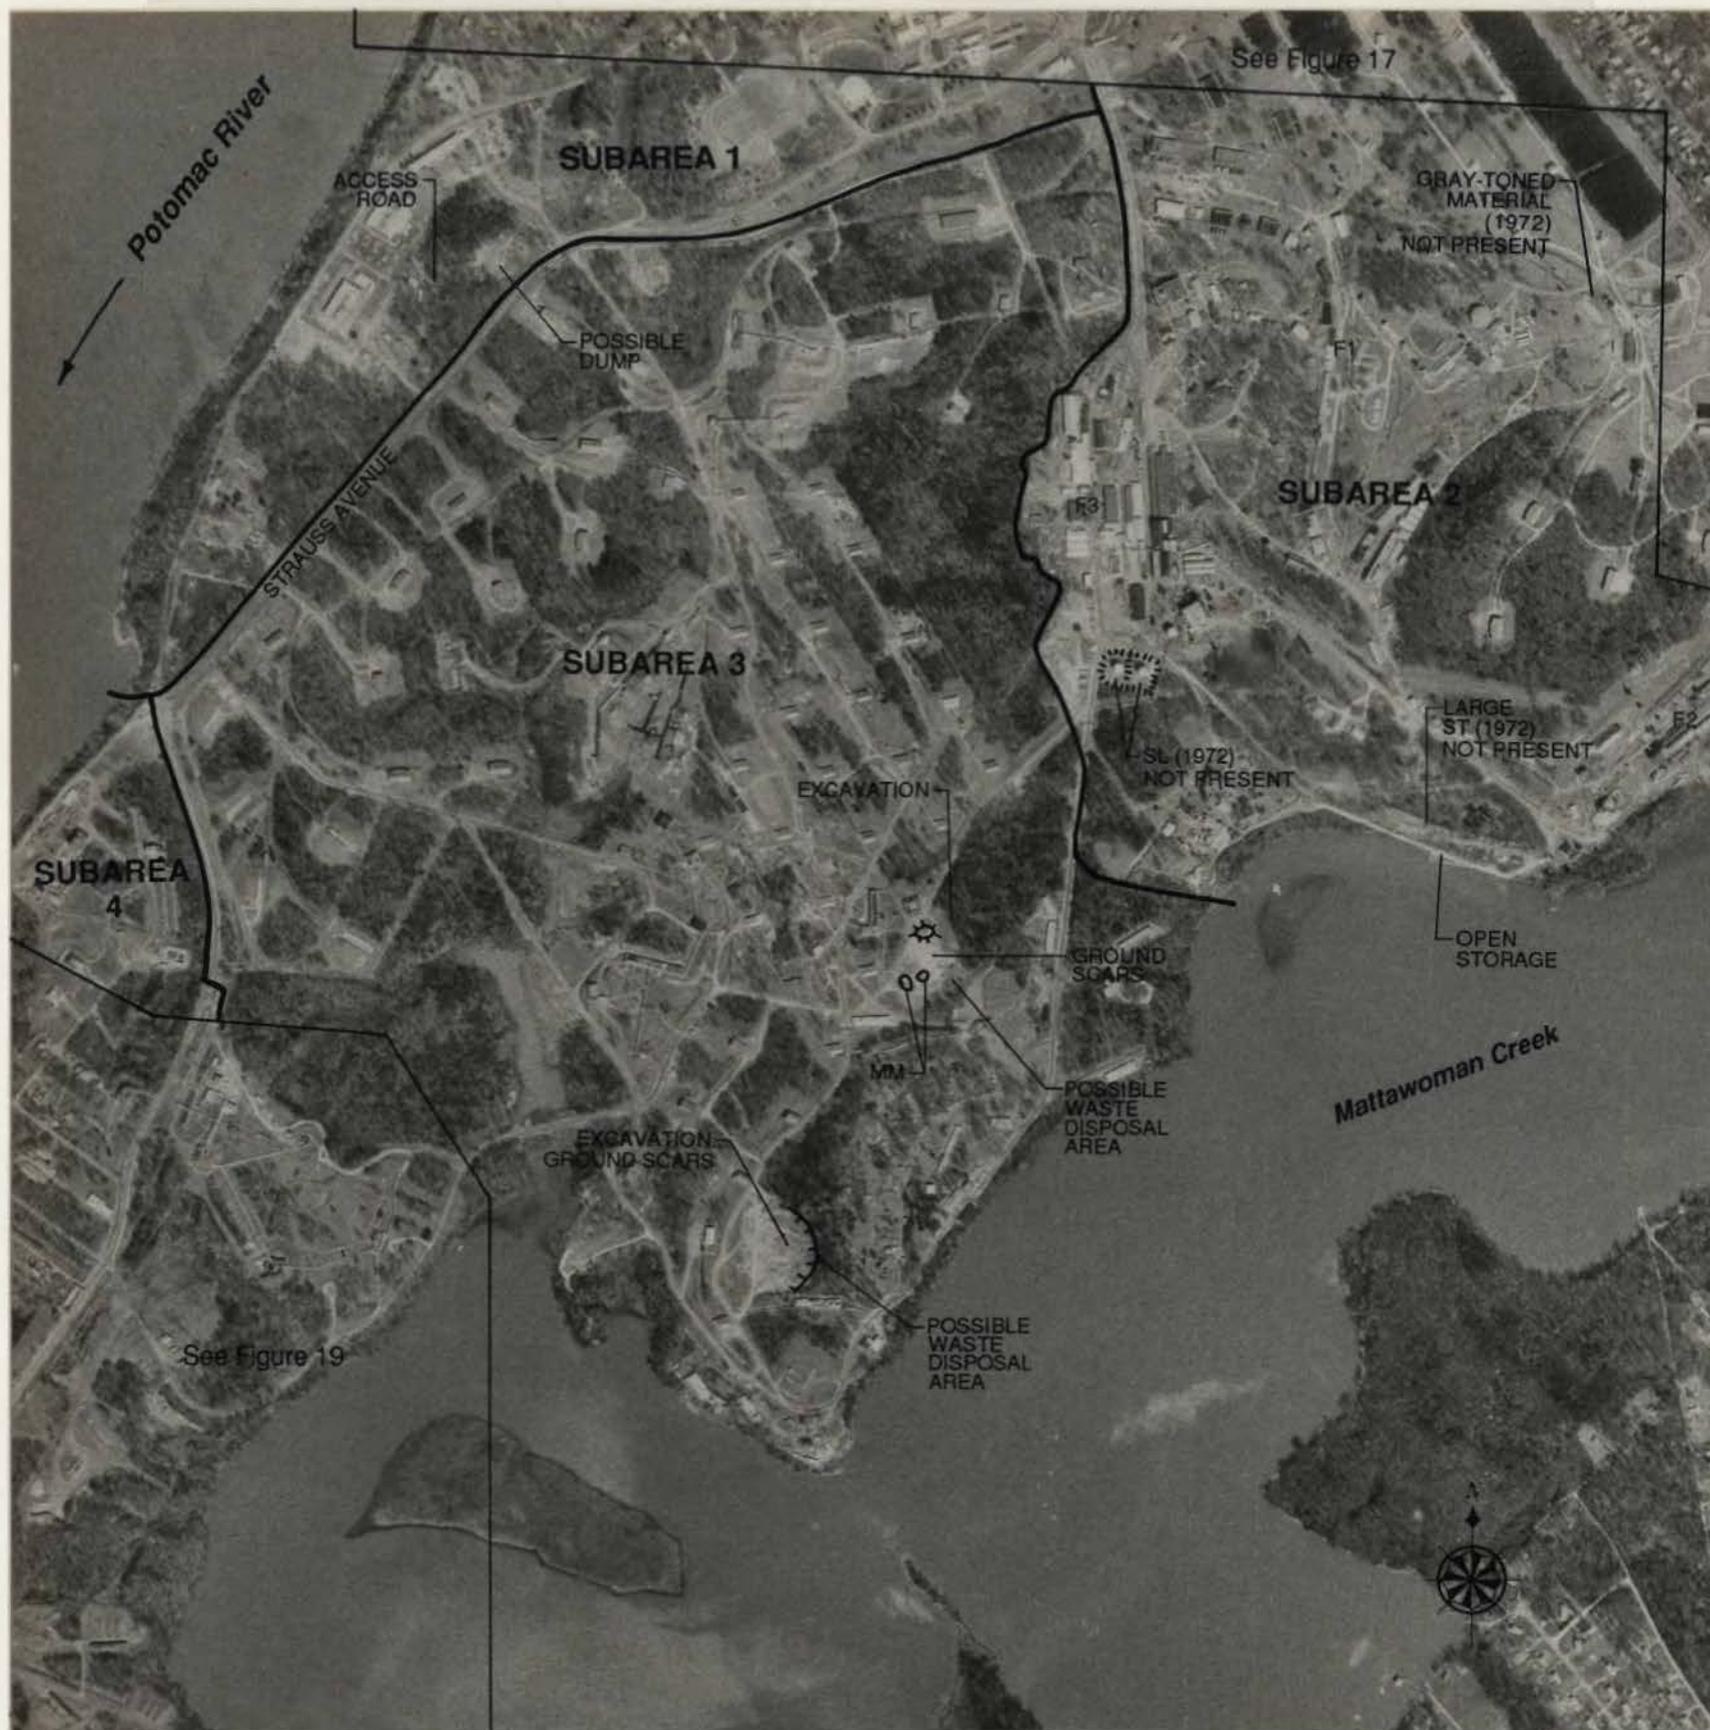
Figure 18. Indian Head NSWC, Main Peninsula, March 29, 1982. Approximate scale 1:11,350.

Gray-toned material seen in 1972 in the northern portion of the subarea is not present in this year. Also, the large stain southwest of Facility 2 (F2) (1972) is no longer visible. Standing liquid seen in 1972 south of Facility 3 (F3) is no longer present.

The excavation in the eastern portion of the subarea (first observed in 1967, Figure 12) is somewhat larger in extent than in 1972. Three new mounds of material and ground scarring are observed. The excavation is a possible waste disposal area. To the south the excavation observed in 1956 has ground scars, but no visible evidences of waste disposal.

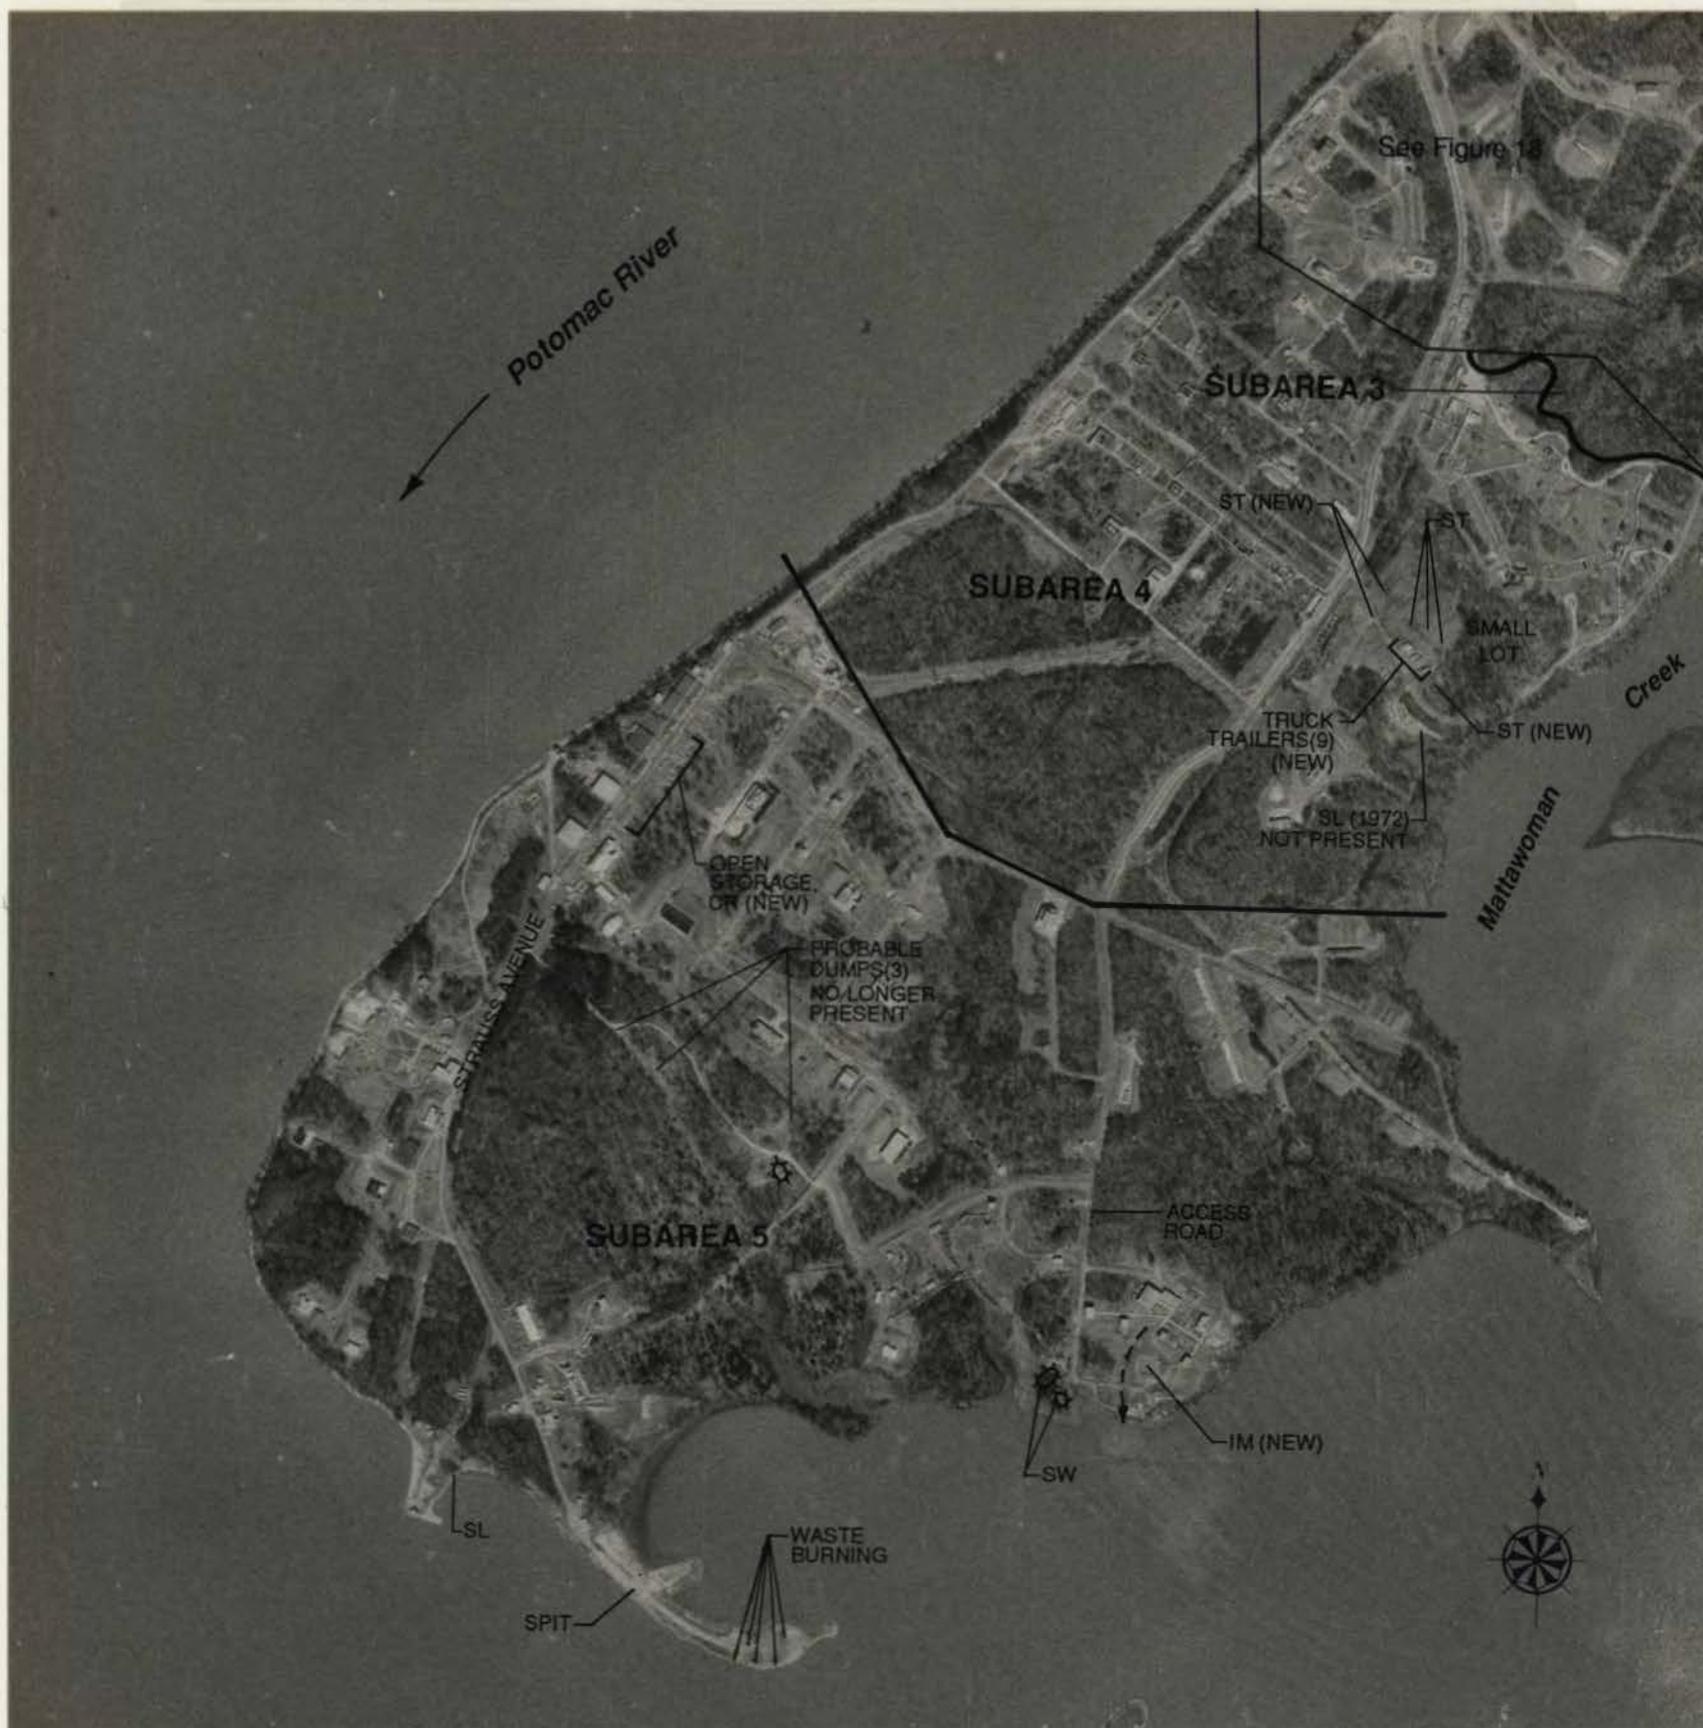
Within the small lot in the eastern portion of this subarea, there are nine truck trailers, staining seen in 1972 and new staining adjacent to the trailers and in the western portion of the lot. Waste disposal activity seen in 1972 appears to be ongoing.

The three probable dumps seen in 1972 appear to be inactive in 1982. Only one small mound of material is visible. Near the western shoreline of the site a new open storage area containing crates is visible. At the end of the access road in the eastern portion of the subarea are two mounds of solid waste. This area continues to be used as a waste disposal area. Six new sheds and buildings as well as a new impoundment are visible nearby. At the end of the spit, five small waste burning areas are observed. Standing liquid is visible on the small peninsula to the west.

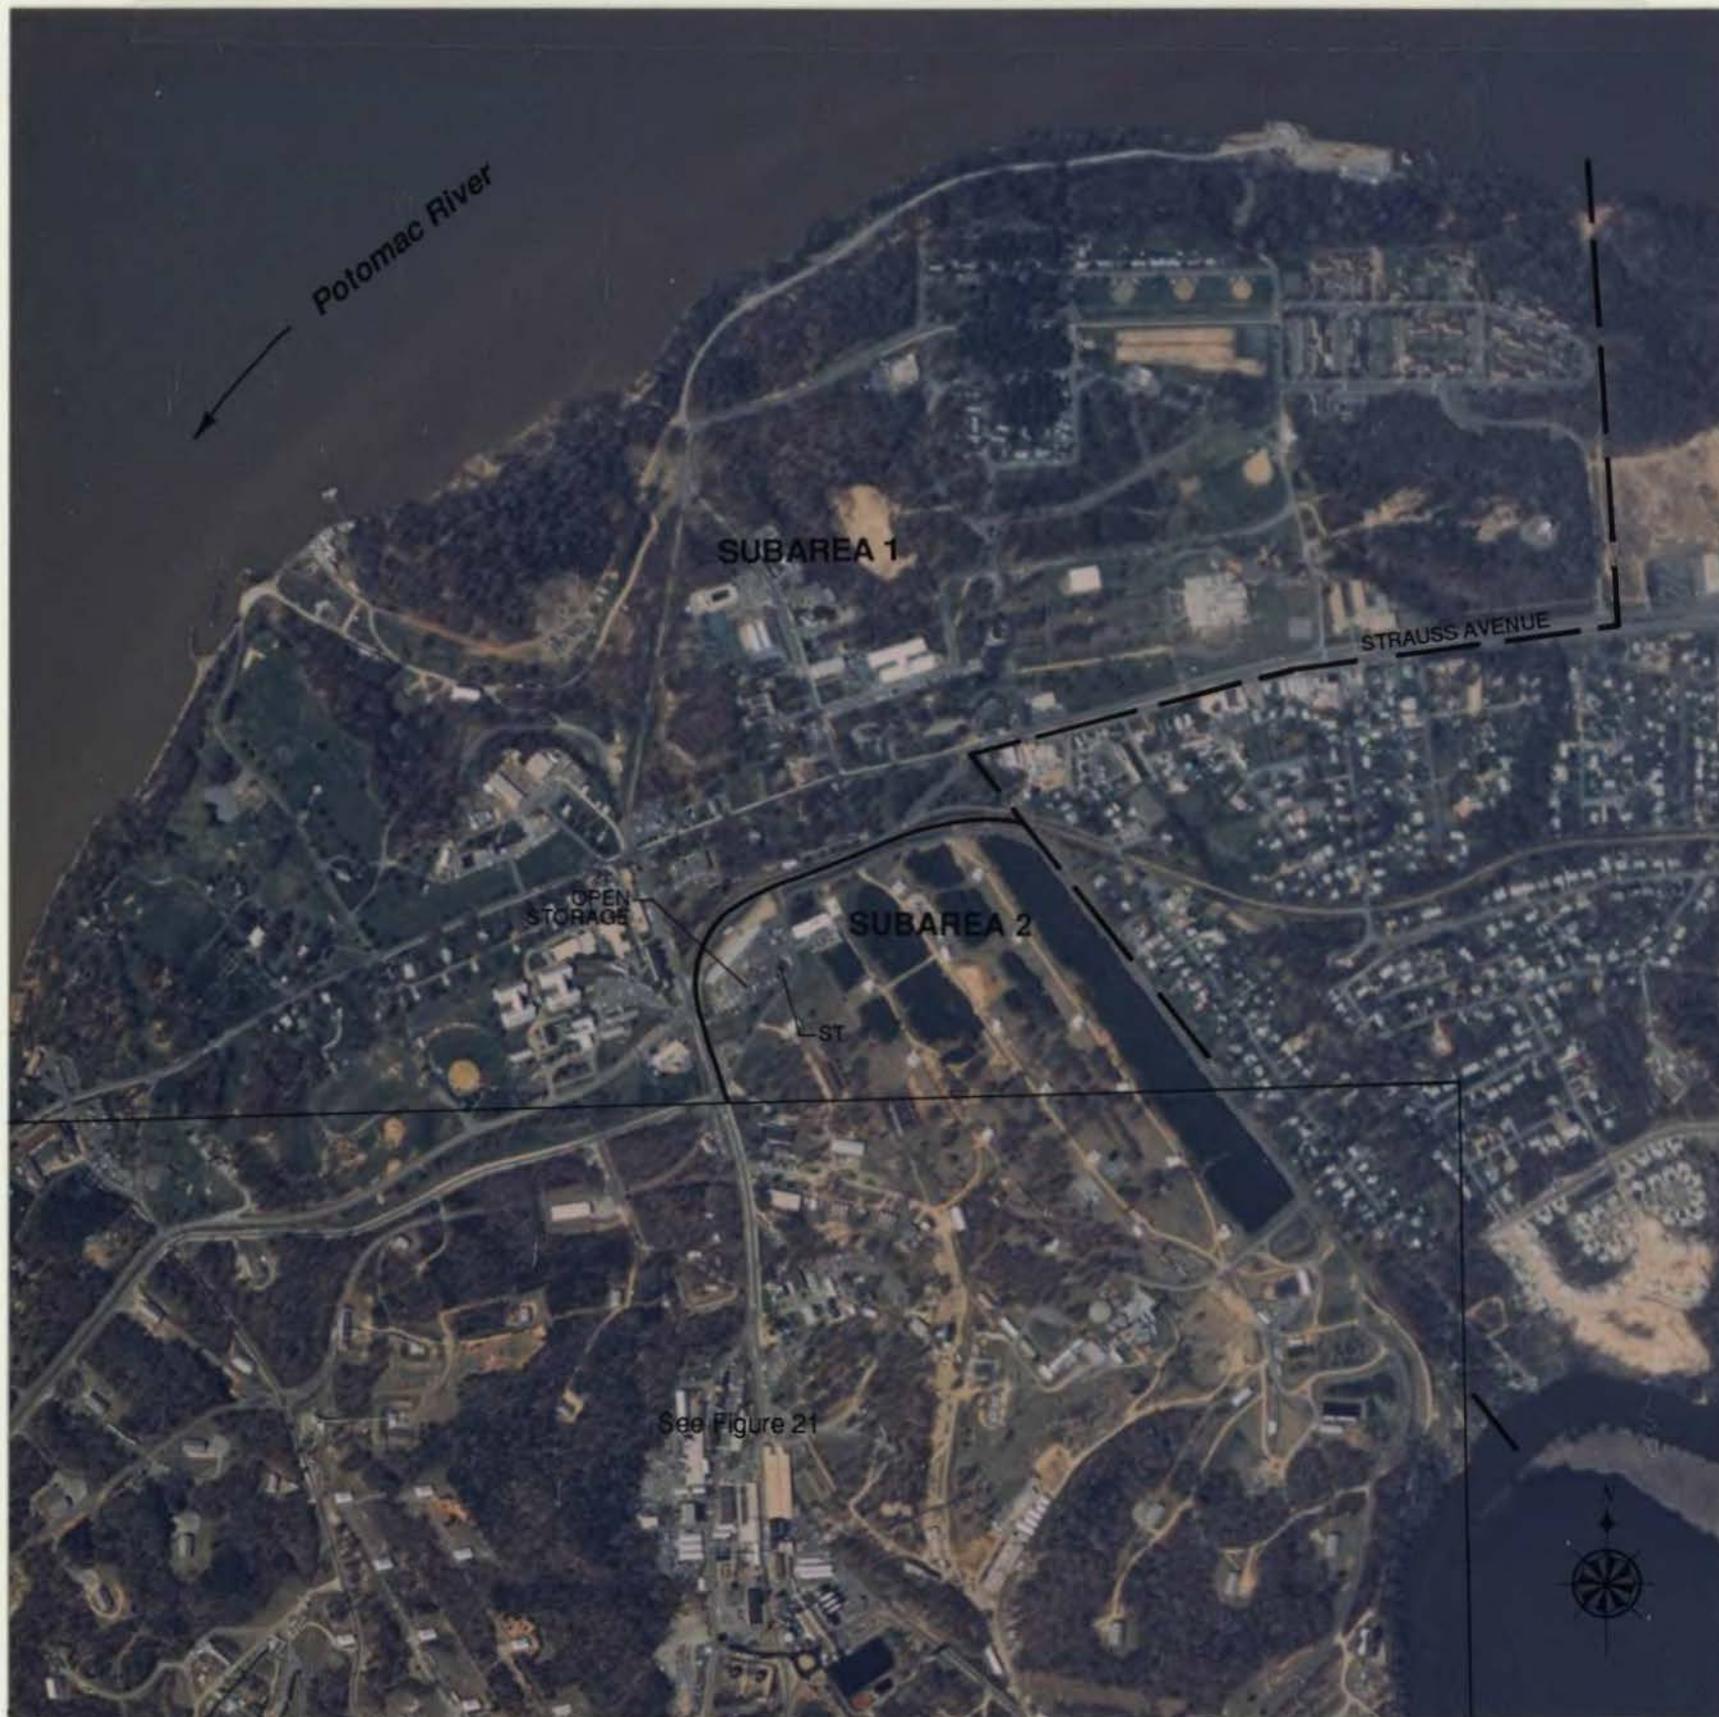
Staining is evident in the open storage area. No other significant features are observed in this portion of Subarea 2.

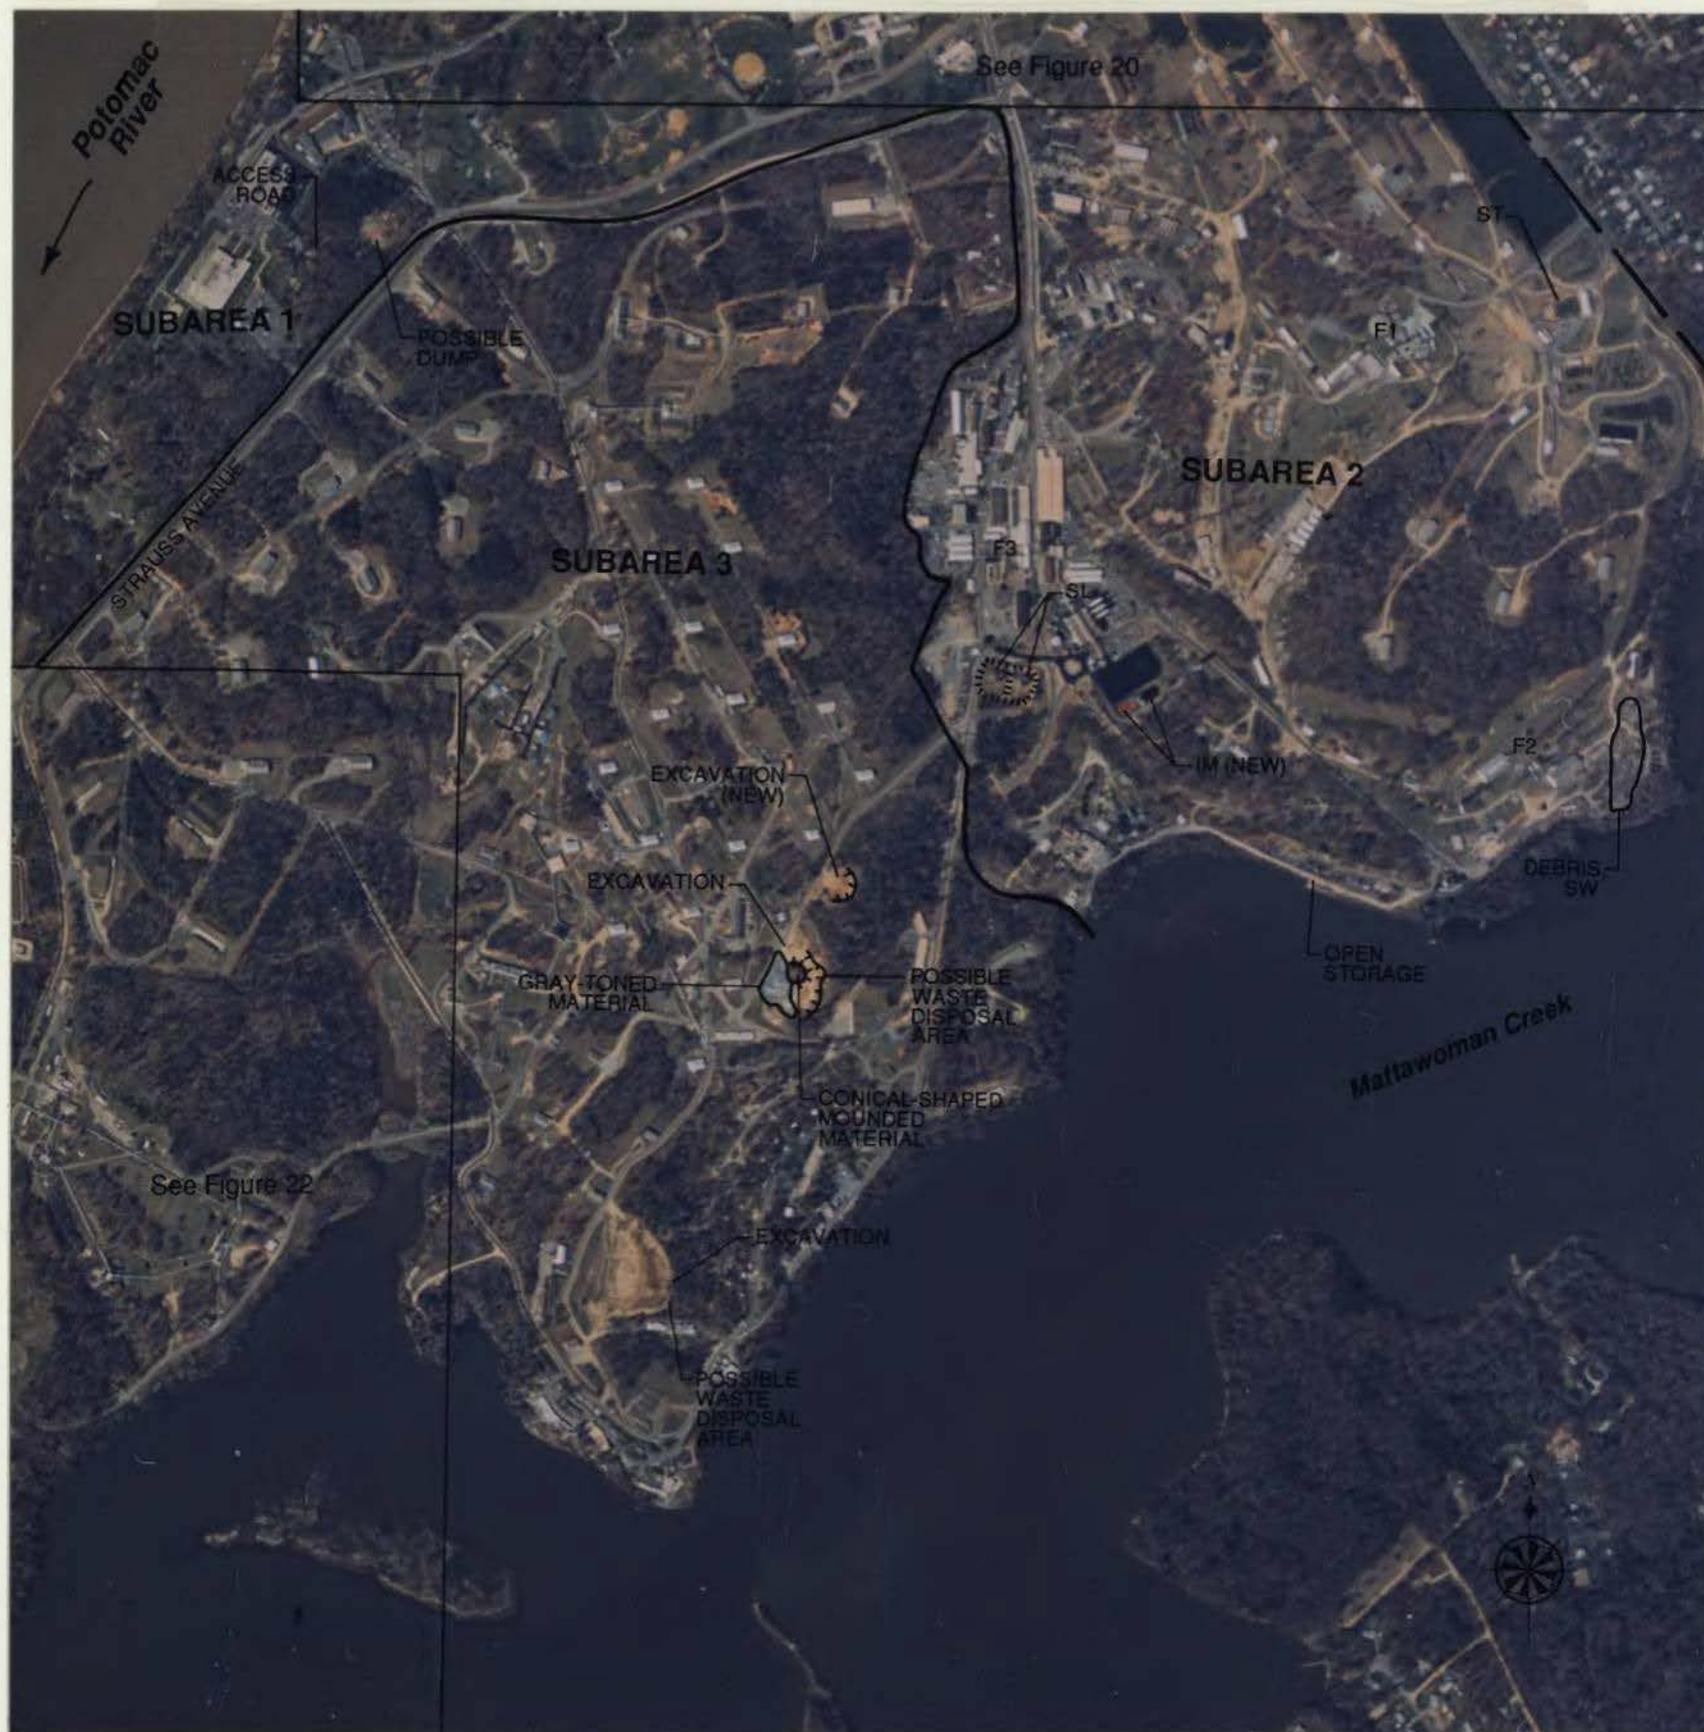
In the southeastern portion of this subarea the possible waste disposal area consists of a large deposit of gray-toned material and a conical-shaped deposit of dark-toned mounded material. A new excavation is visible to the north. The large excavation at the southern end of the subarea exhibits no significant change since 1982.

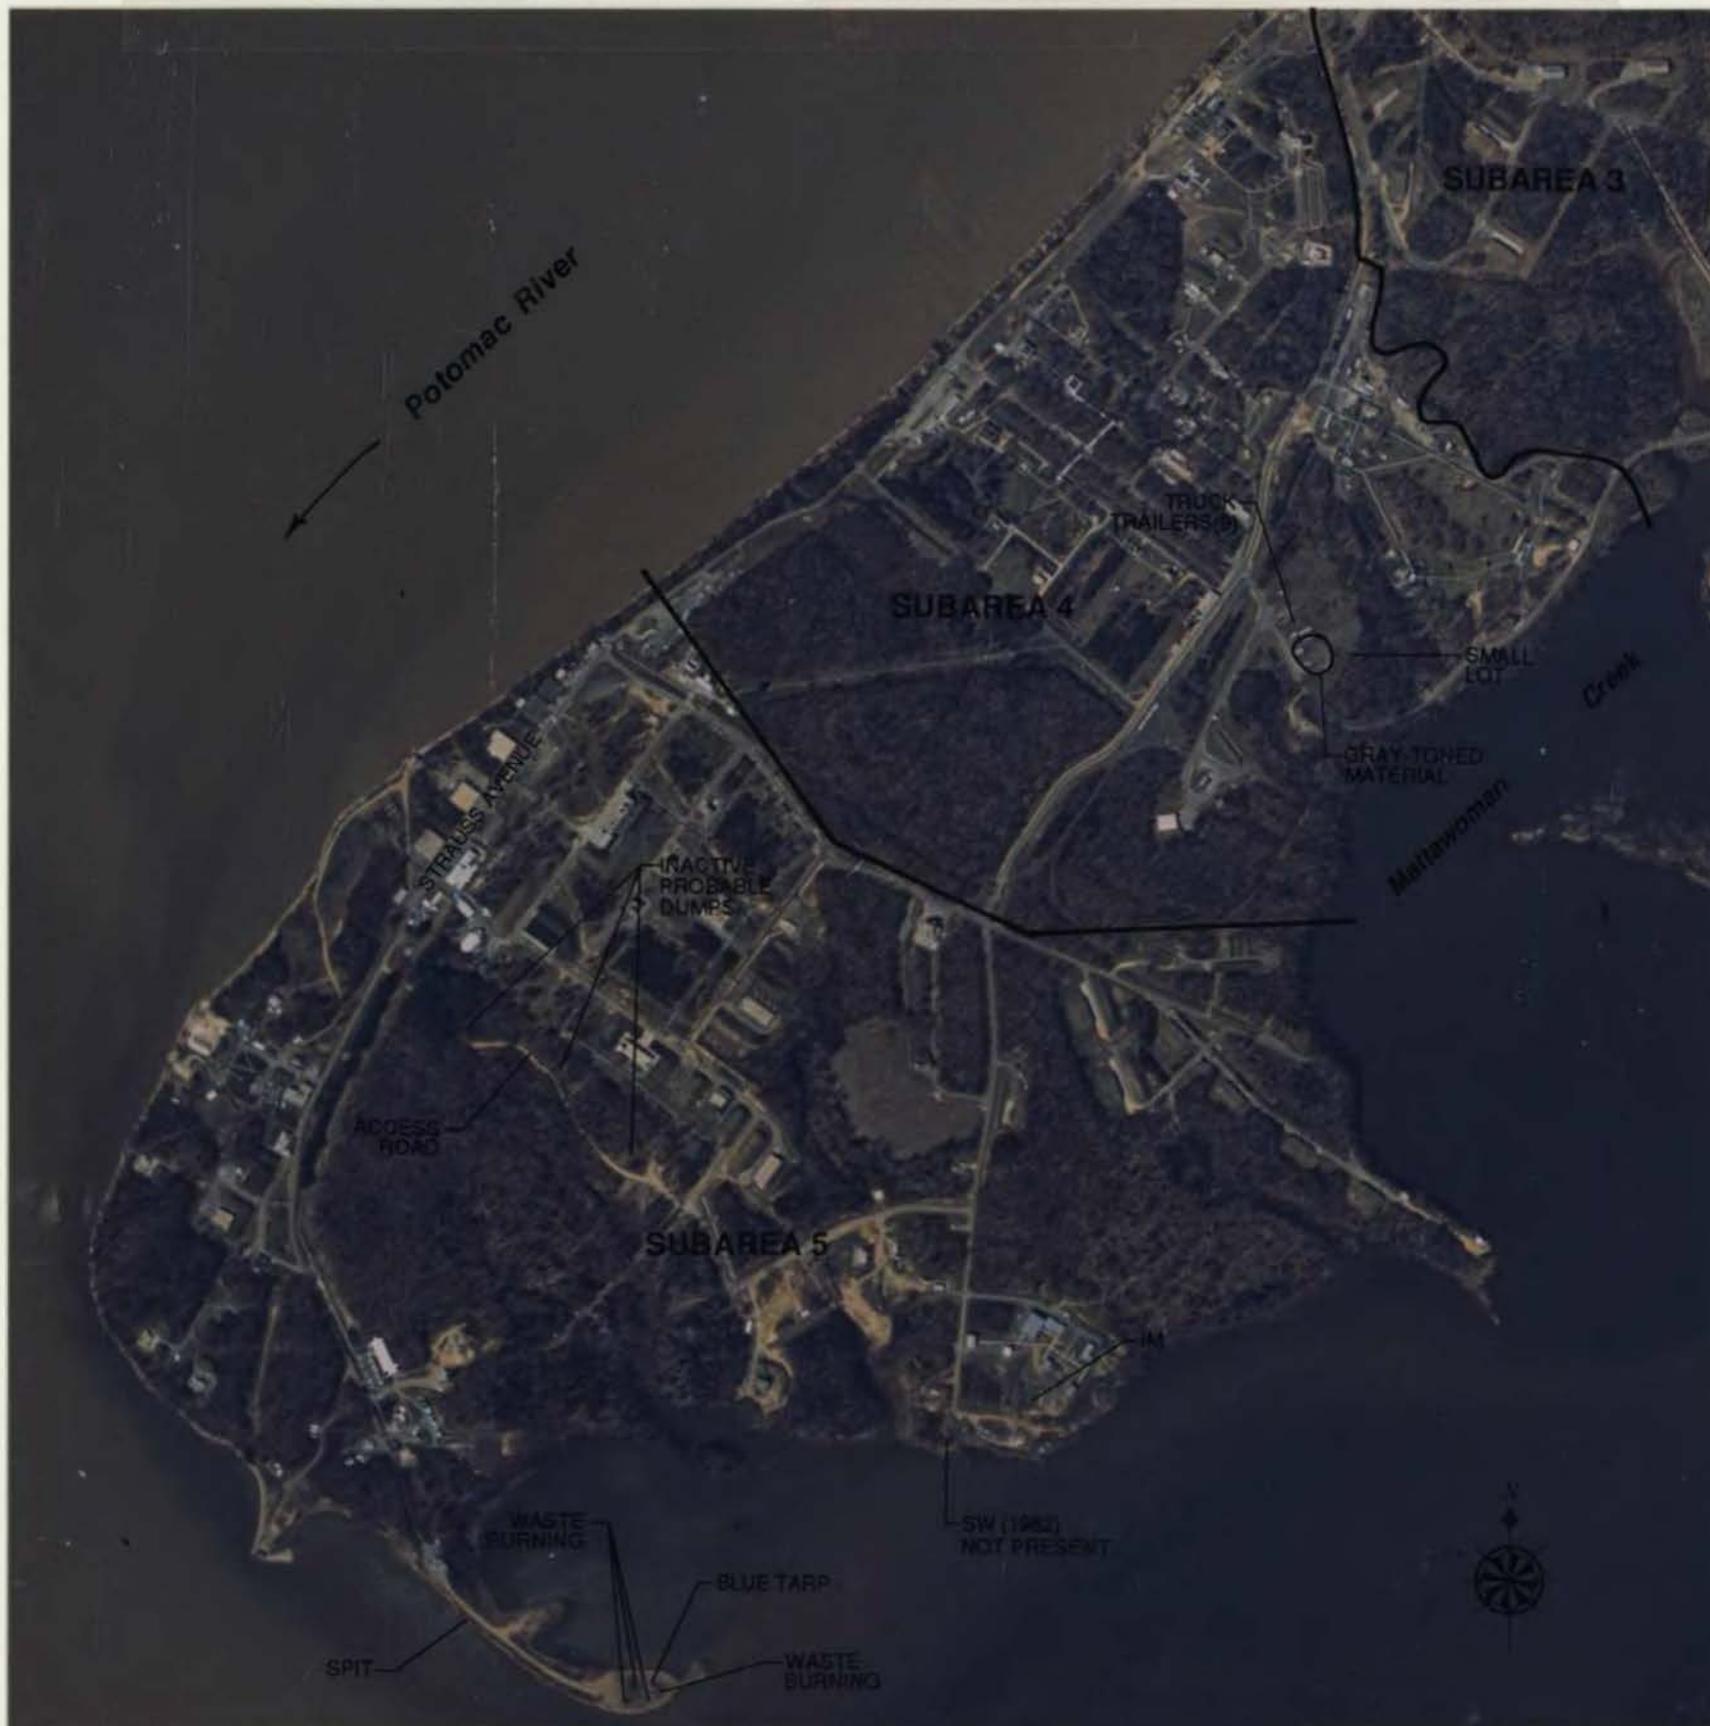
At the small lot in the eastern portion of this subarea, nine truck trailers and gray-toned material spread on the surface of the ground are observed.

In the eastern portion of the subarea the solid waste deposits present at the end of the access road in 1982 are no longer present. Four small areas of continuing waste burning activity are visible on the spit. A blue tarp possibly used as a covering for solid waste is also noted. No other significant features are observed.

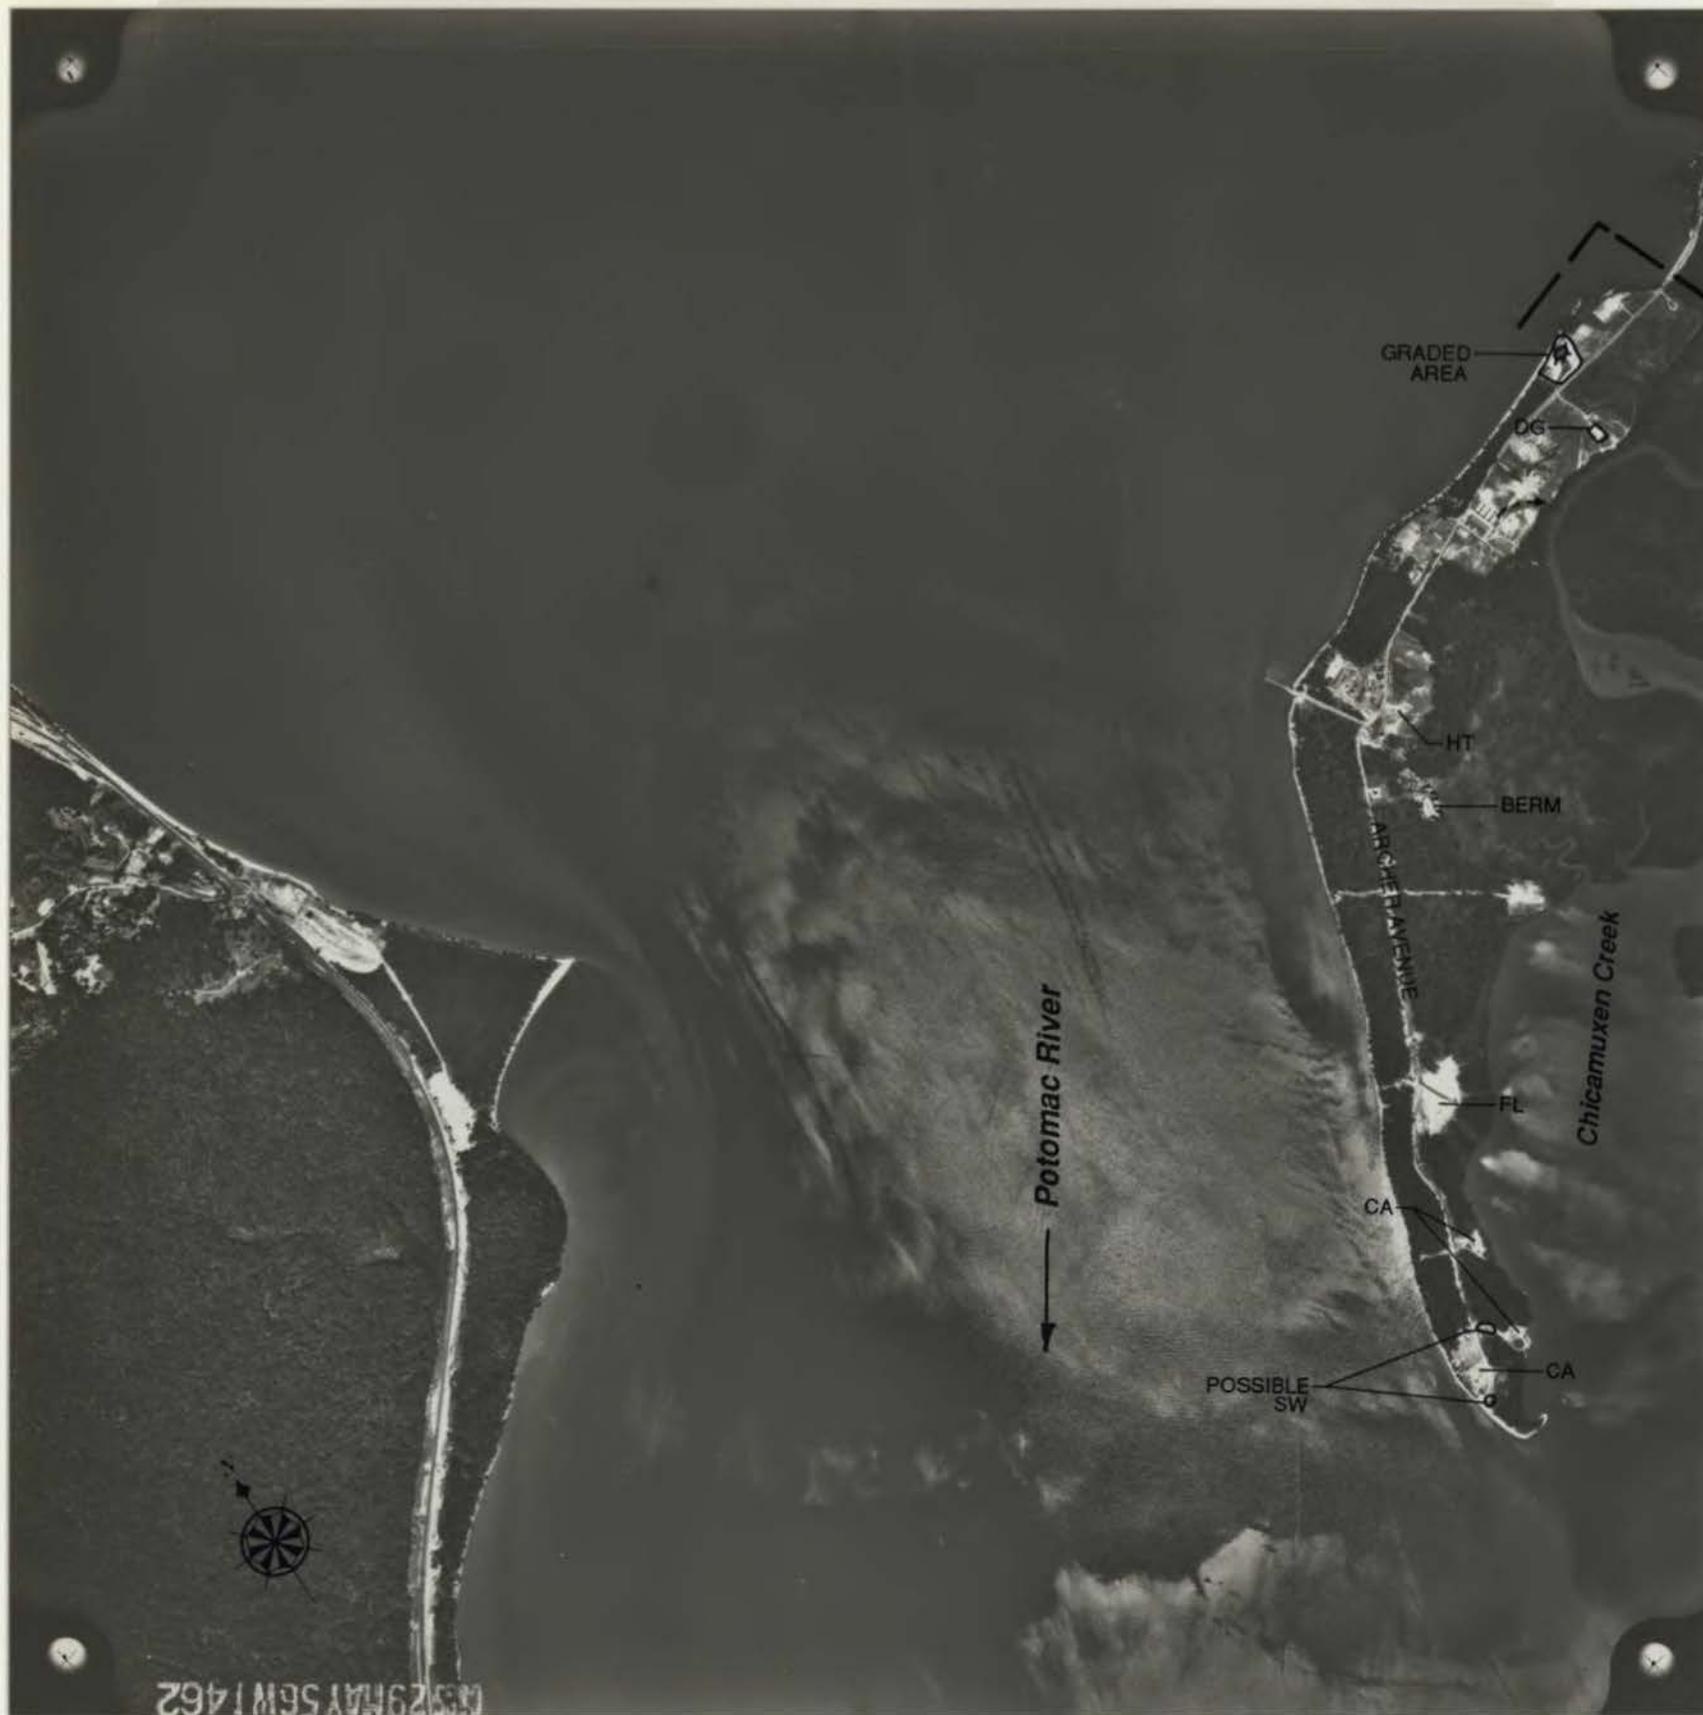
MAY 29, 1956 (FIGURE 24)

In the northeast portion of the annex is a graded area with one large mound of material. Directly across Archer Avenue is a small disturbed area behind two buildings. Continuing southwest, there is an area of cleared land where a berm has been constructed. Further southwest is a large area of fill that has been graded, possibly prior to construction activity. One cleared area is visible to the southwest. At the tip of the peninsula are two other cleared areas and two deposits of possible solid waste.

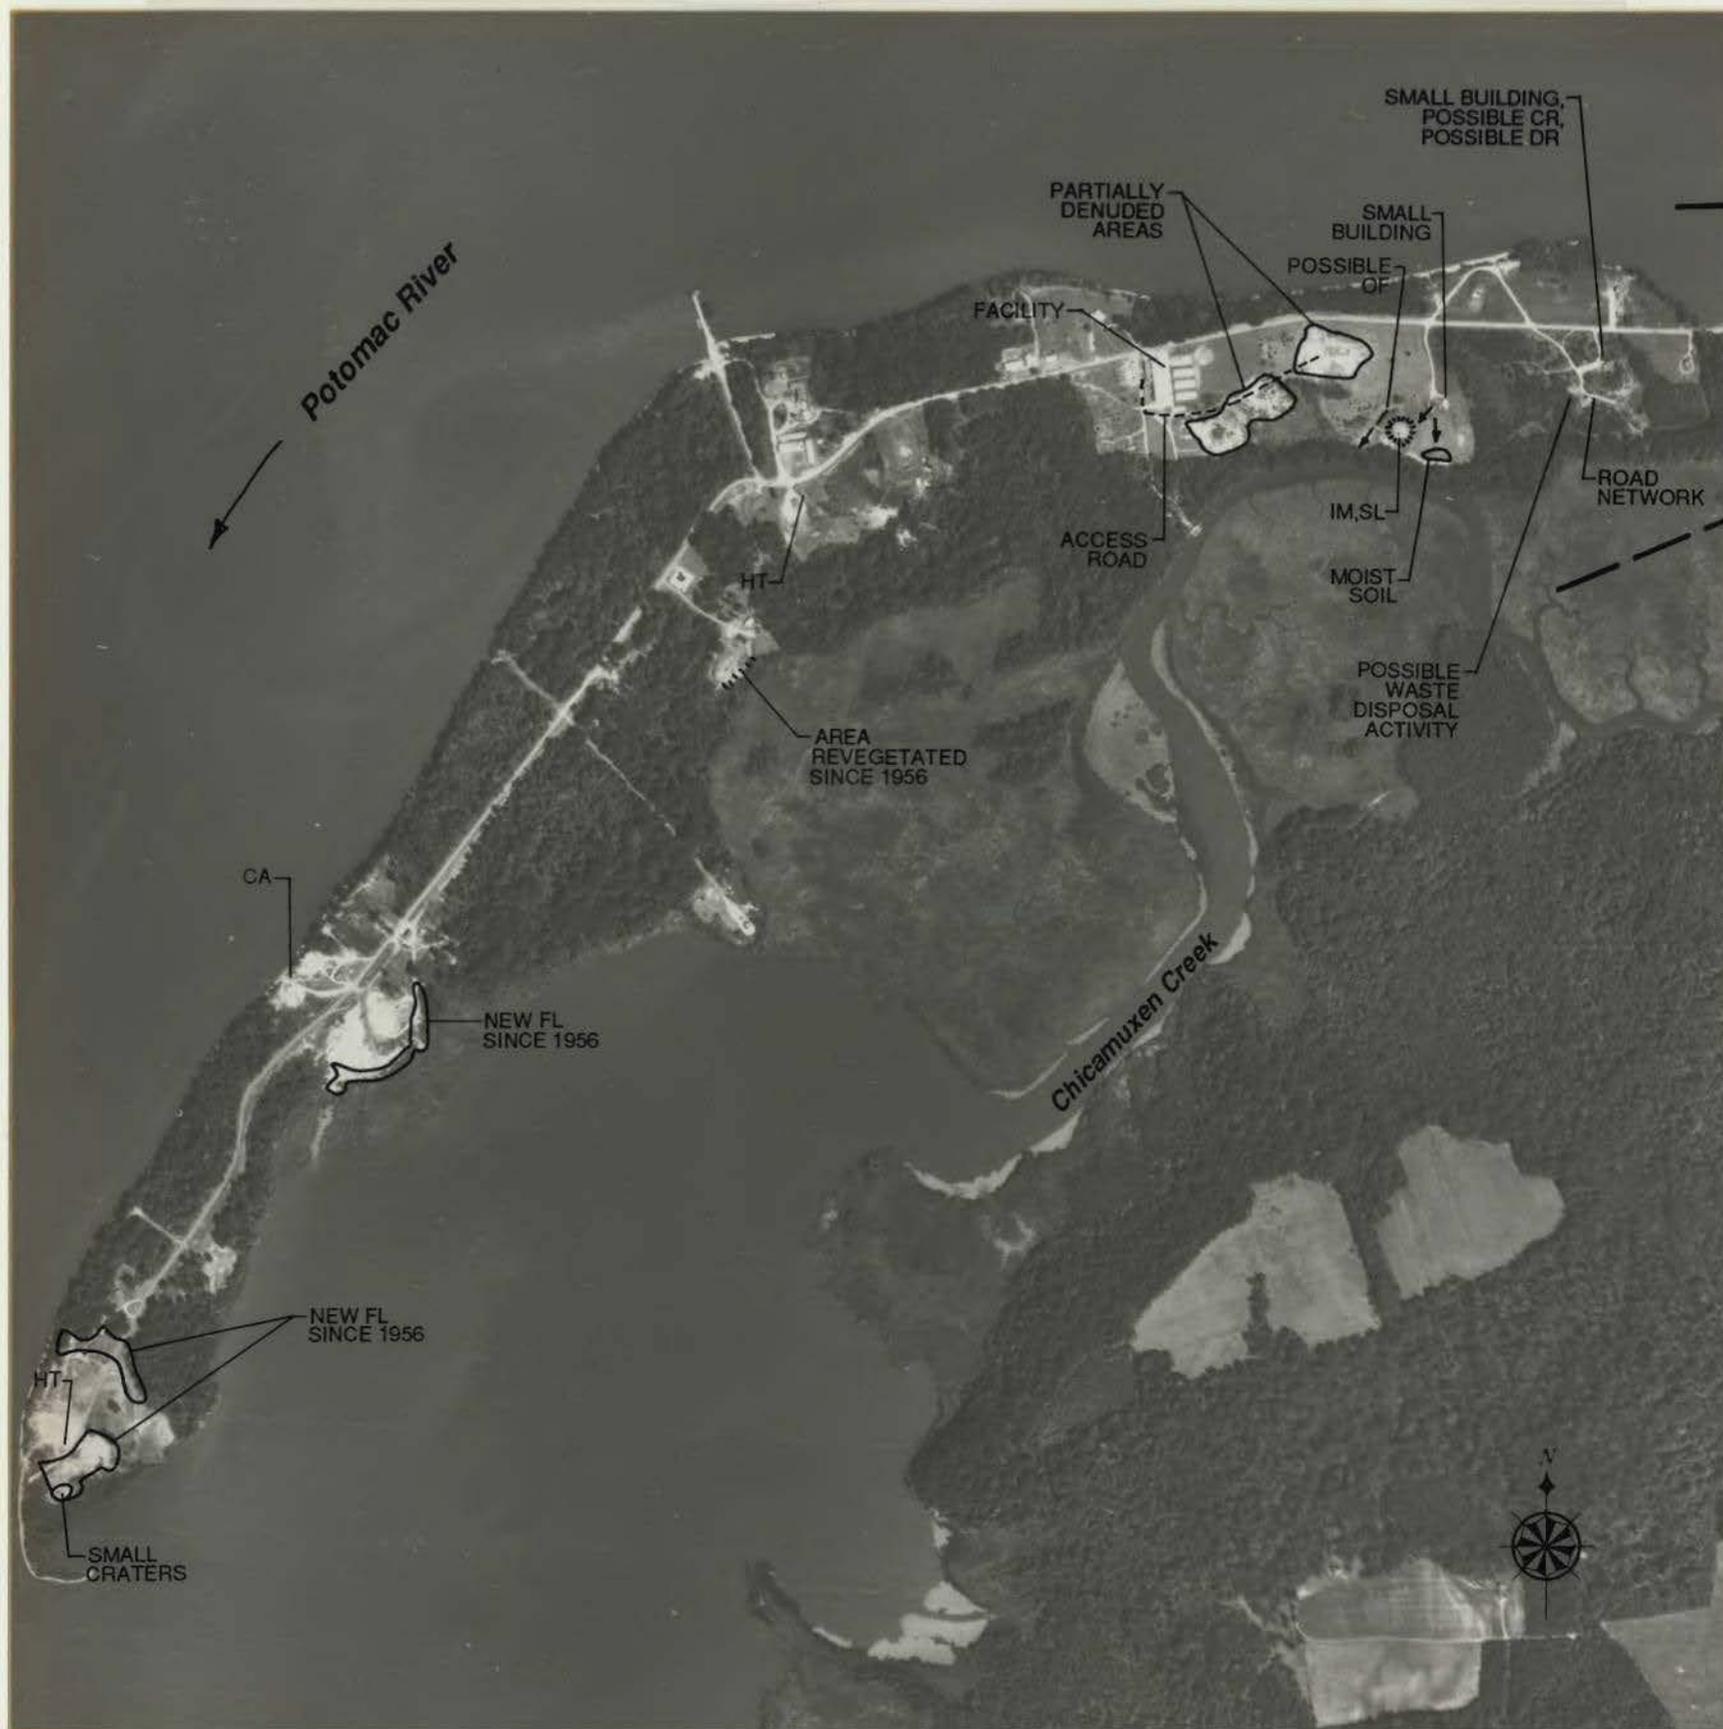
The most significant change in the northeastern portion of the annex since 1956 is a new road network and the presence of possible crates and possible drums. Possible waste disposal activity is also present. Poor resolution of this photograph precludes a more definitive assessment of features and conditions.

At the east end of the site is a small building with surface drainage flowing south to an area of moist soil. A bermed impoundment containing standing liquid is visible nearby. A drainage channel apparently originates near the impoundment (a possible outfall) and flows southwest into Chicamuxen Creek. Partially denuded areas are visible nearby. An access road leads from these areas to a nearby facility. Further down the peninsula is an area of fill that has increased in extent since 1956. A new cleared area is also observed just across Archer Road. At the tip of the peninsula several small craters are visible which indicate probable ordnance disposal (by detonation). The extent of fill on the peninsula is larger when compared to 1956. One horizontal tank (HT) is noted. Possible solid waste seen in 1956 is not present.
