# AERIAL PHOTOGRAPHIC ANALYSIS INDIAN HEAD NAVAL SURFACE WARFARE CENTER

## Charles County, Maryland

TS-PIC-9803362S  
February 1998

This report presents the results of an aerial photographic analysis conducted with historical aerial photographs of the Indian Head Naval Surface Warfare Center located in Charles County, Maryland. Seven dates of black-and-white and color photographs (1956, 1961, 1963, 1967, 1972, 1982, and 1987) were used to analyze the site. Environmentally significant hazardous waste-related features and conditions were identified. The purpose of this report is to provide remote sensing support to field investigations in U.S. Environmental Protection Agency (EPA) Region 3 under the Comprehensive Environmental Response, Compensation, and Liability Act (CERCLA).

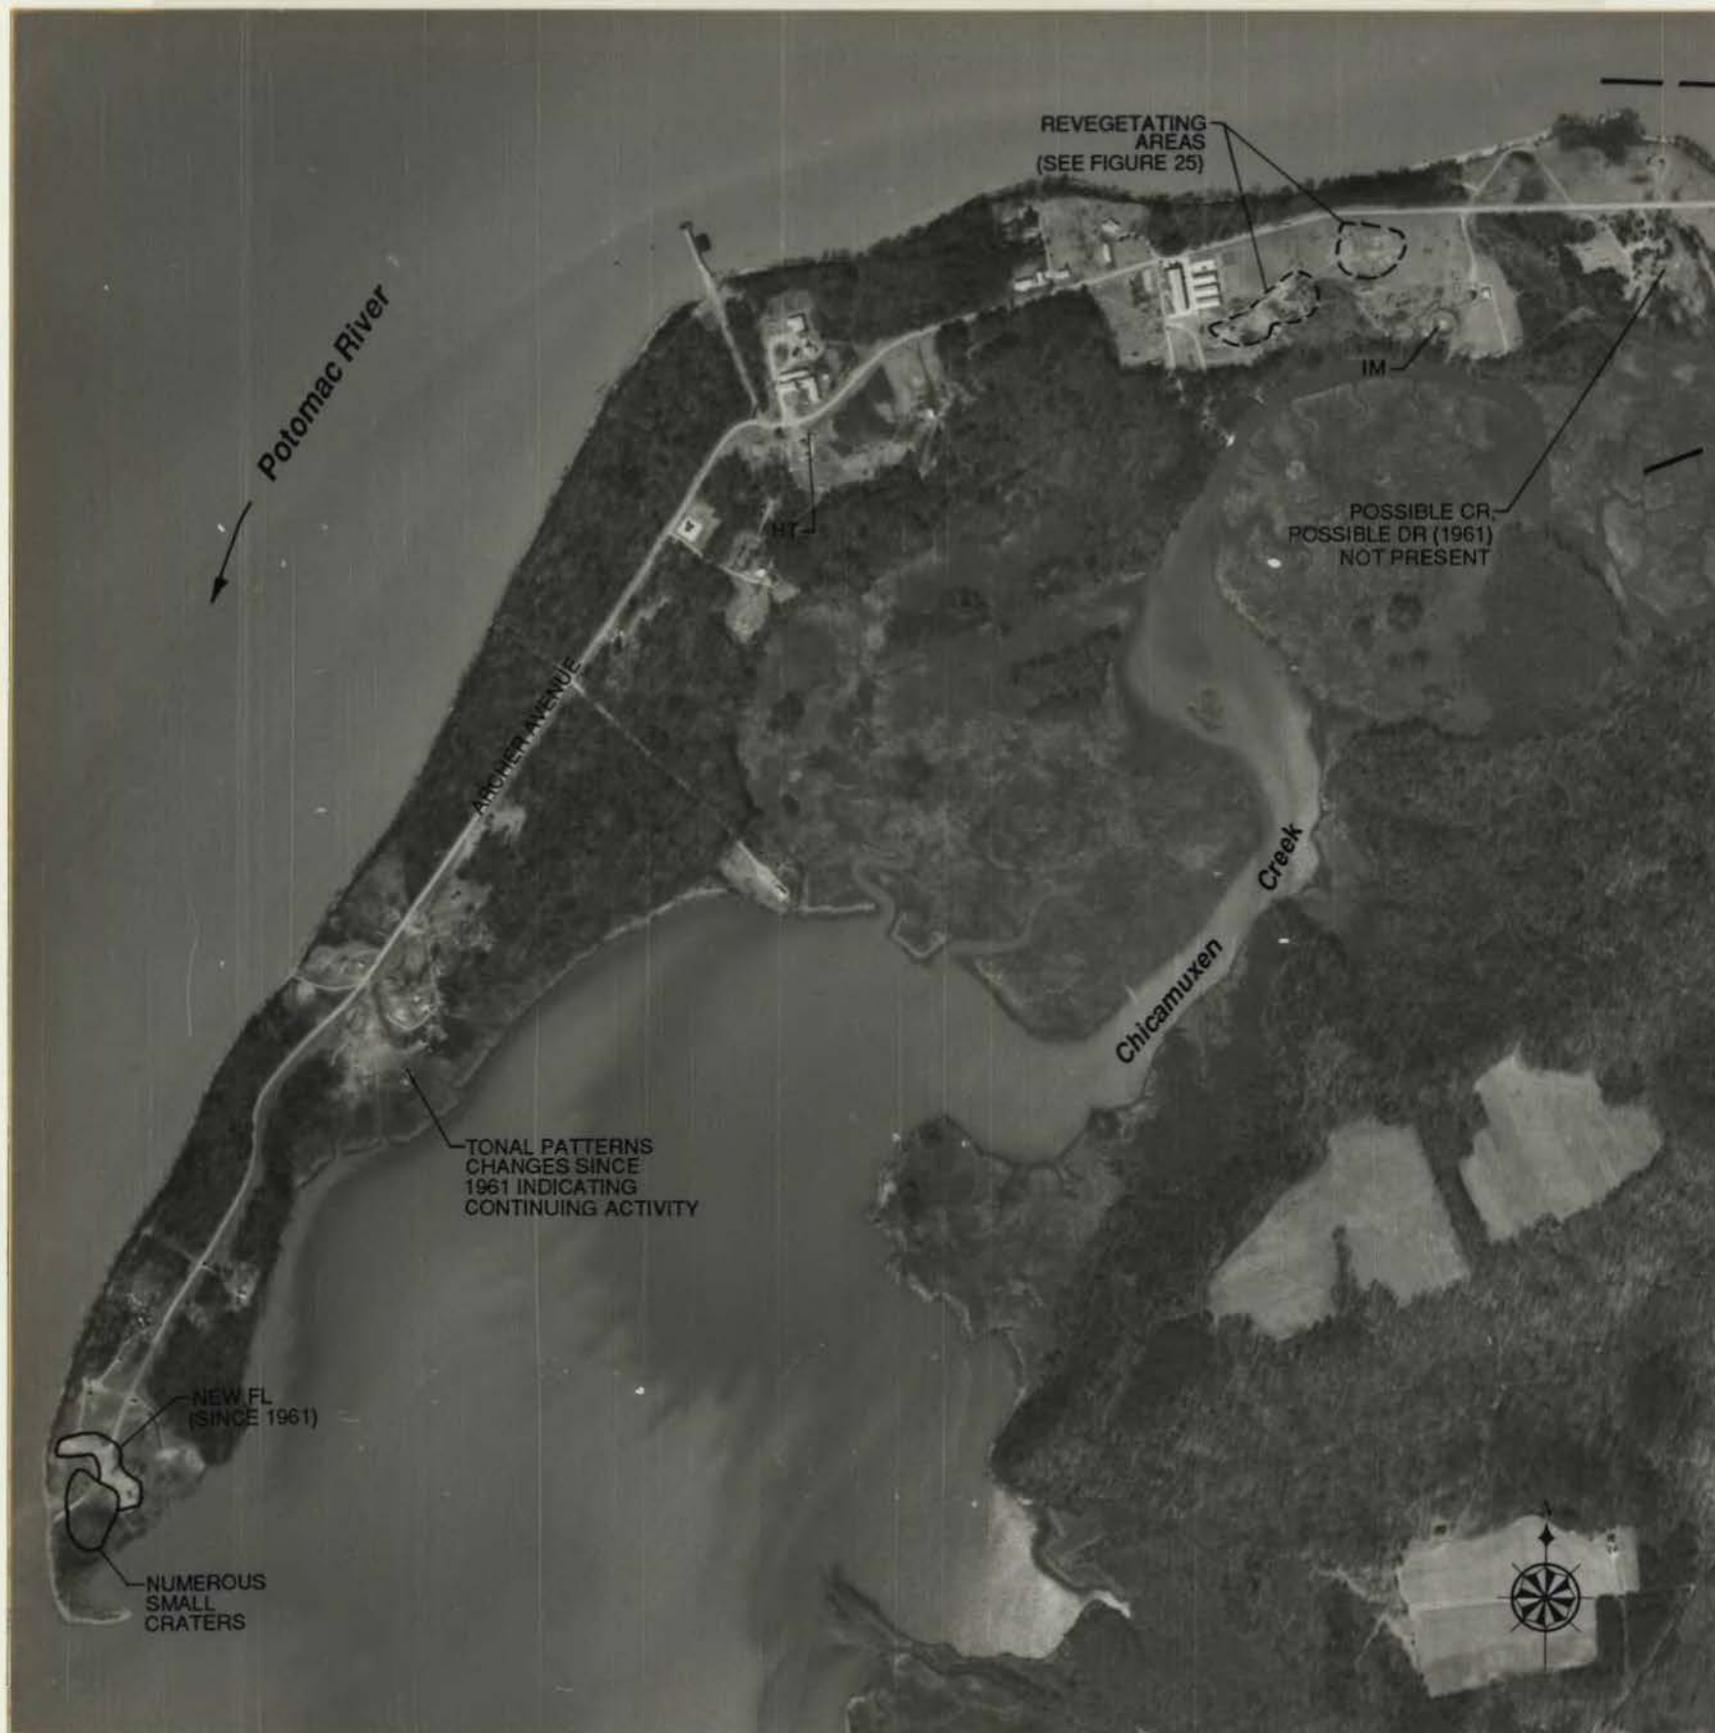
MARCH 15, 1963 (FIGURE 26)

The possible crates and possible drums seen in 1961 in the northeast portion of the site are not present in 1963. The partially denuded areas seen in 1961 have revegetated. Further down the peninsula, soil tonal patterns have changed at the large area of fill which indicates continuing probable ordnance disposal activity. The specific type of activity could not be determined. At the tip of the peninsula new fill has been placed over a portion of the area and numerous small craters are evident indicating continued probable ordnance disposal.

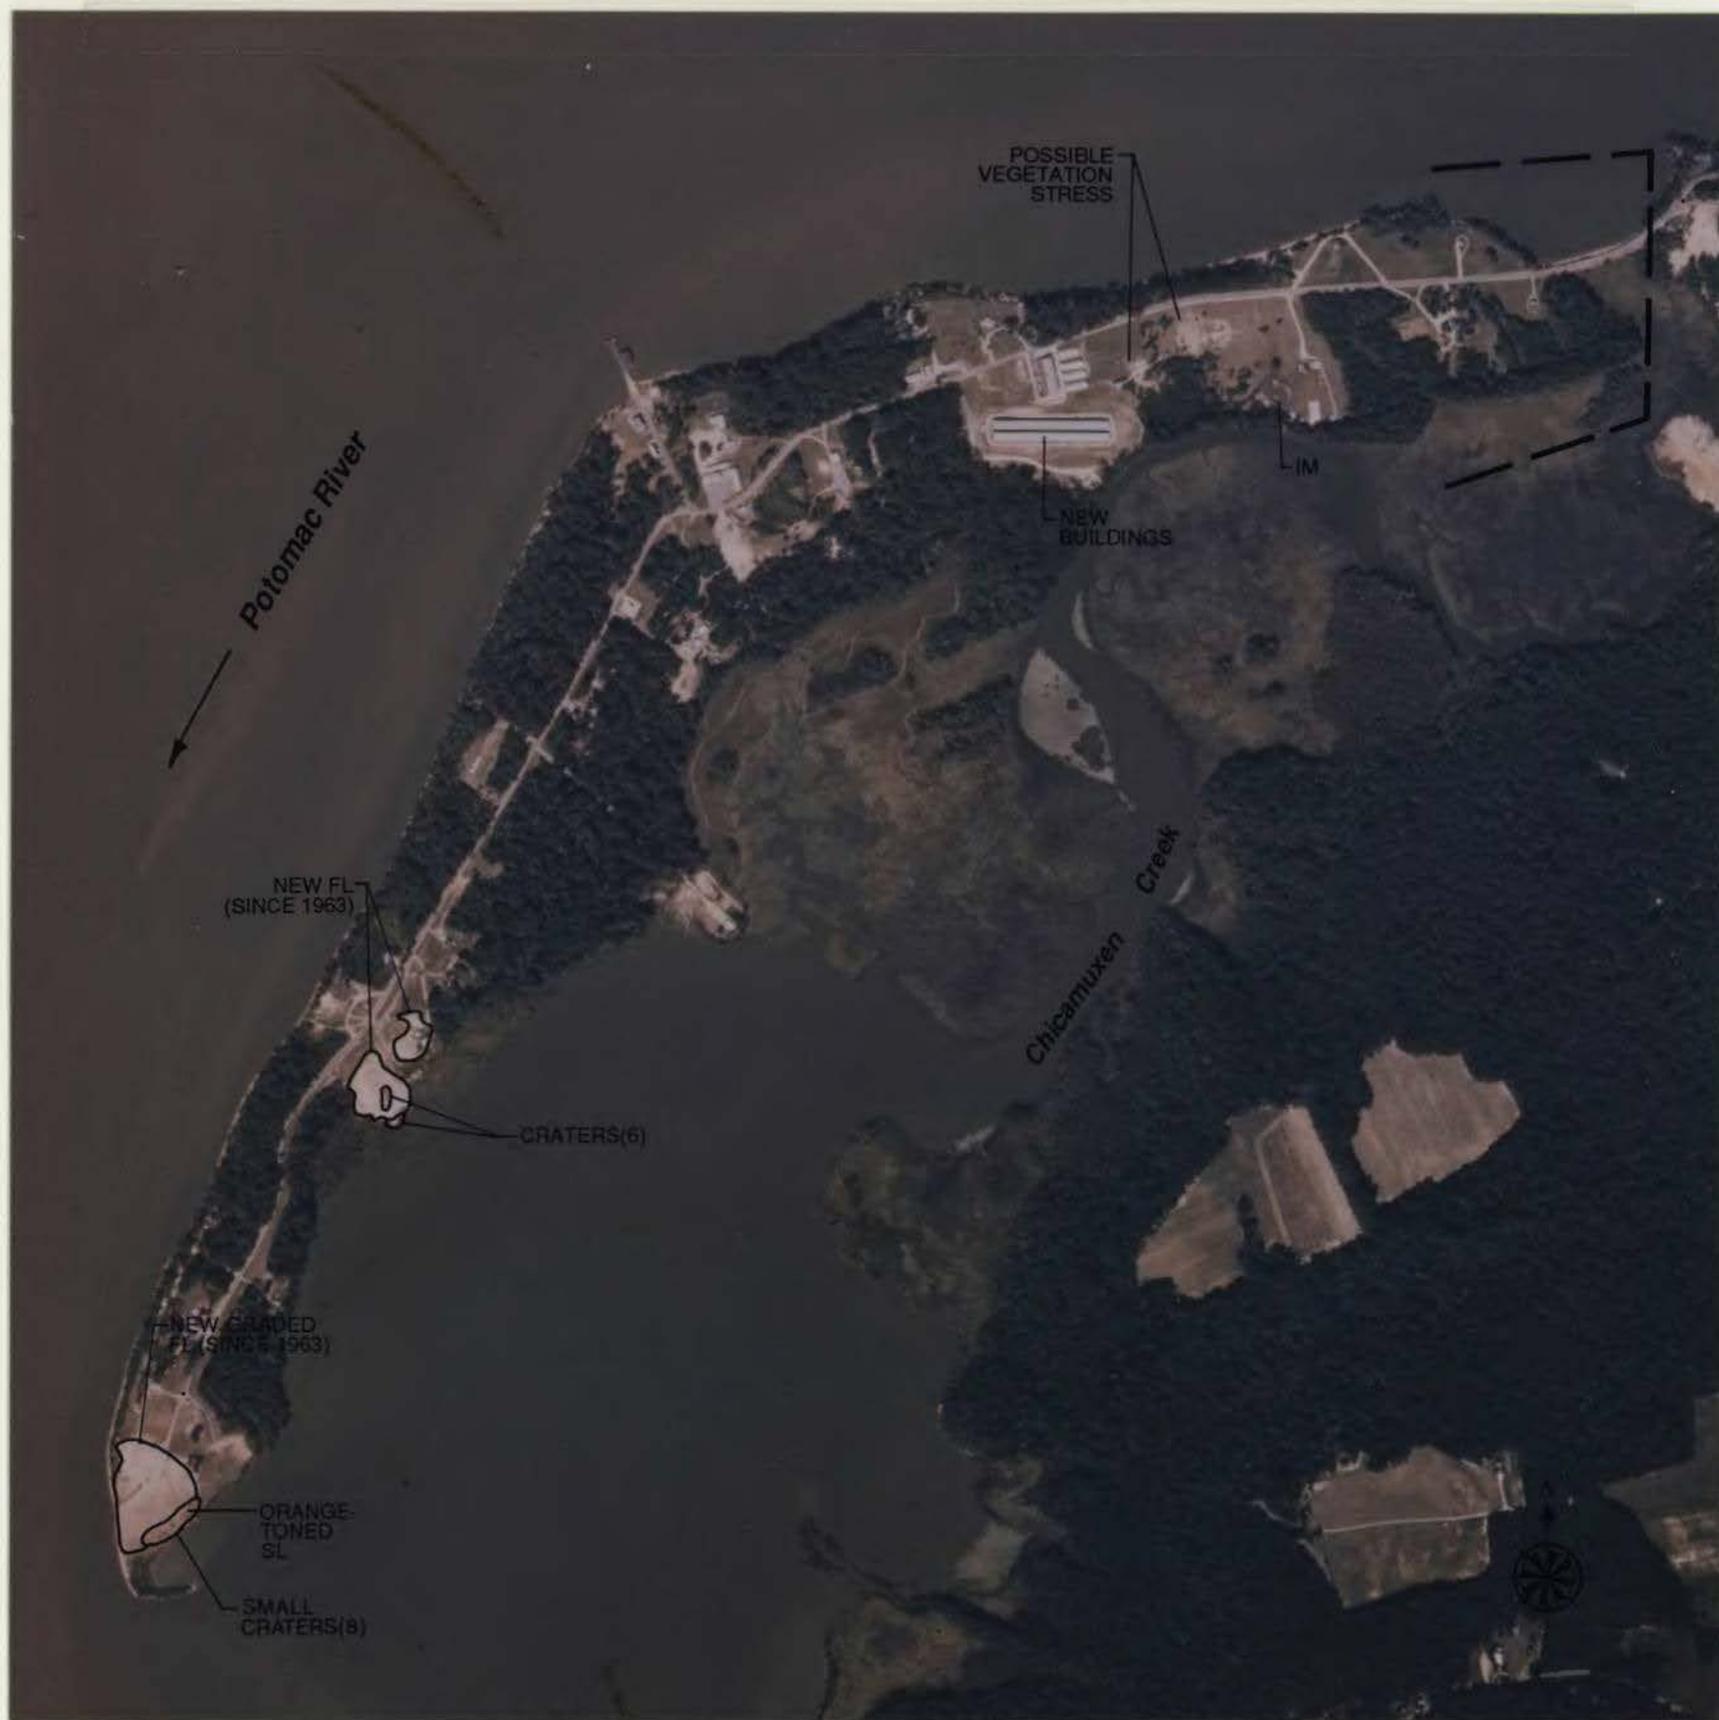
SEPTEMBER 15, 1967 (FIGURE 27)

Bare soil within the revegetating areas seen in 1963 has not revegetated. This may be due to soil contaminants that preclude vegetation reestablishment or natural soil infertility. Further down the peninsula to the southwest is the area where probable ordnance disposal was occurring in 1963. Six new small craters are observed in and near new fill that has been deposited in this area since 1963. At the end of the peninsula the craters existing in 1963 have been covered with new fill. Eight new small liquid-filled craters are visible on the eastern side of the fill. Three craters contain orange-toned liquid.

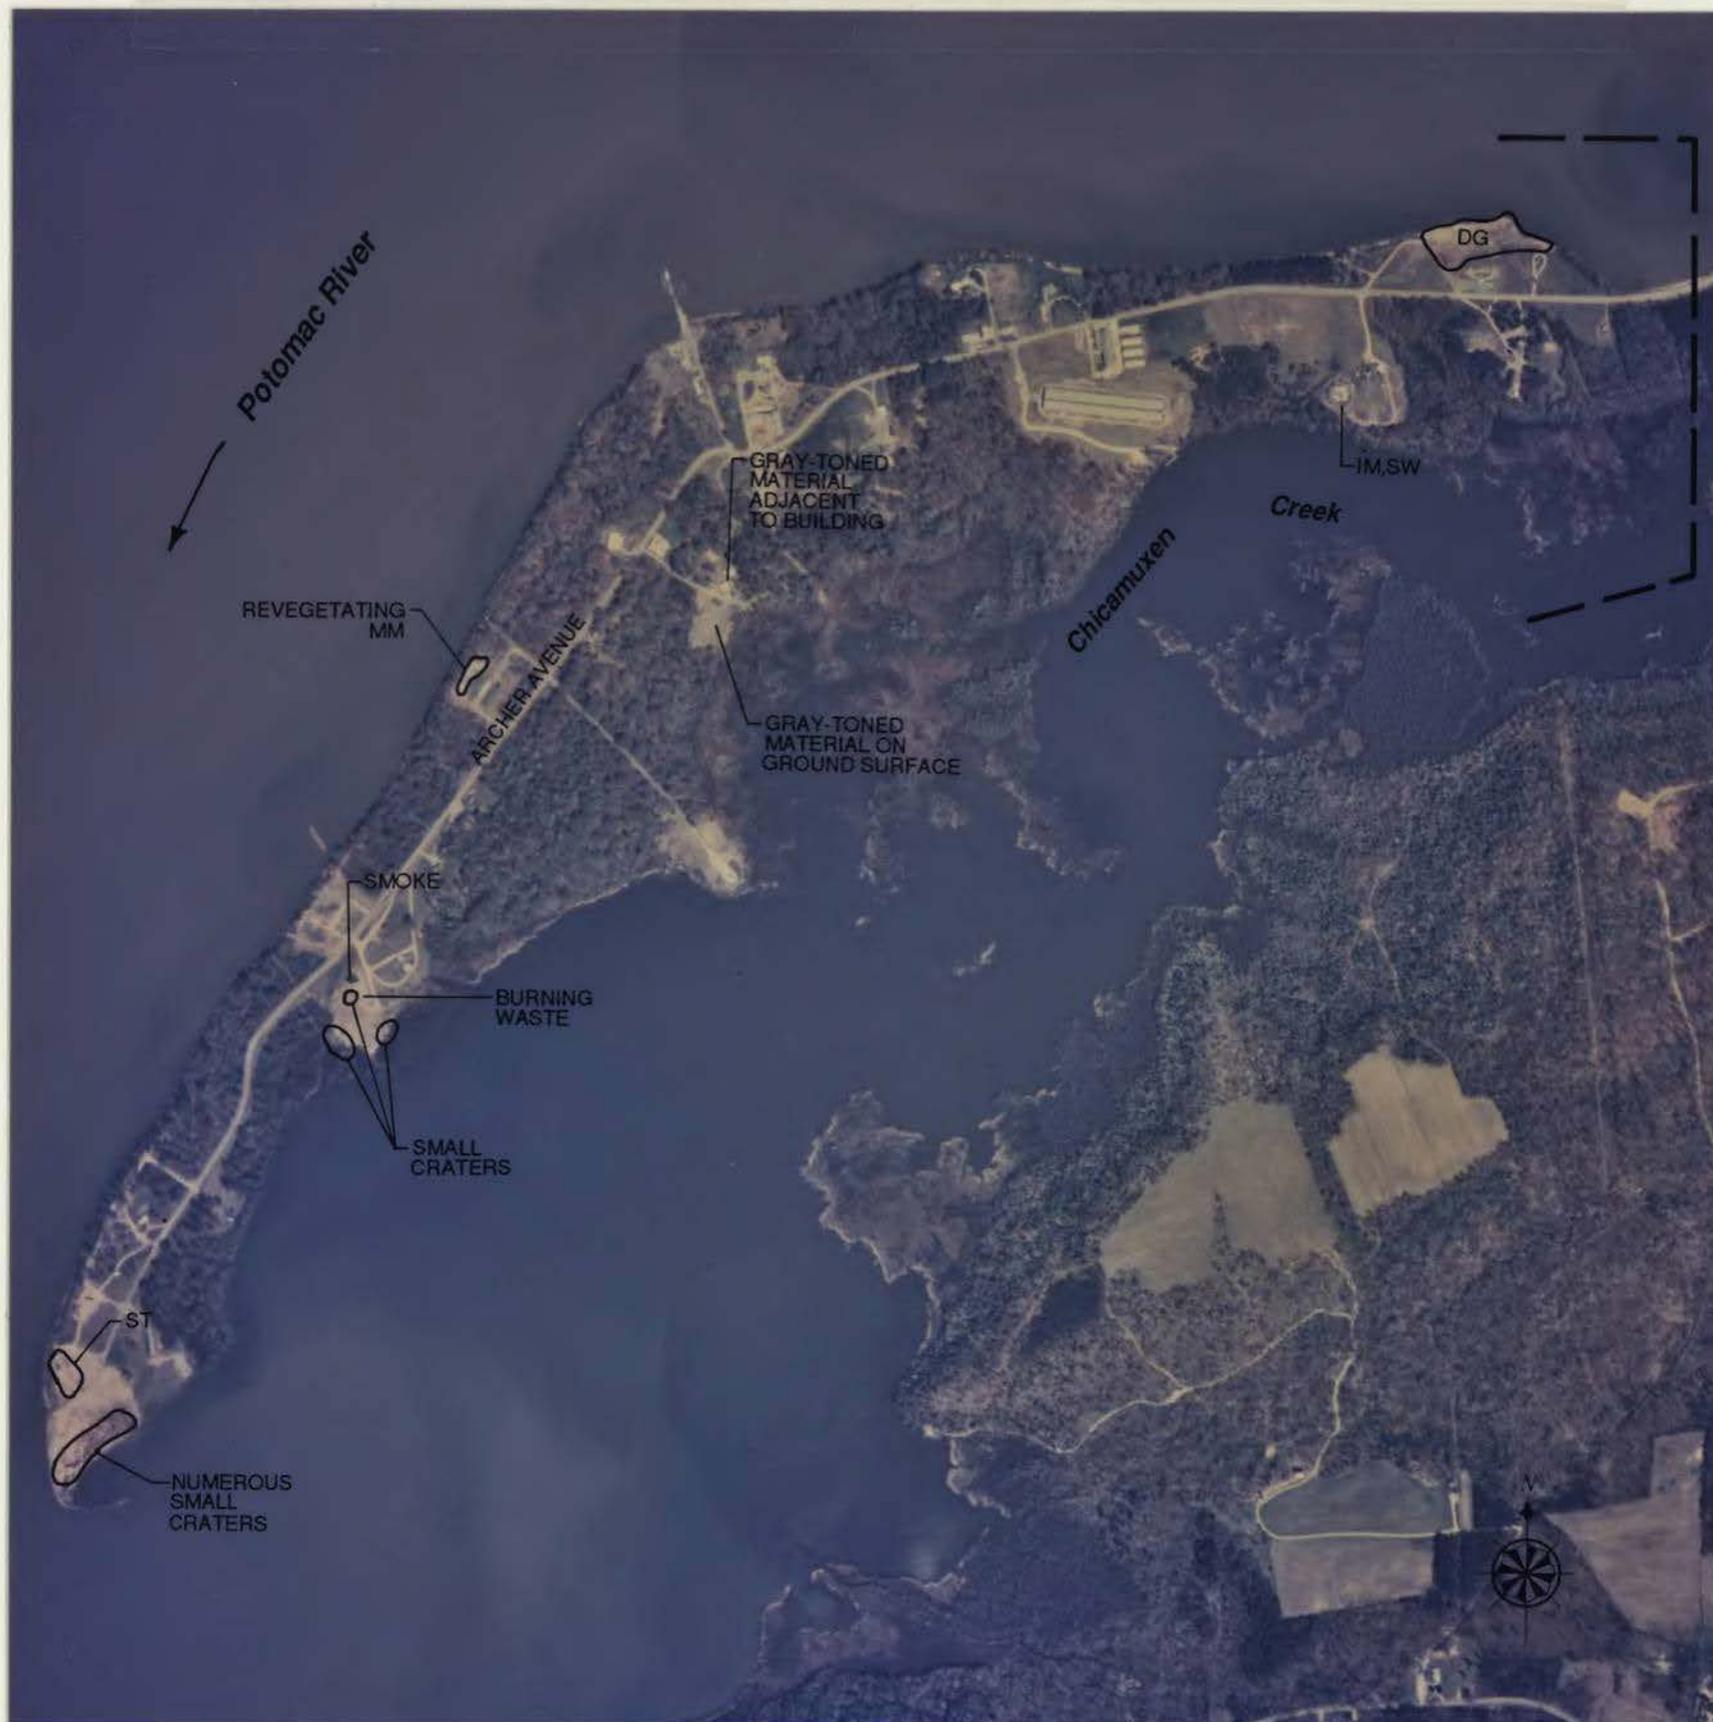
Figure 28. Indian Head NSWC, Stump Neck Annex, April 18, 1972. Approximate scale 1:11,800.

Solid waste is visible within the impoundment in the eastern portion of the annex. To the southwest, gray-toned material is observed adjacent to a small building and in a nearby area that had been cleared sometime prior to 1956. A new revegetating mound of material is visible to the southwest. Small craters, smoke, and burning waste are evident in the area where craters and fill were seen in 1967. At the end of the peninsula numerous small craters are again present suggesting continued disposal of ordnance. An area of staining is seen nearby.

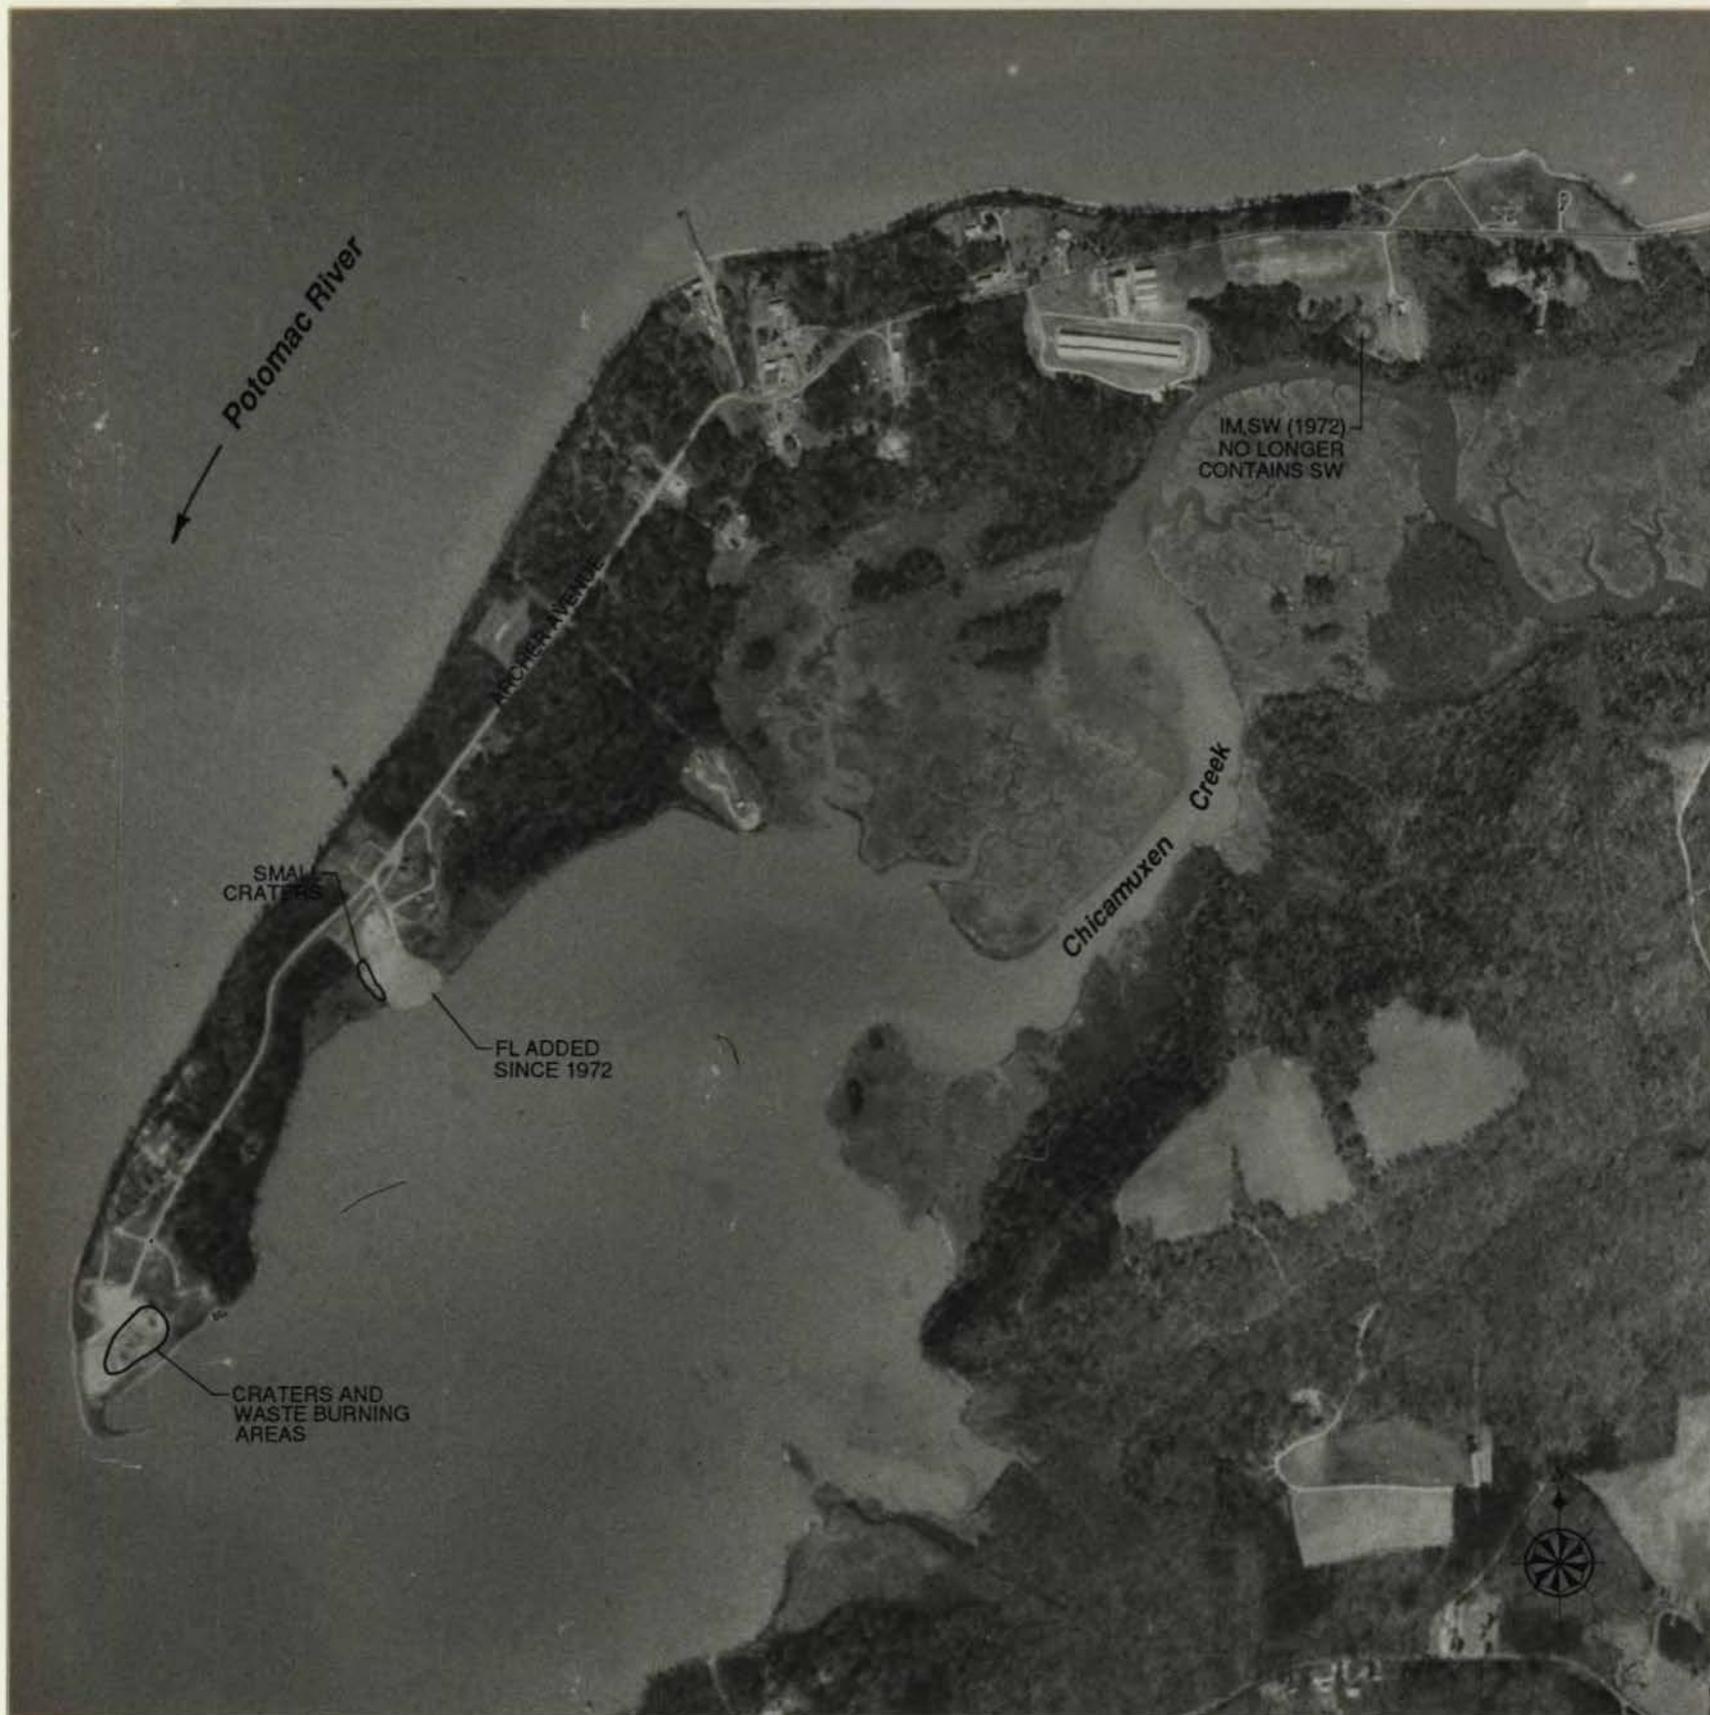
MARCH 29, 1982 (FIGURE 29)

The impoundment in the eastern portion of the annex no longer contains solid waste as seen in 1972. To the southwest, fill has been added at the area where craters, smoke, and burning waste were noted in 1972. No craters or burning areas are observed; however, several old craters are seen adjacent to the south end of the fill area. At the tip of the peninsula, craters and waste burning are evident as observed in 1972, but the location of the craters has changed indicating continuing disposal of ordnance.

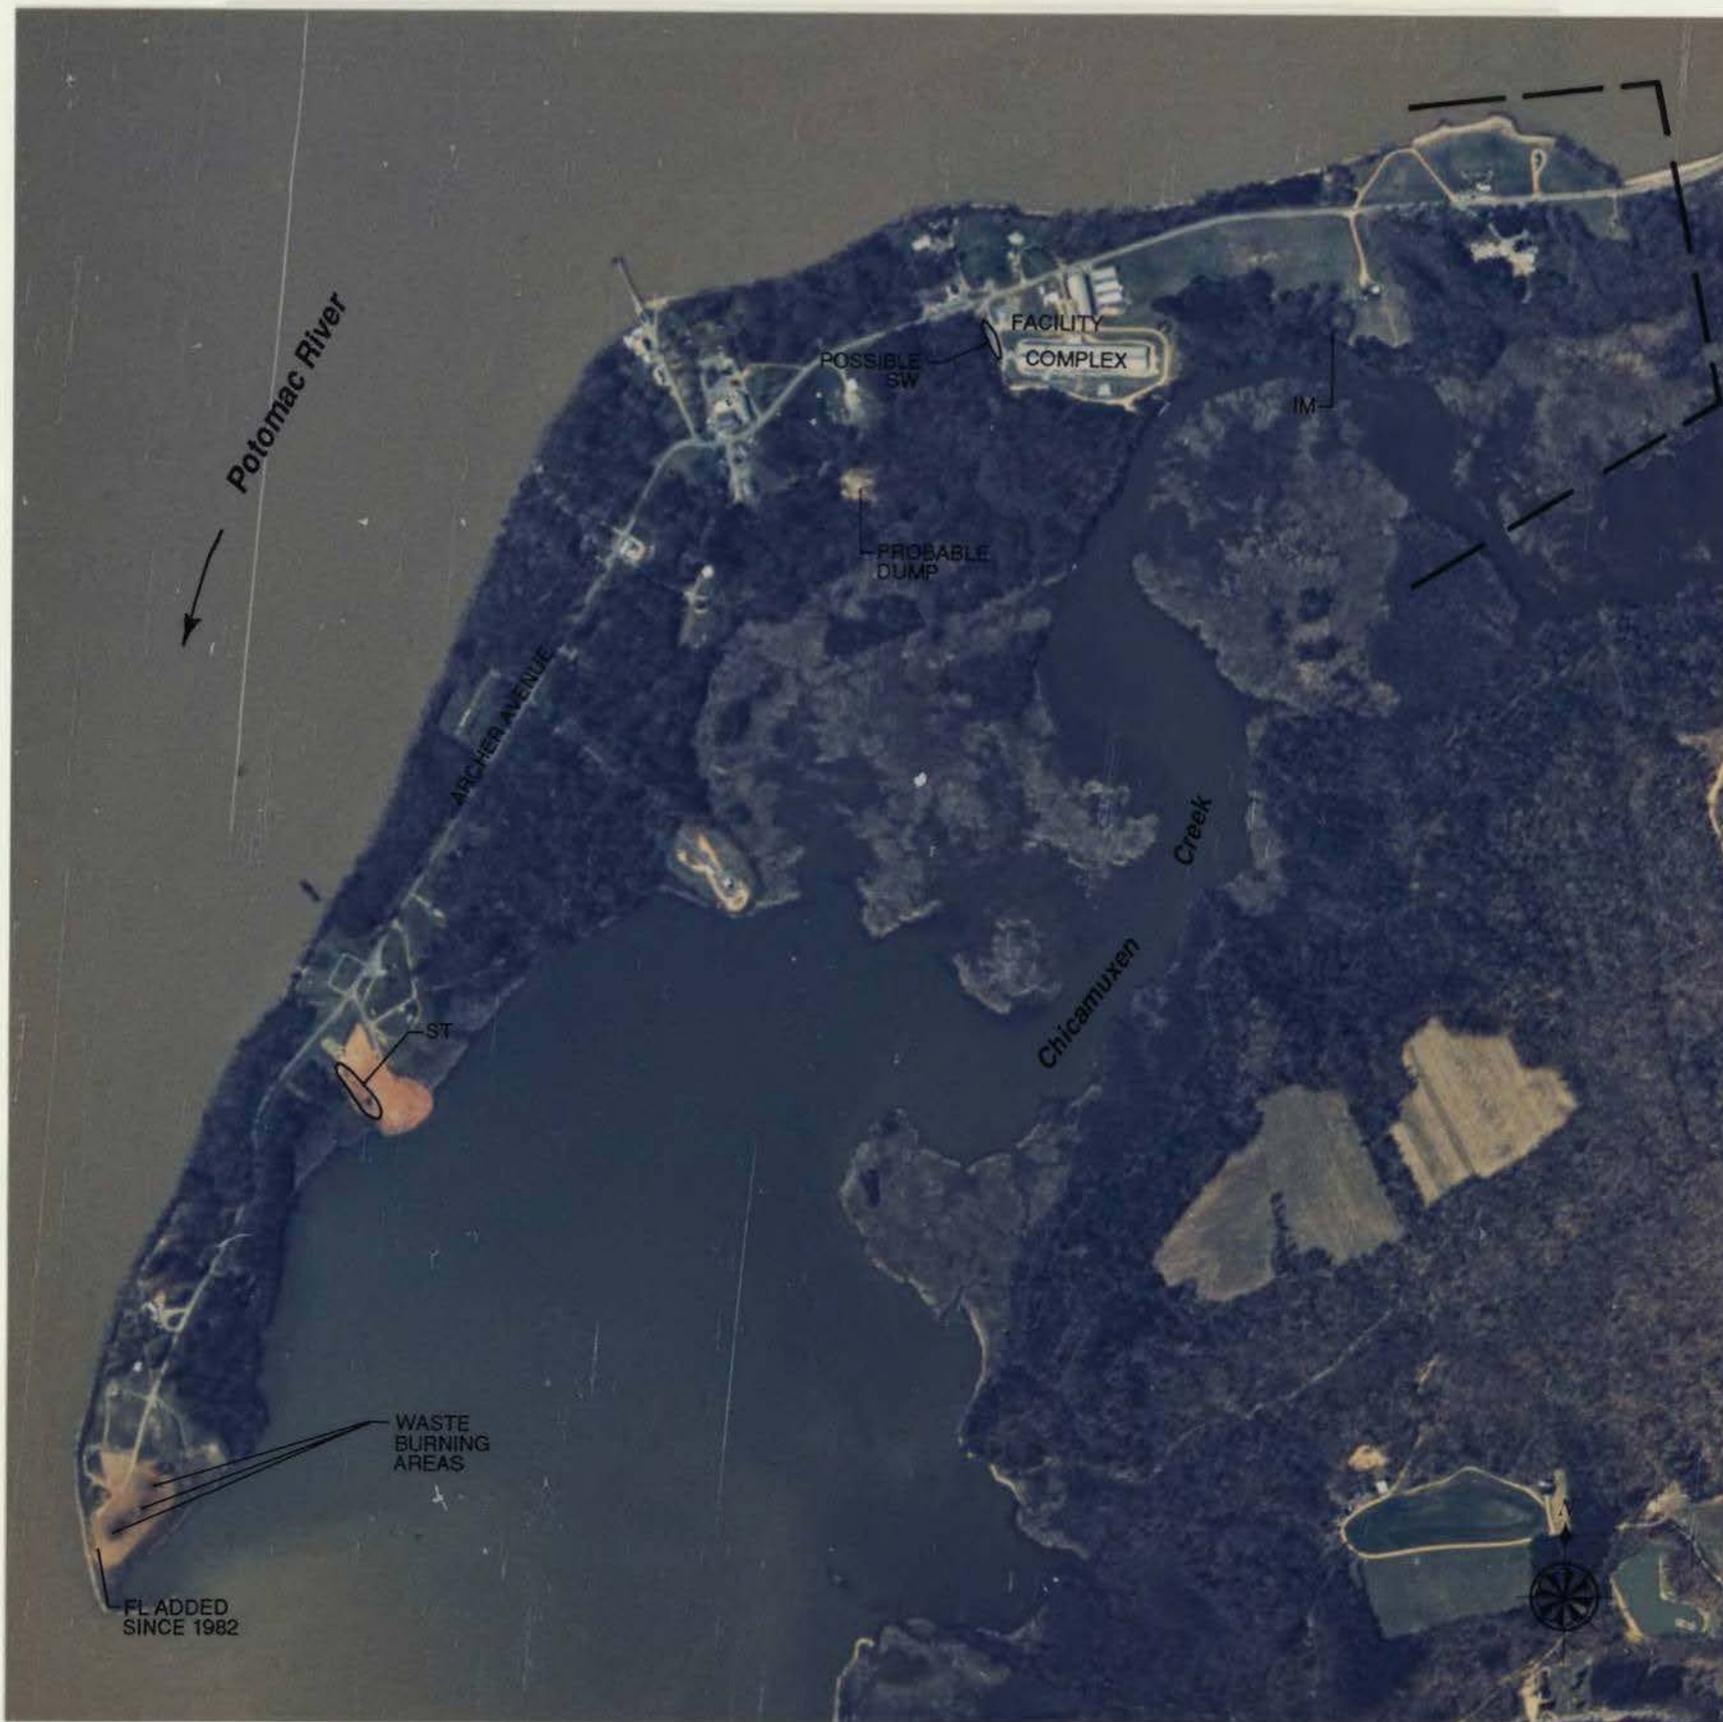
APRIL 10, 1987 (FIGURE 30)

Possible solid waste is observed in a gully on the western side of a large facility complex. A probable dump is also evident to the southwest. Further to the southwest, changes are identified at the ordnance and waste disposal area. New fill covers the old craters seen in 1982 and staining is present on the south side of the fill. At the tip of the peninsula new fill has been added since 1982 covering craters and waste burning areas seen in 1982. Three distinct new waste burning areas are seen on this fill area.
