FACT FINDER NUMBER 24 ENVIRONMENTAL UPDATE FOR FIVE-YEAR REVIEW  
OPERABLE UNITS 1, 2, 3 AND 4 (OU1) (OU2) (OU3) (OU4)NAS JACKSONVILLE FL (PUBLIC  
DOCUMENT)  
3/1/2007  
NAS JACKSONVILLE

## FactFinder Environmental Update

0003 Fact Sheet #24  
March 2007

### Five-Year Review Operable Units (OUs) 1, 2, 3, and 4

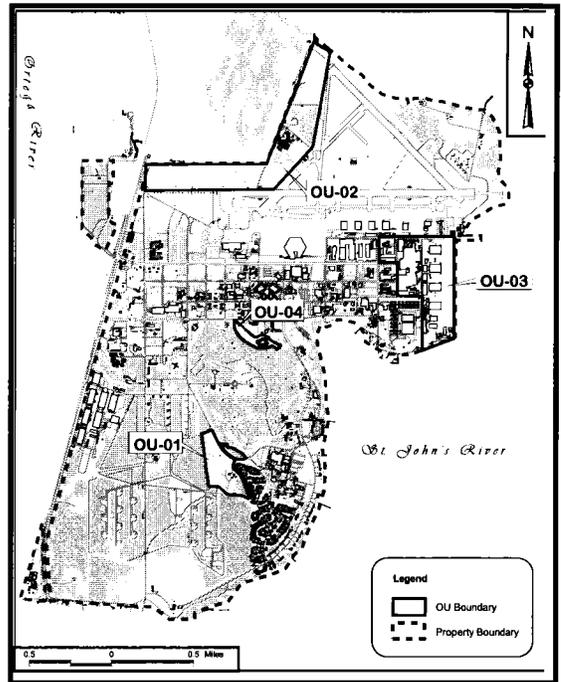
Figure 1. OU Site Map

The OUs covered by this five-year review are shown on Figure 1. A brief introduction to each follows.
