Interim Measures Plan  
SWMU 11 - Building 38  
Naval Station Roosevelt Roads  
RCRA/HSWA Permit No. PR2170027203  
Ceiba, Puerto Rico

Contract No. N62470-95-D-6007  
CTO-0269

July 21, 2003

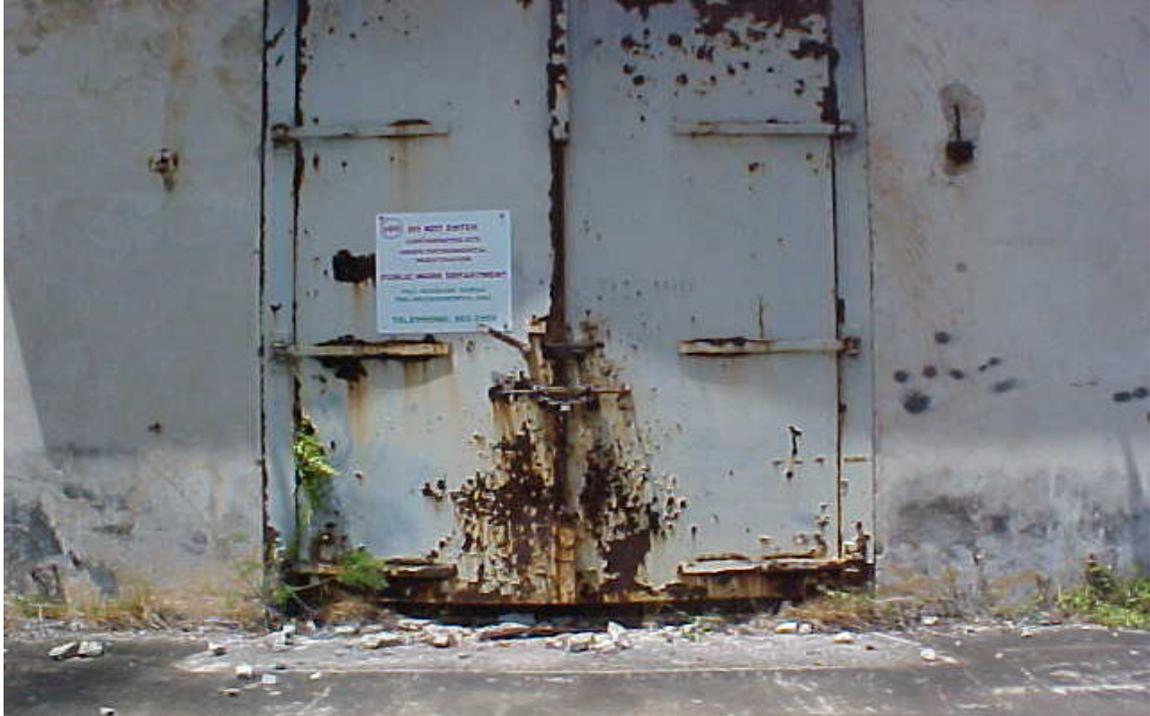
**Photo 1**

View looking towards the eastern entrance to Building 38 (SWMU 11). This photo demonstrates that this entrance door to the building is secured with a chain and padlock, and contains a warning sign with a point of contact for the building.

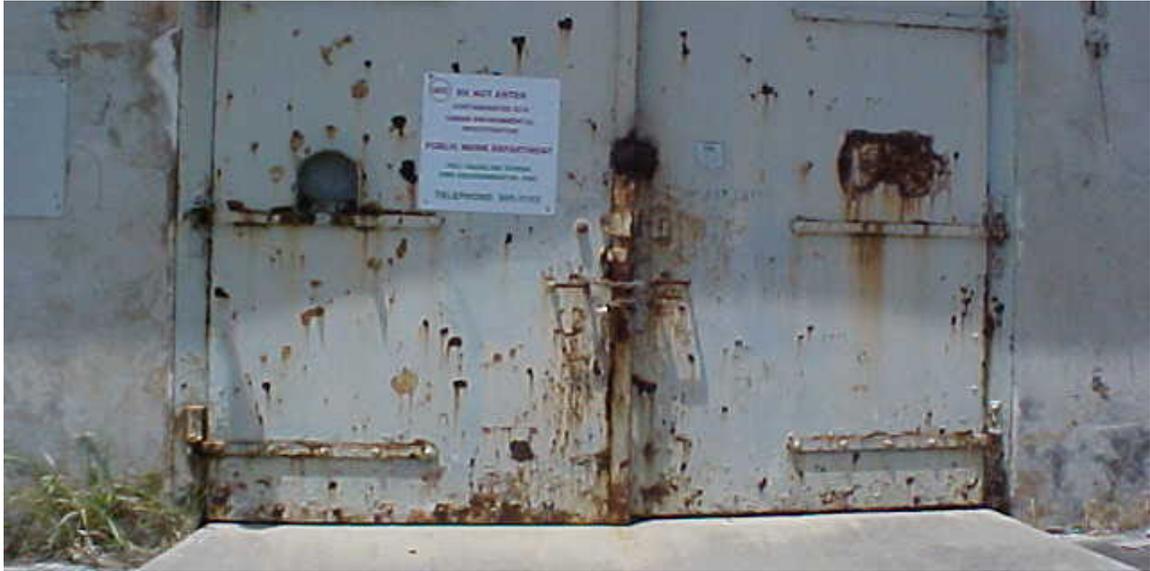
**Photo 2**

View looking towards the western entrance to Building 38 (SWMU 11). This photo demonstrates that this entrance door to the building is secured with a chain and padlock, and contains a warning sign with a point of contact for the building.

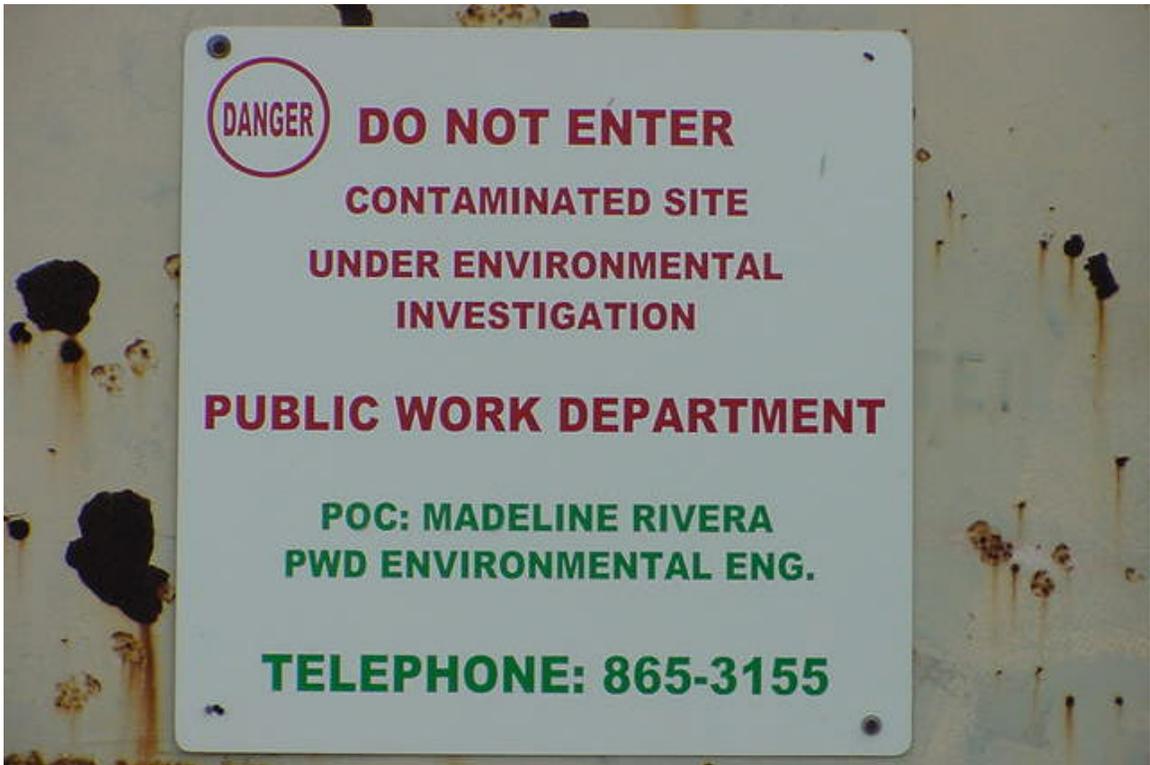
**Photo 3**

Close-up view of the warning signs posted on the doors to Building 38 (SWMU 11). This sign demonstrates that access to the interior portion of the building is prohibited. The sign also presents the point of contact (Madeline Rivera) and telephone number.

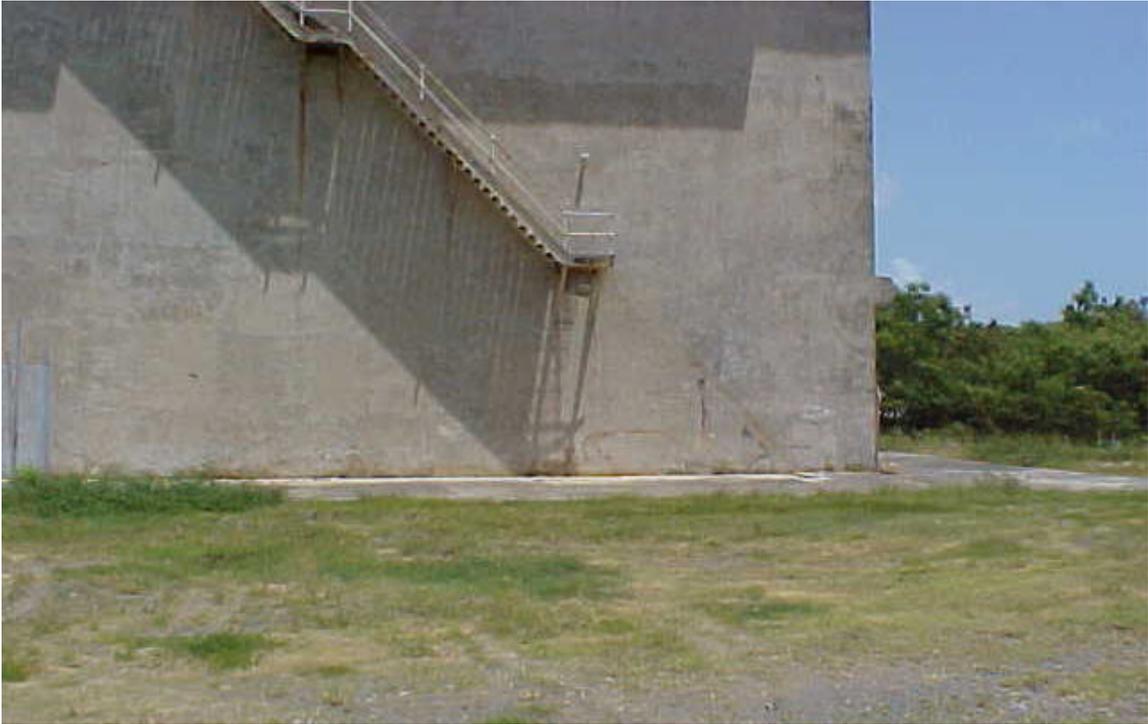
**Photo 4**

View looking towards the eastern side of Building 38 (SWMU 11). This photo demonstrates that the stair access leading to the upper level of Building 38 has been removed.
