Contractor Fatality

Fall from Heights

44 year old contractor employee fatality

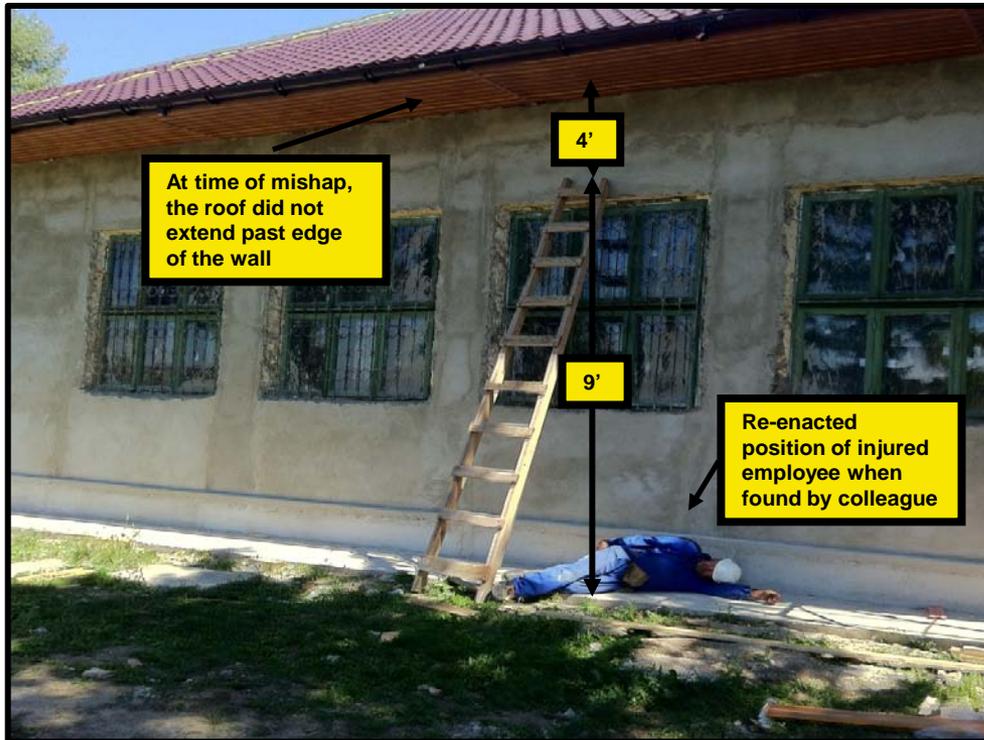
Activity: Two project managers (PM) conducting roof surveys in support of a Humanitarian Assistance (HA) contract to renovate rural schools accessed the roof with an inadequately sized ladder and failed to use any fall protection, despite availability on site. The PMs began working immediately upon arriving on site after having driven for almost nine consecutive hours. Less than 10 minutes after arrival, one PM, who already accessed the roof, was descending the roof to find his colleague laying at the bottom of the ladder bleeding from the head. The PM called emergency support, and the injured employee walked to the ambulance, but succumb to his injuries the next day.

- Failure to utilize correct ladder or appropriate and required fall protection to access to roof and conduct survey
- Failure to provide or employees with correct equipment or adequate training to safely conduct site survey

- **ALL** contractors shall comply with contract specifications and applicable safety & occupational health processes
- Contracts with limited/no direct oversight must focus prevention measures on high hazard features of work
- The Contingency Engineering (CE) specific Accident Prevention Plan that shall be used on all CE/HA projects
