TECHNICAL MEMORANDUM SUMMARY OF DIRECT PUSH SOIL SURVEY OCEANA
SALVAGE ACCESS ROAD NAS OCEANA VA
02/01/2005
CH2M HILL

Summary of Direct-Push Soil Survey, Oceana Salvage Access Road, Virginia Beach, VA

PREPARED FOR: Tim Reisch/NAVFAC Mid-Lant
PREPARED BY: Laura Cook/CH2M HILL
COPIES: Paul Landin/CH2M HILL
DATE: February 1, 2005

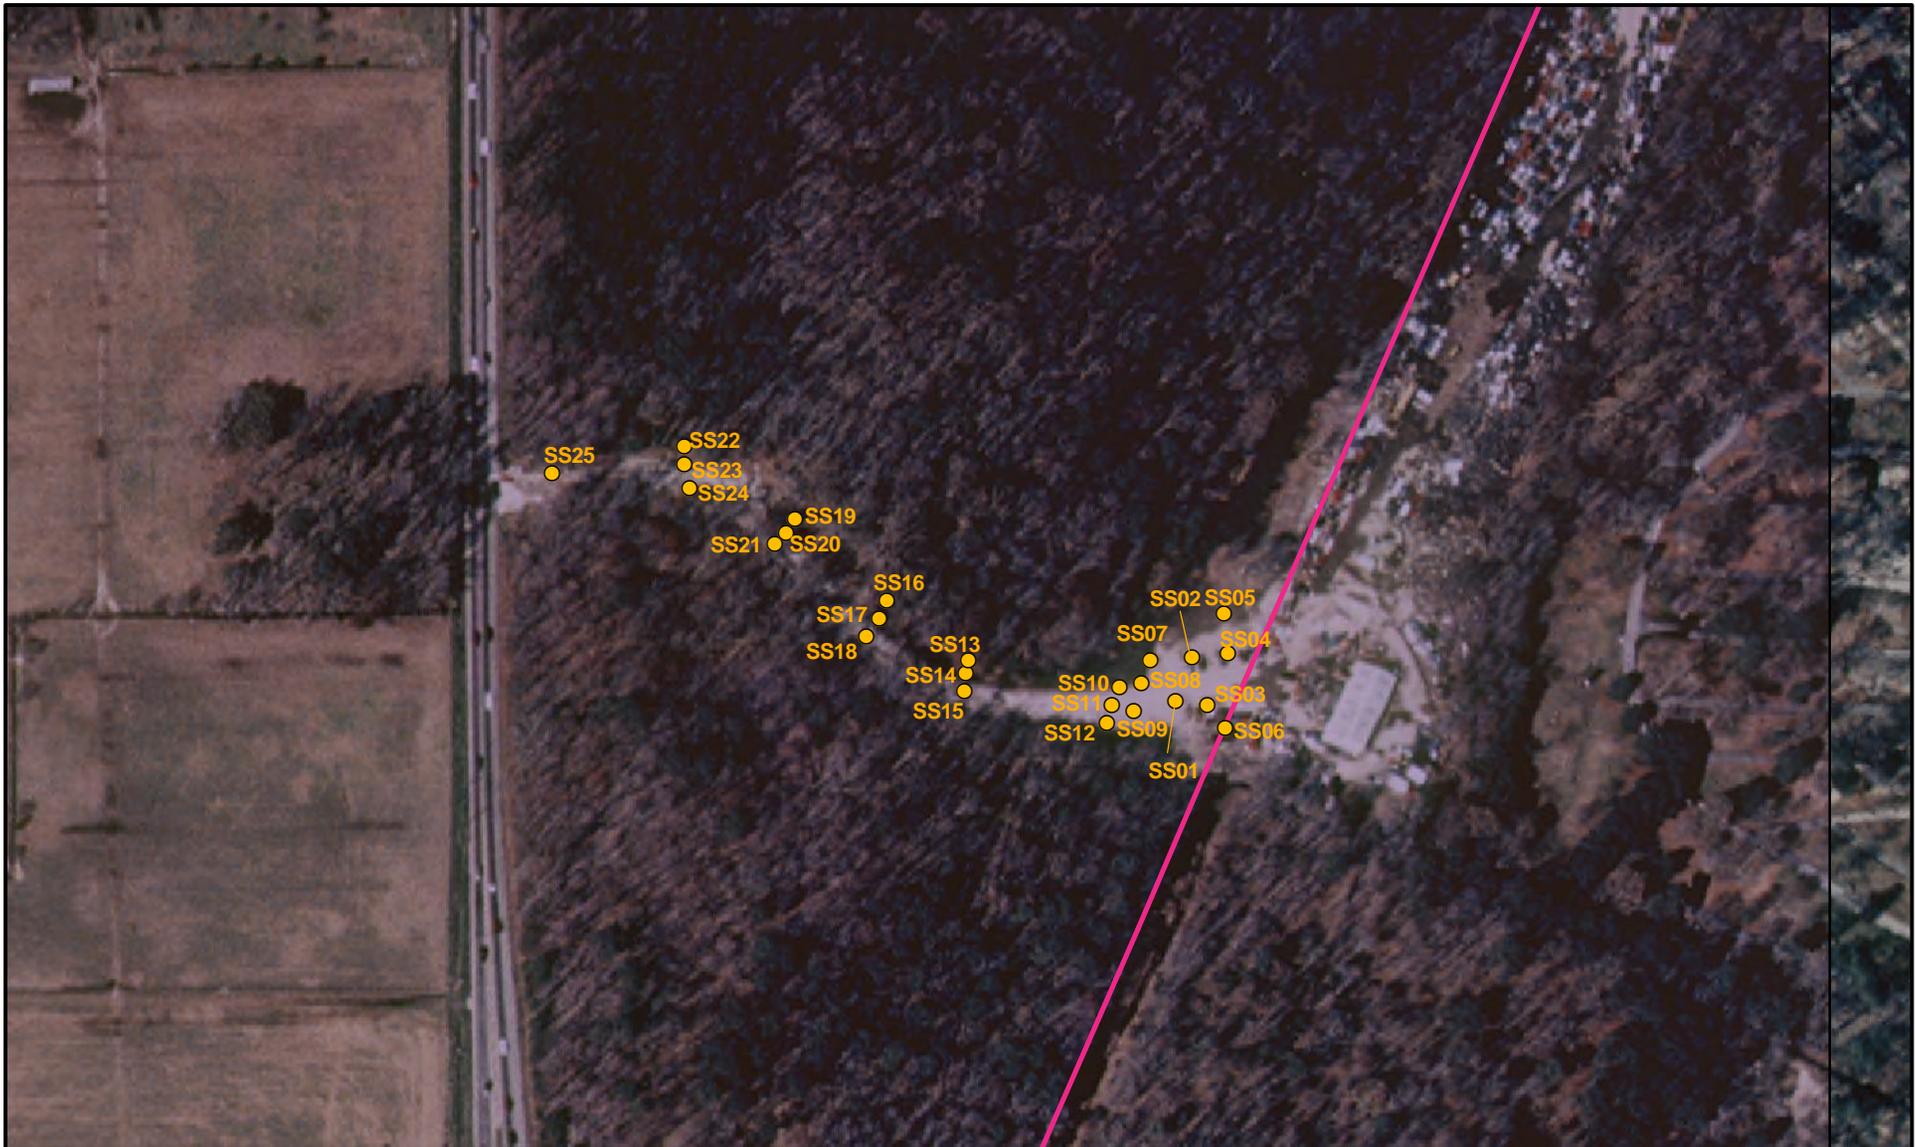
Figure 1
Sample Location Map
Oceana Salvage Access Road
Virginia Beach, Virginia

Sampling was initiated at approximately 9:00 AM. Direct push samples were collected using an IRA300 direct-push rig and 4-foot macrosamplers with disposable acetate sleeves. Direct-push samples were collected at twenty-five (25) locations. Sample locations were not surveyed and are approximated on Figure 1. Presence or absence and approximate depth of crushed battery casings were recorded in a field notebook. Approximate depths to waste and depths to visually clean soil are shown on Table 1. Waste containing battery casings was encountered at all but one (SS16) sample location. Battery fragments were encountered between approximately 0.1 and 2.5 feet below ground surface (bgs). The thickness of the layer of battery fragments was approximately 0.5' to 1.0'. Visual examination of the soil at SS16, where no battery fragments were observed, indicated other debris including plastic and brick from 1.25' - 1.75' bgs. Images 1 and 2 show battery fragments from SS01 and SS09 respectively and are typical of the battery fragment waste encountered beneath the road surface.
