FINAL TECHNICAL MEMORANDUM CONFIRMATION SAMPLING REPORT FOR THE SITE 5  
REMOVAL ACTION ST JULIENS CREEK ANNEX VA  
12/1/2012  
CH2M HILL

## Confirmation Sampling Report for the Site 5 Removal Action

St. Juliens Creek Annex  
Chesapeake, Virginia

December 2012

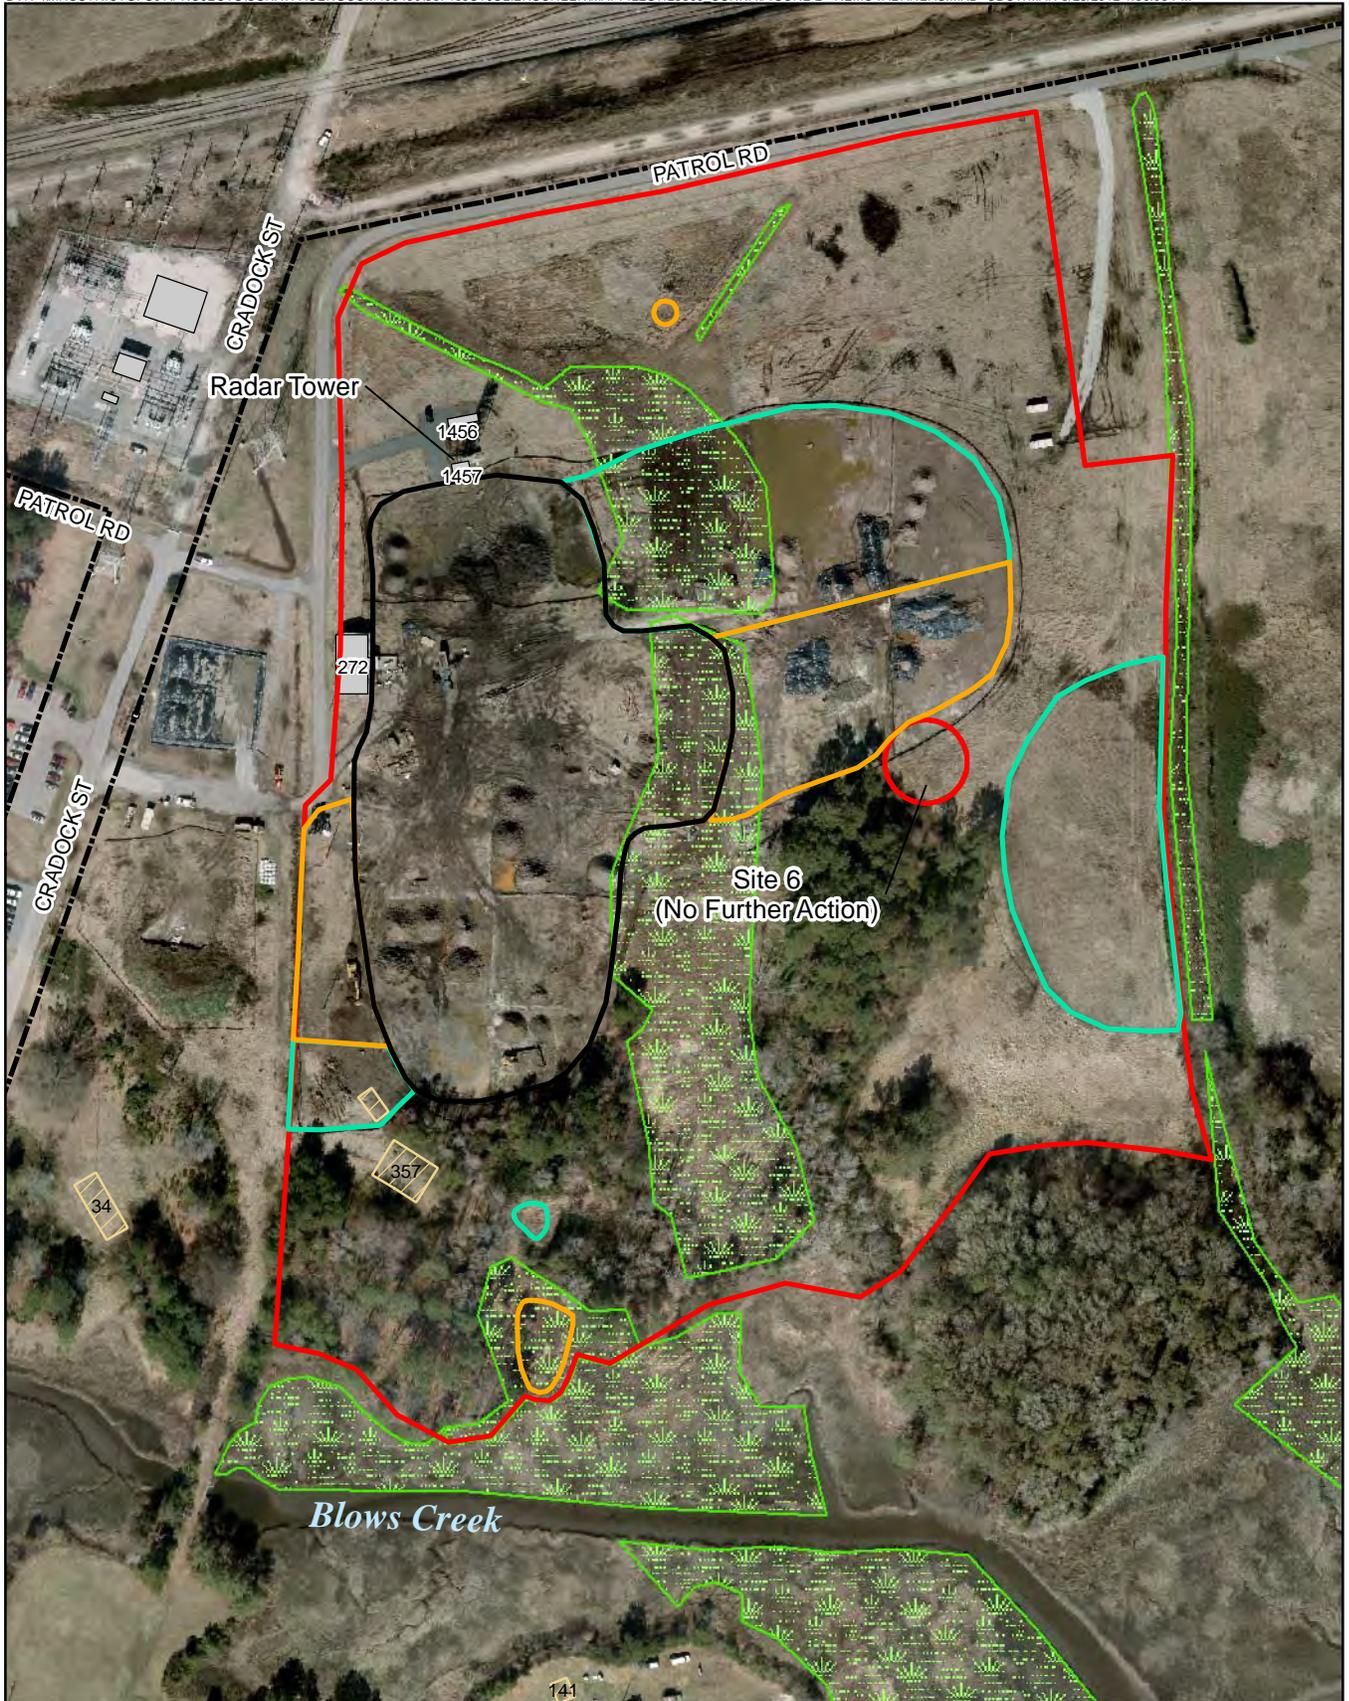
Figure 2  
 Site 5 Removal Areas  
 N Confirmation Sampling Report for the  
 Site 5 Removal Action  
 St. Juliens Creek Annex  
 Chesapeake, Virginia

The removal action at Site 5 consisted of the excavation, removal, backfill and restoration of the waste/burnt soil area, three isolated surface soil hot spots, and additional surface soil and sediment areas that present a risk to human health and ecological receptors as outlined in the Site 5 EE/CA (CH2M HILL, 2007a) (**Figure 2**). Within the EE/CA, risk-based cleanup goals were developed to ensure sufficient removal of the areas determined to pose risks to human health. Ecological cleanup goals were not developed because the site-wide average concentrations of ecological chemicals of potential concern remaining in place in surface soil and sediment following implementation of the removal action reduce the potential risks to an acceptable level, based on the approach described in the EE/CA. Therefore, to verify that the extent of the removal action resulted in concentrations protective of human health, confirmation samples were to be collected from the areas that posed human health risks, areas that included the waste/burnt soil area.

To verify that the vertical extent of the removal resulted in concentrations protective of human health, confirmation samples were to be collected from the floor of the waste/burnt soil and human health risk removal areas shown on **Figure 2**. During the removal action, additional areas of waste/burnt soil were identified in the human health and ecological risk-based removal areas east of the initial waste/burnt soil area and the boundary of the waste/burnt soil area was extended as shown on **Figure 3**, which required collecting an additional 13 confirmation floor samples within that area. One five-point composite confirmation floor sample was collected per hot spot area and within each of the approximate 75- by 75-foot grid cells, as defined in the confirmation sampling work plan (CH2M HILL, 2007c), within the waste/burnt soil and additional surface soil and sediment human health risk-based removal areas (**Figure 3**). The samples were collected from 0 to 6 inches below the floor of the excavation.

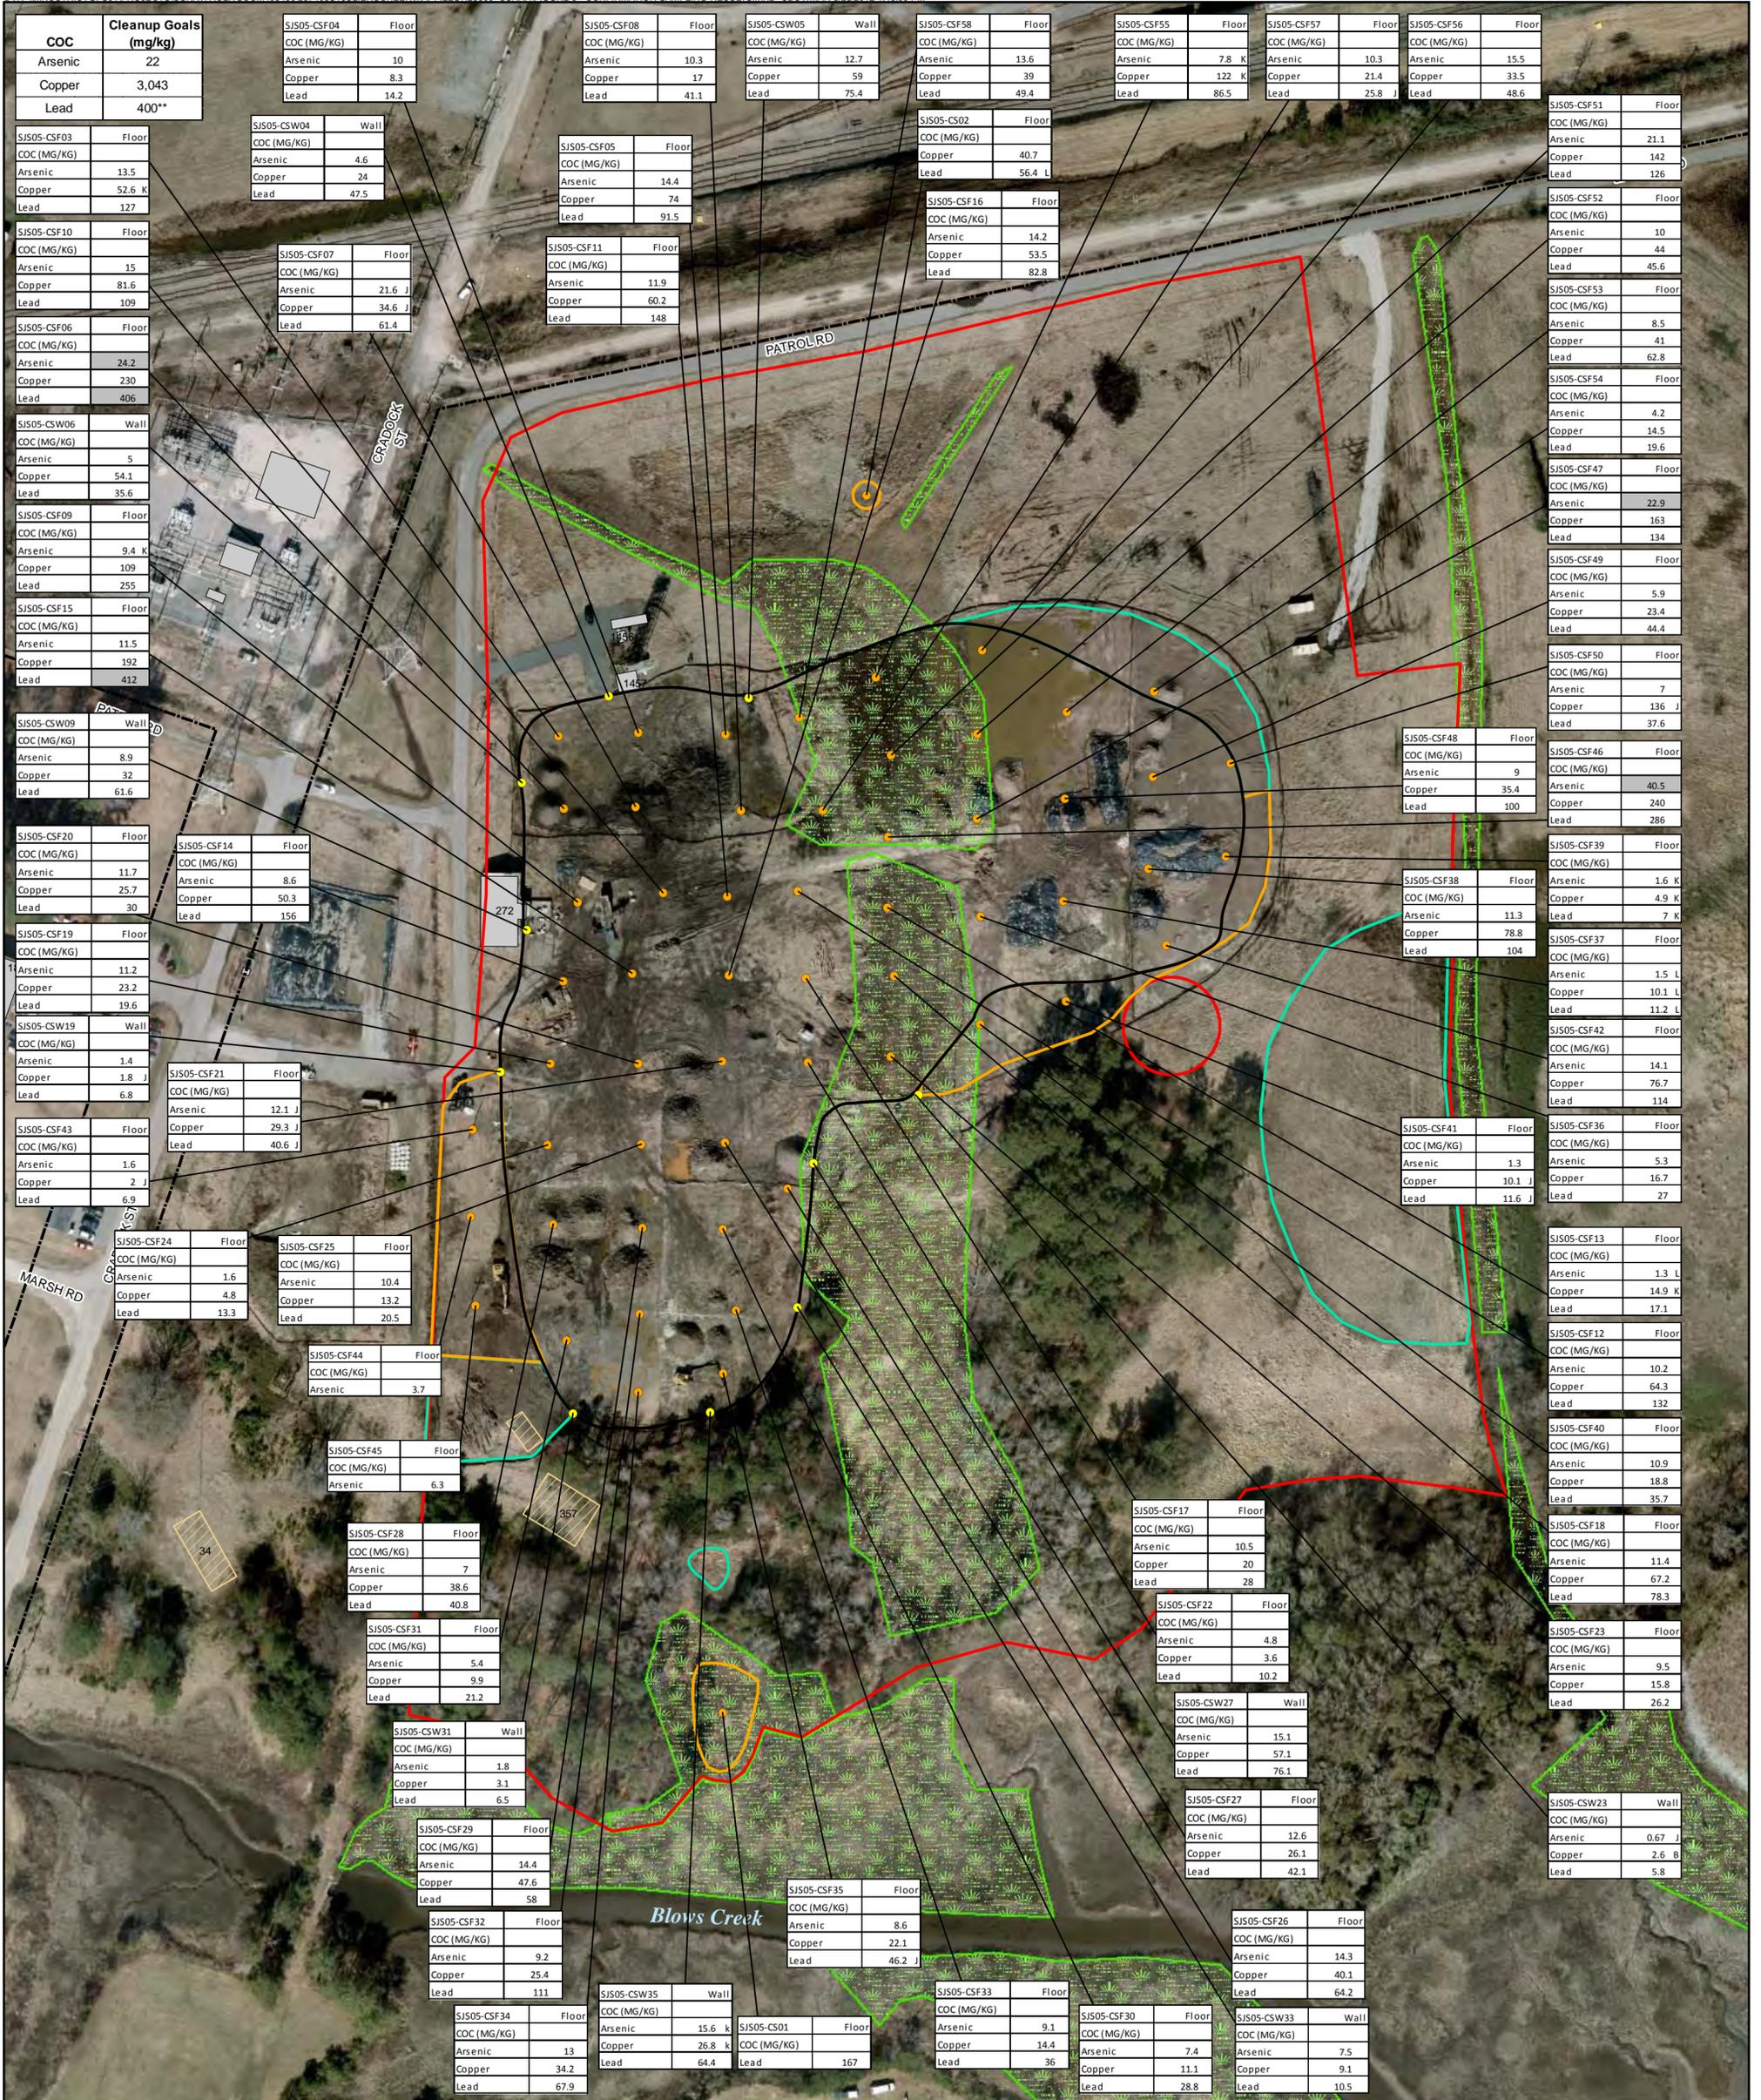
**Figure 3**  
 Confirmation Sampling Results  
 Confirmation Sampling Report for the  
 Site 5 Removal Action  
 St. Juliens Creek Annex  
 Chesapeake, Virginia

To verify that the horizontal extent of the removal conducted in the waste/burnt soil area resulted in concentrations protective of human health, 10 wall samples were collected around the perimeter of the waste/burnt soil area (**Figure 3**). Wall samples were not collected along the perimeter of the waste/burnt soil area adjacent to the human health or ecological risk-based areas, as those areas were also identified for removal. The horizontal extents of the human health and ecological risk-based removal areas were defined using existing

The analytical results for the confirmation samples were compared against the cleanup goals established in the EE/CA (22 milligrams per kilogram [mg/kg] for arsenic, 3,043 mg/kg for copper, and 400 mg/kg for lead<sup>[1]</sup>). Arsenic concentrations in three floor samples (CSF06, CSF46, and CSF47) and lead concentrations in two floor samples (CSF06 and CSF15) exceeded their respective cleanup goal (**Figure 3** and **Table 2**). No exceedances of copper were reported.

Concentrations of copper in the confirmation soil samples were all below the copper cleanup goal. Arsenic concentrations in three of the confirmation floor samples (CSF06, CSF46, and CSF47) and lead concentrations in two of the confirmation floor samples (CSF06 and CSF15) exceeded their respective cleanup goal. However, the 95 percent UCL of the means of the arsenic and lead concentrations were below their respective cleanup goals. The concentrations of arsenic, copper, and lead in all of the confirmation wall samples were below their respective cleanup goals. Therefore, the confirmation samples have verified that the vertical and horizontal extent of the removal action is protective of human health.
